THE EFFECTS OF HIGH INTENSITY ELECTRICAL  
CURRENTS ON ADVANCED COMPOSITE MATERIALS

REPORT NO. U-5018

FINAL REPORT

Prepared Under Contract  
N00019-71-C-0063

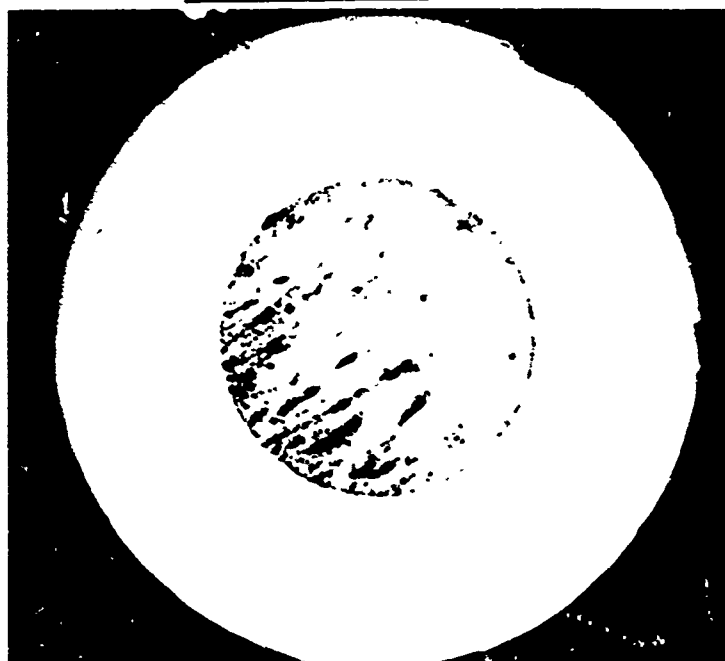
FIGURE 1A. BORON-CARBON CORE FILAMENT CROSS-SECTIONAL  
VIEW (800X) OF UNEXPOSED SPECIMEN

Scanning electron microscope (SEM) pictures were made of the boron-carbon core filaments which were exposed to the various injection current levels. The SEM pictures revealed that the same type of degradation (cracking) exists with the boron-carbon core filament type as was previously determined<sup>1</sup>

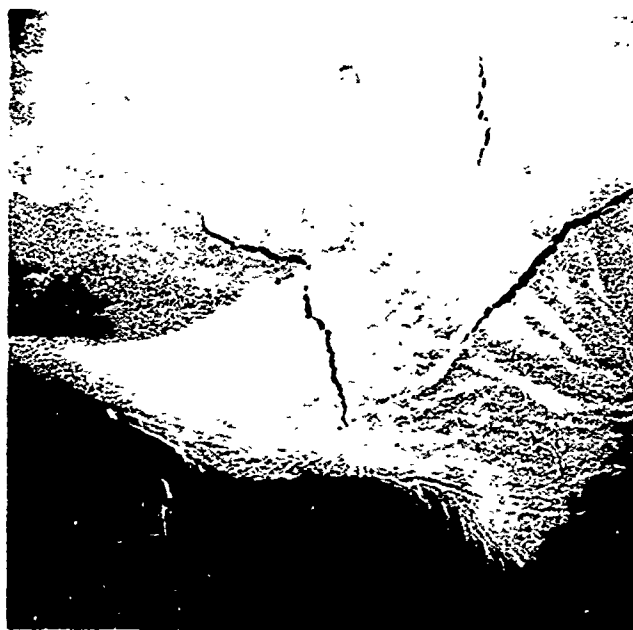
FIGURE 3A. BORON-CARBON CORE FILAMENT-SEM CROSS-SECTIONAL VIEW (600X) OF SPECIMEN BC-3 EXPOSED TO  $3.7 \times 10^4$  AMPS/CM<sup>2</sup> INJECTION

FIGURE 3B. BORON-CARBON CORE FILAMENT-SEM LONGITUDINAL VIEW (200X) OF SPECIMEN BC-3 EXPOSED TO  $3.7 \times 10^4$  AMPS/CM<sup>2</sup> CURRENT INJECTION

for the boron-tungsten core filament type. This is typically illustrated in Figure 3 for Specimen BC-3 in both a longitudinal and cross-sectional view. From the SEM and visual observations, it appears that the degradation level of the boron-carbon core filaments compares to that of the boron-tungsten core filaments as reported in the previous program.<sup>1</sup>

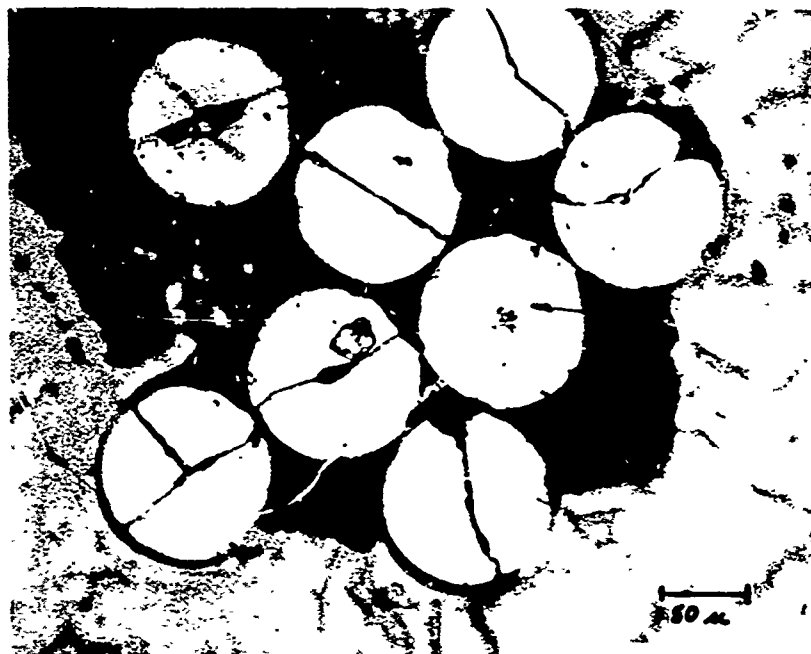
A. 1BW8 EXPOSED

B. 1BW8 CONTROL

FIGURE 14. MICROPHOTOGRAPHS OF MICROPROBE TRAVERSE PATHS ON  
1BW8 BORON FILAMENTS

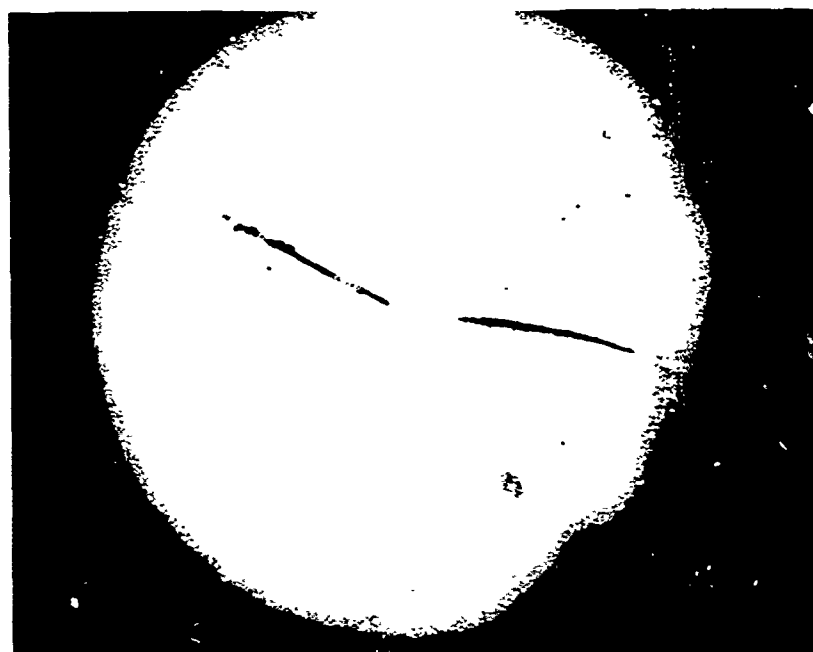
FIGURE 22. SPECIMEN NO. 22 - BORON FILAMENT AFTER EXPOSURE TO  $5.0 \times 10^4$  AMPS/CM<sup>2</sup> ELECTRIC CURRENT INTENSITY (A = cross-sectional view 1/4 inch from filament end; B = cross-sectional view of 2 inches from filament end) (Continued on page 2-46)

FIGURE 22. SPECIMEN NO. 22 - BORON FILAMENT AFTER EXPOSURE TO  $5.0 \times 10^4$  AMPS/CM<sup>2</sup> ELECTRIC CURRENT INTENSITY (C = cross-sectional view 4 inches from filament end)
