HARDWARE DEVELOPMENT FOR
PROJECT QUICK FIND,
THE SEA LION OBJECT RECOVERY SYSTEM

by
Ronald L. Seiple
Ocean Technology Department
July 1972

NAVAL UNDERSEA CENTER, SAN DIEGO, CA. 92132

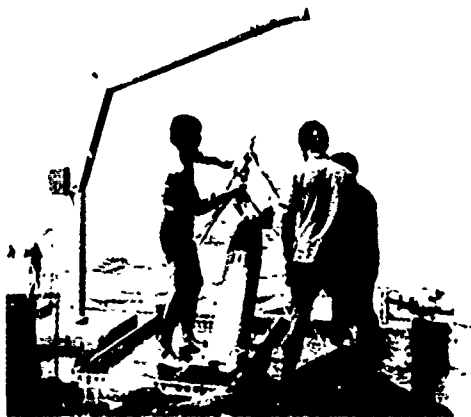
Figure 16. Sea lion training target.

The training target is shown in Fig. 16 at sea aboard the ocean work barge. The tapered portion of the target, dark area between the tail fins and the cylindrical tube section, is sound-isolated from the rest of the target. This section is also a pressure hull and reduces the target's in-water weight. The modified tail cone is attached to a fabricated aluminum cylinder mounted on a base plate. The tail cone, mid-body cylinder, and base plate is a unit for easy assembly and disassembly. The 6-foot-square frame creates a steady platform and ensures an upright position when being lowered to the bottom. A pelican hook, operated from the surface, releases the lowering bridle from the four corners of the frame, leaving the target sitting on the bottom without lines going to the surface.

The sensitive portion of the target is the attachment zone for the animals. This section houses a klunk (hit) detector which is used to indicate that the sea lion has attempted his attachment at the desired area of the target. When a proper hit occurs, the noise made during the attachment turns off the pinger and signals the surface of

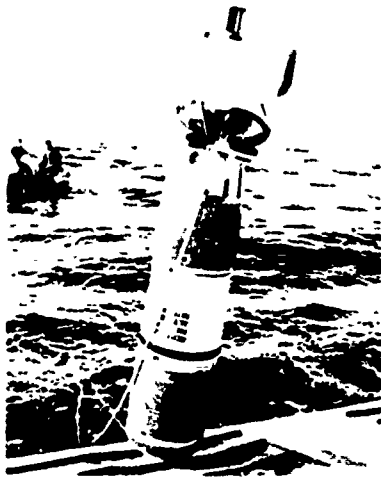
Figure 19. ASROC target recovered during Quick Find operational test.

using only the grabber and line attached by the animal (Fig. 19). The divers observed that the target had been pulled over by the larger-diameter grabber so that it was at an acute angle from the bottom.
