TECHNICAL REPORT 4357

THE EFFECTS OF LONG TERM STORAGE  
ON  
SPECIAL PURPOSE LEAD AZIDE

PICATINNY ARSENAL  
DOVER, NEW JERSEY

Technical Report 4357

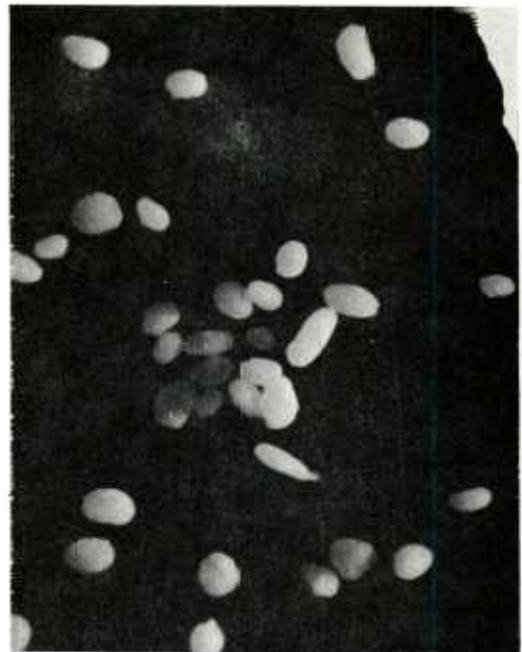
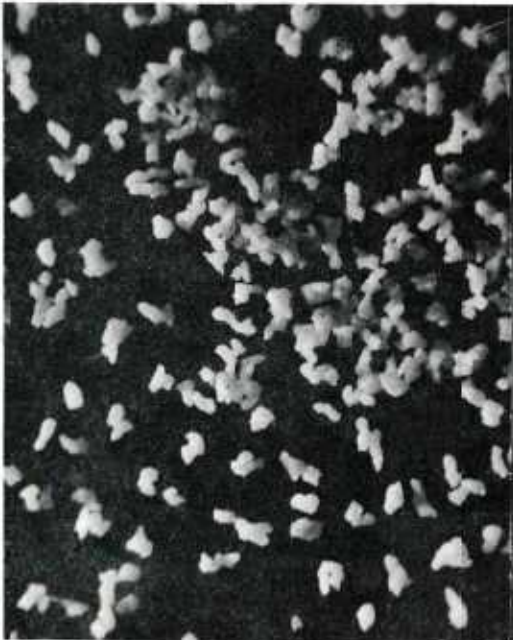
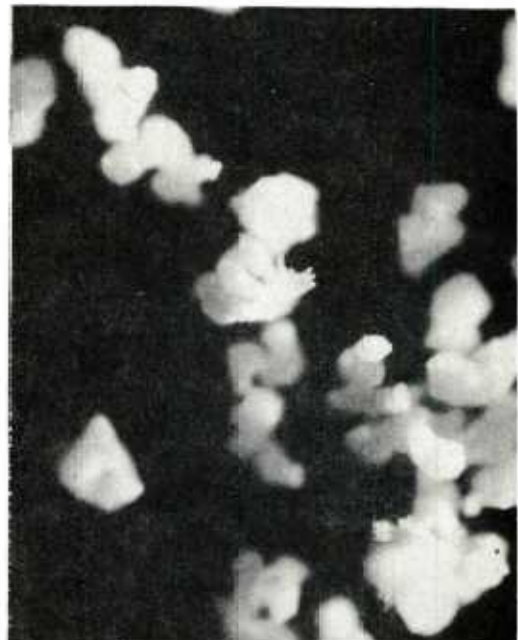
Figure 19

JA-4-71 X 40

JA-4-71 X 100

JA-4-76 X 40

JA-4-76 X 100

It was decided to hold in abeyance any recommendations as to action to be taken pending examination of later surveillance samples. This should allow for a more complete assessment as to frequency of occurrence of these particles, and the detection of any growth of the spines.

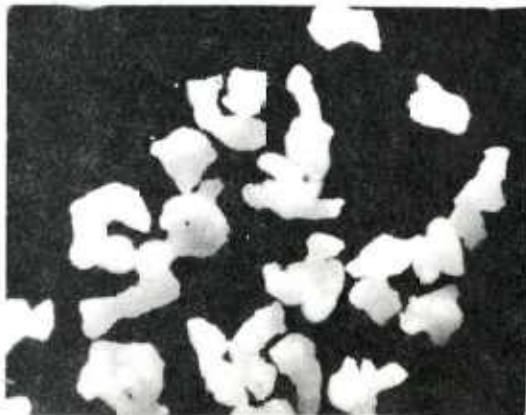
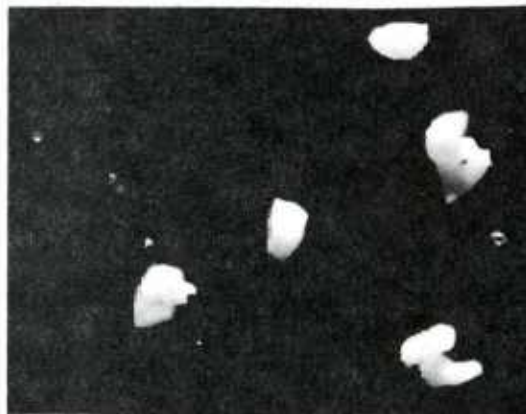
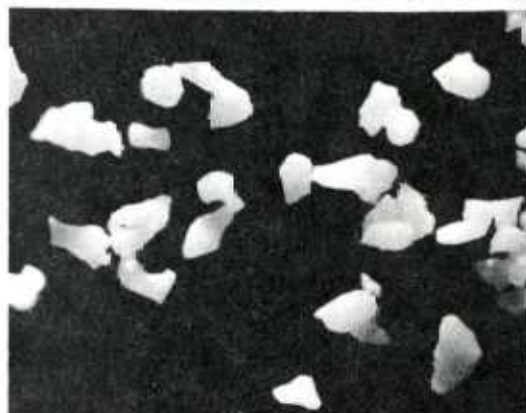
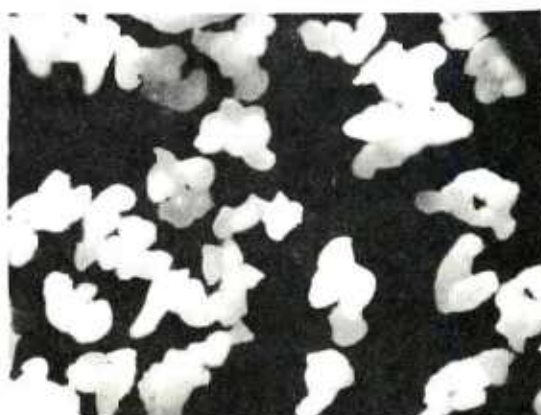
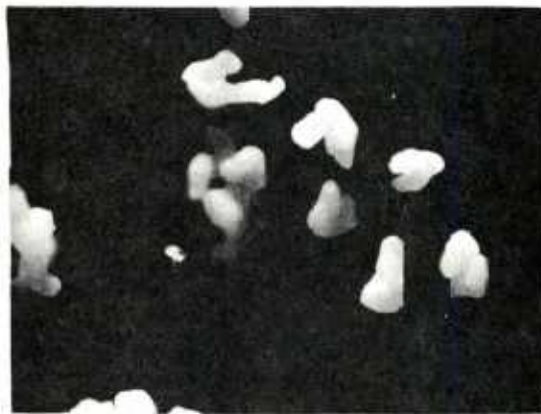
Photomicrographs SPLA as Received & 1st Cycle  
FIGURE 1

JA-4-84  
As Received

JA-4-84  
1st Cycle

DUP 53-44  
As Received

DUP 53-44  
1st Cycle

JA4-52  
As Received

JA-4-52  
1st Cycle

Military specifications require that production lead azide (SPLA and RD 1333) contain no well defined crystalline material if observed through a microscope. With a few exceptions, photomicrographs taken of SPLA and RD 1333, as received from storage, show satisfactory agreement with this requirement (Fig 11). However, following each temperature cycle the photomicrographs indicate the appearance of small crystallites and, in some cases, the growth of clear crystalline material on the lead azide particles. Fig 12 and 13 demonstrate the clarity and show the well-defined crystalline faces of the crystallites. It should be emphasized, however, that the number of the crystallites is not large. (These photomicrographs were chosen specifically to indicate the nature and morphology of the crystallites and are not indicative of their concentration.)

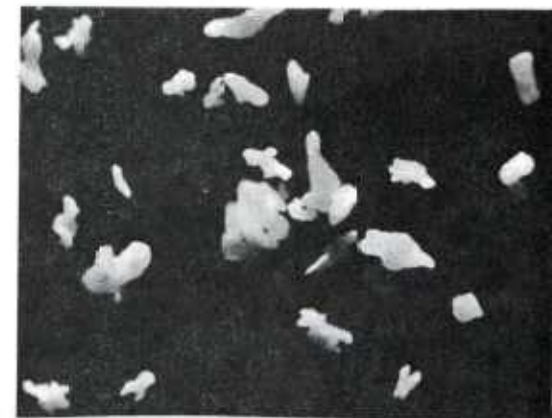
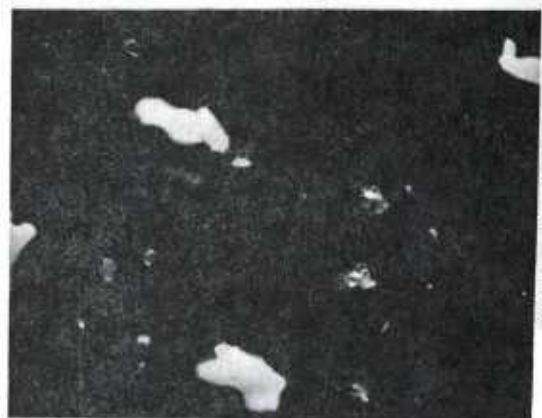
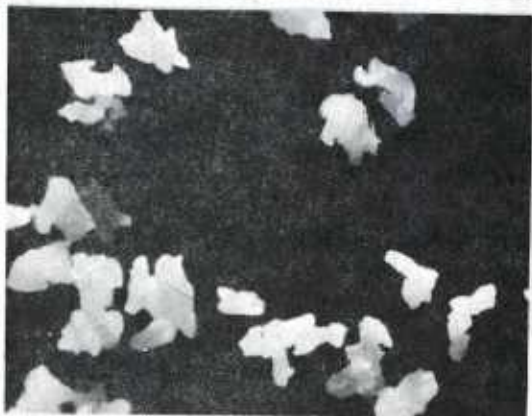
FIGURE 2

Photomicrographs SPLA & RD 1333 As Received & 1st Cycle

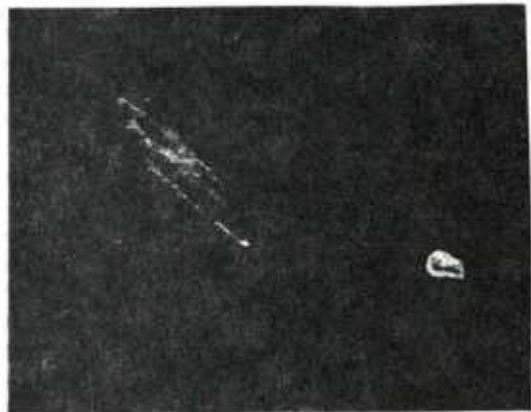
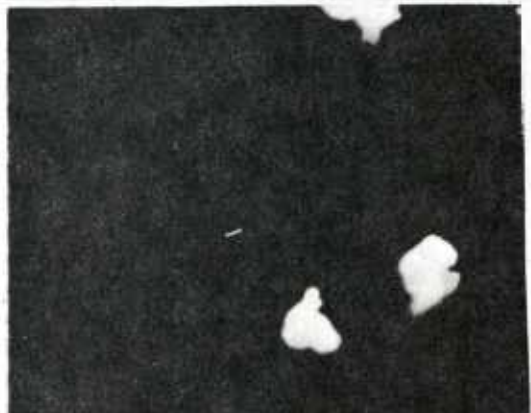
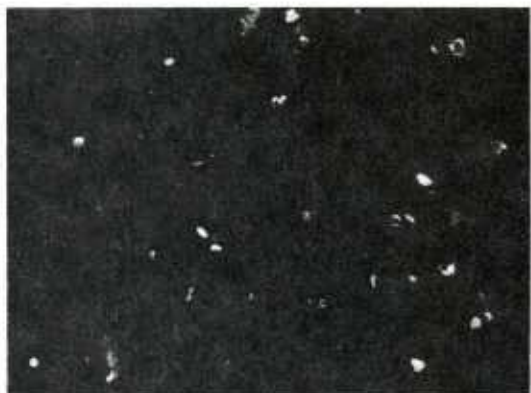
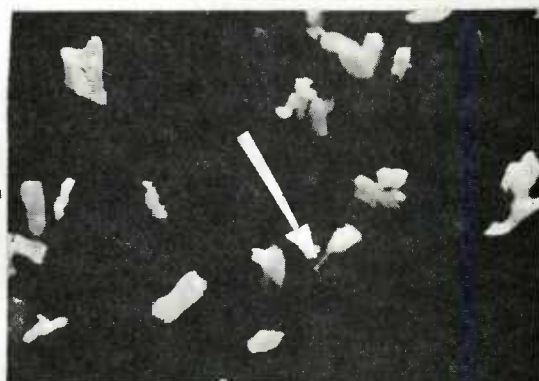
Photomicrographs of Crystals Found in 1st Cycle Samples,  
Also Sodium CMC And A Laboratory Sample PbN6  
FIGURE 3
