EXPENDABLE MAIN ROTOR BLADE STUDY

**USAAMRDL TECHNICAL REPORT 72-47**  
**EXPENDABLE MAIN ROTOR BLADE STUDY**

**CONTRACT DAAJ02-71-C-0C46**  
**SIKORSKY AIRCRAFT**  
**DIVISION OF UNITED AIRCRAFT CORPORATION**  
**STRATFORD, CONNECTICUT**

The report presents results of a design study of expendable main rotor blades for the UH-1H helicopter. The objective of the study was to design blades which could eventually be thrown away after extensive damage rather than be sent back to depot for major overhaul. Unit cost, field repairability, resistance to corrosion and erosion, fatigue strength, and damage tolerance were factors considered for maximum cost effectiveness or lowest life-cycle cost. The study was limited to the UH-1 blade, which requires a structural skin for edgewise rigidity. For an articulated rotor blade, some of the conclusions regarding skin construction and material could be different.

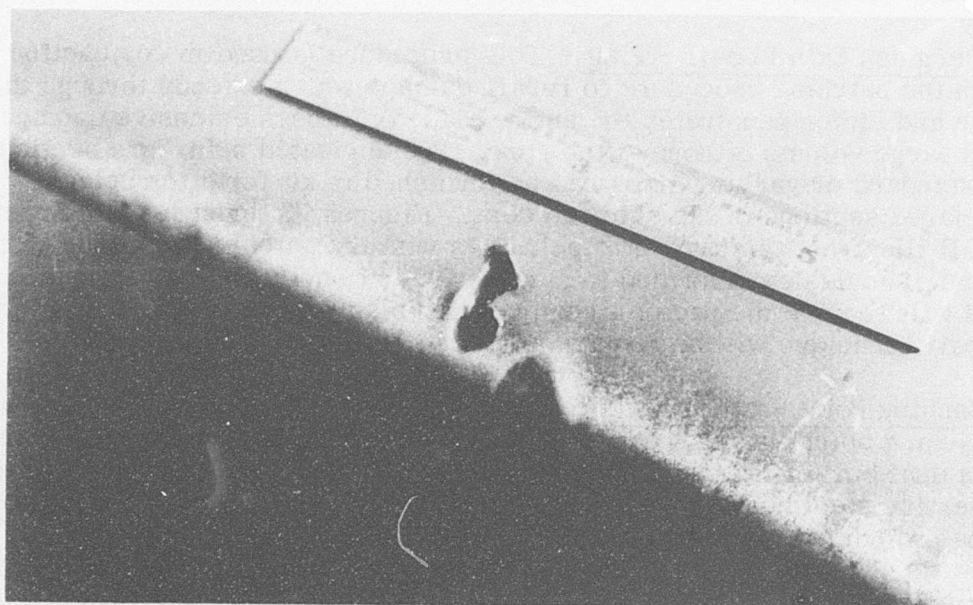
Figure 51. Blade Dent Damage.

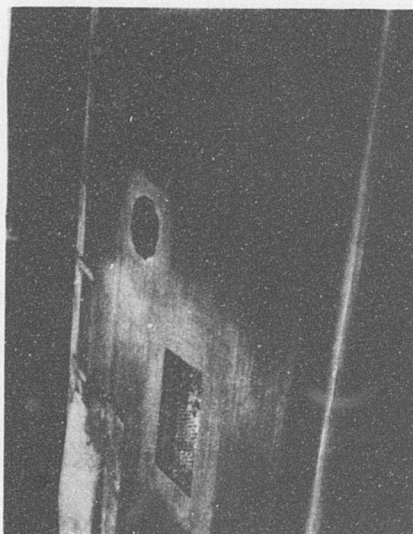
Figure 75. Replacement Ring.

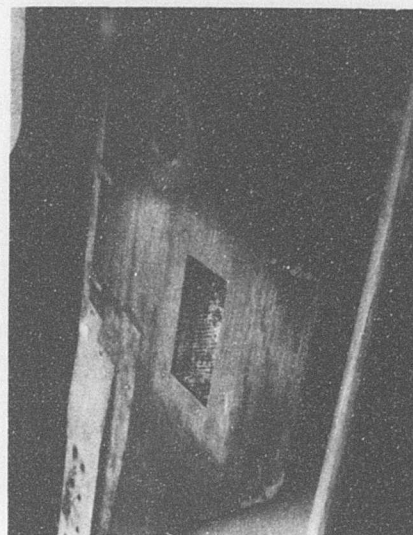
Figure 76. Plug in Place.
