CORROSION OF NICKEL PLATED STEEL AT  
TROPICAL ENVIRONMENTS

REPORT A71-16

FRED PEARLSTEIN  
and  
LEONARD TEITELL

November 1971

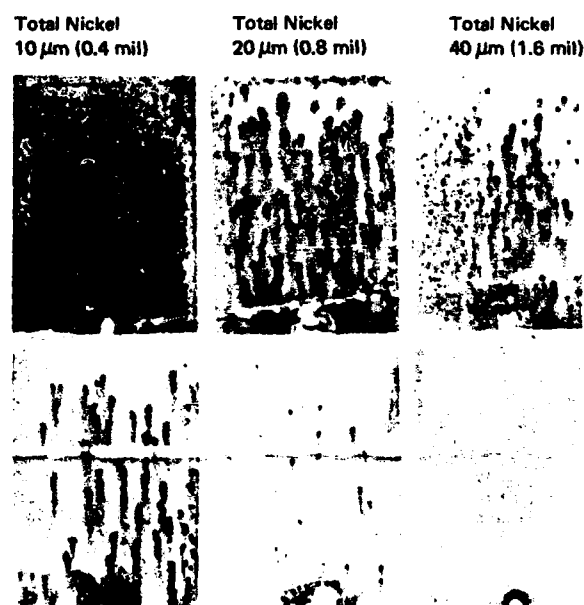
Figure 2 - Nickel plated steel panels (0.5  $\mu\text{m}$  chromium topcoat) after 35 months' exposure to tropical open field environment. A-Single-layer nickel. B-Double-layer nickel.

Double-layer nickel deposits were clearly superior (Figure 2) to single layer nickel in providing corrosion protection to steel exposed at the open field site. However, double-layer deposits of 20  $\mu$ m (0.8 mil) thickness or less were not completely protective after 35 months. The 40  $\mu$ m double-layer was protective and of generally excellent appearance, though a number of shallow pits were visible which apparently extended only to the semibright nickel
