CORRELATION OF MICROSTRUCTURES WITH FRACTURE TOUGHNESS
PROPERTIES IN METALS

LOCKHEED MISSILES AND SPACE COMPANY, INCORPORATED

PREPARED FOR
NAVAL AIR SYSTEMS COMMAND

SEPTEMBER 1973

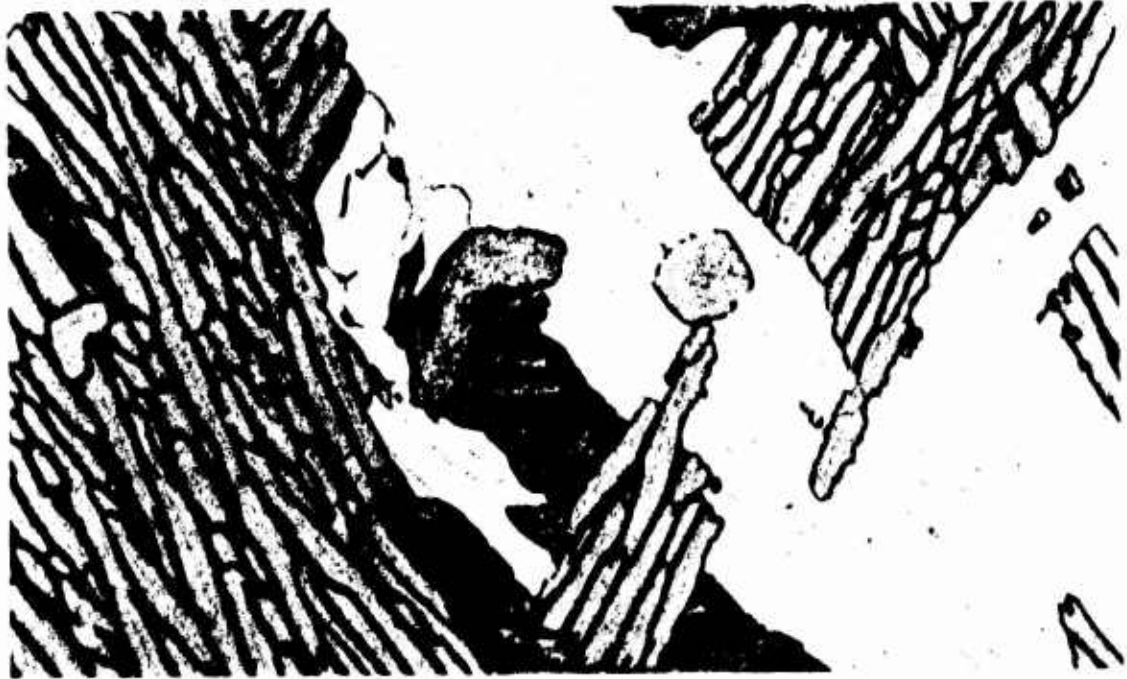
B4616

Fig. 15 - Ti-6Al-4V Condition 7, 1-in. plate, 1850°F-½ h-AC, 1775°F-½ h-AC, 1450°F-1 h-AC. $K_Q = 85 \text{ ksi-in}^2$, $F_{ty} = 124 \text{ ksi}$.

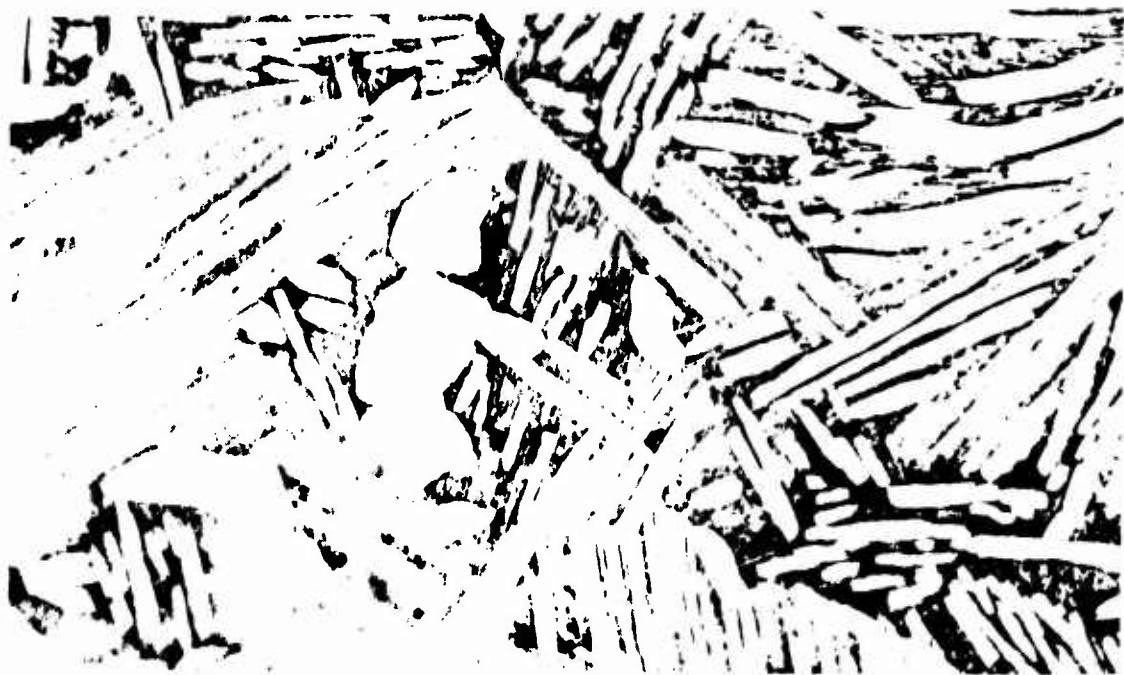
B.648

Fig. 18 - Ti-6Al-4V Condition 10, 1-in. plate, 1850°F- $\frac{1}{2}$ h-AC, 1750°F- $\frac{1}{2}$ h-
WQ, 1000°F-2 h-AC. $K_{Ic} = 67 \text{ ksi-in}^{\frac{3}{2}}$, $F_{ty} = 157 \text{ ksi}$.

Etchant: 10 pct aq. sol. of 49 pct conc. HBF_4 , immersion for 1.5 to 2 min.

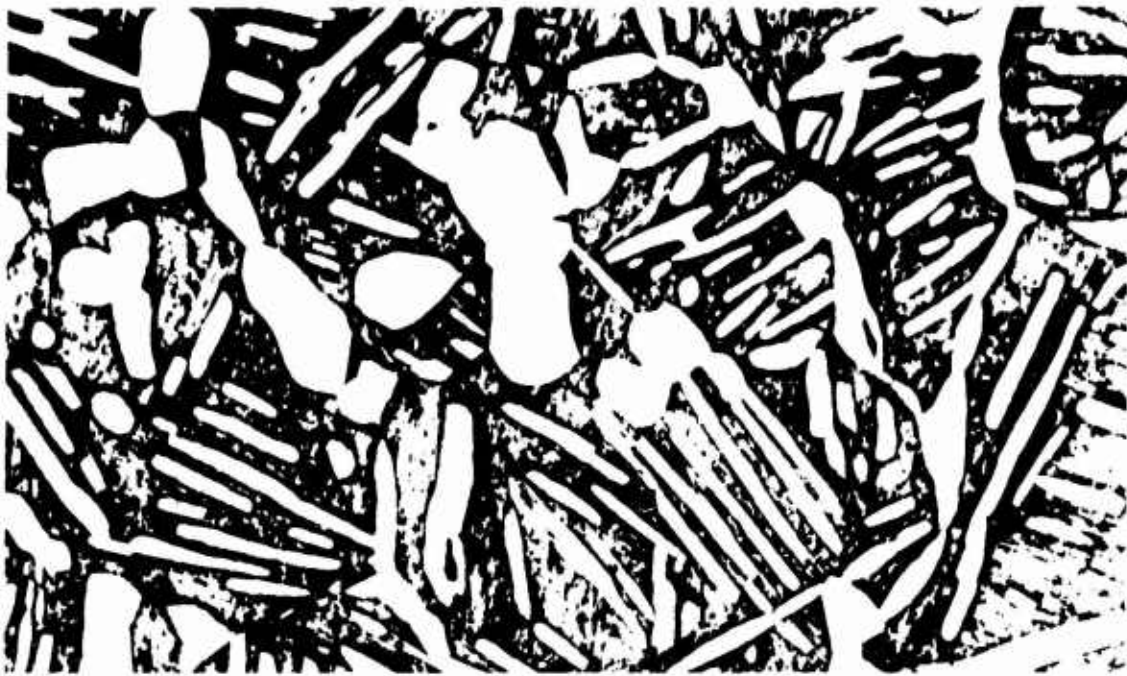
B4649

Fig. 19 - Ti-6Al-4V Condition 11, 1-in. plate, 1850°F-½ h-AC, 1750°F-2 h-WQ, 1000°F-2 h-AC. $K_{Ic} = 58 \text{ ksi-in}^{\frac{3}{2}}$, $F_{ty} = 159 \text{ ksi}$.

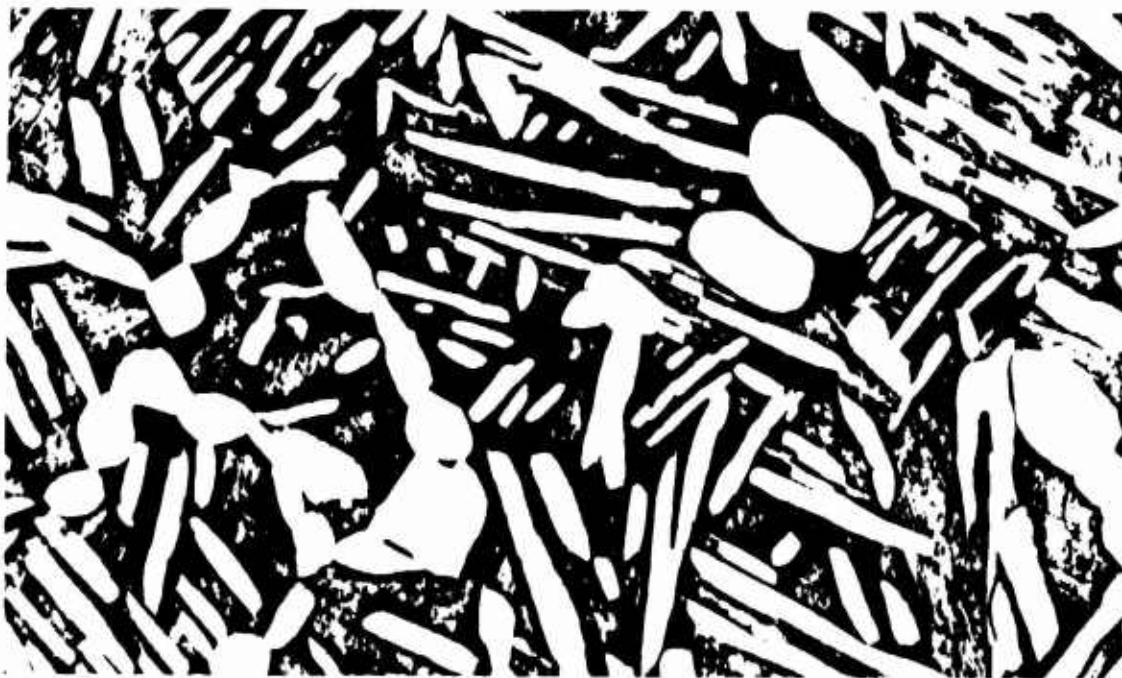
B4650

Fig. 20 - Ti-6Al-4V Condition 12, 1-in. plate, 1850°F-½ h-AC, 1750°F-4 h-WQ, 1000°F-2 h-AC. $K_{Ic} = 59 \text{ ksi-in}^{\frac{3}{2}}$, $F_{ty} = 160 \text{ ksi}$.

Etchant: 10 pct aq. sol. of 49 pct conc HBF_4 , immersion for 1.5 to 2 min.

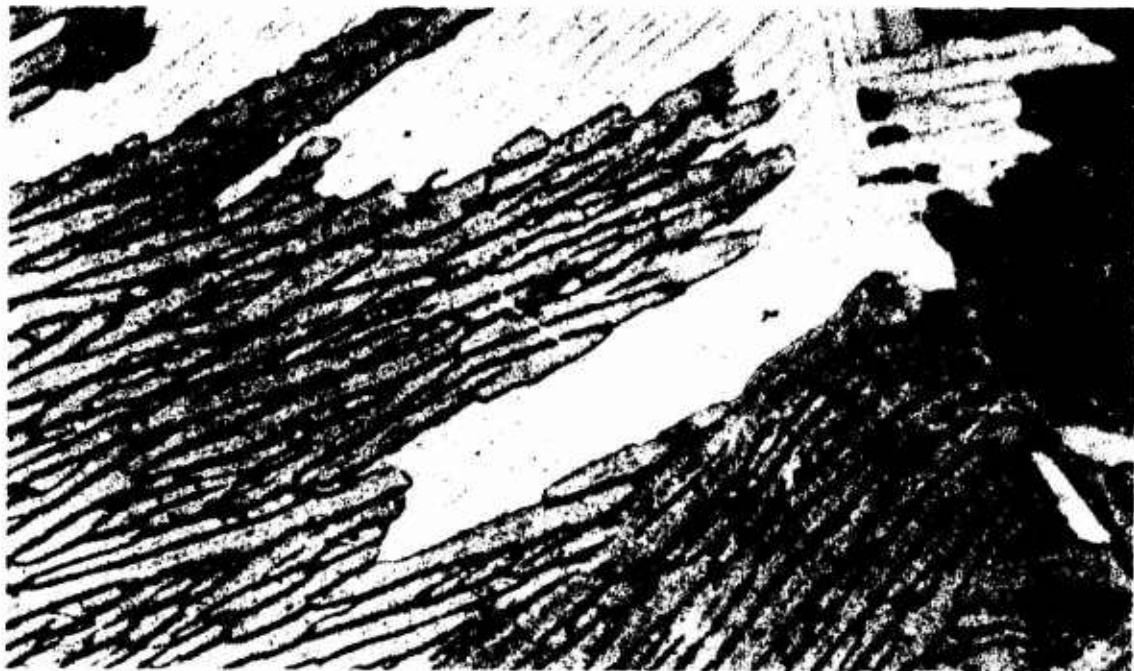
B4651

Fig. 21 - Ti-6Al-4V Condition 1s, 1-in. plate, 1875^oF-1 h-AC, 1750^oF-2 h-AC, 1-90^oF-1 h-AC. $K_{Ic} = 37 \text{ ksi-in}^{3/2}$, $F_{ty} = 125 \text{ ksi}$.

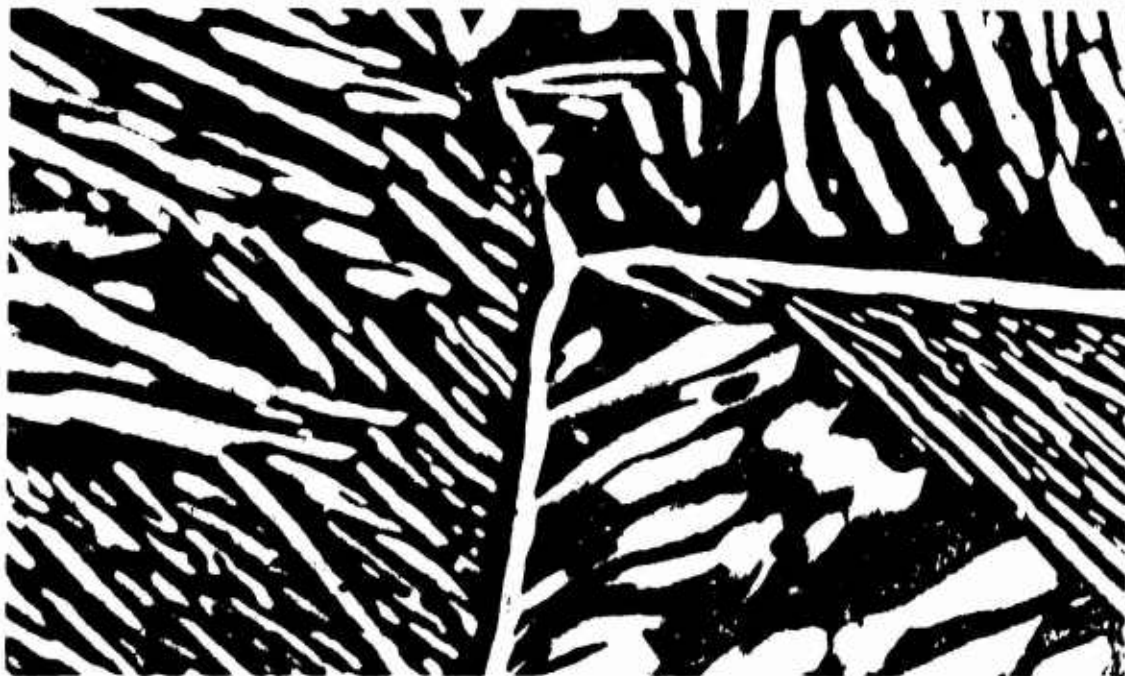
B4652

Fig. 22 - Ti-6Al-4V Condition 1a, 1-in. plate, 1875^oF-1 h-AC, 1750^oF-2 h-WQ, 1000^oF-2 h-AC. $K_{Ic} = 71 \text{ ksi-in}^{3/2}$, $F_{ty} = 156 \text{ ksi}$.

Etchant: 10 pct aq. sol. of 49 pct conc. HBF₄, immersion for 1.5 to 2 min.

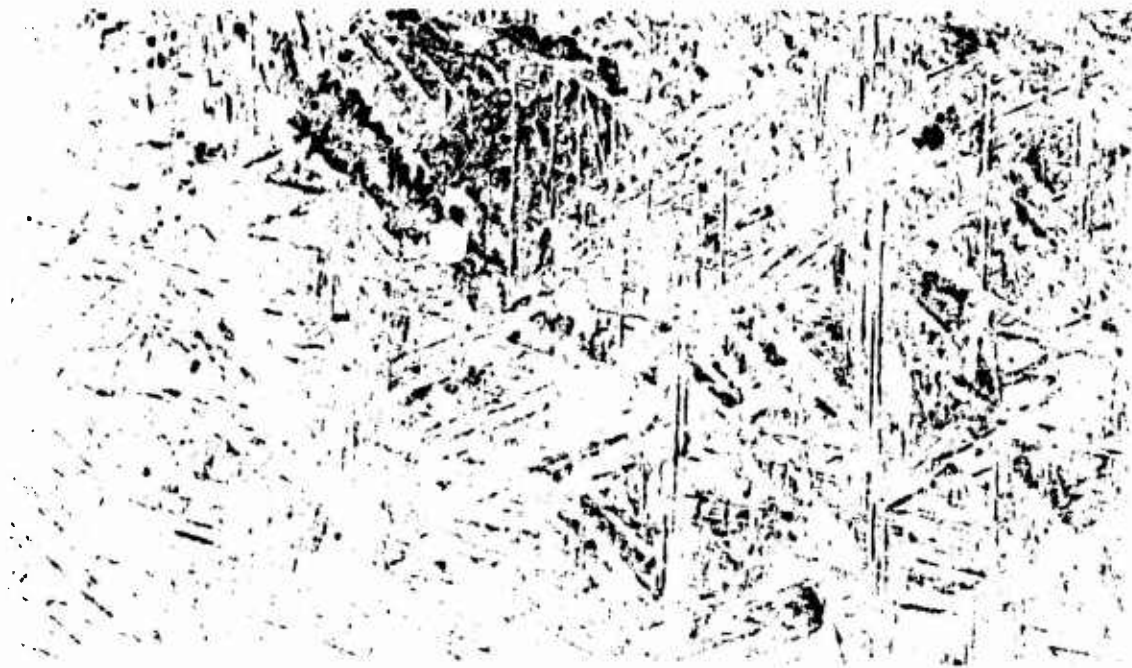
B4659

Fig. 23 - Ti-6Al-4V Condition 23, 1-in. plate, 1850°F- $\frac{1}{2}$ h-IBQ.

$K_{Ic} = 78 \text{ ksi-in}^{\frac{3}{2}}$, $F_{ty} = 148 \text{ ksi}$.

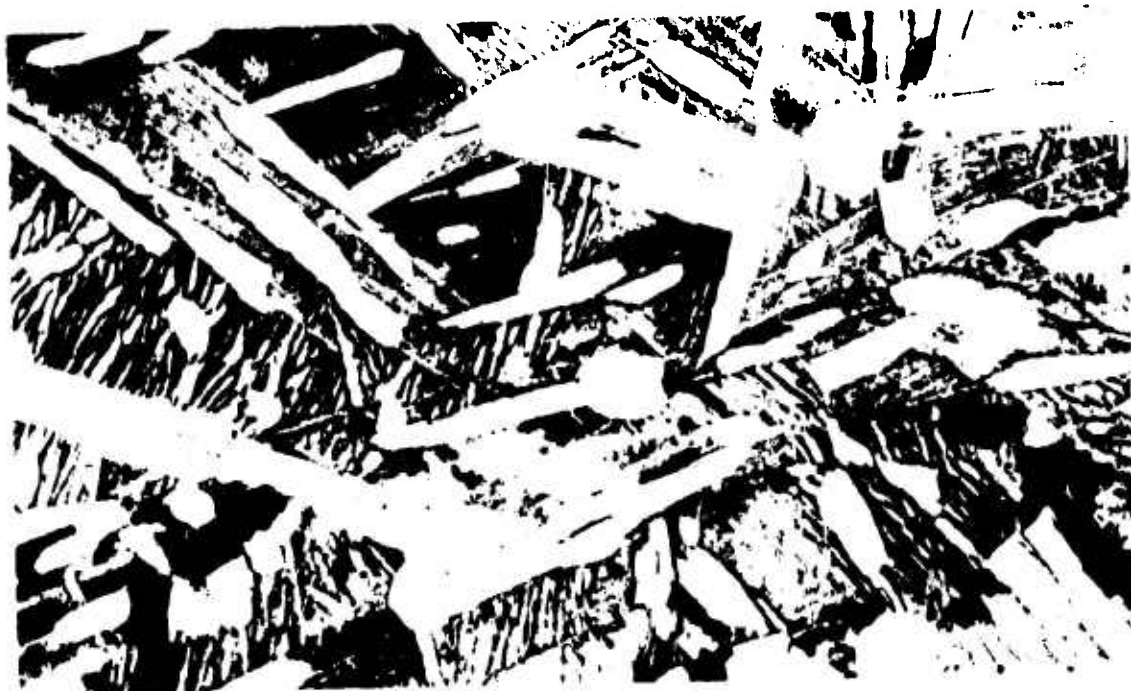
B4653

Fig. 28 - Ti-6Al-4V Condition 16, 2.4-in. plate, 1775°F- $\frac{1}{2}$ h-AC, 1450°F-
 1 h-AC. $K_{Ic} = 80 \text{ ksi}$, $F_{ty} = 134 \text{ ksi}$.

Etchant: 10 pct aq. sol. of 49 pct conc. HBF_4 , immersion for 1.5 to 2 min.

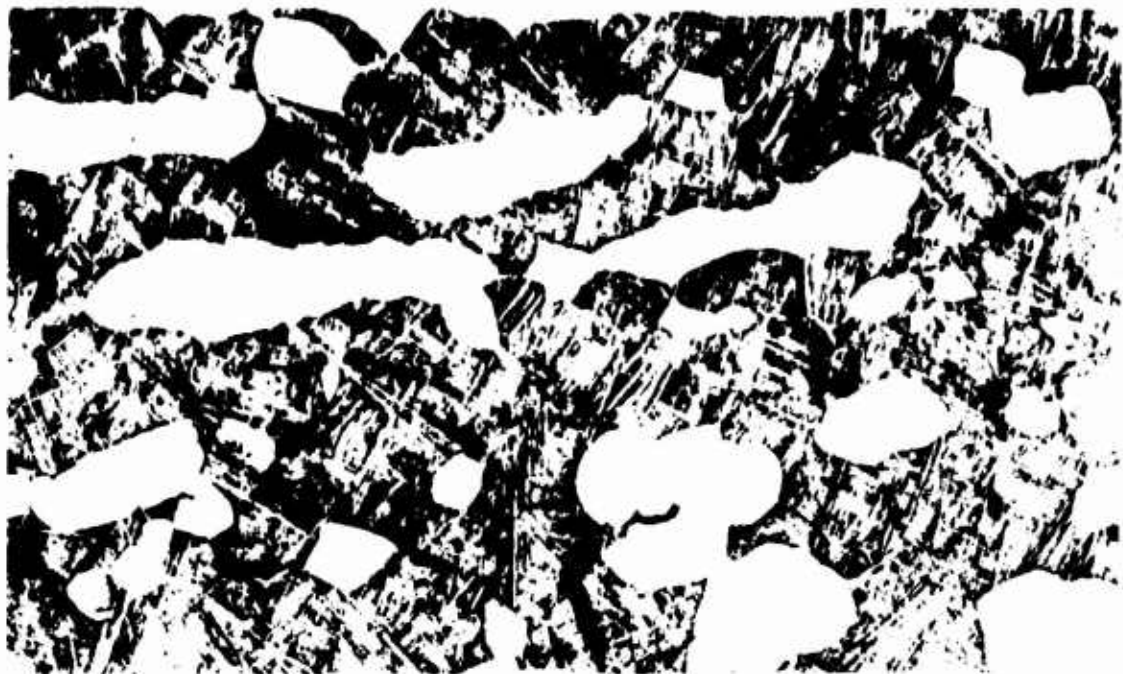
Bl-637

Fig. 33 - Ti-6Al-4V Condition 21, 4- X 4-in. forged billet, 1750°F-2 h-WQ, 1000°F-2 h-AC. $K_{Ic} = 51 \text{ ksi-in}^{3/2}$, $F_{ty} = 147 \text{ ksi}$.
