IMPACT AND OPERATIONAL TESTS OF THE  
CONTAINER HOPPER

Naval Civil Engineering Laboratory  
Port Hueneme, California

November 1973

Technical Note N-1313

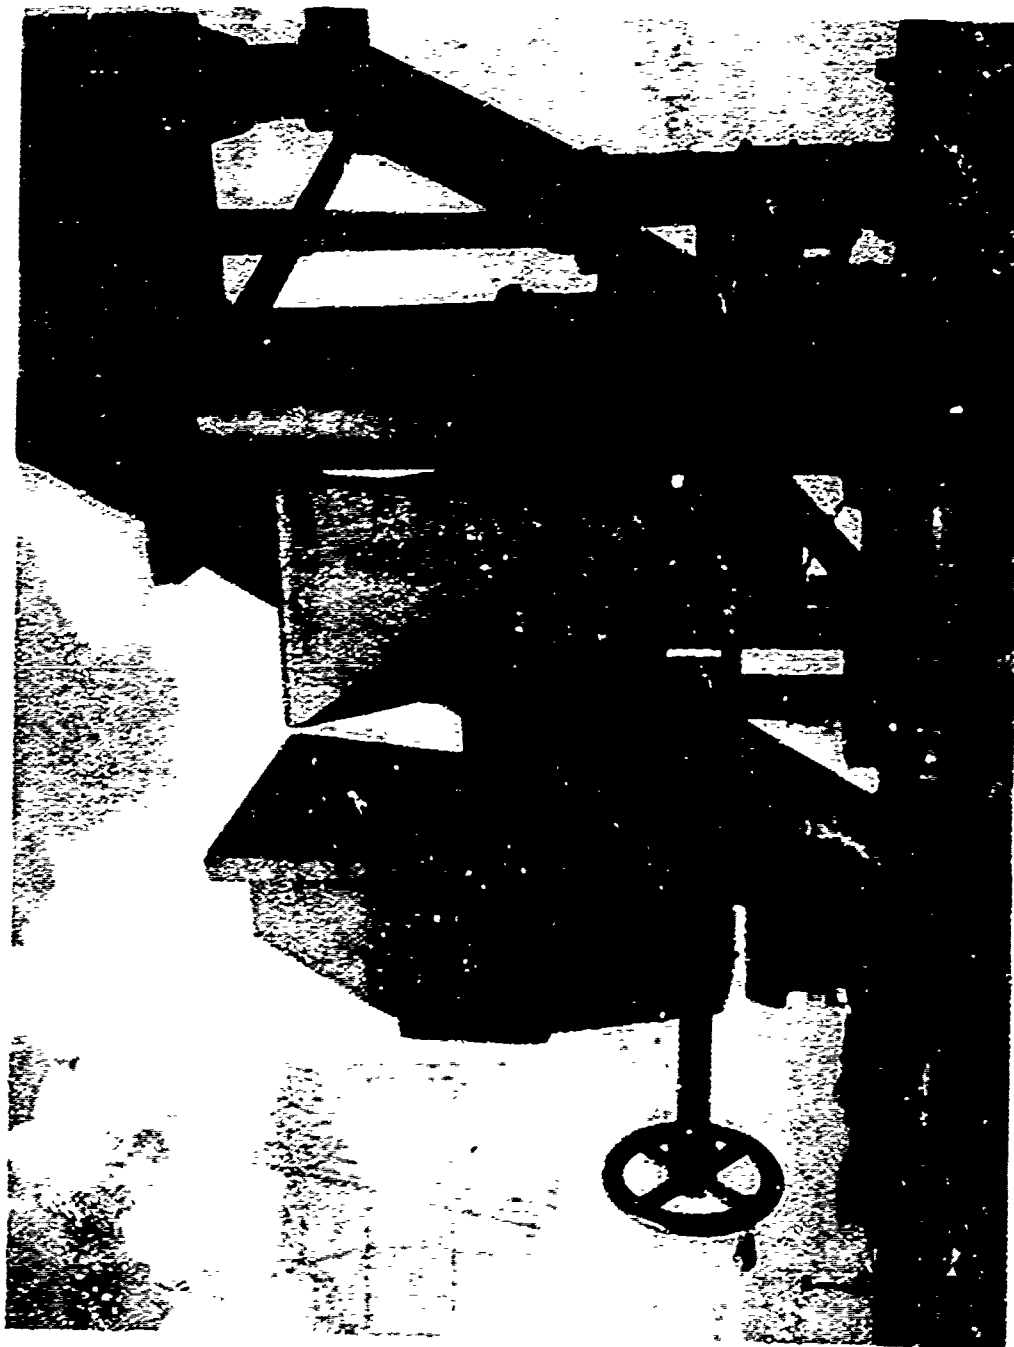
Figure 10. Close-up of one of the fine positioning assemblies.  
The assembly is in the "open" position.
