TECHNICAL REPORT NO. LWL-74-70

PUBLIC ADDRESS SET

AN/UIQ-10

April 1974

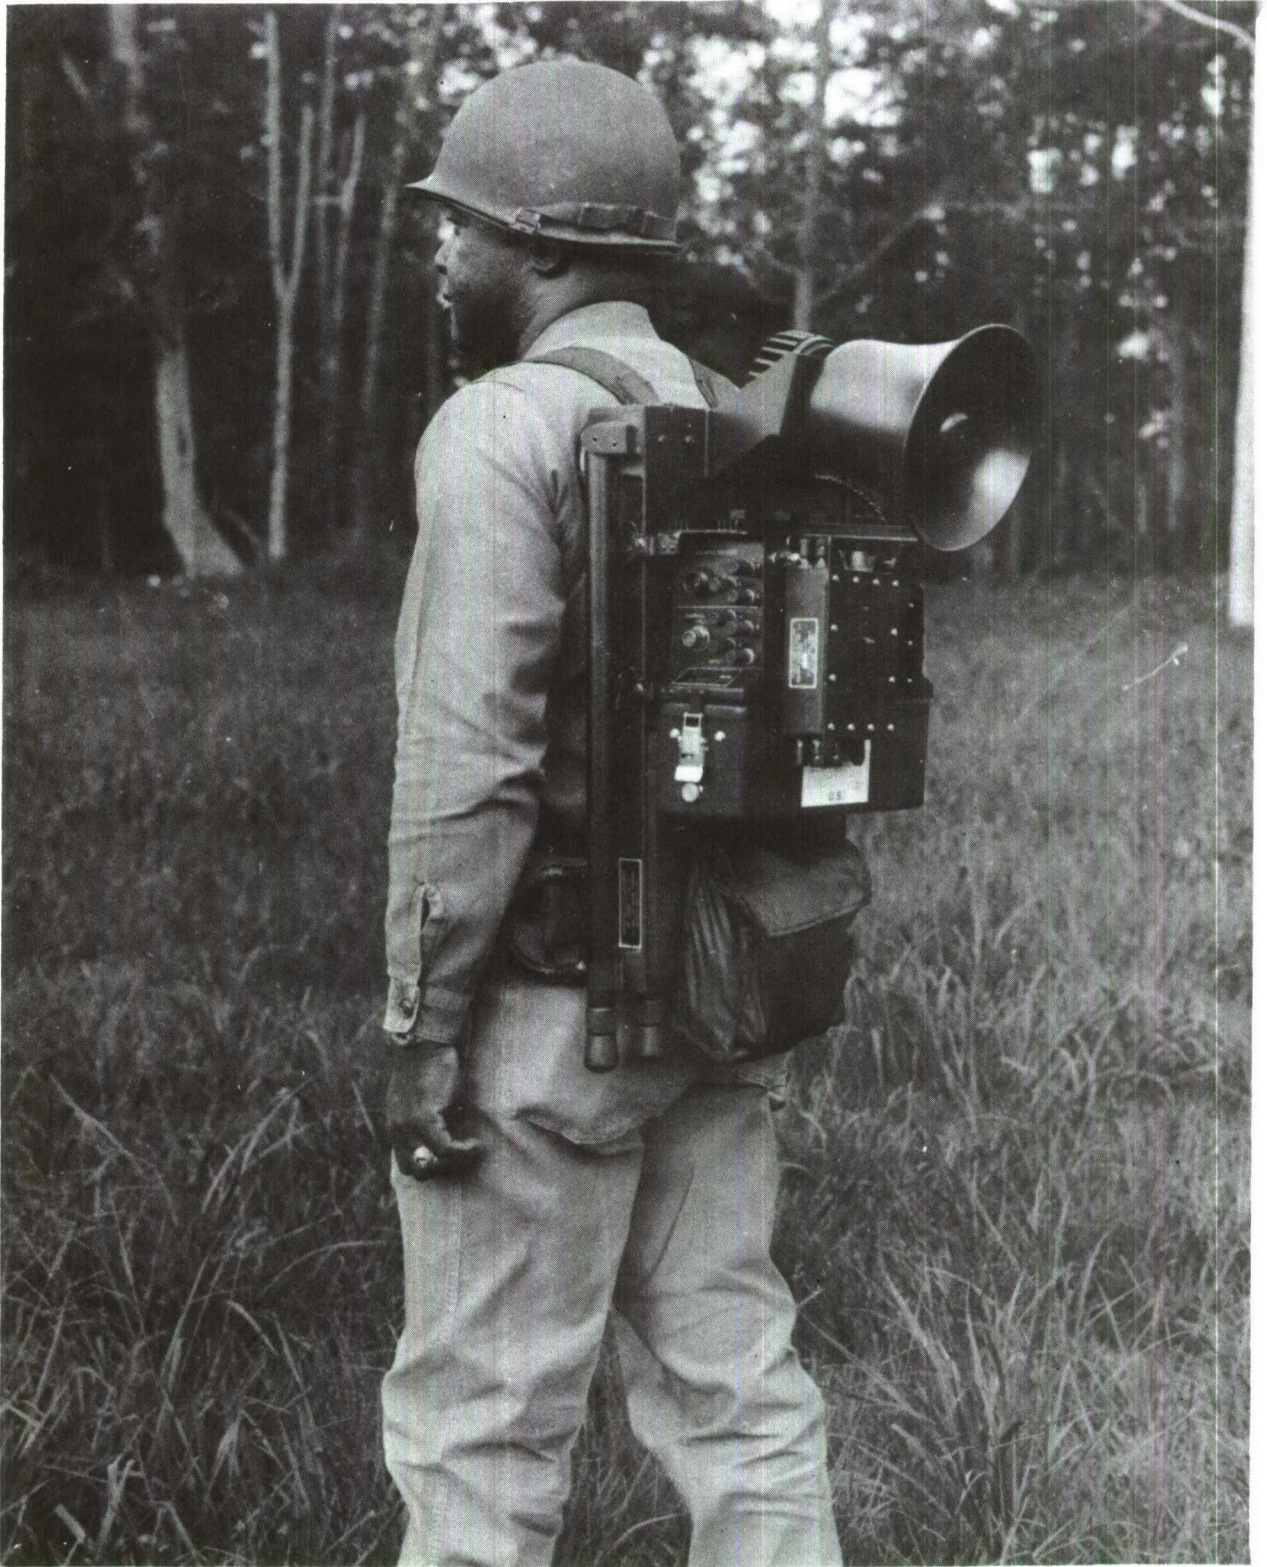
Figure 3. Public Address Set AN/UIQ-11 Shown Backpacked

The basic system (Figure 3) consists of the Amplifier Unit, Control Unit, one Loudspeaker LS-608/UIQ-10, and an Accessory Kit. With batteries attached, this unit weighs 35 pounds. This system is nomenclatured Public Address

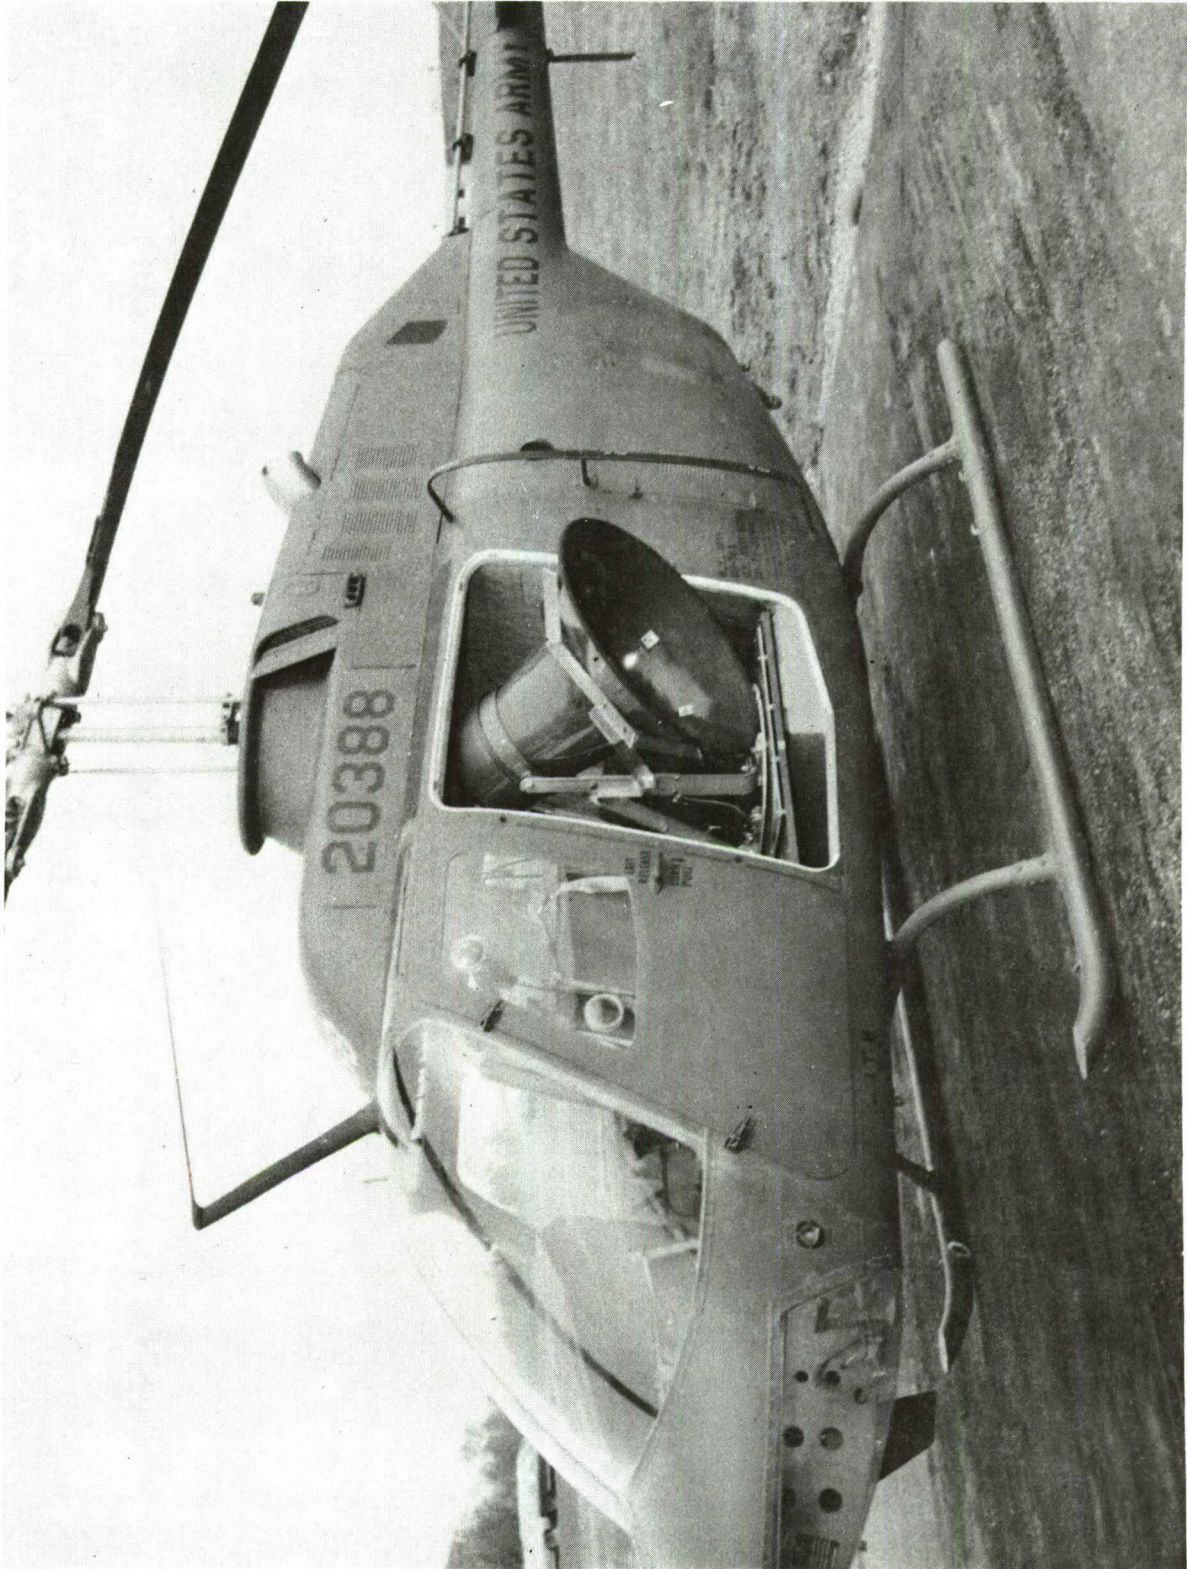
Figure 9. 300 Watt Airborne Public Address System Shown Mounted in OH-58 Helicopter

A smaller, 300 watt system (undesignated) using one amplifier and a 4A4L speaker was configured for the OH-58 helicopter (Figure 9). This system can also be trained in azimuth and elevation.
