ADVANCED MARINE TECHNOLOGY:
BENTHIC ARRAY

William A. Prothero, Jr., et al

Scripps Institution of Oceanography

July 1974

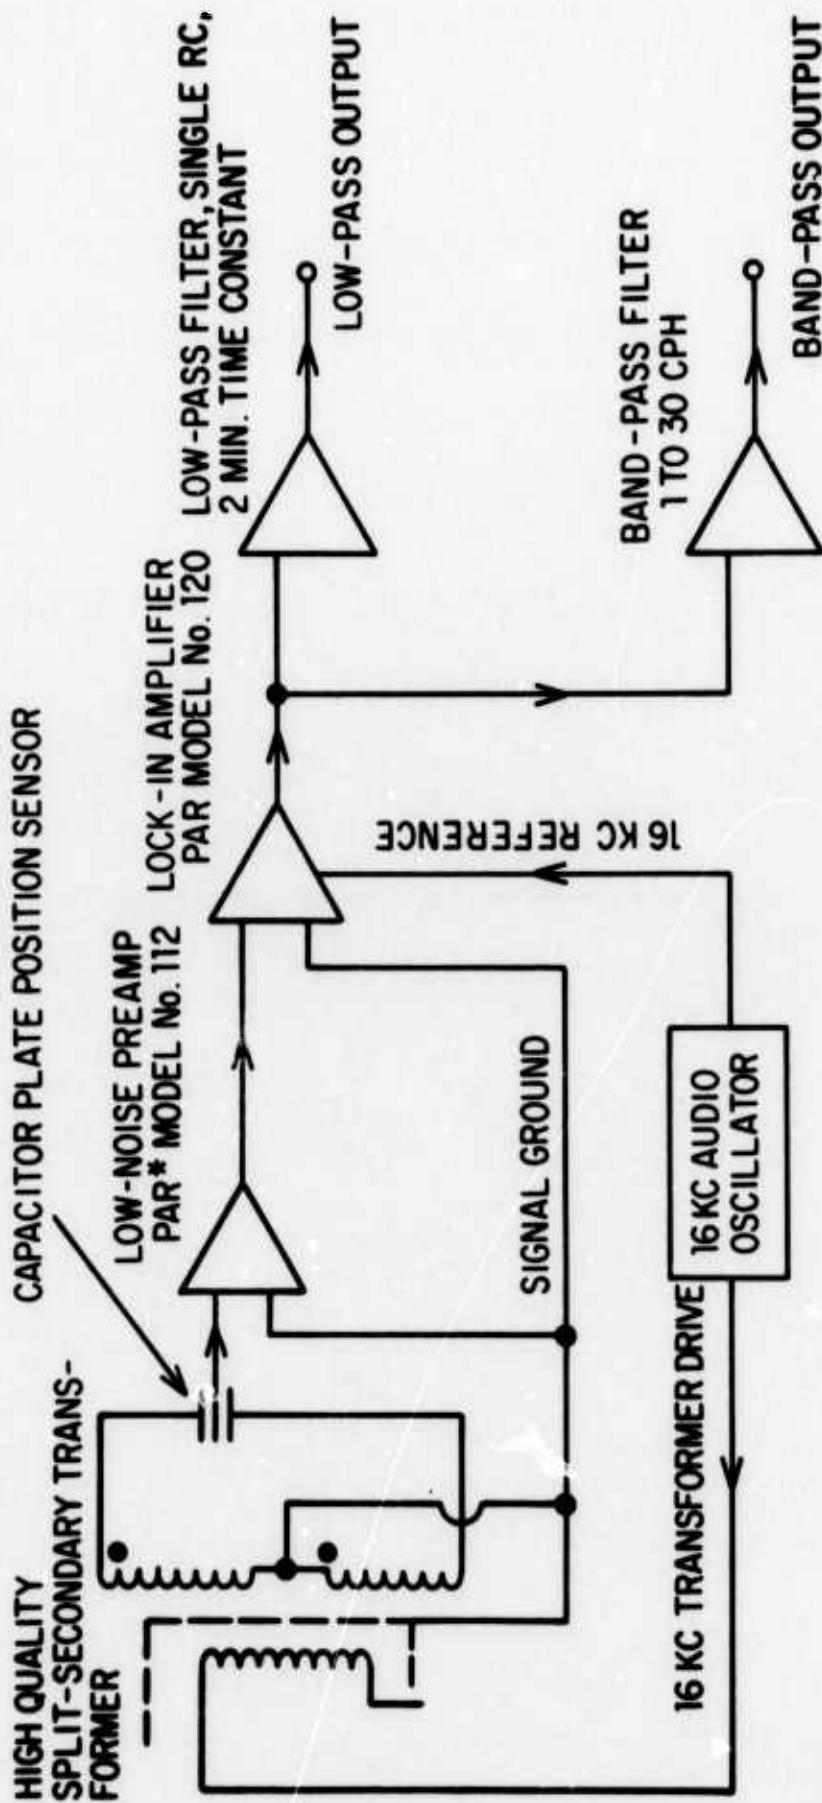
The quartz accelerometer output is generated by a capacitance bridge that senses the position of the moving mass. Figure 13 shows the circuit used. The transformer provides two equal AC voltages 180° out of phase. The capacitance between the top plate and the moving mass is compared to the capacitance between the bottom plate and the moving mass. The output voltage is proportional to the distance off-center and has the phase of the nearest plate. It is amplified by a preamplifier built into the accelerometer, then further amplified and processed by a phase-sensitive detector, which has a DC output which varies between ± 10 volts. The circuits are shown in Figures 14 to 17. The preamplifier has a gain of 10, the gravimeter amplifier has a switchable gain of 10, 100, and 1000. The maximum gain is determined by how fine the remote zeroing can be done and is limited to an equivalent acceleration of $\pm 1.4 \times 10^{-5}$ g. The mixer converts the AC carrier signal into a DC signal

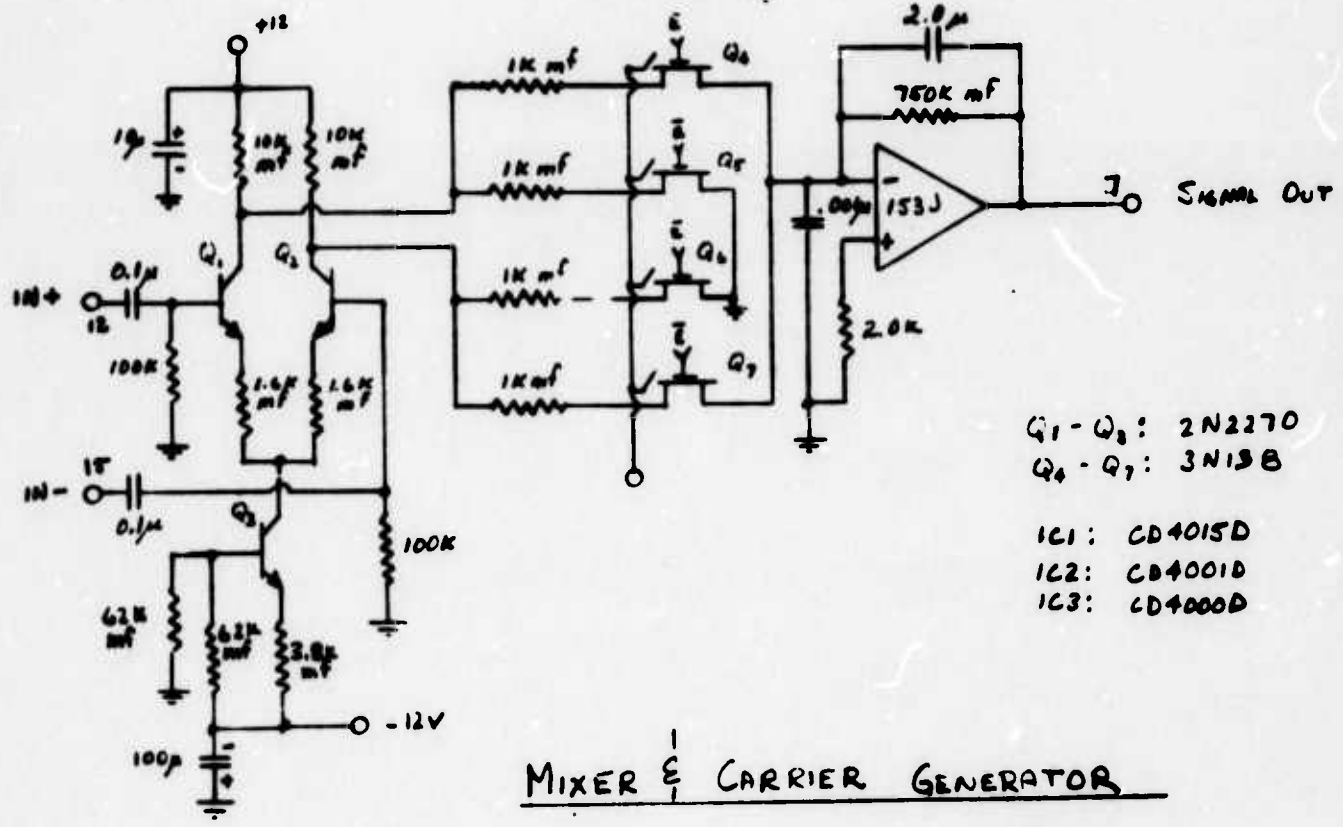
Figure 16

- Q1 - Q2: 2N2270
- Q4 - Q7: 3N138
- IC1: CD4015D
- IC2: CD4001B
- IC3: CD4000D

MIXER & CARRIER GENERATOR

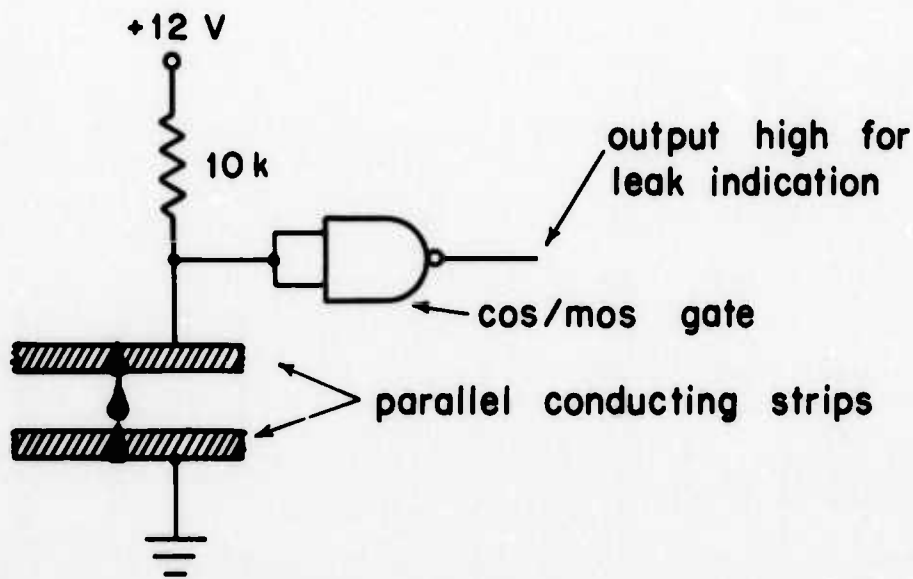
Since the detailed bottom conditions are often unknown, a sensor which would initiate an alert code if a tilt of more than 15° was designed. It consists simply of an array of four mercury switches mounted so that the required tilt ~~cross~~ the contact. This provides a logic level to the alert code generator which initiates the gross tilt alert. The gross tilt function was extremely useful during the RUM-ORB deployment (Appendix III) where the RUM control line and capsule buoy line became entangled. Gross tilt alerts were also heard during the deep ocean test when the buoyancy of the polypropylene line was enough to enable the surface buoy to drag the capsule along the bottom.

A good leak detector is crucially important. Initially, parallel strips of lead tape separated by $1/8$ to $1/4$ inch were run around the edge and along the bottom of each lower hemisphere. Figure 25 shows the circuit used to indicate a leak. During the first deployment, a leak of about one drop per day occurred, beginning on the second or third day. Normally, the capsule would be deployed in one day, diagnosed, and left. A leak after the ship leaves station would result in an automatic release and the probable loss of the capsule. So, it was decided to install a second leak detector that indicated a puddle. The first leak detector would initiate a leak alert, but only the puddle detector would release the capsule.

LEAK DETECTOR

GROSS TILT DETECTOR
