**QUARTERLY TECHNICAL PROGRESS REPORT  
FOR PERIOD ENDING SEPTEMBER 30, 1966**

**SNAP-50/SPUR CONTRACT AF 33(615)-2326**

**AEROSPACE ELECTRICAL DIVISION  
LIMA, OHIO**

This Quarterly Technical Progress Report describes work conducted on the SNAP-50/SPUR Generator Development Program by the Westinghouse Aerospace Electrical Division during the period from July 1, 1966, to September 30, 1966, under United States Air Force Contract AF33(615)-2326.

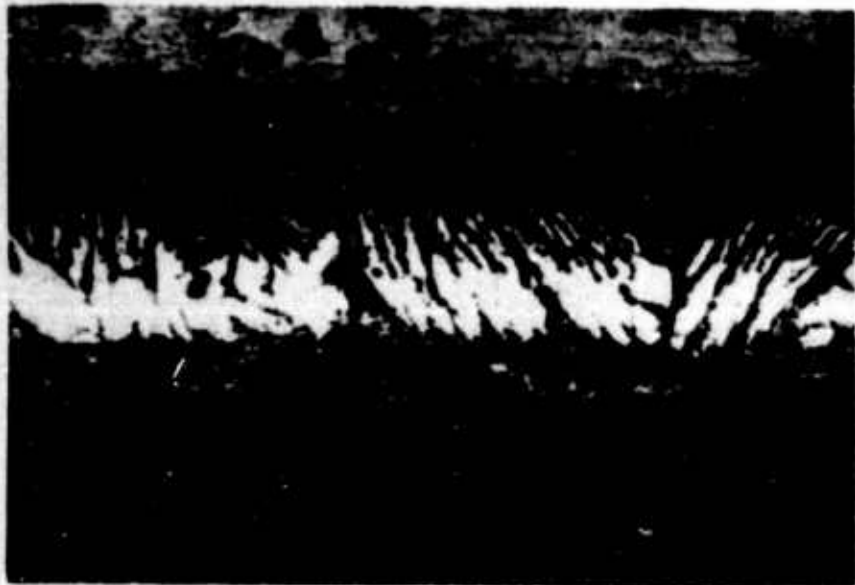
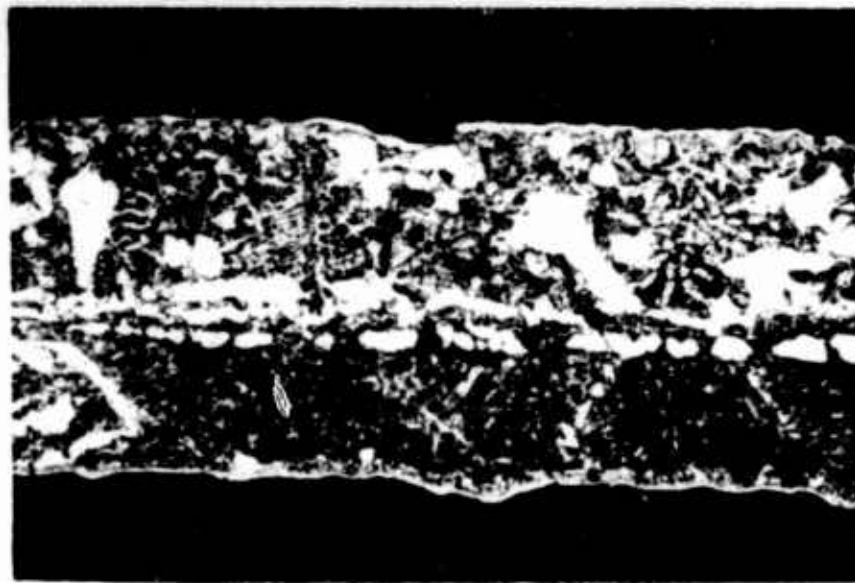
Figure 1. Micrographs of Brazed Joints in 2.5-Inch Tubular Ceramic-Metal Specimen No. 1 After 1000-hour Potassium Exposure at 1100°F

Photomicrographs of brazed joint sections after exposure for 1000-hours at 1100°F to liquid potassium at the bottom and vapor at the top joint of the 2.5-inch diameter tubular bore-seal type specimens are given in Figures 1 through 7. The grade of ceramic, the metal end closure material, and the brazing alloy are identified for each figure. Sample No. 9 developed a leak at one point in the upper braze exposed to vapor and No. 8 was broken when the enclosing capsule was accidentally dropped in removing it from the aging oven.

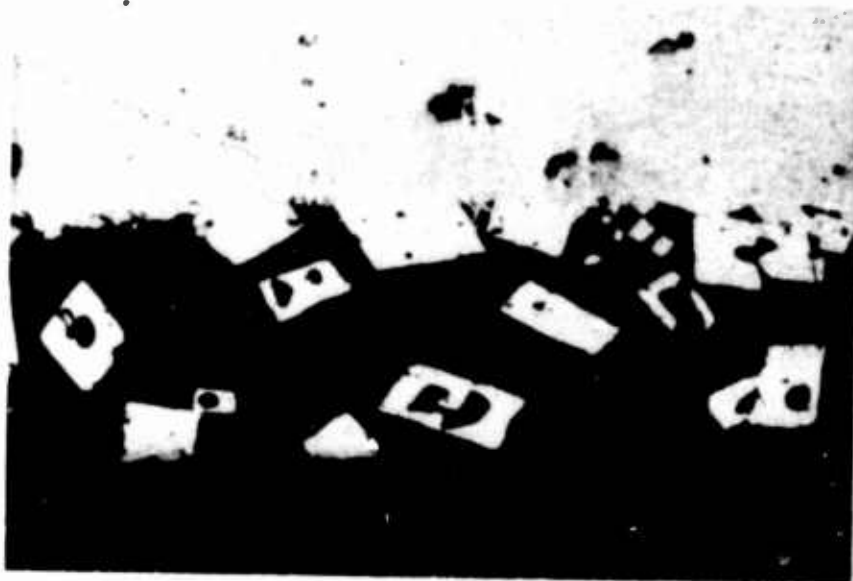
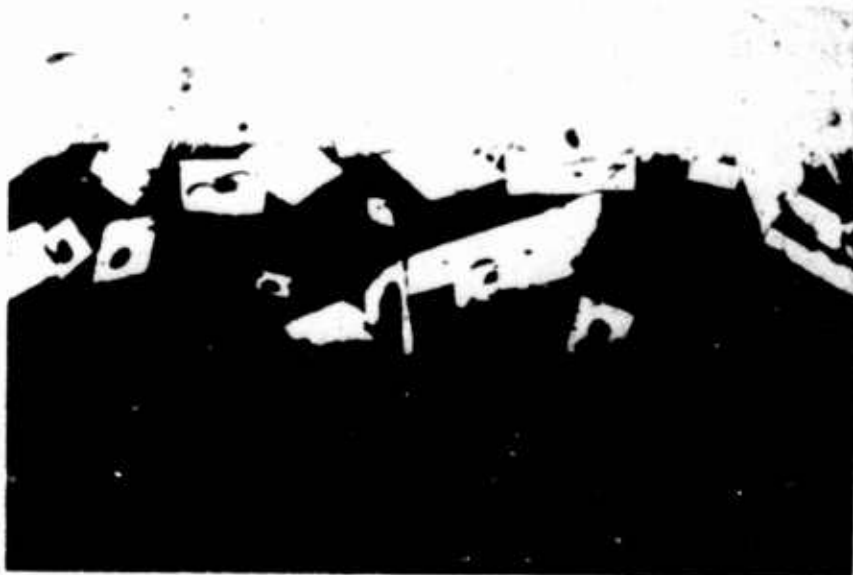
Figure 2. Micrographs of Brazed Joints in 2.5-Inch Tubular Ceramic-Metal Specimen No. 2 After 1000-hour Potassium Exposure at 1100°F

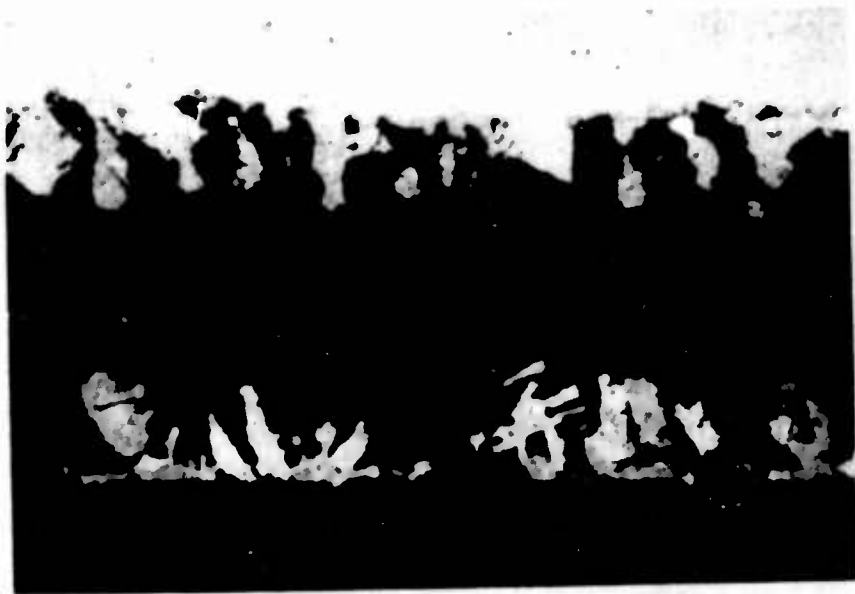
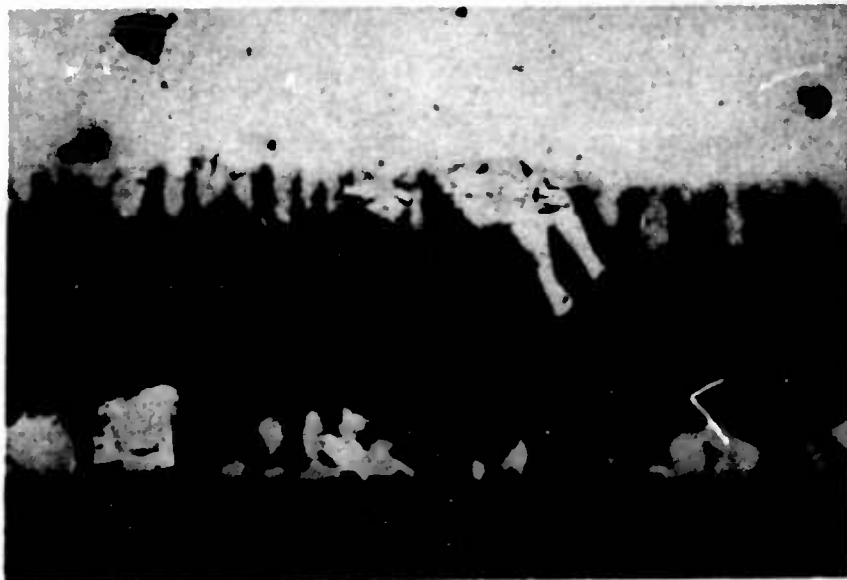
Figure 4. Micrographs of Brazed Joints in 2.5-Inch Tubular Ceramic-Metal Specimen No. 4 After 1000-hour Potassium Exposure at 1100°F

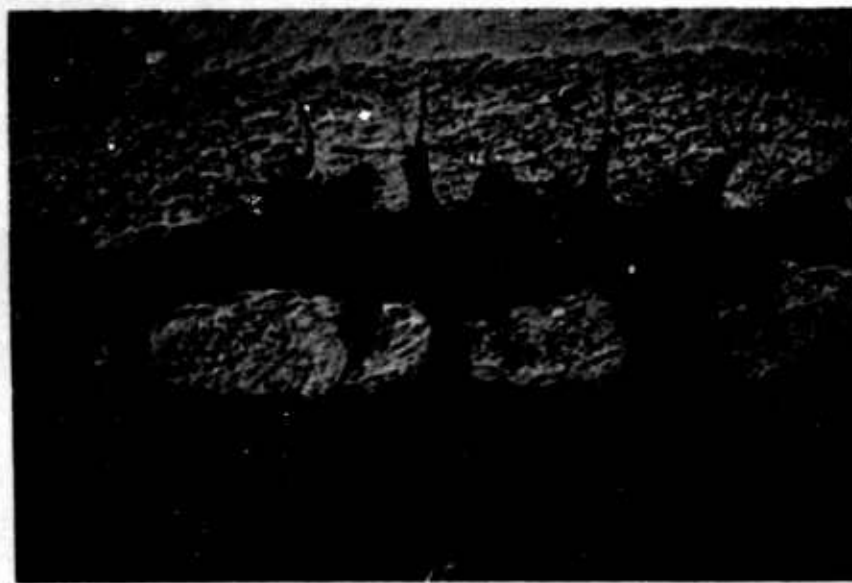
Figure 5. Micrographs of Brazed Joints in 2.5-Inch Tubular Ceramic-Metal Specimen No. 5 After 1000-hour Potassium Exposure at 1100°F

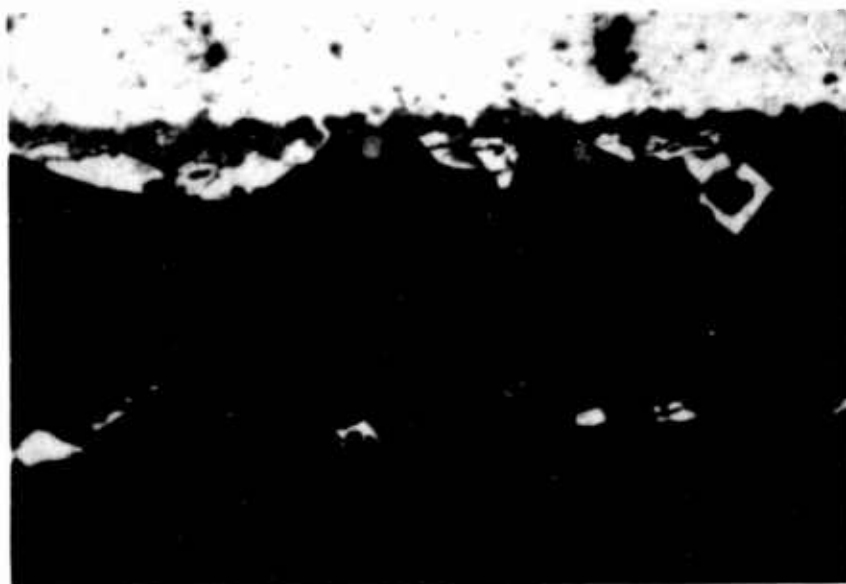
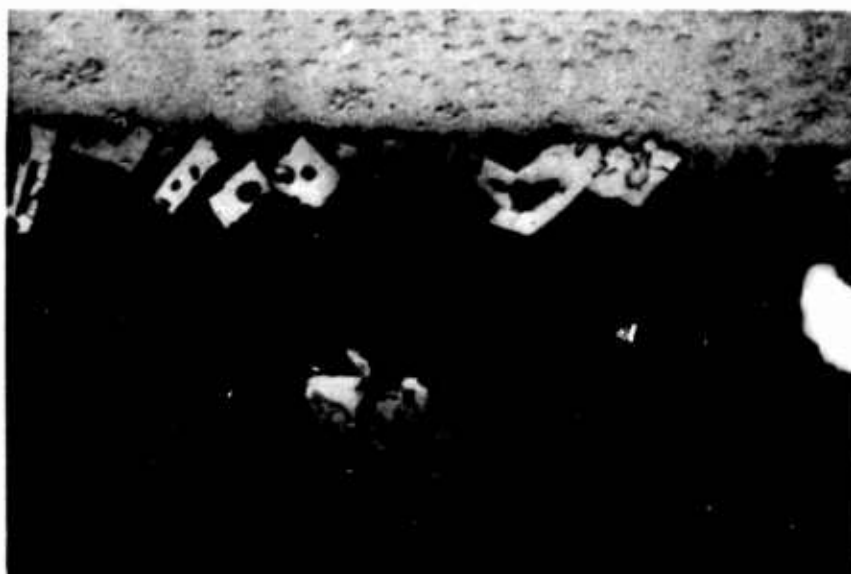
Figure 6. Micrographs of Brazed Joints in 2.5-Inch Tubular Ceramic-Metal Specimen No. 8 After 1000-hour Potassium Exposure at 1100°F

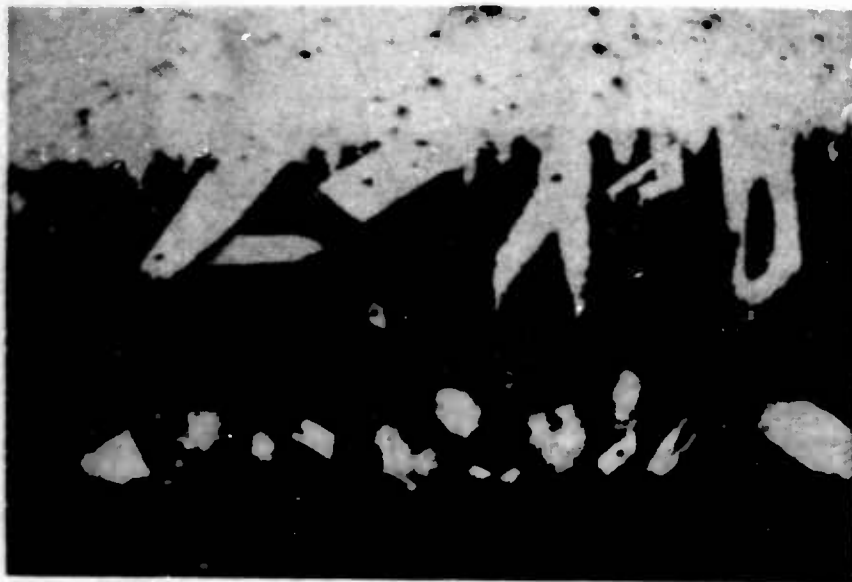
Figure 7. Micrographs of Brazed Joints in 2.5-Inch Tubular Ceramic-Metal Specimen No. 9 After 1000-hour Potassium Exposure at 1100°F

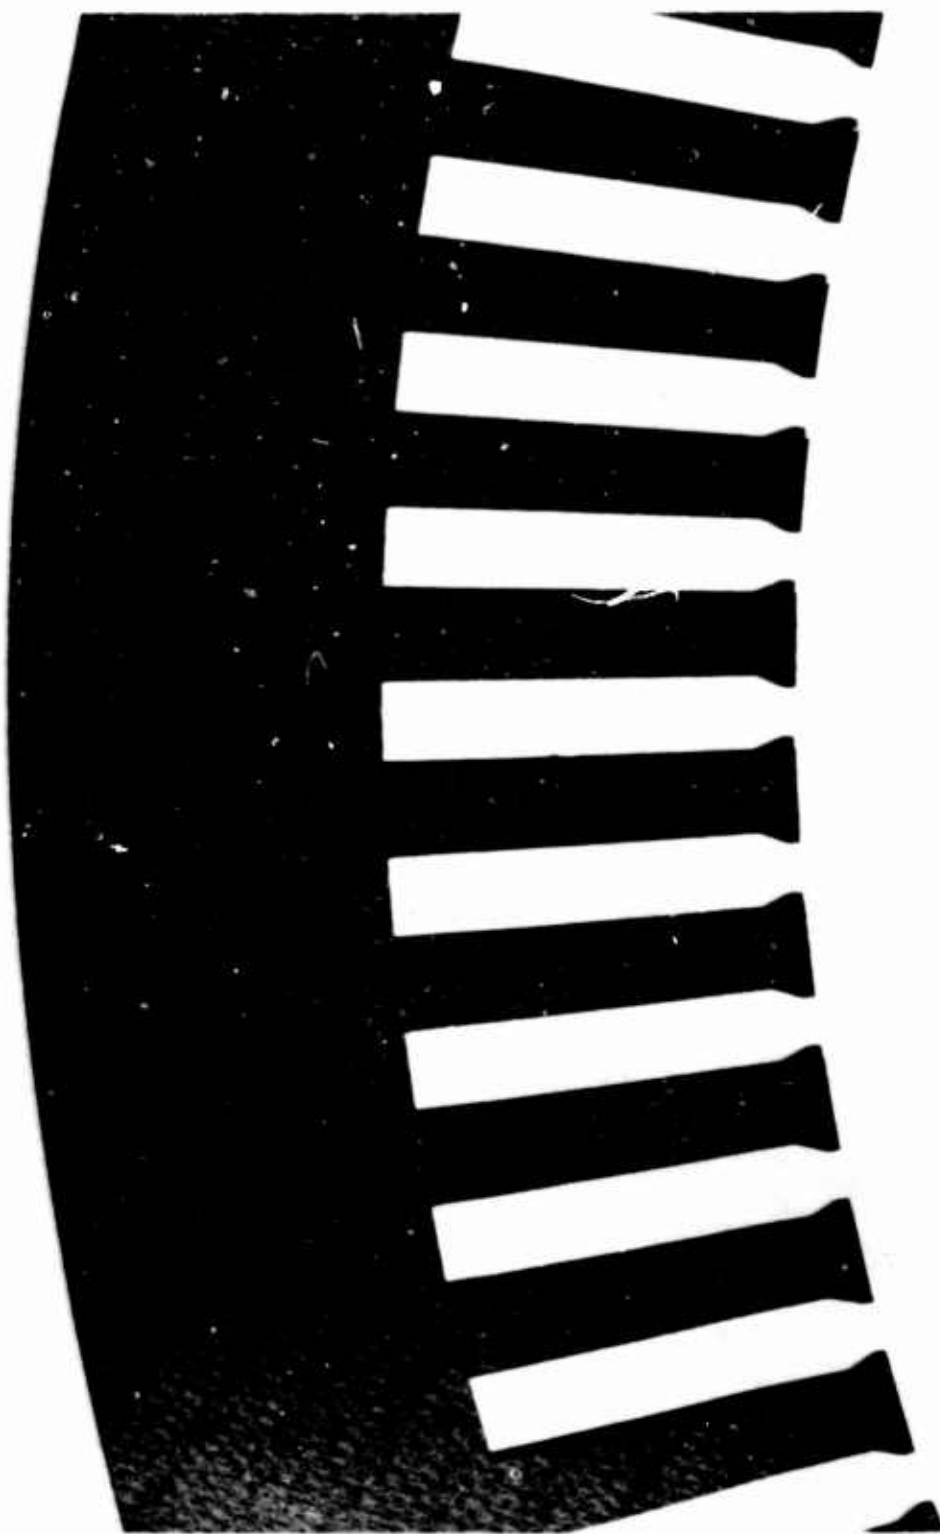
**Figure 17. 0.004 Inch Stator Lamination Coated With Aluminum-Orthophosphate**

The 0.004-inch thick stator laminations were coated with aluminum-orthophosphate to an average double thickness of 0.00014 inches. Figure 17 is representative of the appearance of the laminations after the coating is applied. The laminations were built into stacks by aligning on an arbor as illustrated in Figure 18. The stack outer diameters were machined to size while still on the building arbor.
