802124  
RADC-TR-66-505  
Third Semi-annual Report

## FAILURE MECHANISMS IN SEMICONDUCTOR DIODES

General Electric Company

October 1966

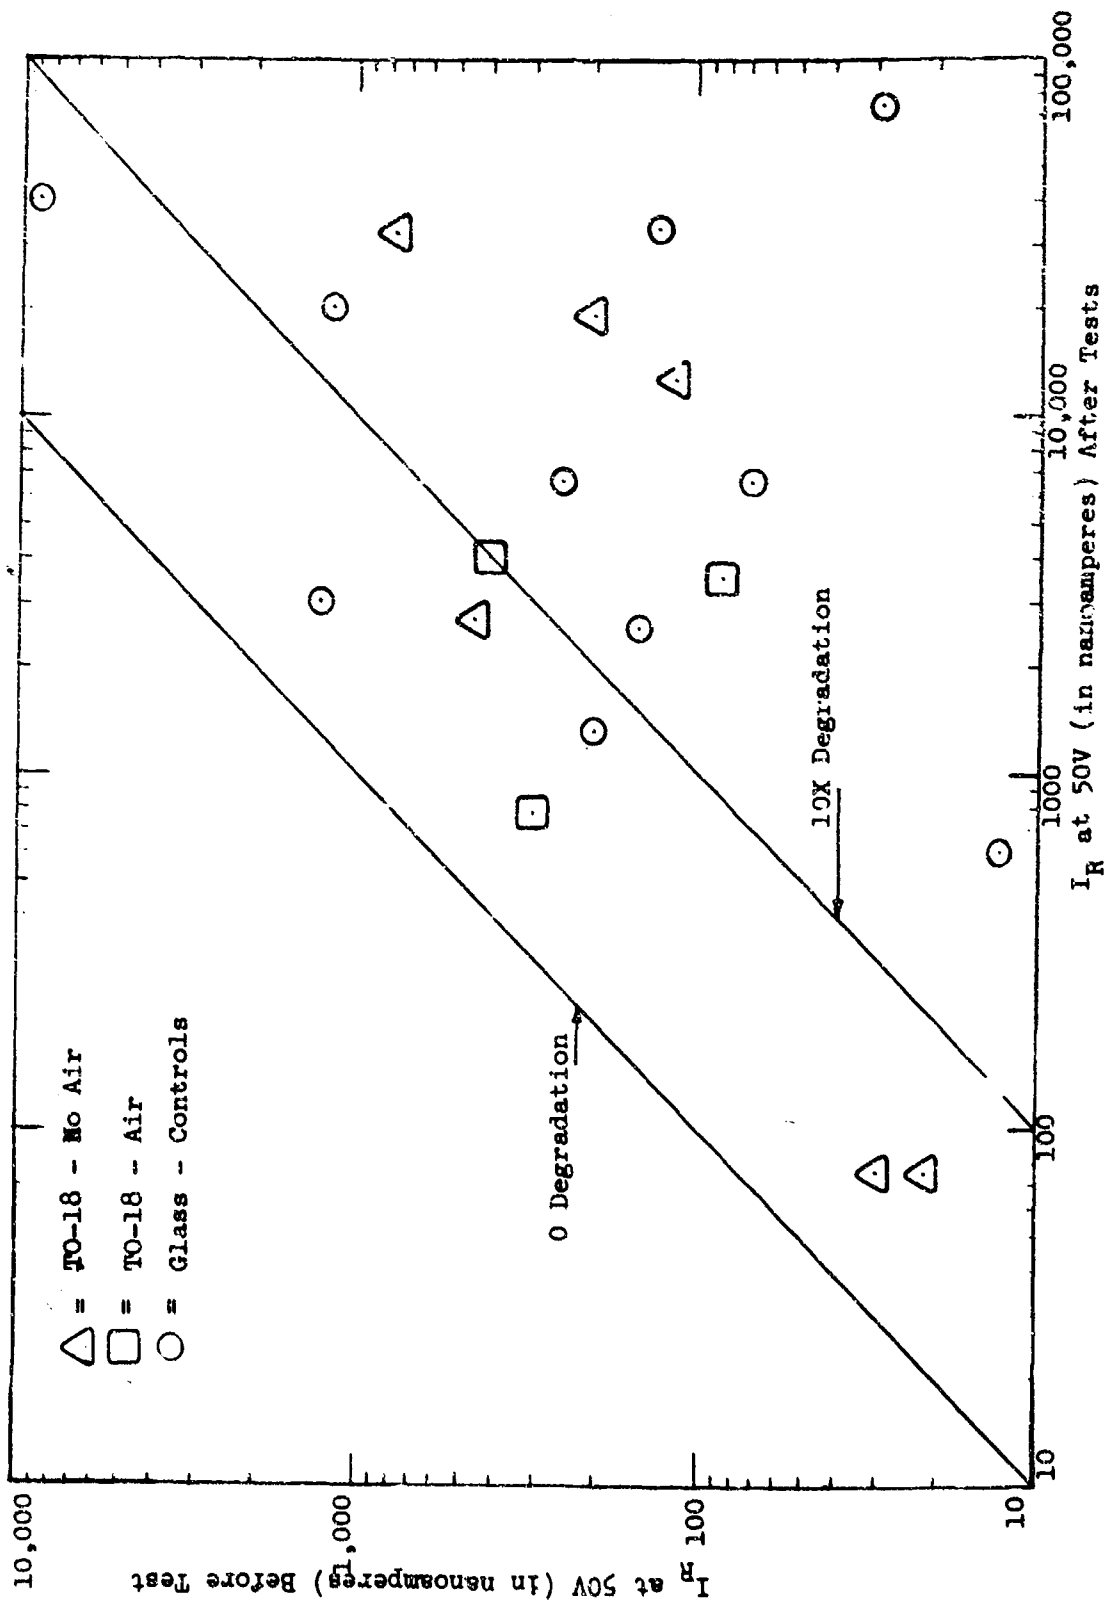
FIGURE 29  
 REMOUNTED PELLETS - 50 VOLT  $I_R$
