**COMBUSTION
TERMINATION SYSTEM
FOR 120-INCH-DIAMETER
SOLID ROCKET MOTOR
(TITAN III-C)**

**F.B. NIELSEN
UNITED TECHNOLOGY CENTER**

OCTOBER 1966

**AIR FORCE ROCKET PROPULSION LABORATORY
RESEARCH AND TECHNOLOGY DIVISION
AIR FORCE SYSTEMS COMMAND
UNITED STATES AIR FORCE
EDWARDS, CALIFORNIA**

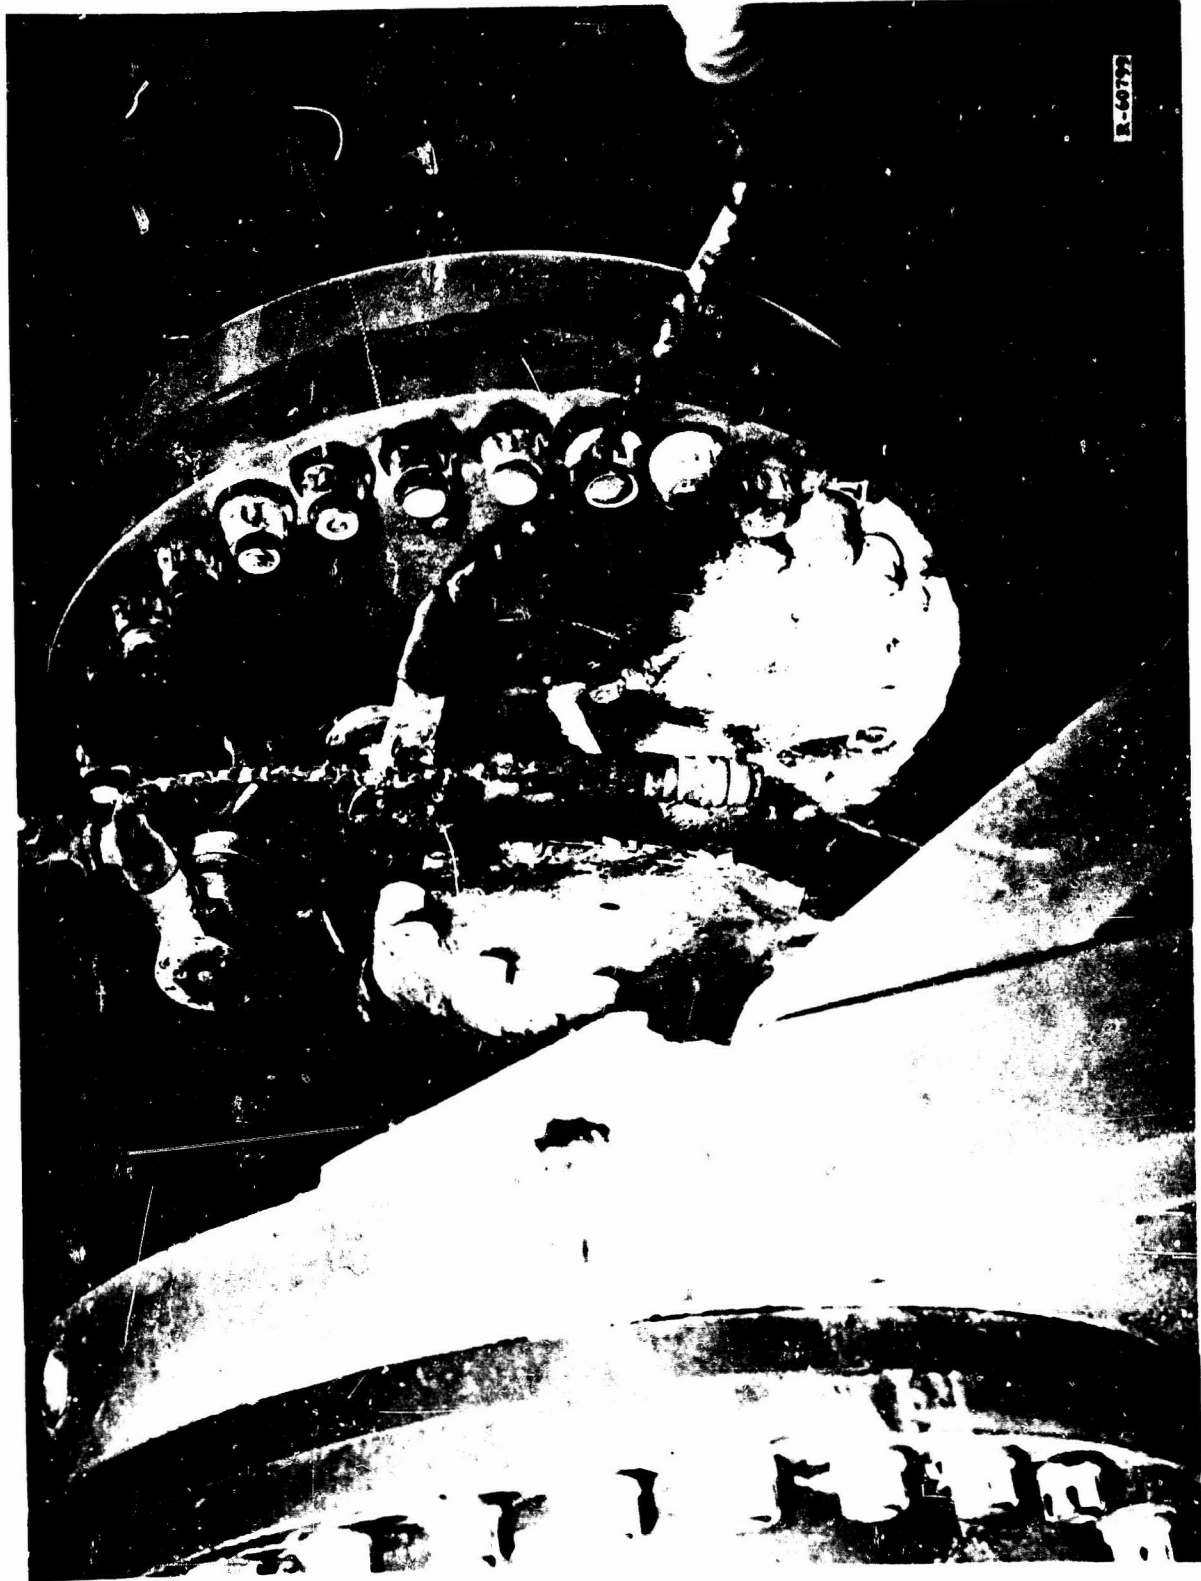
Figure 81. Postfire View of Injector Damage, Test 5-1

At approximately 4 sec after complete reignition of the motor, the inlet line of the backup system failed and the motor exhausted through both the nozzle and the secondary injector inlet until the propellant burnout. Figures 81 and 82 show the area of failure and the resulting damage to the injector.

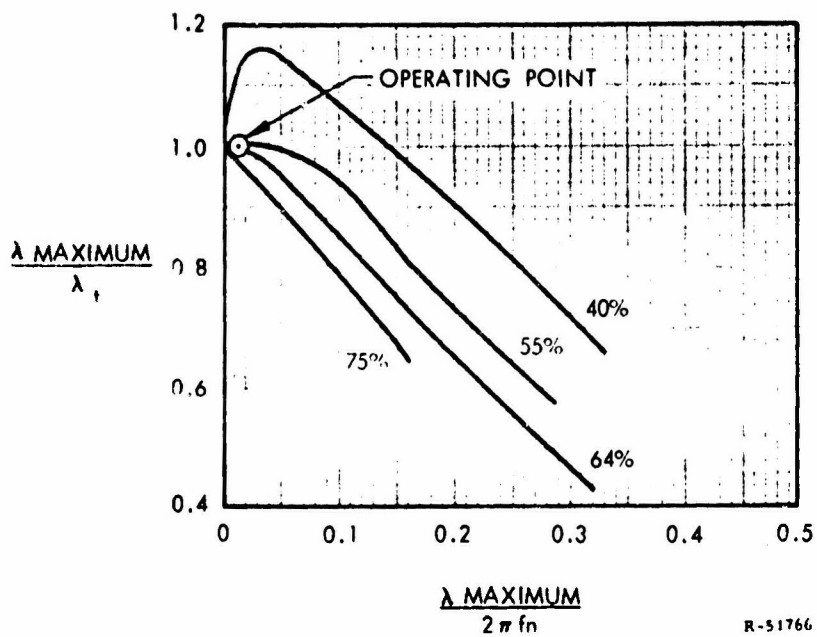
Figure 92. Instrumentation Error in Exponential Decay Rate Measurements, Parameter As Percent Critical Damping

The instrumentation configuration used on the TM-1 motors has a natural frequency (f_n) of 430 cps, and the maximum value of λ_{max} observed to date is 60 sec^{-1} . As shown by figure 92, the error in the measured depressurization rates resulting from instrumentation lags is less than 3%.
