**SUPERSONIC TRANSPORT PROGRAM  
PHASE II-C**

**BI-MONTHLY TECHNICAL  
PROGRESS REPORT**

**CONTRACT FA-SS-66-5  
NOVEMBER 1966**

D6-18110-8

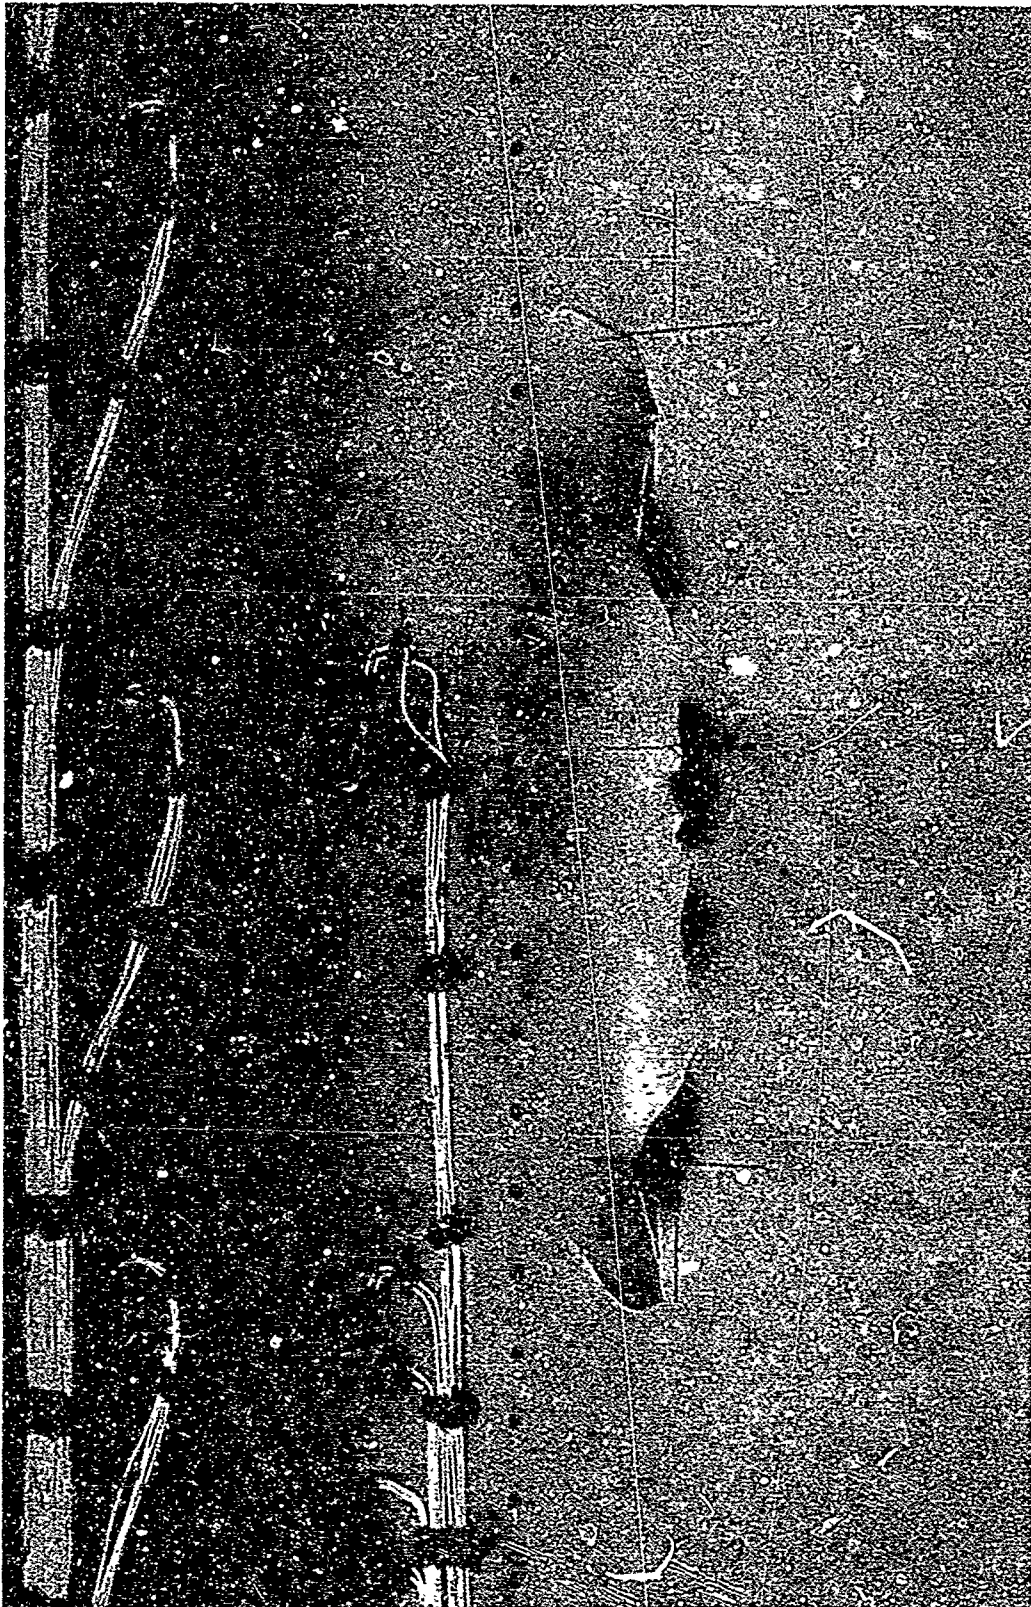
Figure 13. Puncture Test on .050 Gage S Panel

The first puncture test was conducted on the 0.050 gage skin panel. Damage from the 12-inch wide blade was confined to the punctured area.

Damage resulting from these tests is shown in Figs. 13 and 14.
