# **RAPID PREPARATION OF QUICK-CURE RESIN TEST SITES IN SOUTHEAST ASIA**

**Part I Southeast Asia Test Program**

**TECHNICAL REPORT AFAPL-TR-66-148, PART I**

**28 FEBRUARY 1967**

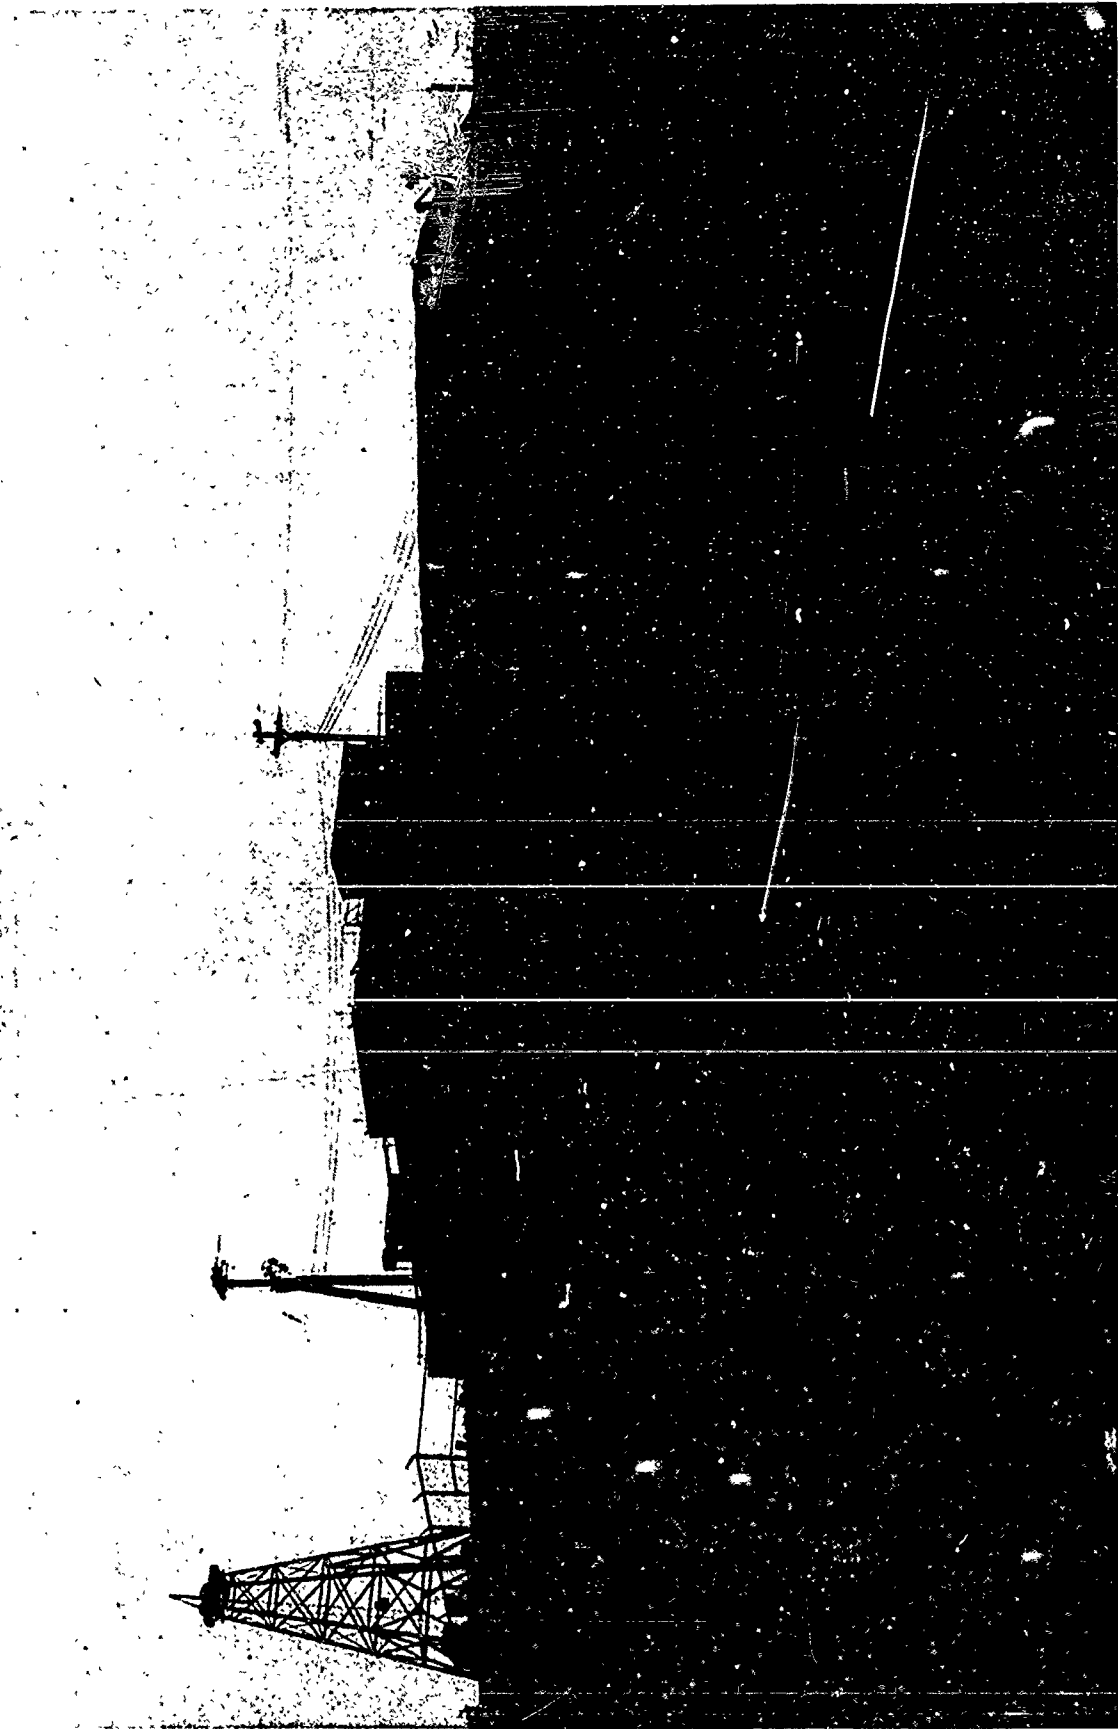
Figure 10. View of the Sand Revetment Constructed  
For Southeast Asia Team Training

A simulated sand revetment section was constructed which is shown in Figure 10, page 28. Three types of sand revetment coverage (resin only, resin and spray glass, and resin and woven glass fabric) were tested. Footprints in the sand were raked out before spraying some of the test sections, and were allowed to remain for others. Figures 11 and 12, pages 29 and 30, show views of the sand revetment test site during and after completion of spraying operations. All surfaces sprayed supported foot traffic with no

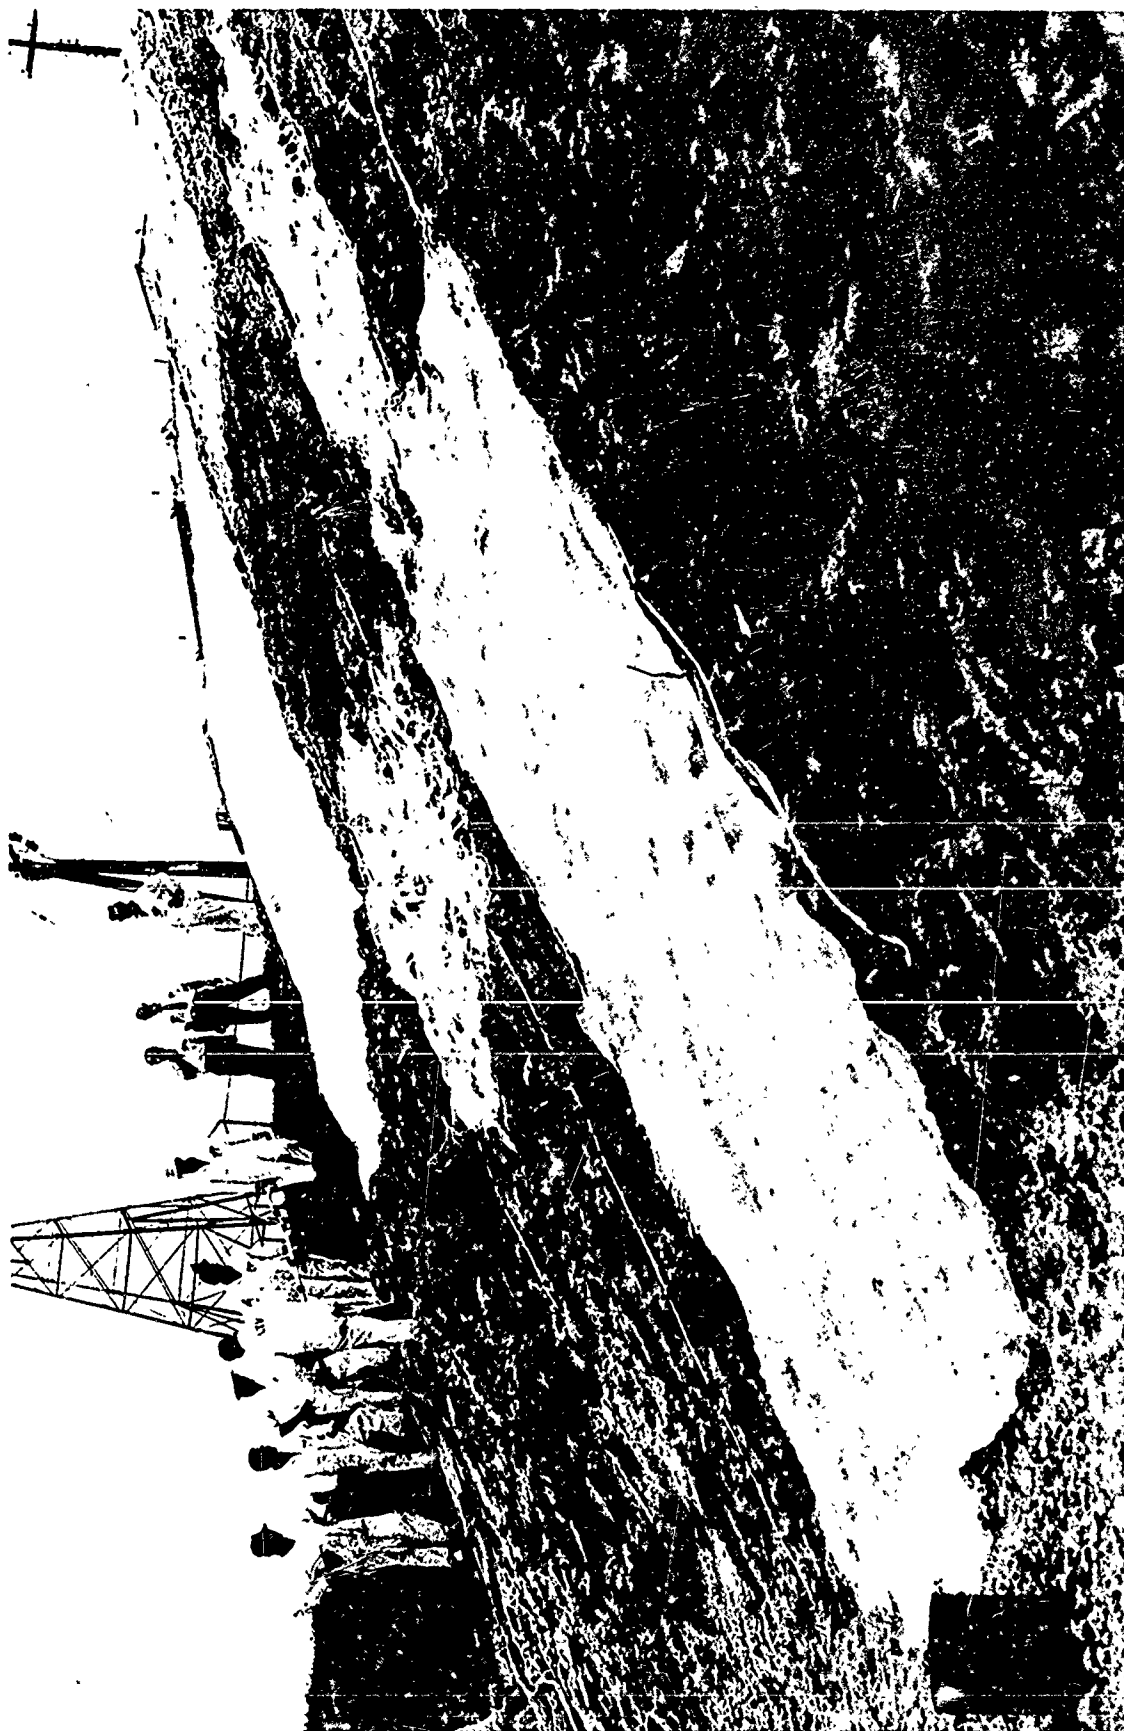
Figure 11. View of Sand Revetment During Spraying  
Operations

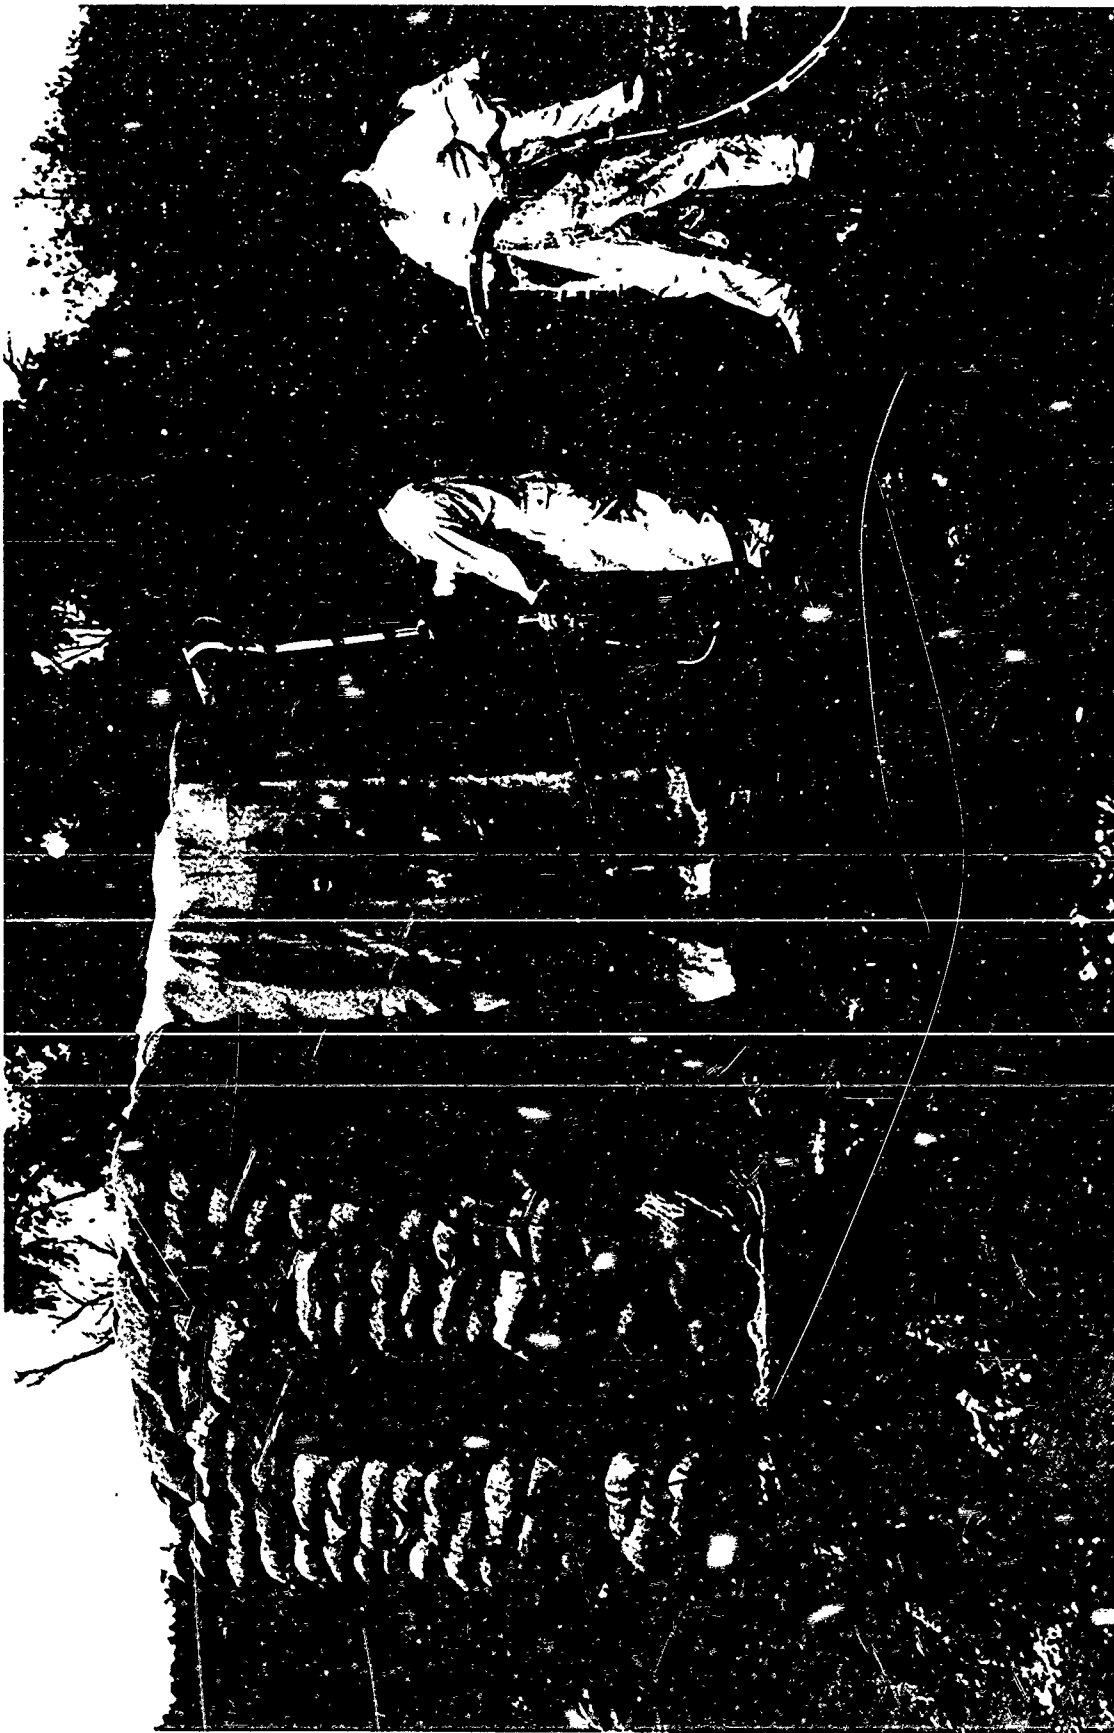
Figure 14. View of Sand Bag Emplacement During Spraying Operations

(b) The Glasscraft pole gun worked best for all wall areas of the sand bag emplacement.

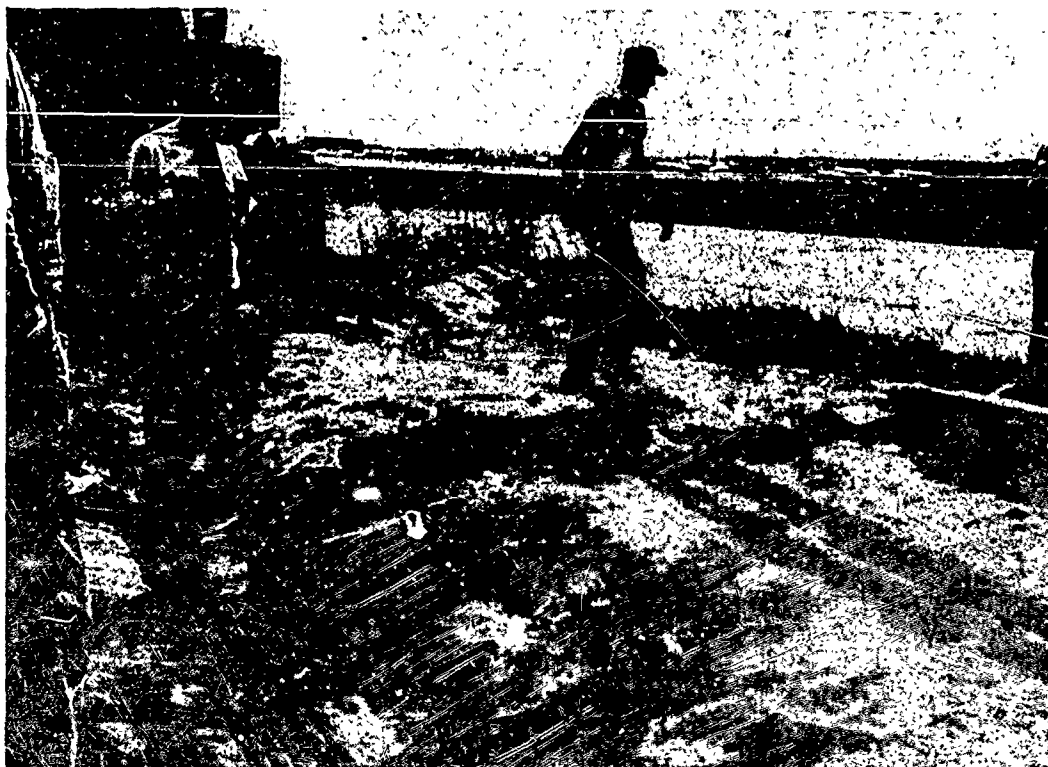
Figure 20. Views of Testing of Simulated C-130 Airplane - Pad 3  
on Soil 2 (Clay) in the Soil Trench

| Soil Base | Pad No. (a)(c) | Section No. | Pad Density (lbs/ft <sup>2</sup> ) | Number of Layers of Woven Glass | Percent Spray Glass | Resin and Spray Glass System Used | Rolling Wheel Test Results (b) |
|---|---|---|---|---|---|---|---|
| Clay | 3 | | 4.86 | 4 | 11.5 | Combined | After 12 passes with the loaded crane there were 2 small surface cracks, and ruts were about 15 inches deep (peak to peak). |

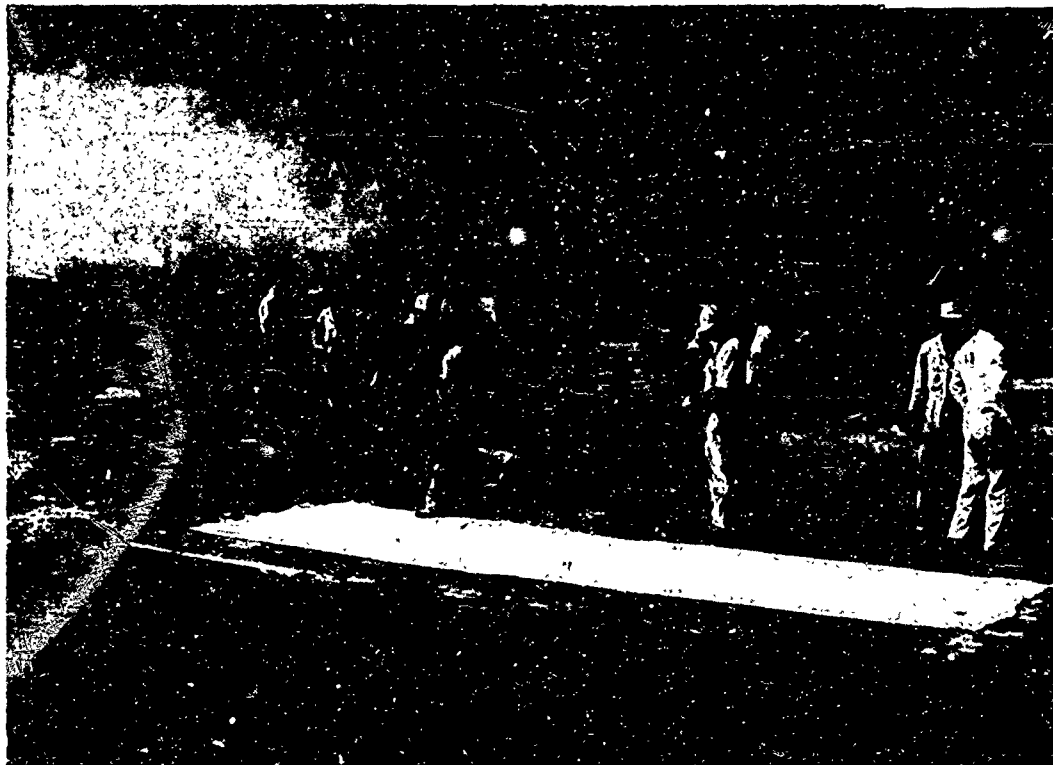
Figure 21. Views of Construction and Testing of Simulated C-130 Airplane -  
Pad 4 on Soil 2 (Clay) in the Soil Trench

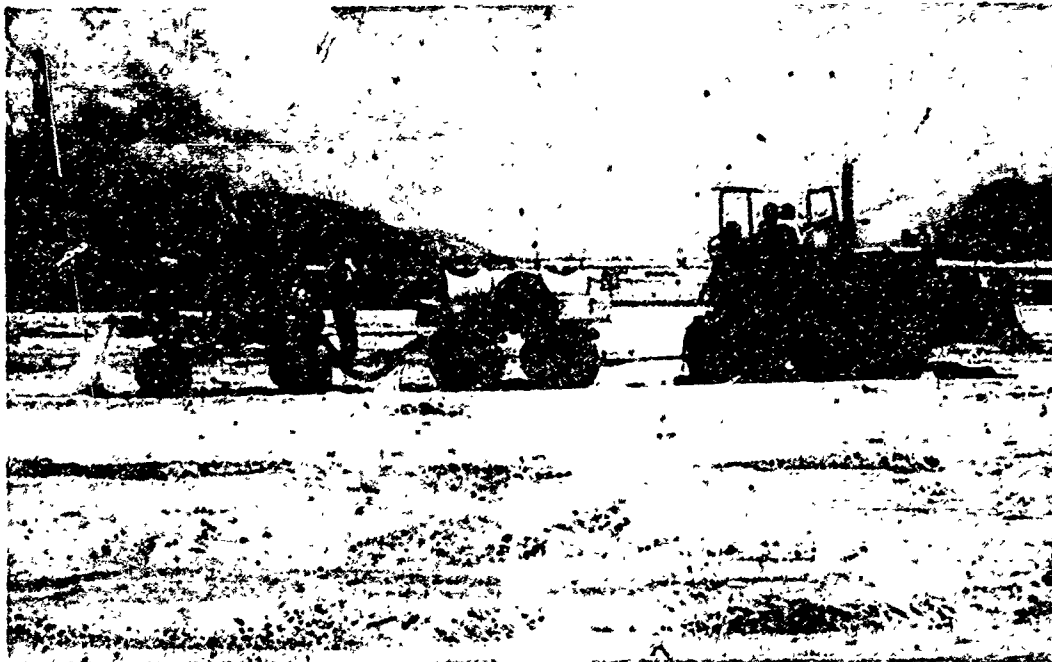
MATERIAL APPLICATION

BROKEN SOIL STABILIZATION MATERIAL CRUST

Figure 22. Views of Latex Base Soil Stabilization Material Application and Results

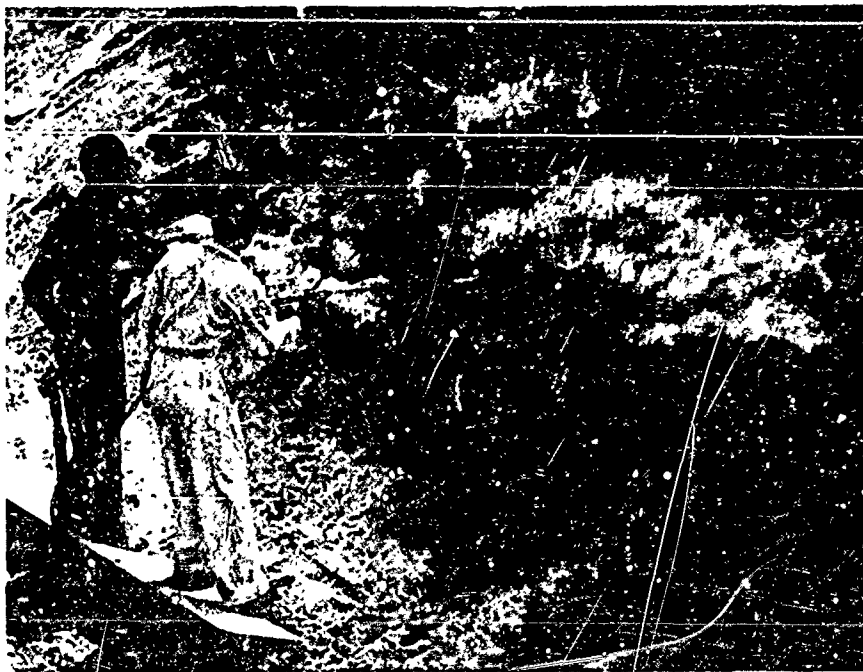
WOVEN ROVING AND RESIN COVERAGE

GUN ROVING AND RESIN COVERAGE

Figure 23. Views of Sand Ammunition Revetment Site Construction  
(Sheet 1)

Figure 23, page 54, shows views of the ammunition revetment site construction. Table XII, page 56, presents material coverage data for this site. Three types of coverage were used for this site (resin only, resin with spray glass, and resin with woven glass). Resin with spray glass and resin with woven glass were very satisfactory. The resin only area was not considered satisfactory due to cracks that developed from the sand shifting, and was subsequently recovered with resin and woven glass. Also, some areas along the bottom of the revetment required reinforcement with woven glass, spray glass, and resin due to vehicles running up on them. The revetment reinforcement material coverage data is presented in Table XIII, page 57. Figure 24, page 59, shows a view inside the ammunition revetment along one side after completion of the lower edge reinforcement.

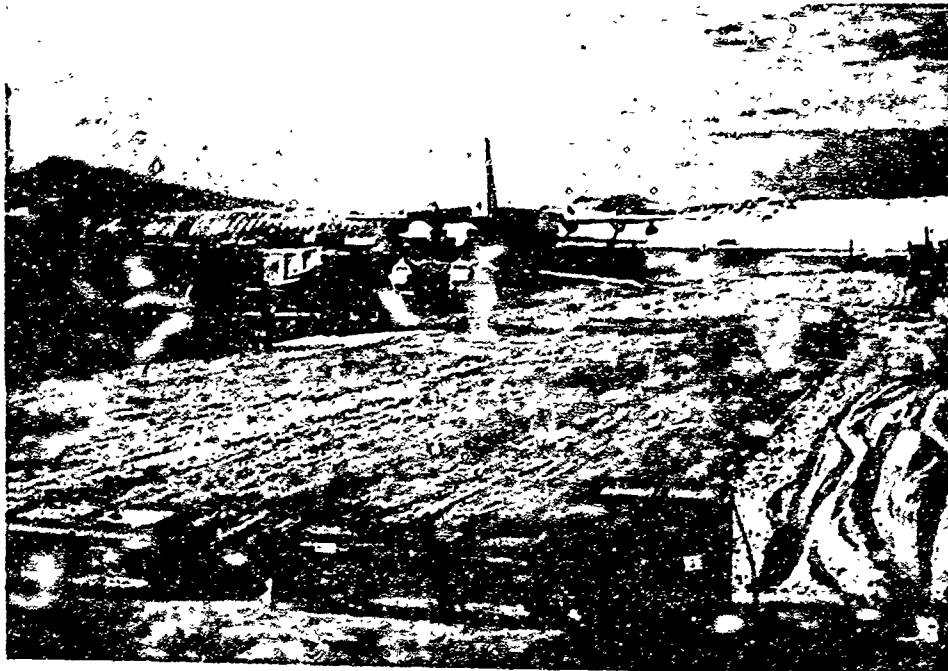
PARTIALLY CONSTRUCTED

TYPICAL OVERLAP ONTO PSP

Figure 25. Views of Cargo Storage Site Construction  
(Sheet 2)

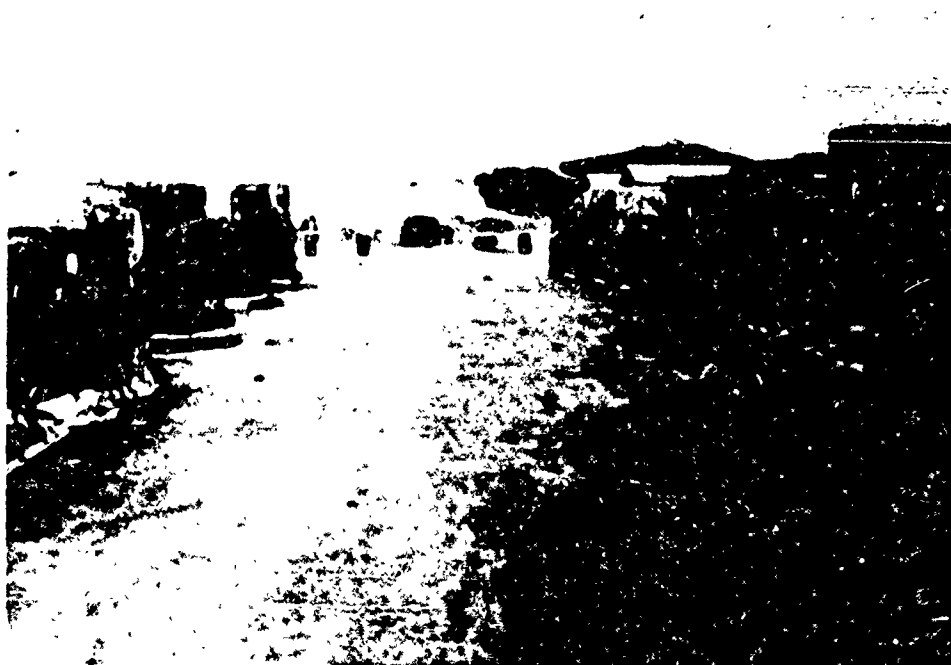
FUEL TRUCK ON PAD NO. 2

STORAGE OF CARGO

Figure 26. Views of Cargo Storage Site Testing  
(Sheet 2)

Other testing was accomplished, however, using loaded fork lifts, a large loaded fuel truck, and cargo pallets placed on two boards (static loading). Views of initial testing of the Cargo Storage Site are presented in Figure 26, page 64. Table XV, page 66, presents test conditions and results of this testing. Before departure from SEA (after two weeks of heavy use), this site was examined and found to be in excellent condition.
