FTC-TR-67-11

**LIMITED
PERFORMANCE AND
STABILITY AND
CONTROL TESTS**

This report contains the results of limited performance and stability and control tests performed on C-123K, USAF S/N 54-581 at the Fairchild-Hiller Corporation, Hagerstown, Maryland and Olmsted Air Force Base, Pennsylvania, between 3 October 1966 and 26 January 1967. The tests were conducted under Air Force Flight Test Center (AFFTC) Project Directive 66-104, 16 June 66. The program structure was 921A and the AFFTC priority was 25.

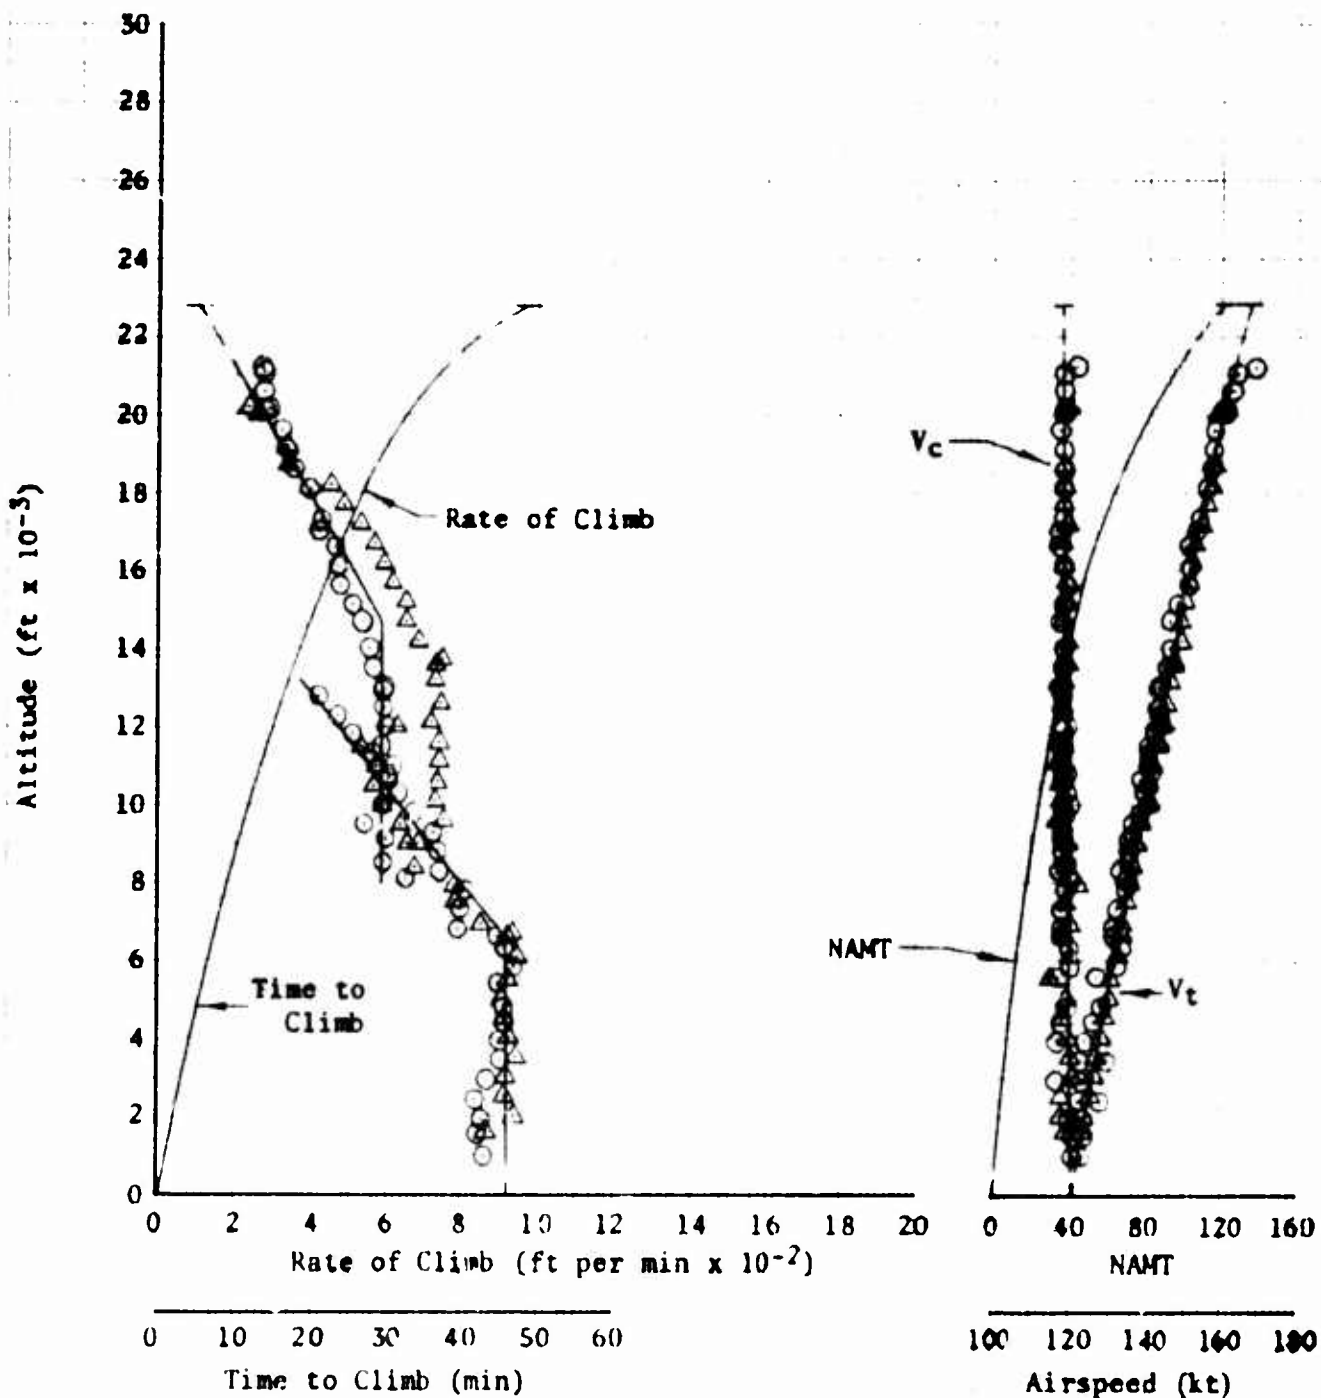
Figure 9. Climb Performance

C-123K USAF S/N 54-581
 R2800-99W and J85-G2-17 Engines
 PR-58E5 Carburetors 43E60-607 Propellers
 Left Recip Engine Inop Right Recip Engine - METO Power
 Both Jet Engines - Military Rated Thrust

- NOTES: 1. Cowl flaps - TAKEOFF.
 2. Oil coolers - COLD.
 3. Gear and flaps - UP.
 4. Gross weight at engine start - 56 000 lb.
 5. Fuel allowed for taxi, takeoff, and acceleration to climb speed - 500 lb.

climb data corrected to standard day conditions are shown in figures 7 through 9, appendix I.

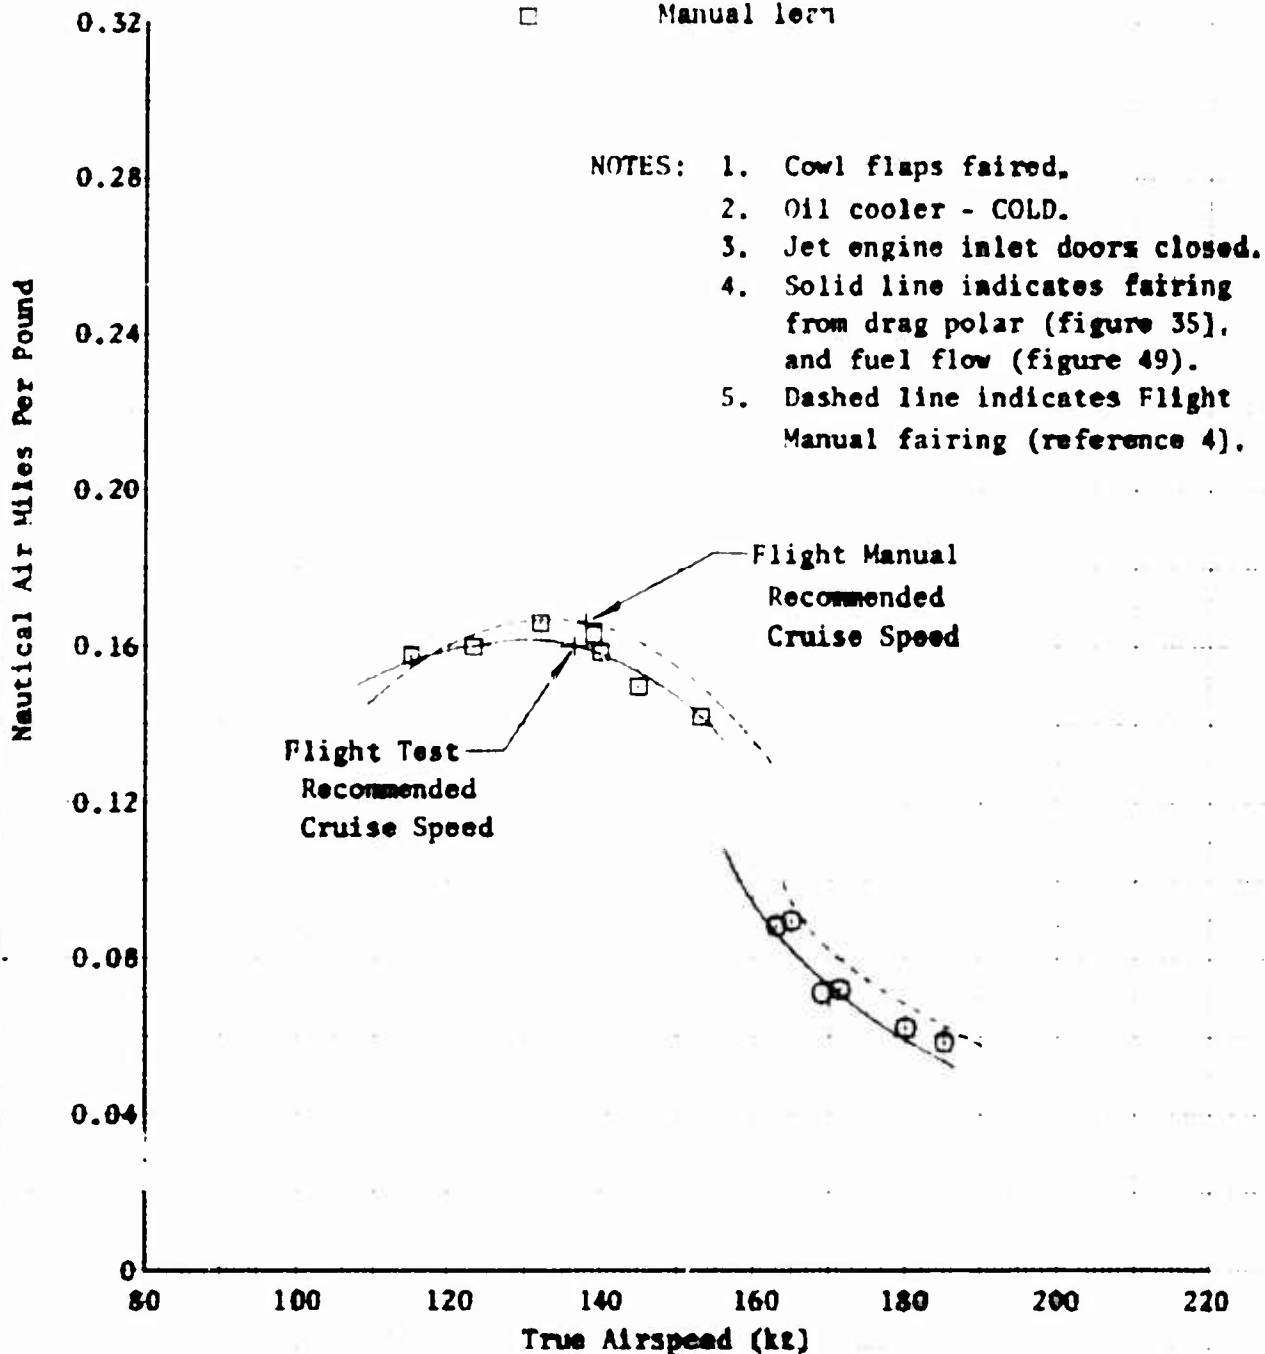
Figure 19. Specific Range

Symbol	Mixture Setting
○	Auto rich
□	Manual lean

Specific range data (NAMPP) are presented in figures 19 through 25, appendix I. The solid line fairings on the NAMPP plots represent data cross plotted from the drag polars and the engine characteristic data. Corresponding NAMPP data fairings from the Flight Manual are also shown. It should be noted that the nautical air miles traveled per pound of
