## SPECIAL FRACTOGRAPHIC TECHNIQUES FOR FAILURE ANALYSIS

MATERIALS RESEARCH AND PRODUCTION

DOUGLAS AIRCRAFT COMPANY

PRESENTED TO  
70TH ANNUAL MEETING OF AMERICAN SOCIETY  
FOR TESTING MATERIALS  
BOSTON, MASSACHUSETTS  
29 JUNE 1967

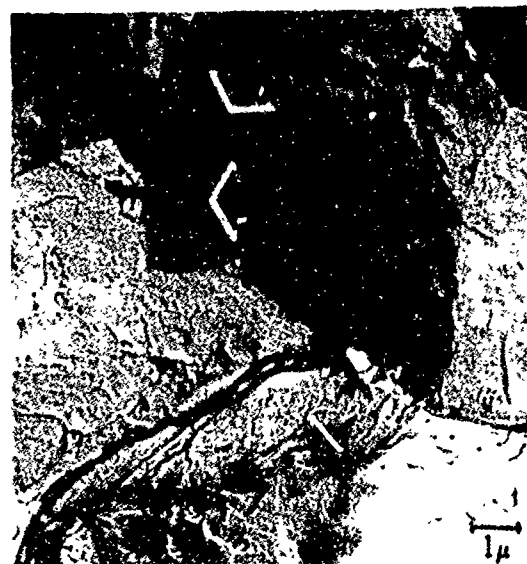
**Figure 11. Illustration of Subtle Differences Between Hairline Indications (Arrows) of Stress Corrosion and Hydrogen Embrittlement Fractures in 4340, 260/280 Steel, Magn. 6500X**

**Hydrogen Embrittlement**

**Stress Corrosion**

Other features associated with each type of fracture are shown in Figure 10. Stress corrosion usually showed evidence of secondary cracking and corrosion products in the nucleus region. The hairline indications in the intergranular regions and partial dimples which are thought to be associated with the fracturing process are somewhat more distinct in hydrogen embrittlement than in stress corrosion fractures. These subtle differences are illustrated in Figure 11.
