## Qualification Testing of the FMU-68/B Fuze

TECHNICAL REPORT AFATL-TR-67-135  
OCTOBER 1967

QUALIFICATION TESTING OF THE FMU-68/B FUZE

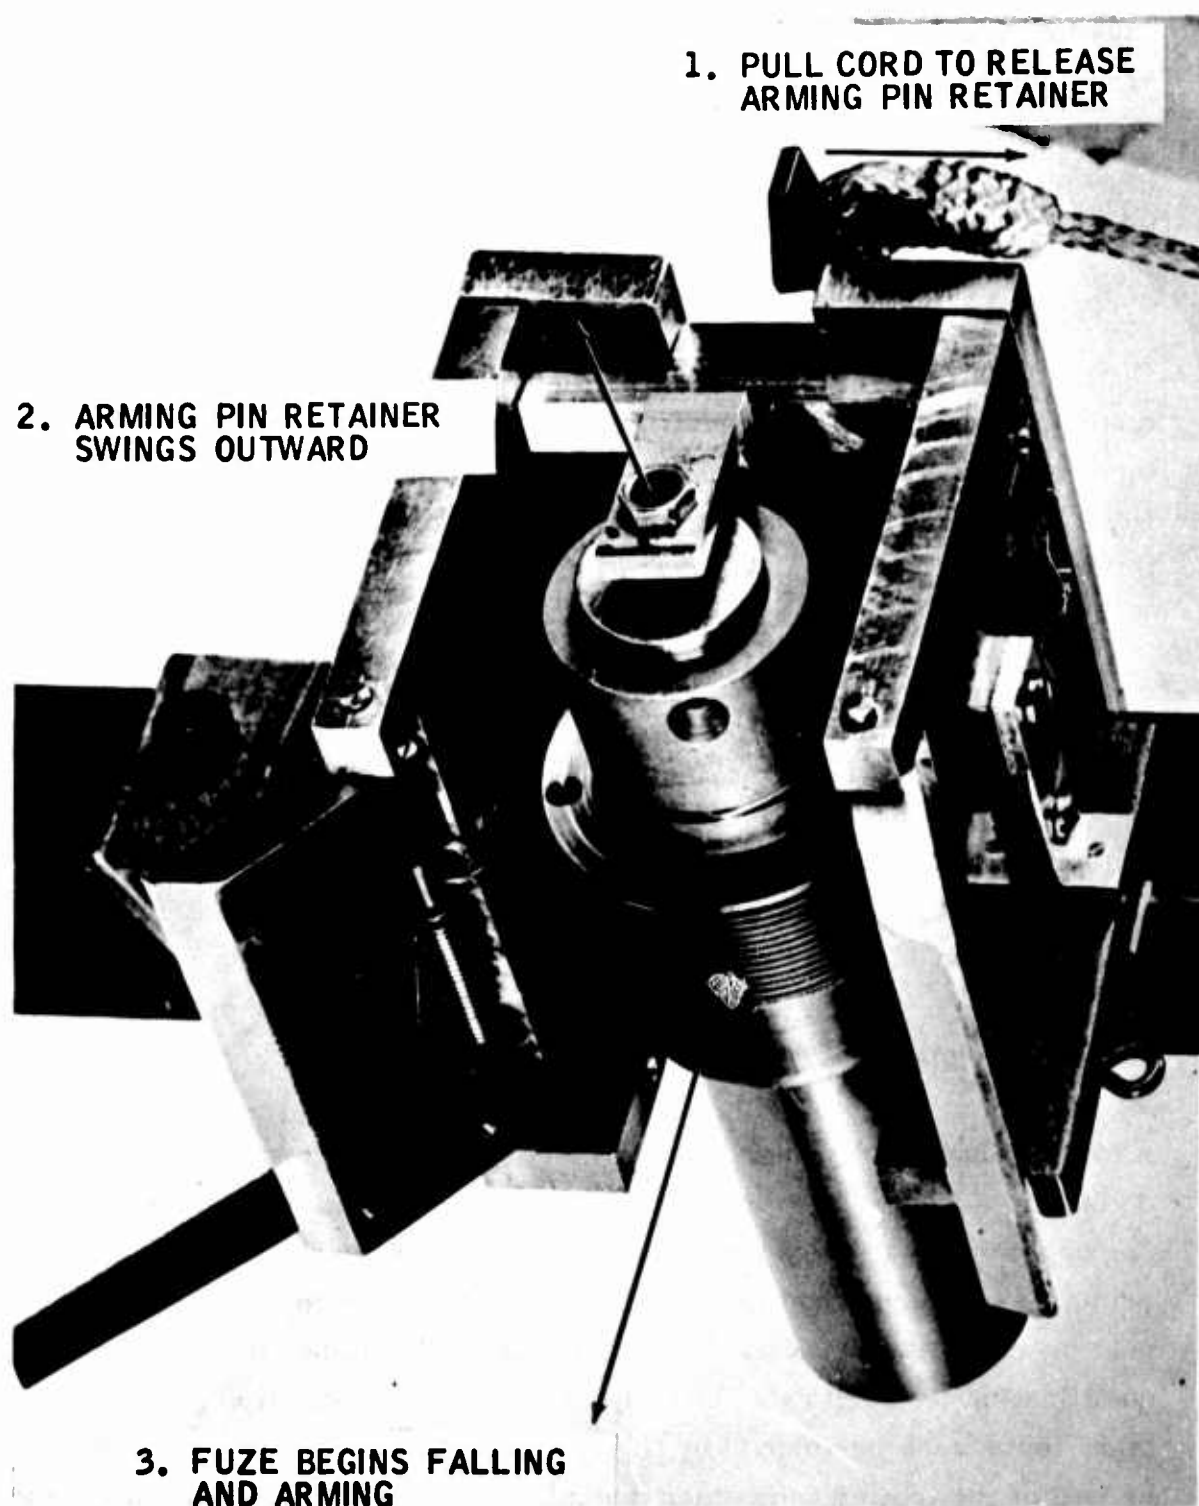
Figure 7 - TEST FIXTURE FOR DROPPING FUZES

The tube fixture was replaced by a trap door fixture in which the fuze was oriented parallel to the floor and at a height of three feet. This new fixture was a five-sided box with the open side facing down. The fuze was retained between two ends of the box, one of which was hinged, and the hinged end was retained by a lanyard. The trap door fixture provided unrestrained fuze descent from the point of release. When the remaining fuze was dropped from the fixture, it aborted properly (figure 7). The qualification lot ("304 lot") of fuzes was built before testing was resumed.

Fifty-one fuzes from the "304 lot" were dropped 11.5 feet onto concrete, using the fixture shown in figure 7 which simultaneously released the arming pin and initiated the fuze drop. Six fuzes failed to function. Upon recovery, five were aborted and one was fully armed but had not fired. The latter unit had landed on the arming pin which probably absorbed enough energy through the arming pin spring to prevent proper functioning of the centerplate assembly.

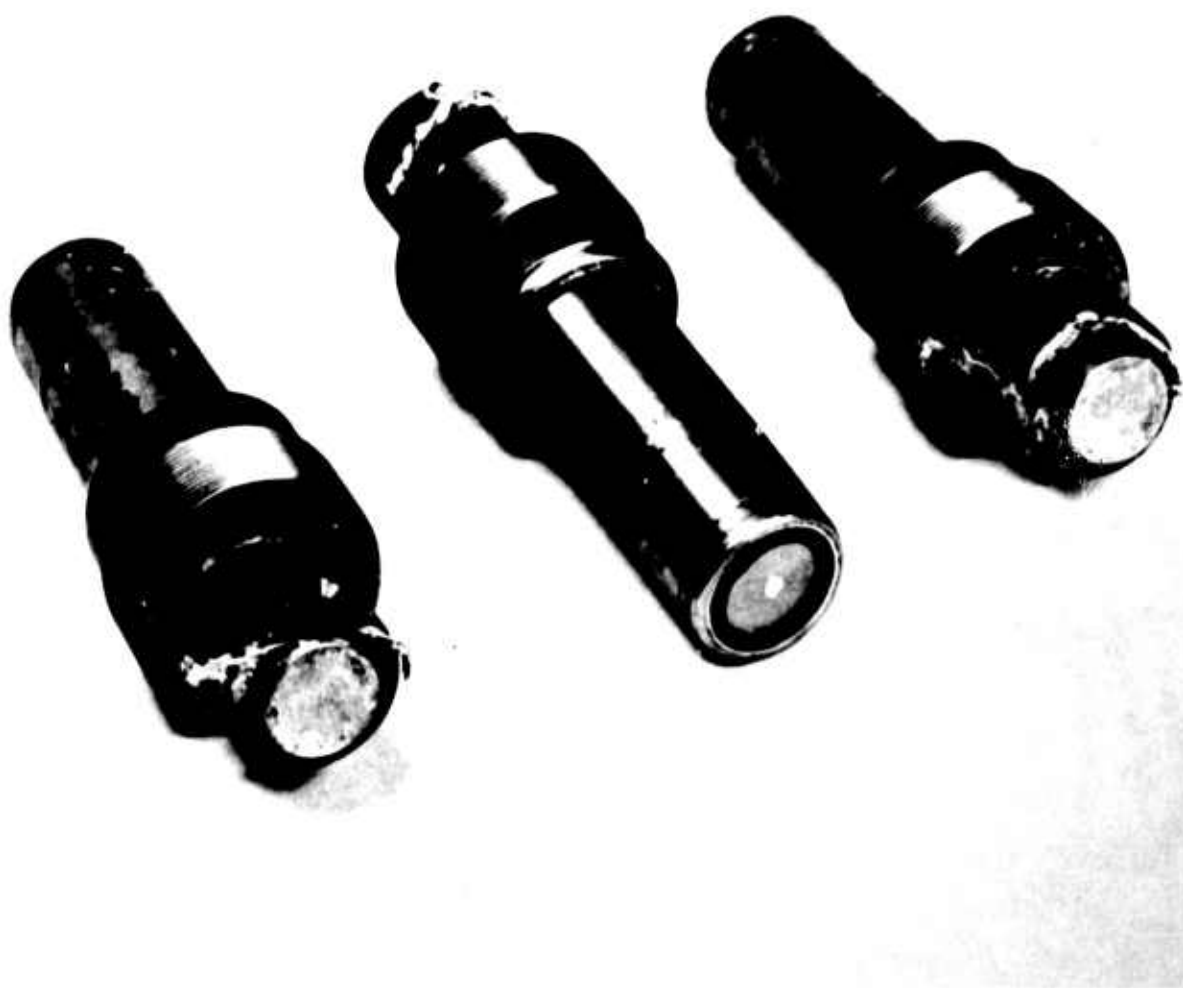
Figure 10 - FMU-68/B FUZES AFTER SALT SPRAY TEST

Five fuzes from the "304 lot" were subjected to salt spray as per MIL-STD-810A, method 509.1 (refer to figure 10). After completion of the test, all five fuzes were manually armed and the arming times were monitored. Three fuzes were then dropped 11 feet for a function test; all three functioned properly. The remaining two were cut open to inspect for leakage and/or corrosion. No leakage or corrosion was evident except on the arming pin safety wire.

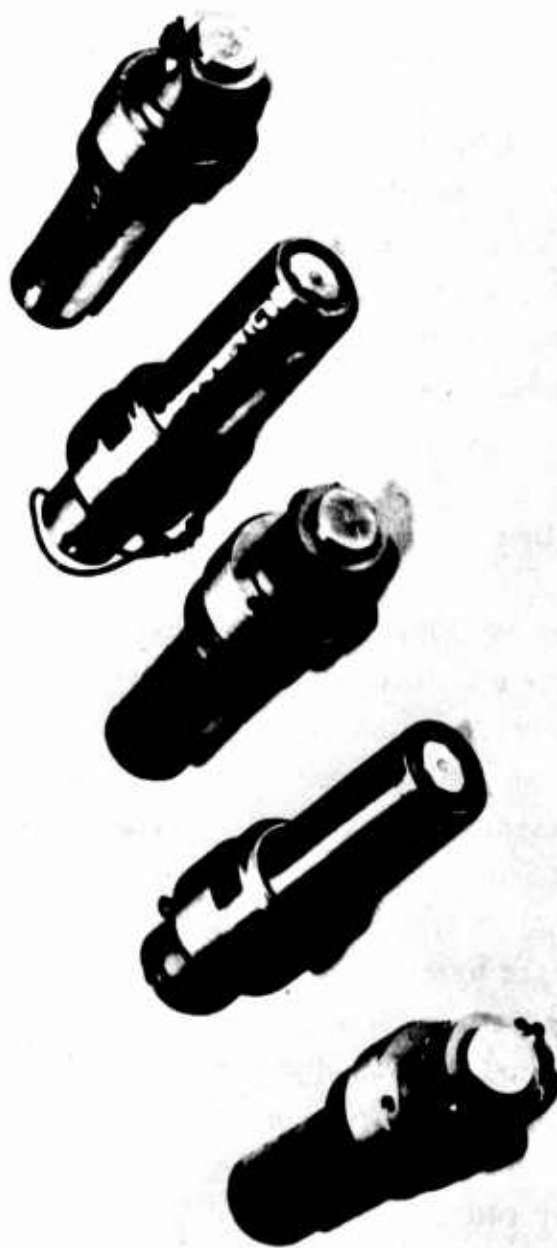
**Figure 13 - FMU-68/B FUZES AFTER 16 DAYS OF TEMPERATURE-  
HUMIDITY CYCLING**

Fourteen fuzes from the "304 lot" were subjected to a temperature-humidity cycle per MIL-STD-304. After 16 days, five units were removed from the chamber (figure 13), manually armed, and dropped 11 feet for a function test. All five fuzes functioned properly. After 28 days, the remaining nine units were removed and manually armed while the arming times were monitored. Five units were functioned from a three-foot drop height. All five fuzes functioned properly. The remaining four fuzes were cut open and inspected. No leakage or corrosion was detected.

| TYPE OF TEST | SERIAL NUMBER | CONDITION AFTER TEST | STATIC ARMING TIME (SEC) | DROP HEIGHT (FT) | FUNCTION RESULTS | COMMENTS |
|---|---|---|---|---|---|---|
| ENVIRONMENTAL (TEMPERATURE-HUMIDITY CYCLING) (14) | 6 | SEE FIGURE 13 | 0.62 | 11.0 | FUNCTIONED | REMOVED AFTER 16 DAYS |
