TECHNICAL REPORT NO. 3-783

AN ANALYTICAL MODEL FOR PREDICTING  
CROSS-COUNTRY VEHICLE PERFORMANCE  
APPENDIX B: VEHICLE PERFORMANCE IN LATERAL AND  
LONGITUDINAL OBSTACLES (VEGETATION)  
VOLUME I: LATERAL OBSTACLES

U. S. Army Engineer Waterways Experiment Station

**VOLUME I: LATERAL OBSTACLES**

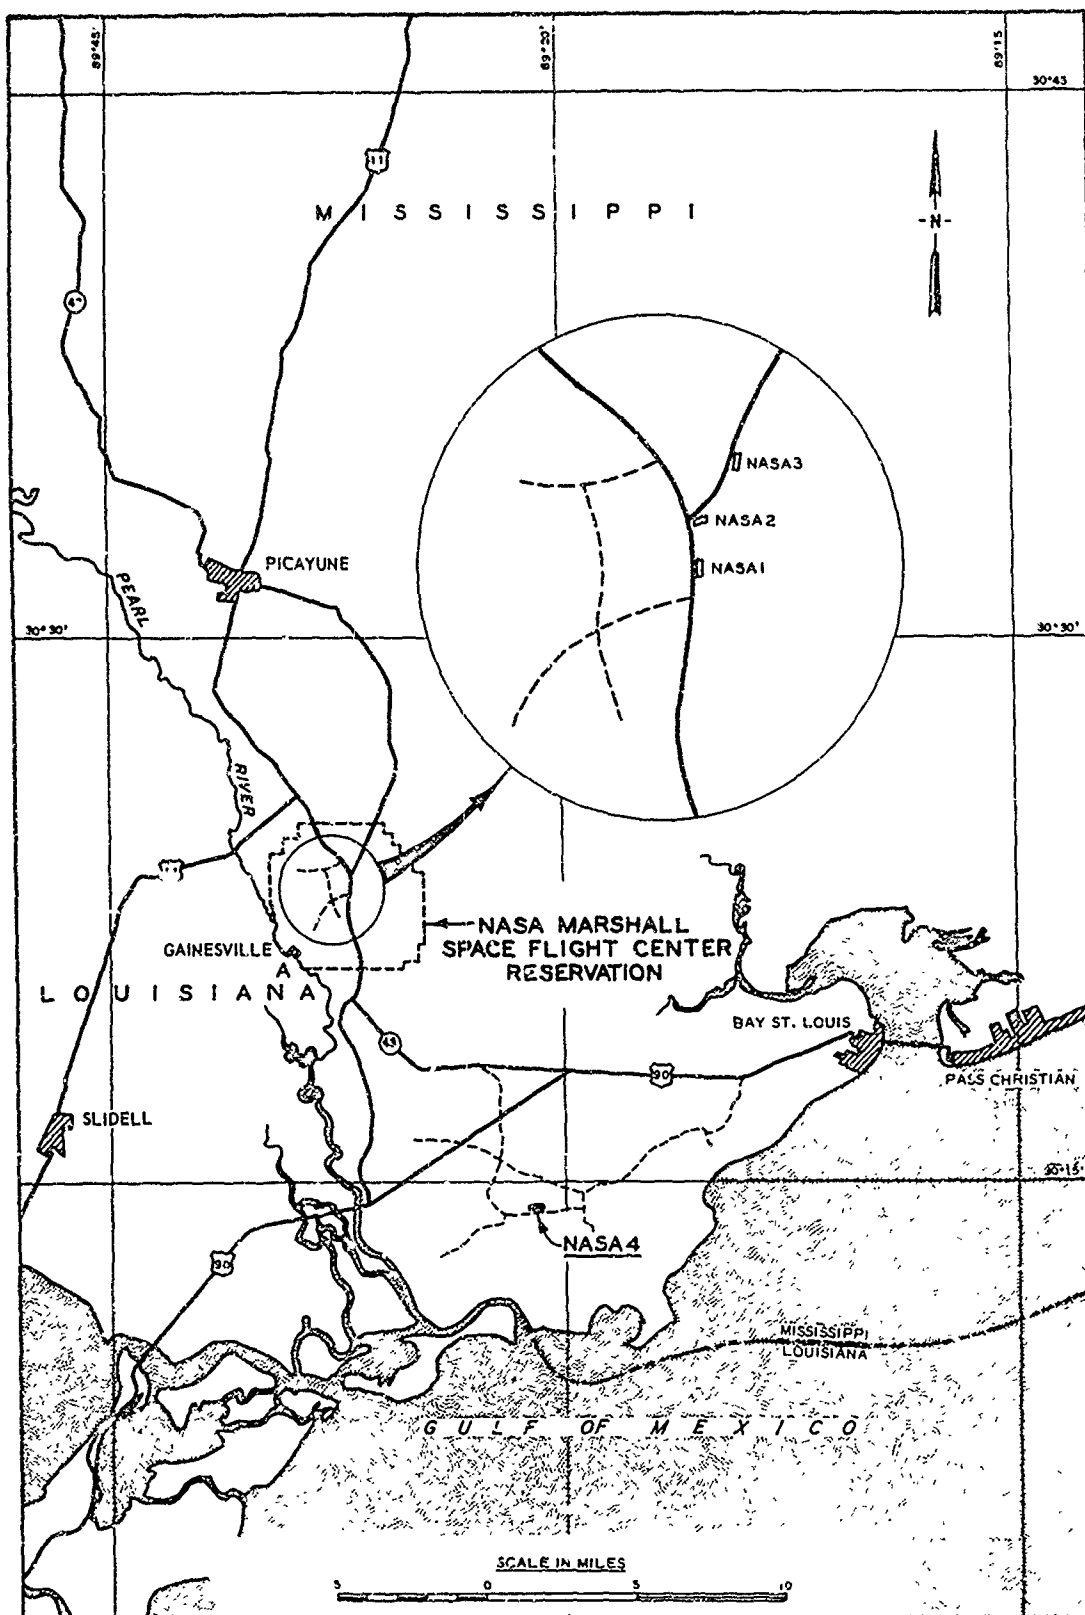
Fig. B2. Location of test sites, NASA Marshall Space Flight Center test area

7. The four sites at NASA Marshall Space Flight Center were identified as NASA1, NASA2, NASA3, and NASA4 (fig. B2). The sites were approximately 500 ft long and 250 ft wide and very nearly level (less than 0.5 percent slope along each test run). Trees at the sites were coniferous, or coniferous and hardwood mixed. Ground cover varied from pine straw to small bushes (fig. B3). Soils in the area were classified as ML, CL-ML,

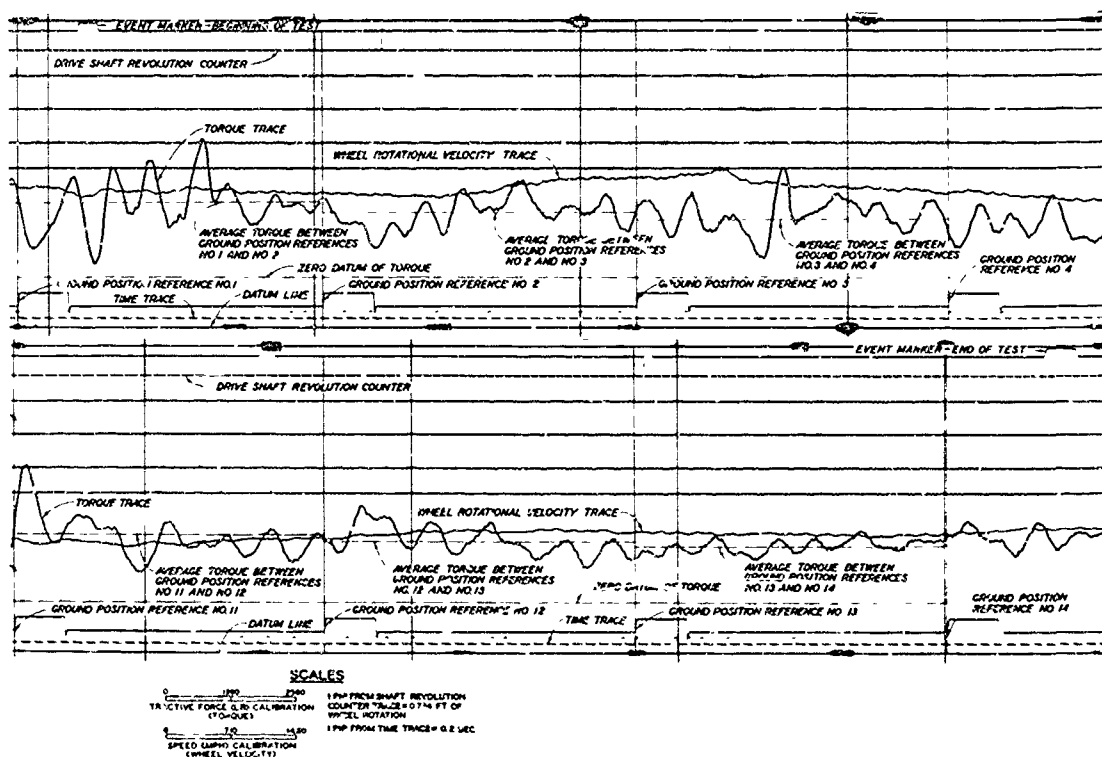
Fig. B9. Oscillogram record, test 281, M37 3/4-ton cargo truck

13. Instrumentation installed on the test vehicles (except the M151 1/4-ton truck) recorded continuous measurements of time, drive shaft revolutions, wheel or track rotational velocity, and drive line torque. In addition, for some tests vertical and longitudinal accelerations were measured and recorded. Event marks on an oscillogram indicated the beginning and end of the test and correlated the record with ground reference points. An example of an oscillogram record is shown in fig. B9. For the M151 1/4-ton truck, time from start to end of the test

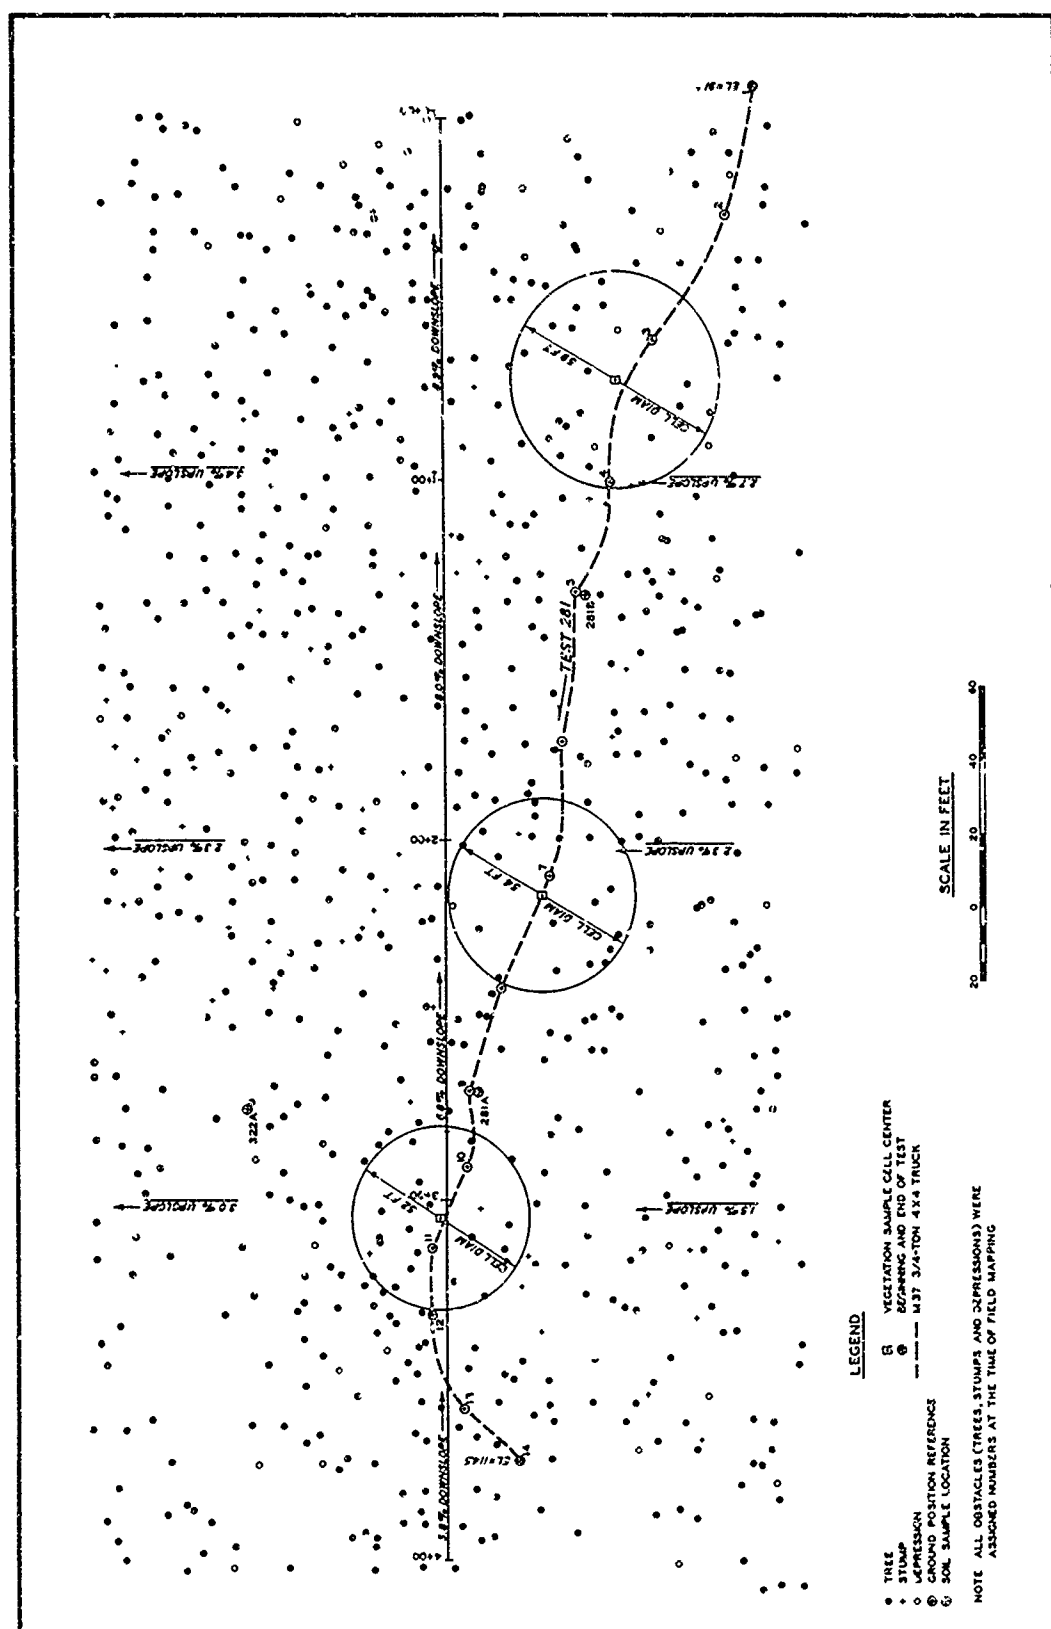
run was measured by a stopwatch. A stopwatch was also utilized on the other vehicle tests in case the oscillograph recorder malfunctioned and to permit a quick estimate of speed immediately after each test. Appropriate data from the tests are summarized in table B2.

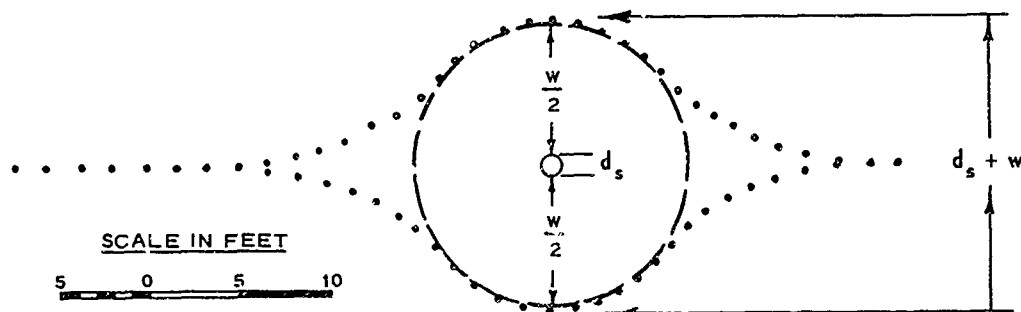
37. Accordingly area denied ( $A_d$ ) by a single tree was defined as the area encompassed by a circle whose diameter was equal to the stem diameter ( $d_s$ ) plus the vehicle width ( $w$ ). An example of the computation is shown in fig. B11. Note that although the area of the dashed circle

$$A_d = \frac{\pi}{4} (d_s + w)^2$$

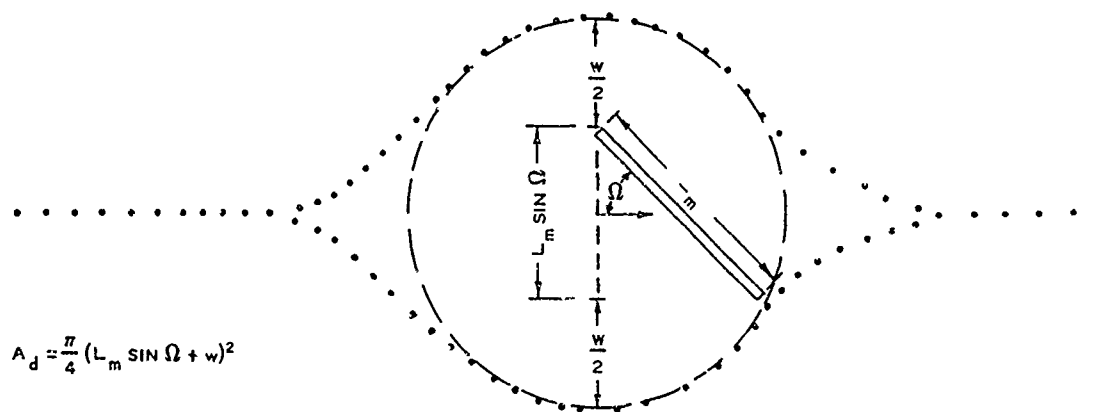
44. The area denied by a log is dependent upon the orientation of the log with respect to the direction of vehicle travel. Fig. B12 illustrates the computation for area denied by a log when the vehicle approaches at an angle  $\Omega$ . Since the angle  $\Omega$  is not known,  $\sin \Omega$  is arbitrarily selected as 0.635 which is the average sine of all angles between 0 and 90 deg.

- ..... PATH OF POINT ON CENTER LINE OF VEHICLE
- $L_m$  = LENGTH OF LOG
- $\Omega$  = ANGLE FORMED BY LOG AND DIRECTION OF VEHICLE TRAVEL
- $w$  = VEHICLE WIDTH

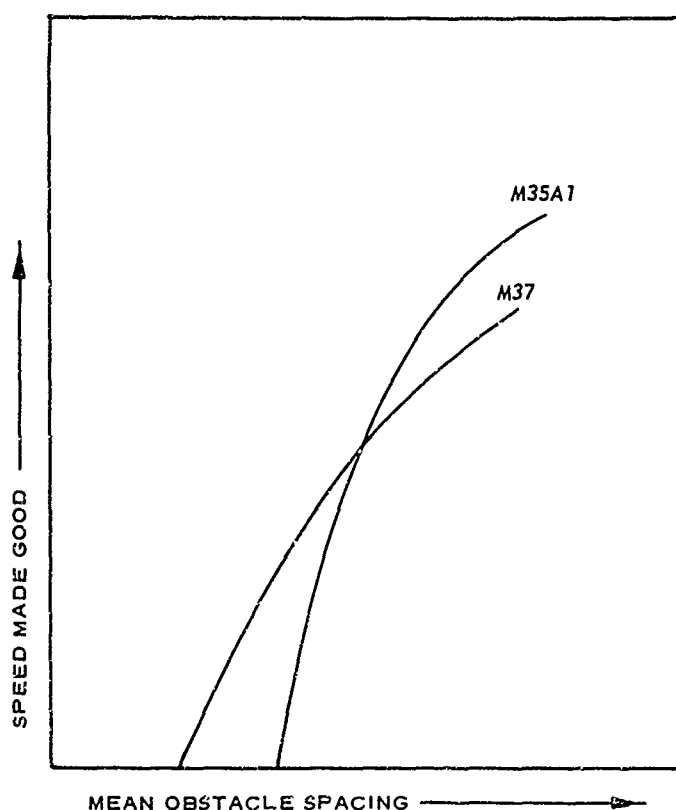
Fig. B13. Comparison of the speed made good-mean obstacle spacing curves for the M37 and M35A1

47. The problem of interrelating the factors influencing vehicle performance in lateral obstacles is not lessened when it is realized that the degree of influence of some of the factors varies inversely with the influence of others. For instance, in the tests resulting in low speeds, such vehicle factors as width, length, wheelbase, and turning radius, and such terrain factors as size and spacing of obstacles appeared most significant. In the tests resulting in higher speeds, vehicle and driver factors such as power, weight, steering response rate, and reaction time, and terrain factors such as soil strength, surface condition, slope, and visibility seemed to be of prime importance. From observation only, it was noted that driver influence was most significant when speeds exceeded 8 to

10 mph. Differences in vehicle performances can be demonstrated by comparing the shape of the speed made good versus obstacle spacing curves for the M37 and M35A1 (fig. B13). Below the point of intersection of the two curves speed made good is controlled mainly by vehicle geometry and spacing. Above this point other vehicle and terrain factors begin to assume significance as do the driver factors. Yet the steepness of the M35A1 curve suggests that the vehicle's capability for acceleration exerts influence even at small obstacle spacings.

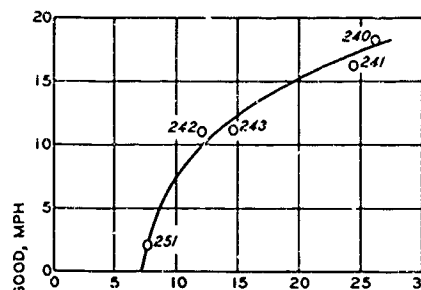
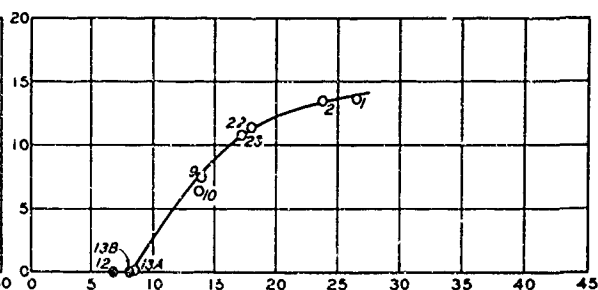
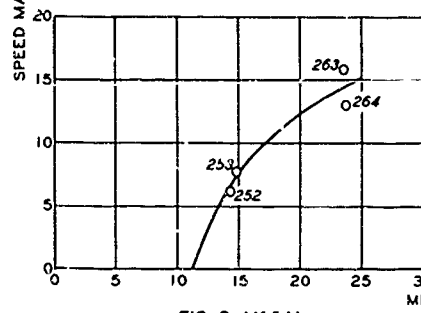
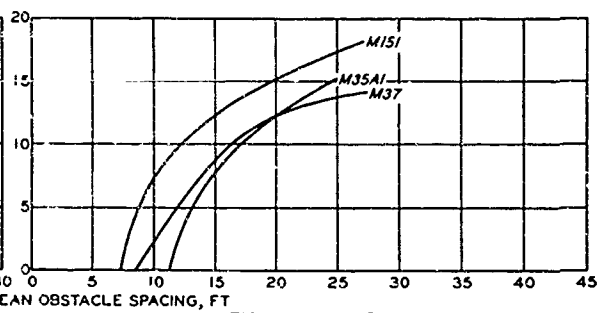
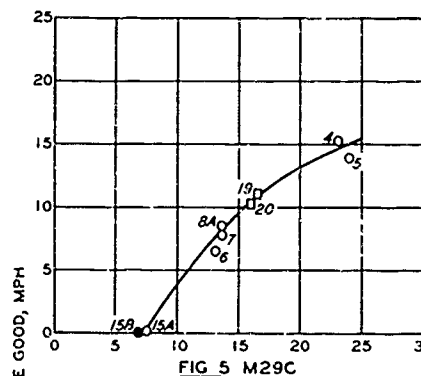
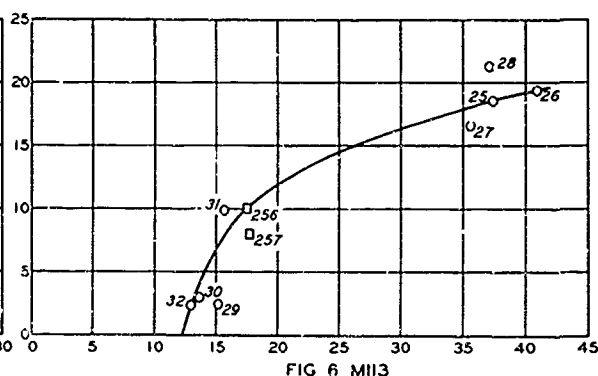
NOTE NUMBERS NEAR PLOTTED POINTS  
INDICATE TEST NUMBERS  
CLOSED SYMBOLS DENOTE  
IMMOBILIZATIONS

**SPEED - SPACING RELATIONS**  
SPEED MADE GOOD VS  
MEAN OBSTACLE SPACING  
TESTS ON FINE-GRAINED SOILS AND SANDS  
WITH FINES, POORLY DRAINED  
NEARLY LEVEL SURFACES

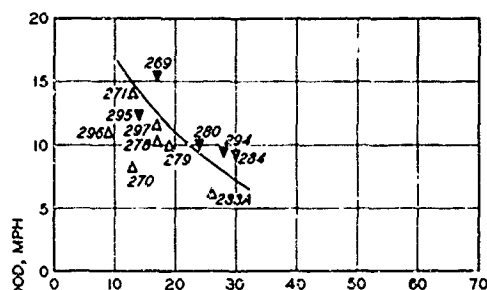
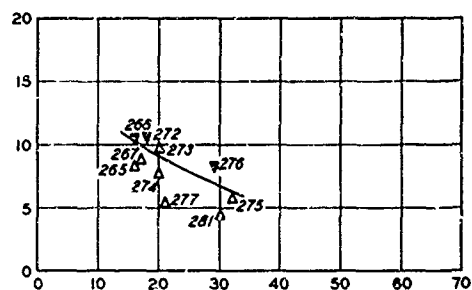
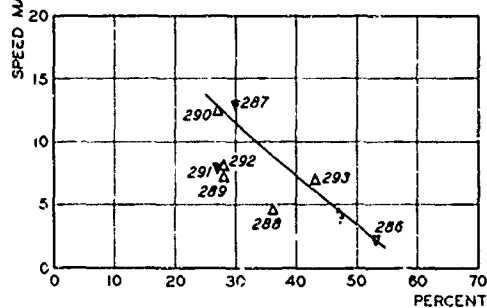
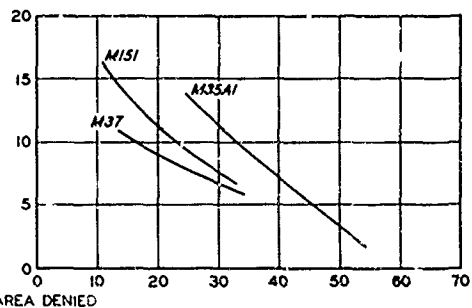
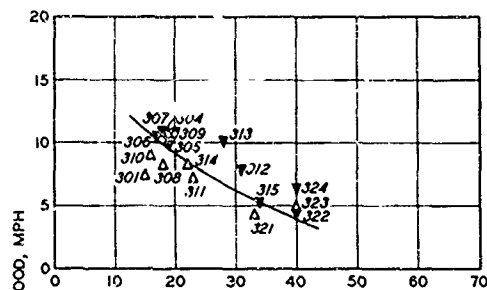
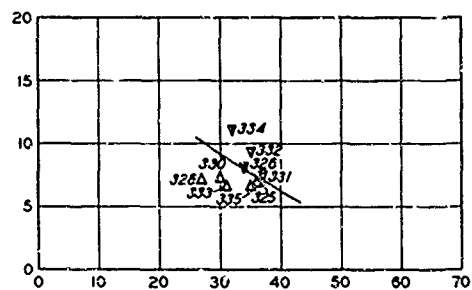
NOTE: NUMBERS NEAR PLOTTED POINTS  
INDICATE TEST NUMBERS  
CLOSED SYMBOLS DENOTE  
IMMOBILIZATIONS

**SPEED-AREA DENIED RELATIONS**  
SPEED MADE GOOD VS  
PERCENT AREA DENIED  
TESTS ON FINE-GRAINED SOILS AND SANDS  
WITH FINES, POORLY DRAINED  
NEARLY LEVEL SURFACES
