SUBJECT: Operational Report - Lessons Learned, Headquarters, 184th  
Ordnance Battalion, Period Ending 30 April 1969

SUBJECT: Operational Report of the 184th Ordnance Battalion (Ammo)  
for Period Ending 30 April 1969 RCS CSFOR-65 (R-1)

Operational Report for Period Ending 30 April 1969, RCS CSFOR-65 (R-1)

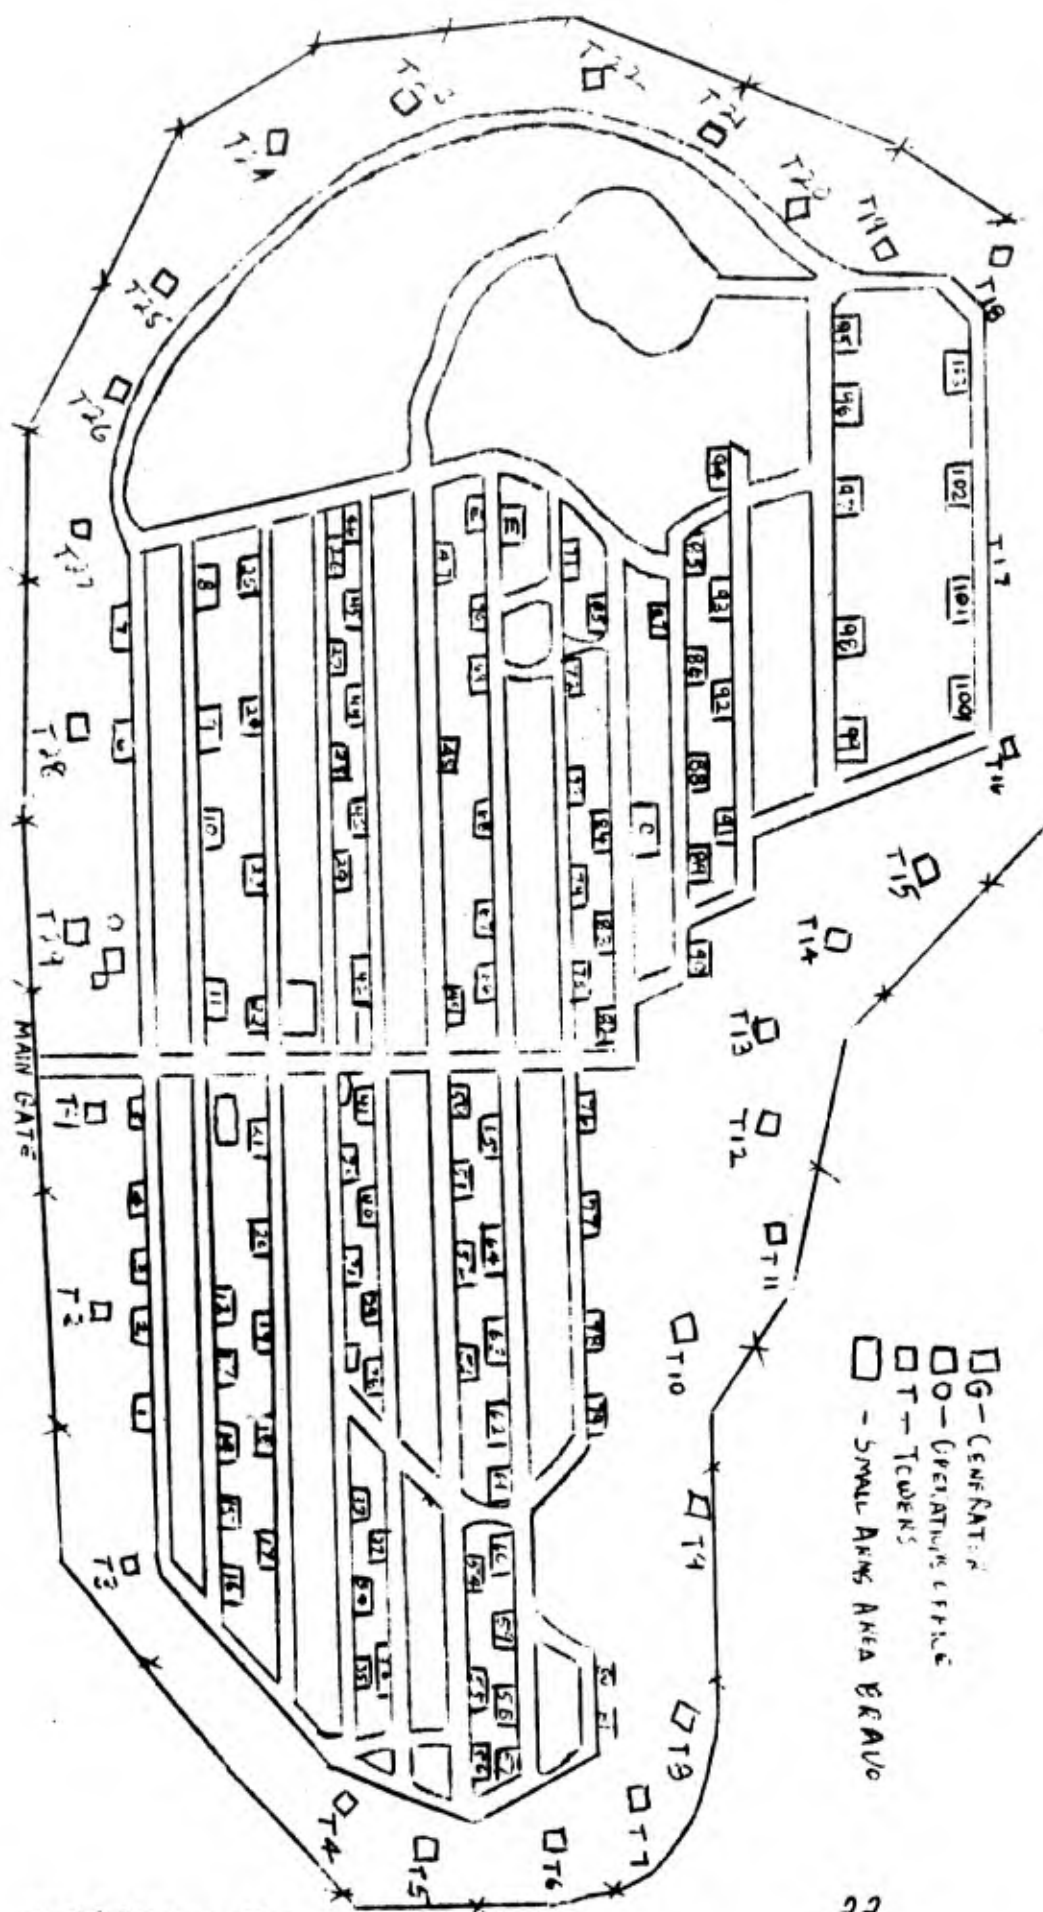
Appendix 1  
Depot Map

a. At approximately 0220 hours 23 February 1969 an explosion was observed at pad 92, Qui Nhon Ammunition Base Depot. The explosion was in the direct center of the front or east side of the pad. The pallets of ammunition began to burn immediately.

b. Within three minutes after the initial explosion on pad 92, similar explosions were observed on pads 95 and 103. Fires also began to burn on these pads immediately. At the time of these explosions, CPT Bourque and CPT Carter were directly in front of pad 95. They described the explosion on pad 95 as being V shaped and having a large amount of red hot shrapnel or sparks. The explosion was on the south end of the pad between the ammunition stack and the berm.

h. The fragmentation from pads 92, 95 and 103 ignited pads 93, 96 and a portion of small arms area B. Three dozers were sent to the small arms area to attempt to extinguish the fire by covering it with dirt. As the dozers were approaching the small arms, pad 85 began to burn. An attempt was made to put out the fire on pad 85 with water but this was unsuccessful. As the fire became more intense the rounds began to cook off. The fragmentation from this pad made attempts to extinguish the fire in the small arms area too hazardous.

m. At approximately 0945 hours pad 65 burst into flames, pads 98 and 94 were ignited by fragmentation from other pads between 0945 and 1130 hours. These pads began burning and cooking off within 30 minutes.

n. At approximately 1530 hours explosions were observed on pads 101, 102 and 97 in rapid succession. These explosions occurred four hours after pad 94 and after it appeared that the fire would not spread. Personnel in the depot reported these rounds as incoming and some guards in the towers reported spotting smoke in the hills to the east of the ABD. At the same time personnel from Delta Company, 58th Infantry also reported spotting the smoke. Gunships were requested from Lane Army Airfield and they arrived over target within the minutes. Two gunships strafed and rocketed the suspected firing positions, no return fire or secondary explosions reported.

a. At approximately 0220 hours 23 February 1969 three separate explosions ignited fires on three pads in the Qui Nhon Ammunition Base Depot. The fact that no muzzle flashes or sounds of weapons firing were reported and that all the explosions were on pads strongly suggests that the explosions were set off by sappers. The search of the depot failed to reveal any traces of sapper activity and there were very few reports of individuals being sighted.

b. At approximately 0830 explosions on pads 91 and 99 set off fires on these pads. Although low order detonations had been occurring since the initial five pads were set off it appeared just prior to these explosions that the fires had diminished and that no additional pads would be ignited. A burning round had been seen in a small fire on pad 91 at approximately this time.

c. Pads 97, 102 and 103 were ignited by explosions at approximately 1530 hours. At this time the density of explosions had again diminished. Personnel in the depot reported incoming rounds at this time, however the explosions in the depot area could have been caused by rounds being thrown from burning pads and detonating on impact or cooking off after landing. Security personnel in the depot towers reported spotting smoke on the hillside east of the ABD. At the same time personnel from Delta Company, 58th Infantry reported spotting smoke in the same area from the cantonment area. White phosphorous rockets from pad 85 had been cooking off and this smoke spotted on the hill could have been one of these rounds.

6. CONCLUSION: Although the actual cause of the initial explosions cannot be positively identified, it appears from the evidence and testimony available and a knowledge of enemy forces and tactics used in the Qui Nhon area, that these explosions were the work of a sapper unit. This unit was able to infiltrate into the depot, set their charges and escape undetected. It is also extremely possible that the enemy realizing his opportunity, used a firing position on the east side of the depot to fire mortar, rocket or recoilless rifle fire into the explosion area to set off additional pads during the daylight hours of 23 February 1969.

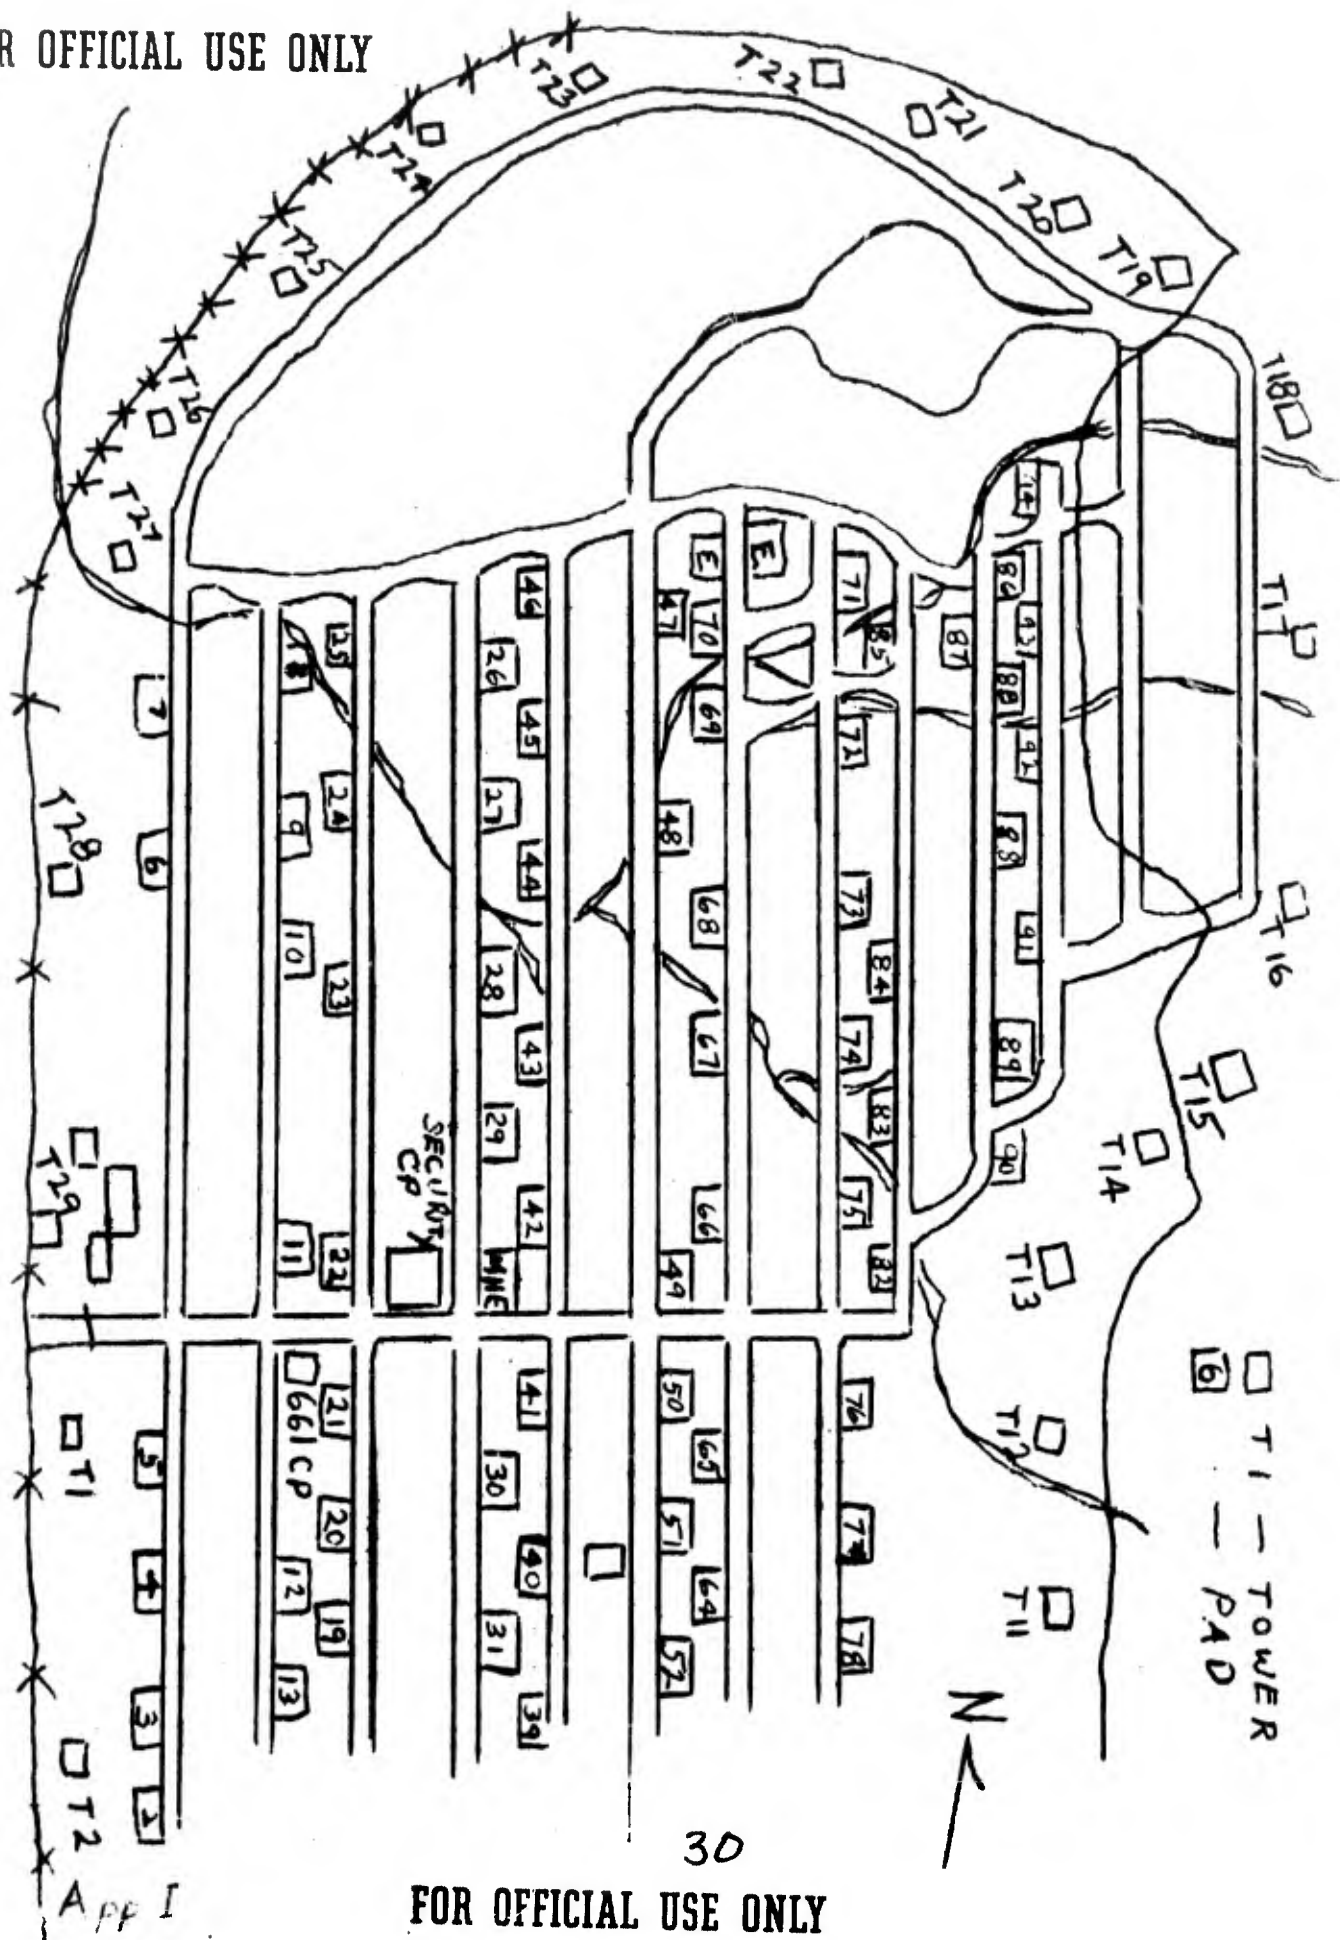
(1) At 2250 hours an explosion was observed at Pad 89 in the Qui Nhon Ammunition Base Depot. This explosion immediately ignited ammunition pallets on the pad. Within two to three minutes personnel who had been working in the vicinity of the pad began to fight the fire. A water truck from the 820th Ordnance Company Operations Office arrived at the pad within five minutes and was used to assist in extinguishing the fire.

(5) At approximately 2320 hours an explosion was heard from the vicinity of pad 28. It was soon confirmed that pad 28 was burning and immediately detonations began on this pad.

(8) At approximately 2335 hours an explosion was observed on pad 90. The pad started burning immediately and went high order very soon thereafter. Although the pad had been searched twice with negative results it appears that a sapper was responsible for this explosion as there was no debris from other pads being thrown into this area.

(9) At 2345 hours a high order mass detonation of pad 28 occurred. This detonation scattered 81mm HE mortar rounds throughout the entire depot area, heavily damaging all structures in the depot area. At 2346 hours Major Michael ordered all personnel to evacuate the depot area as the danger from shrapnel and rounds being thrown from the pads and exploding on impact was too hazardous to risk unnecessary exposure of a large number of personnel. The security guards were the last personnel to leave the depot area. Upon their departure they formed a defensive perimeter on the north, west and south sides of the depot.

a. At 2258 hours, 10 March 1969, an explosion was observed on pad 89 in the Qui Nhon Ammunition Base Depot. This explosion resulted from a satchel charge which had been placed on the east side of the pad between the middle and bottom pallets of a stack of three pallets. From the manner in which the pad immediately burst into flames it is assumed that the satchel charge was composed of an extremely combustible material.

e. At approximately 2330 hours an explosion was observed on pad 90 by personnel who were departing pad 89. Although this pad had been searched twice and the security force was in the area there is no manner in which this explosion could have been started other than a sapper setting a satchel charge. There was no pad burning at this time which was throwing rounds into the area near pad 90.

f. Five pads were destroyed and one pad was damaged during the attack. A complete listing of items lost by DODIG and dollar value was forwarded through Class V supply channels. In addition to ammunition losses a large amount of equipment was lost due to the suddenness and violence of the initial high order mass detonation.

Recommendation: That the Qui Nhon Ammunition Base Depot be provided sufficient water trucks so that they can be placed at strategic points in the depot area to be readily available and able to reach any location in the minimum time possible.

Recommendation: That all vehicles which are assigned to personnel who work in the depot area and all water trucks be required to carry an axe, crowbar and shovel.

Recommendation: That an alternate gate be constructed providing access to Highway 1 at a distance from the existing gate. This gate should be constructed so that it can be locked, trip flared and equipped with concertina barriers, yet easily opened when required.

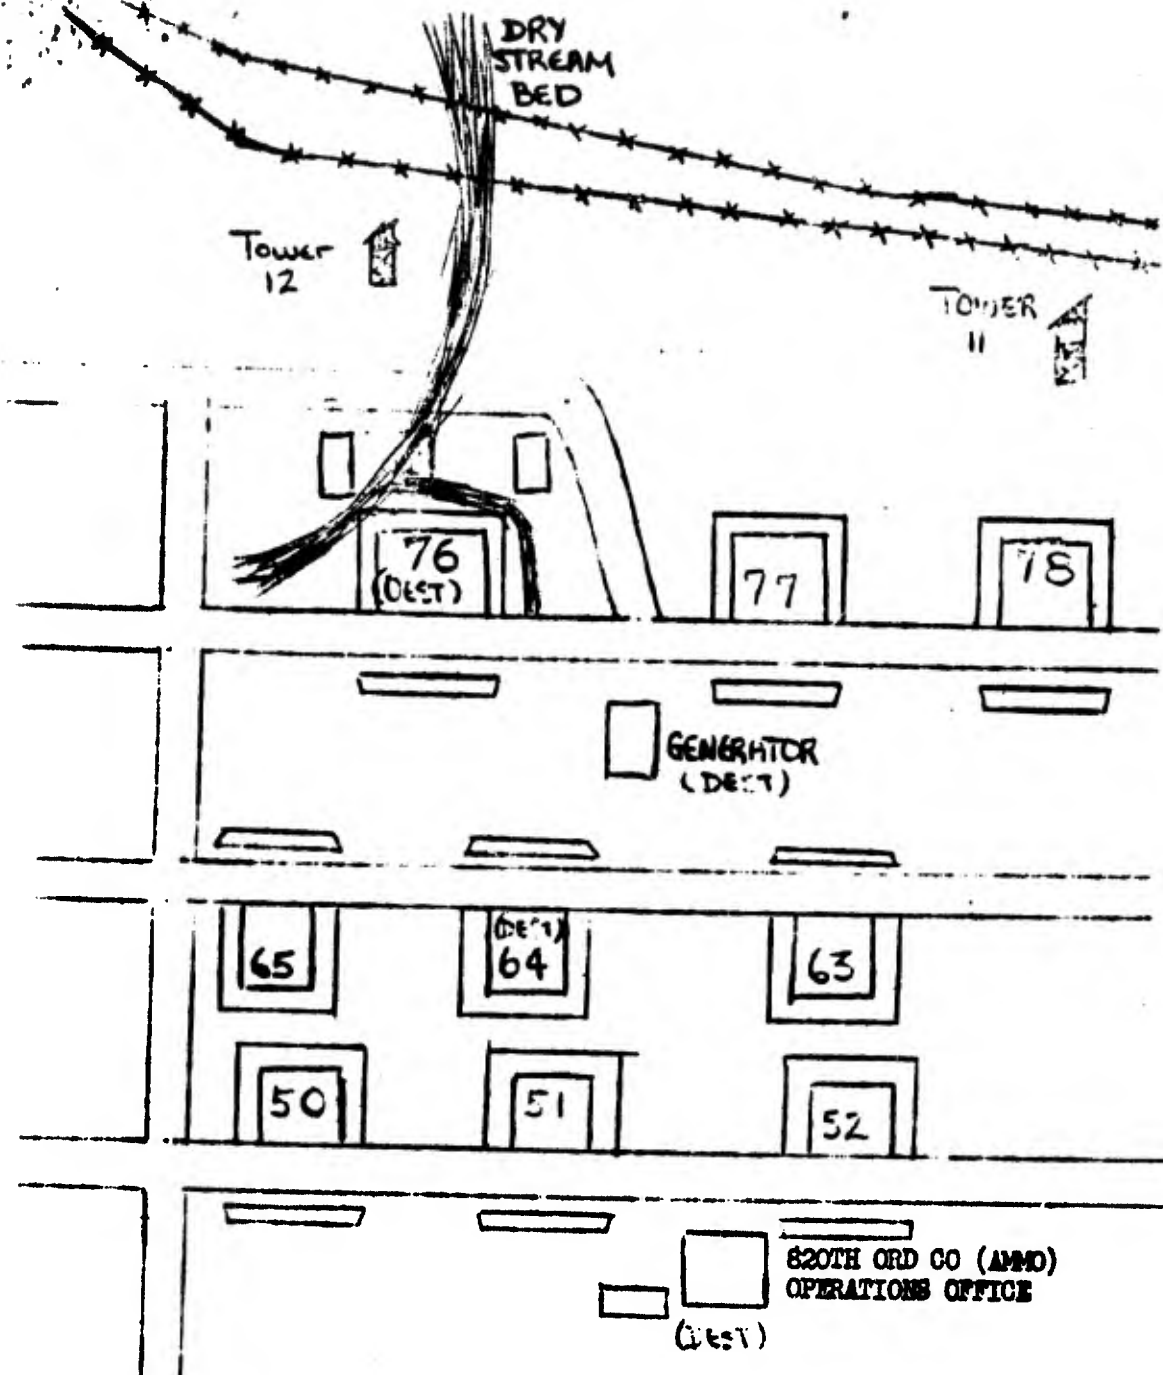
APPENDIX 1 to AFTER ACTION REPORT; ATTACK ON QUARD 23 MARCH 1969

a. At approximately 2300 hours an explosion was observed on a pad in the vicinity of Tower 12. A fire on the pad started immediately.

c. At approximately 2310 hours pad 64 mass detonated. There had been no fire or other explosion on this pad prior to this mass detonation. At the time of the explosion at least two individuals were searching this pad. Captain Keith C. Manley went past this pad 60-90 seconds prior to the explosion and observed a  $\frac{1}{2}$  ton vehicle on the pad but saw no indication of a fire.

1. At 0830 hours 24 March a hole in the wire was found in a gully to the right of Tower 12.

b. At 2305 hours an explosion started a fire on pad 76. From the description and results of the explosion it appears that this explosion was caused by a satchel charge similar to the type previously employed in the QNABD.

c. Between 2310 and 2315 hours, pad 64 mass detonated. At this time there were no fires in the depot area and personnel from the 184th Ordnance Battalion were on all pads in that vicinity searching for satchel charges or sappers. The cause of this detonation cannot be definitely determined but the evidence available indicates that a satchel charge with a timed fuse was placed on the pad in such a manner as to cause a mass detonation of the ammunition.

Recommendation: That an area be designated to be used to park vehicles off QL 1 where protection can be provided for the drivers and vehicles. Such an area could be to the northwest of the depot, across from the retrograde brass yard. This area would be leveled off, with at least two access roads to QL 1 and have bunkers and revetments available for use by drivers and to protect the vehicles.

Recommendation: That Class VII pads not be entered or approached until a reasonable delay after the initial explosion and in no instance should a Class VII pad be approached when the ammunition on the pad is burning.

Recommendation: That water trucks be provided to this battalion to be placed at strategic locations so that they can be readily available when required.

**Recommendation:** That the water point which was located across from the main entrance to the Qui Nhon Ammunition Base Depot be reopened, so all water trucks could be rapidly refilled.
