ENGINEERING EVALUATION OF THE  
CHEMICAL AND BIOLOGICAL MODIFICATION  
KIT FOR EXISTING FIELD STRUCTURES

This test, Project 3762W004, was responsive to an Air Force Armament Laboratory (AFATL) letter, dated 1 August 1968, subject: "Test Request for CB Mod Kit for Structures." Testing was conducted from 9 December 1968 to 15 April 1969.

An engineering evaluation was conducted on the CB Modification Kit for Structures. Environmental testing demonstrated the ability of the system to withstand extremes of temperature, dust, and rain. Floor buckling and corrosion prevented operation after humidity testing. CB simulant testing demonstrated that the system meets design requirements and will protect personnel with 99.6 percent efficiency in chemical simulant (Methyl Acetoacetate) concentrations up to 100 mg/m<sup>3</sup> and with 99.99 percent efficiency in biological simulant (*Bacillus globigii*) concentrations up to 10<sup>6</sup> cells/m<sup>3</sup>. A C-123 aircraft will accommodate the service module and three filter-blower units.

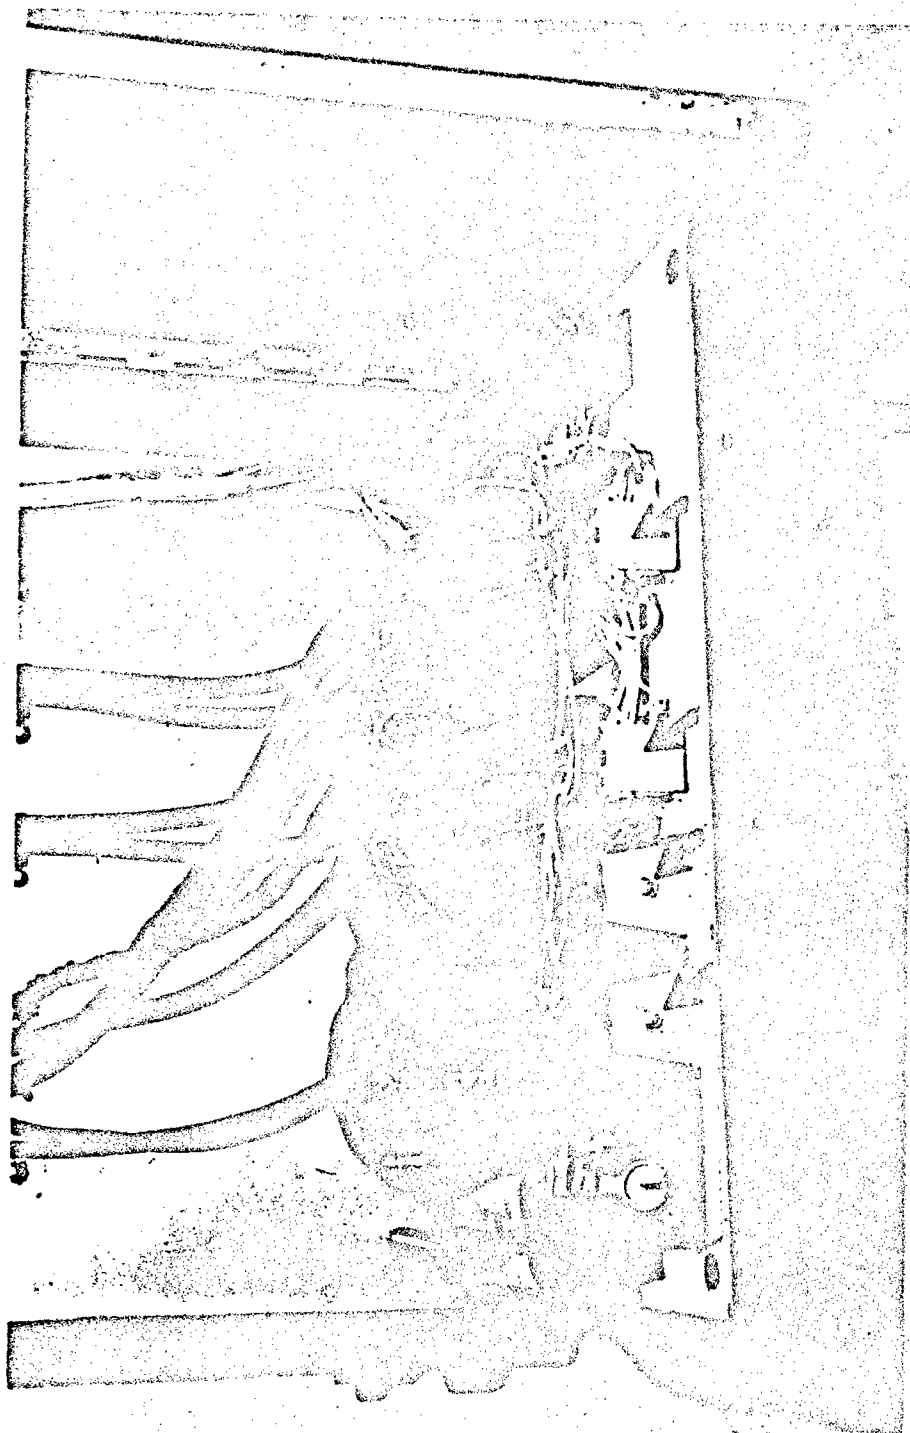
**HUMIDITY TEST.** The humidity test severely degraded the modification kit. Although all fittings were military specification items, uncoated steel screws, latches, and fittings were severely corroded. Those fittings which had a chromate dip were unaffected. The plunger-type door releases on the inside of the outer airlock doors had to be broken loose with a hammer before they would function (Figure 9). The switches on the door jams of the outer airlock doors, which control the dampers, were frozen. This means that the modification kit would lose overpressure whenever an airlock door was opened. This switch also controls the WAIT-ENTER lights in the entrance airlock. The floor in the shower was buckled upward so that the side panels could not be opened, precluding use of the shower (Figure 10). The interior airlock doors had swollen and were cracked. Air heater control relays located in the electrical control panel were corroded (Figure 11). The gasket on the front box containing the control panel was loose. The floor in the plenum chamber was buckled slightly so that the perforated door could not be opened (Figure 12). Further inspection revealed that the swelling and buckling were due to expansion of the polyurethane foam insulation (Figure 13 and 14). Rust on the ceiling had blistered (Figure 15).

Figure 11. Back of electrical control panel showing corroded air heater system relays after  
humidity test

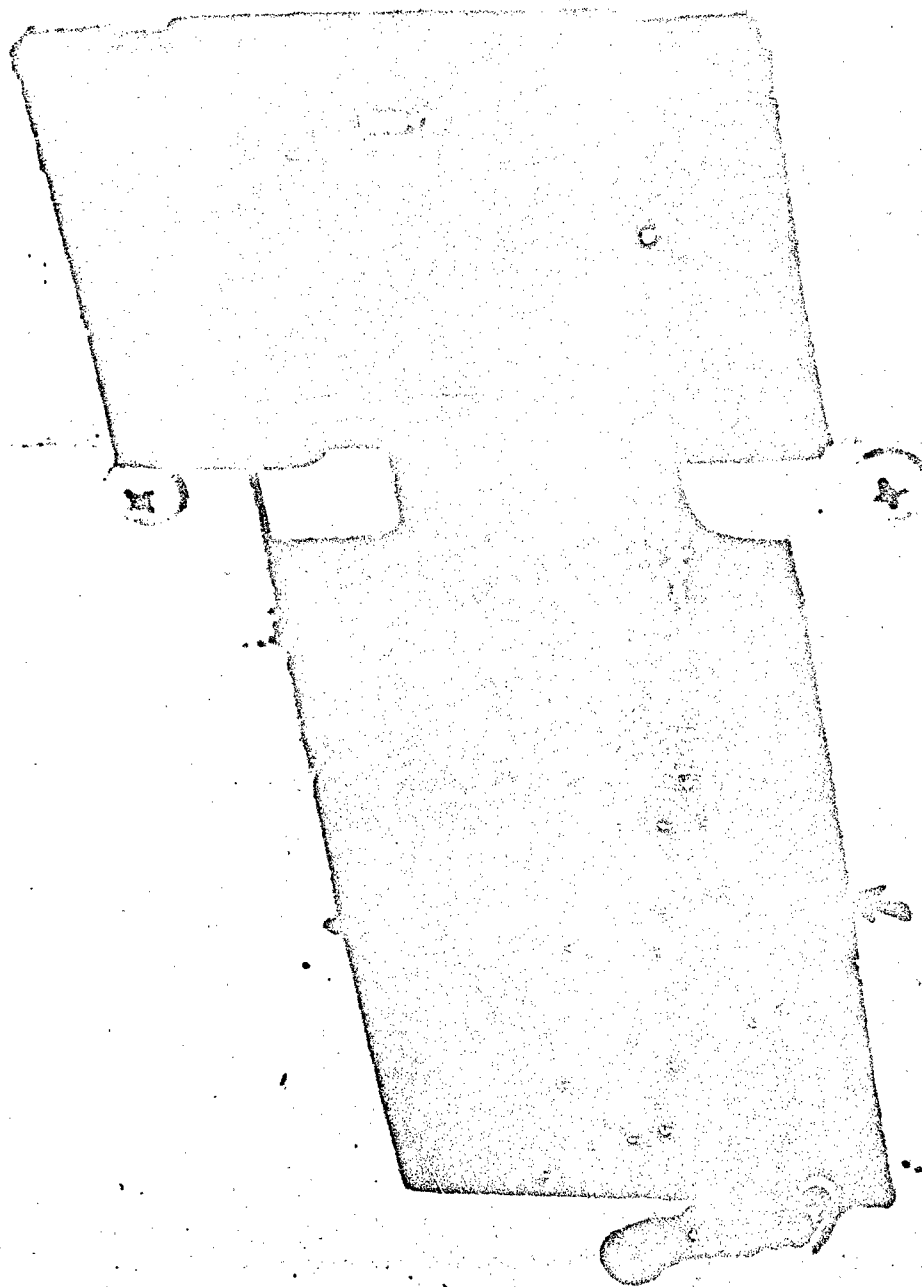
Figure 13. Polyurethane foam swelled from humidity test
