## AIRWORTHINESS AND FLIGHT CHARACTERISTICS TEST

### PRODUCTION OH-58A HELICOPTER UNARMED AND ARMED WITH XM27E1 ARMAMENT SUBSYSTEM

#### STABILITY AND CONTROL

#### FINAL REPORT

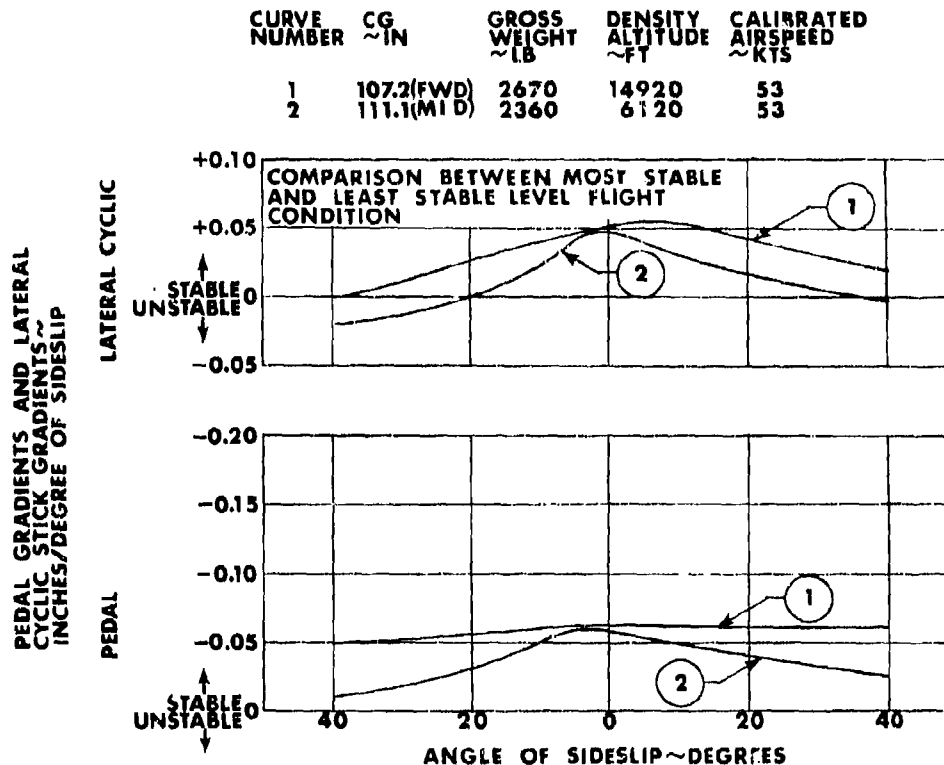
**FIGURE C**  
**STATIC LATERAL DIRECTIONAL STABILITY GRADIENTS**

25. Static lateral-directional stability was tested under the flight conditions listed in table 2. The tests were conducted by establishing a trim airspeed with zero sideslip and varying the sideslip angles while maintaining constant airspeed and ground track. The boom-mounted, pitot-static swivel probe used during the stability and control testing, eliminated sideslip-induced errors in the indicated airspeed. Control positions were recorded for each steady-heading sideslip. The results of the static lateral-directional stability tests are summarized in figure 19, appendix IV, and presented in detail in figures 20 through 29. A comparison between the most stable (2670-lb grwt, fwd cg) and the least stable (2360-lb grwt, mid cg) lateral and directional control position gradients is presented in figure C.

26. The directional control pedal position versus sideslip gradient was stable (negative) for all level flight and climb flight conditions and aircraft configurations (fig. 19, app IV). The pedal position gradients decreased with decreasing gross weights and aft cg movement. Pedal position gradients increased with increasing airspeed for all flight conditions. Density altitude variations showed no clearly defined trend. The effect of other test condition variables was negligible (*ie*, doors and armament subsystem configurations) upon the level-flight, static lateral-directional stability.

27. Bank-angle gradients were essentially linear which indicates that there were positive side force characteristics for all level-flight and climb conditions tested. Side force increased with increasing airspeeds and provided strong cues as to the directional stability of the helicopter.

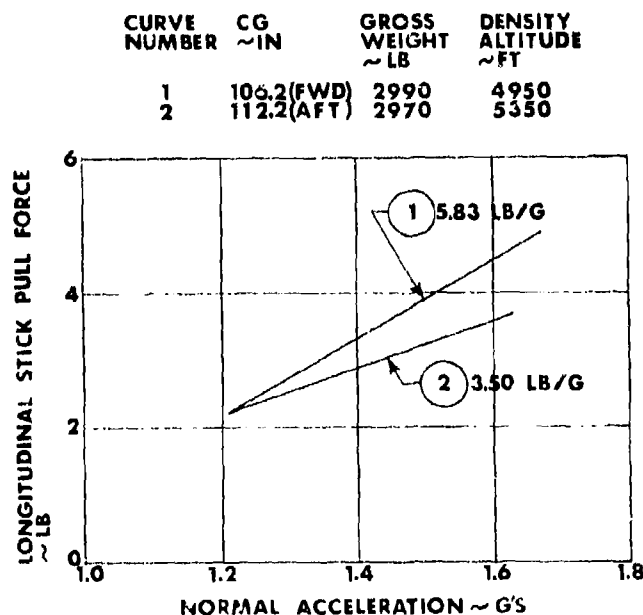
**FIGURE E  
MANEUVERING STABILITY**

47. The boost-ON stick force gradient relative to the acceleration ( $F_s/g$ ) was positive for all conditions tested, *ie*, a greater aft cyclic force was required for an increased load factor. The force gradient depends entirely on the spring effect of the force trim system. The gradients became more positive with increased gross weight (increasing from 4.43 lb/g at 2705 pounds to 5.83 lb/g at 2990 pounds). The gradients also increased as the cg was moved forward (fig. E). Changing the airspeed, altitude or helicopter configuration had no significant effect on the stick force gradients.

48. The maximum normal acceleration recorded was 1.9 g's at a 2650-pound grwt. It was not possible to reach the limit load factor of 2.8 g's. Although stick-force-per-g gradients are light, it is not likely that the helicopter will be overstressed during normal operation because of the large pitch attitudes required. The helicopter did not tend to roll in either direction during symmetrical pull-ups, nor was any rotor overspeed encountered. At the highest airspeed tested (100 KCAS), blade stall was experienced (as evidenced by a severe 2-per-rev vertical vibration during pull-ups from dives). This vibration was not transmitted through the control system, and adequate warning was provided. The effect was not a problem at the conditions tested.

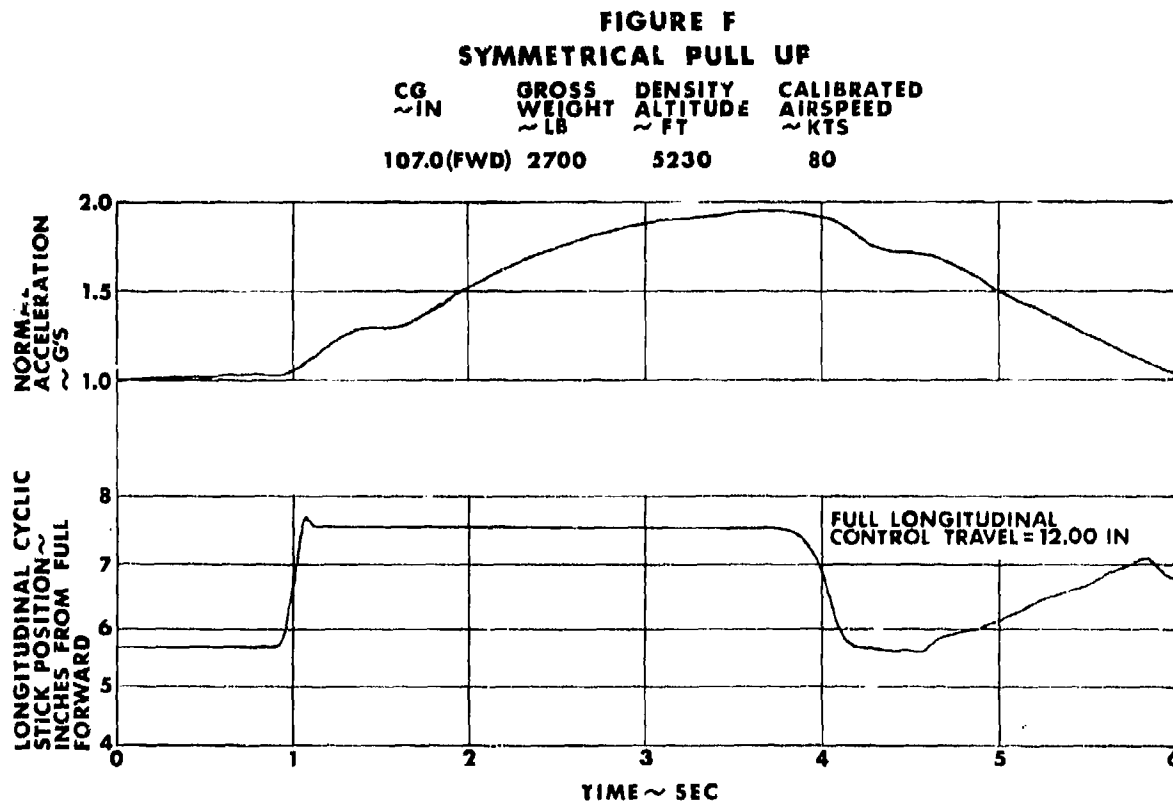
49. Typical time history plots of normal acceleration during symmetrical pull-ups are shown in figure F and also in figure 61, appendix IV. Although the normal acceleration decayed slightly after an initial rise, it then continued to build and became concave downward within 2 seconds following the start of the maneuver. It then remained concave until maximum acceleration was attained. This characteristic met the requirements of paragraph 3.2.11.1 of the mil spec. The helicopter stick-force-per-g characteristics (boost ON) were satisfactory (HQRS 3).

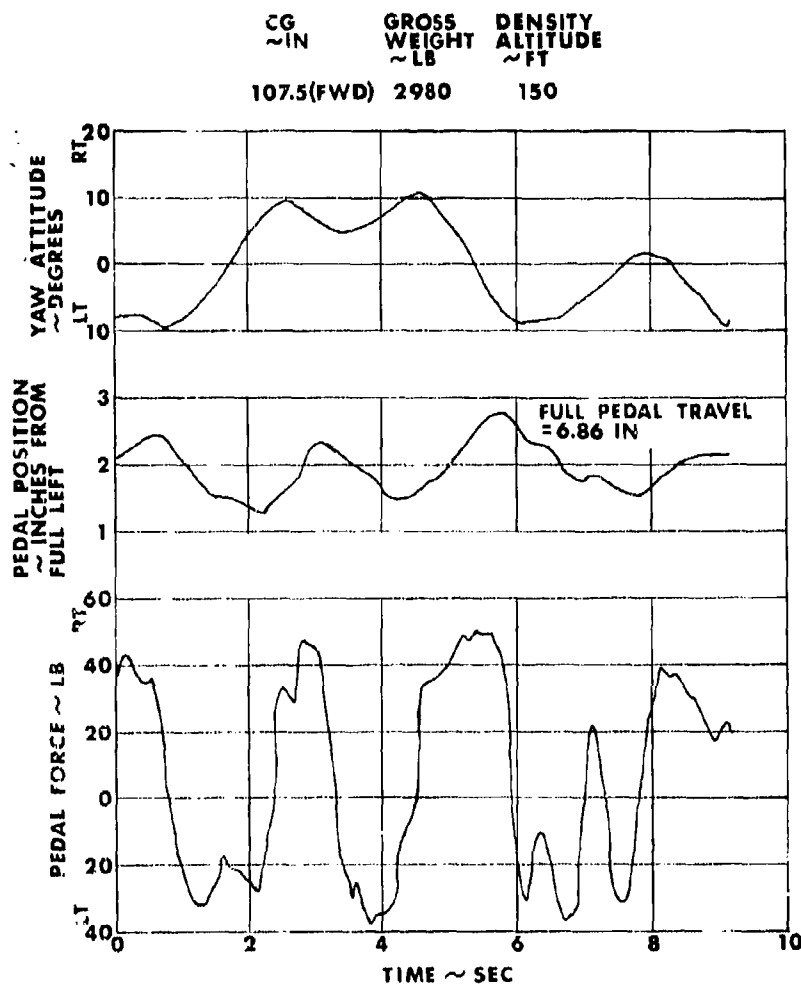
**FIGURE G**  
**LEFT SIDEWARD FLIGHT AT 15 KTAS**

52. The capability of hovering in crosswinds of various speeds and azimuths was adequate for most of the conditions tested. However, in left sideward flight at speeds from 15 to 25 KTAS and wind azimuths of 240 and 270 degrees, the helicopter was directionally unstable

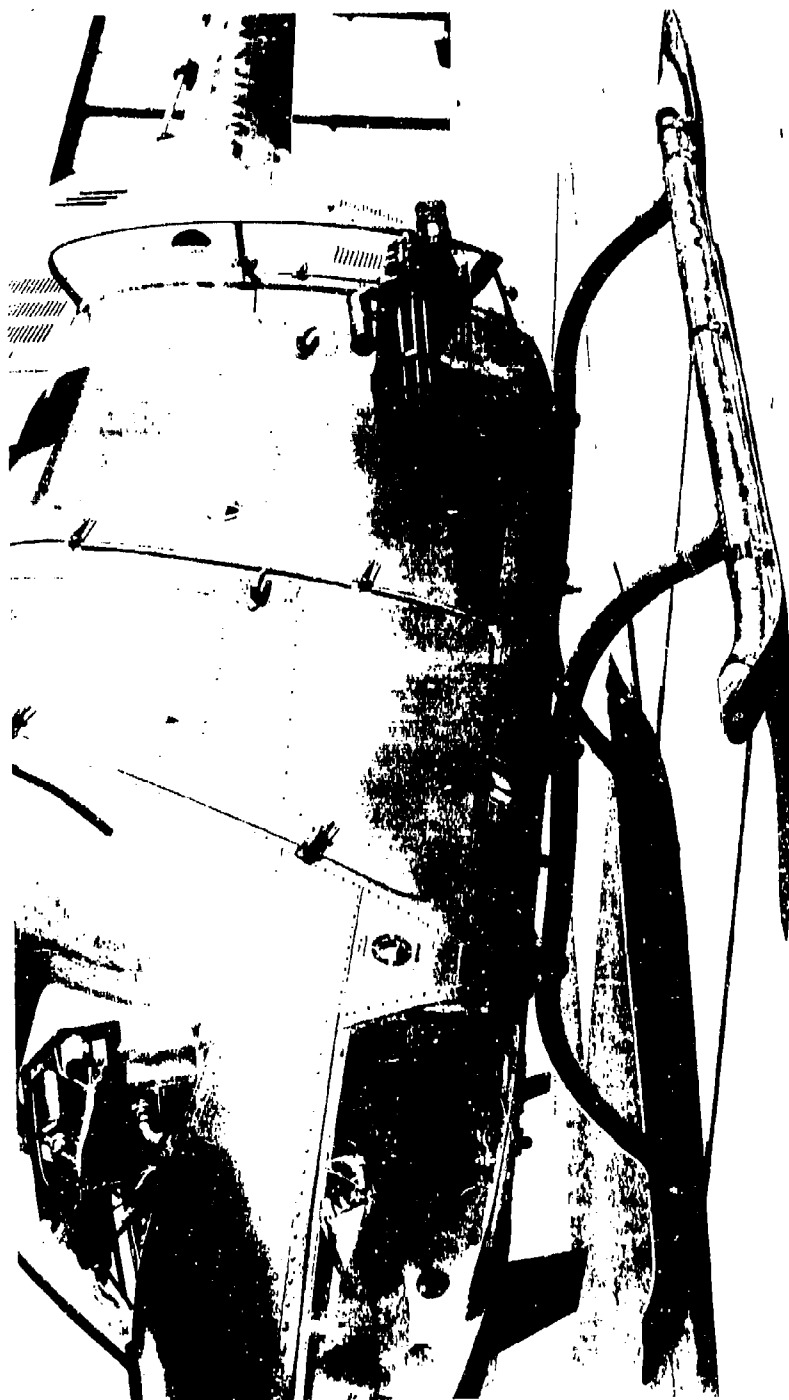
Photo 1. Ski Installation.

94. A brief qualitative evaluation was conducted to determine the OH-58A flying qualities with Airglas Corporation skis (model no. L2700-206) installed. The ski installation is shown in photo 1. The following tests were conducted at the maximum airspeed for level flight ( $V_H$ ) in the armed configuration: static and dynamic longitudinal, lateral and directional stability, maneuvering stability

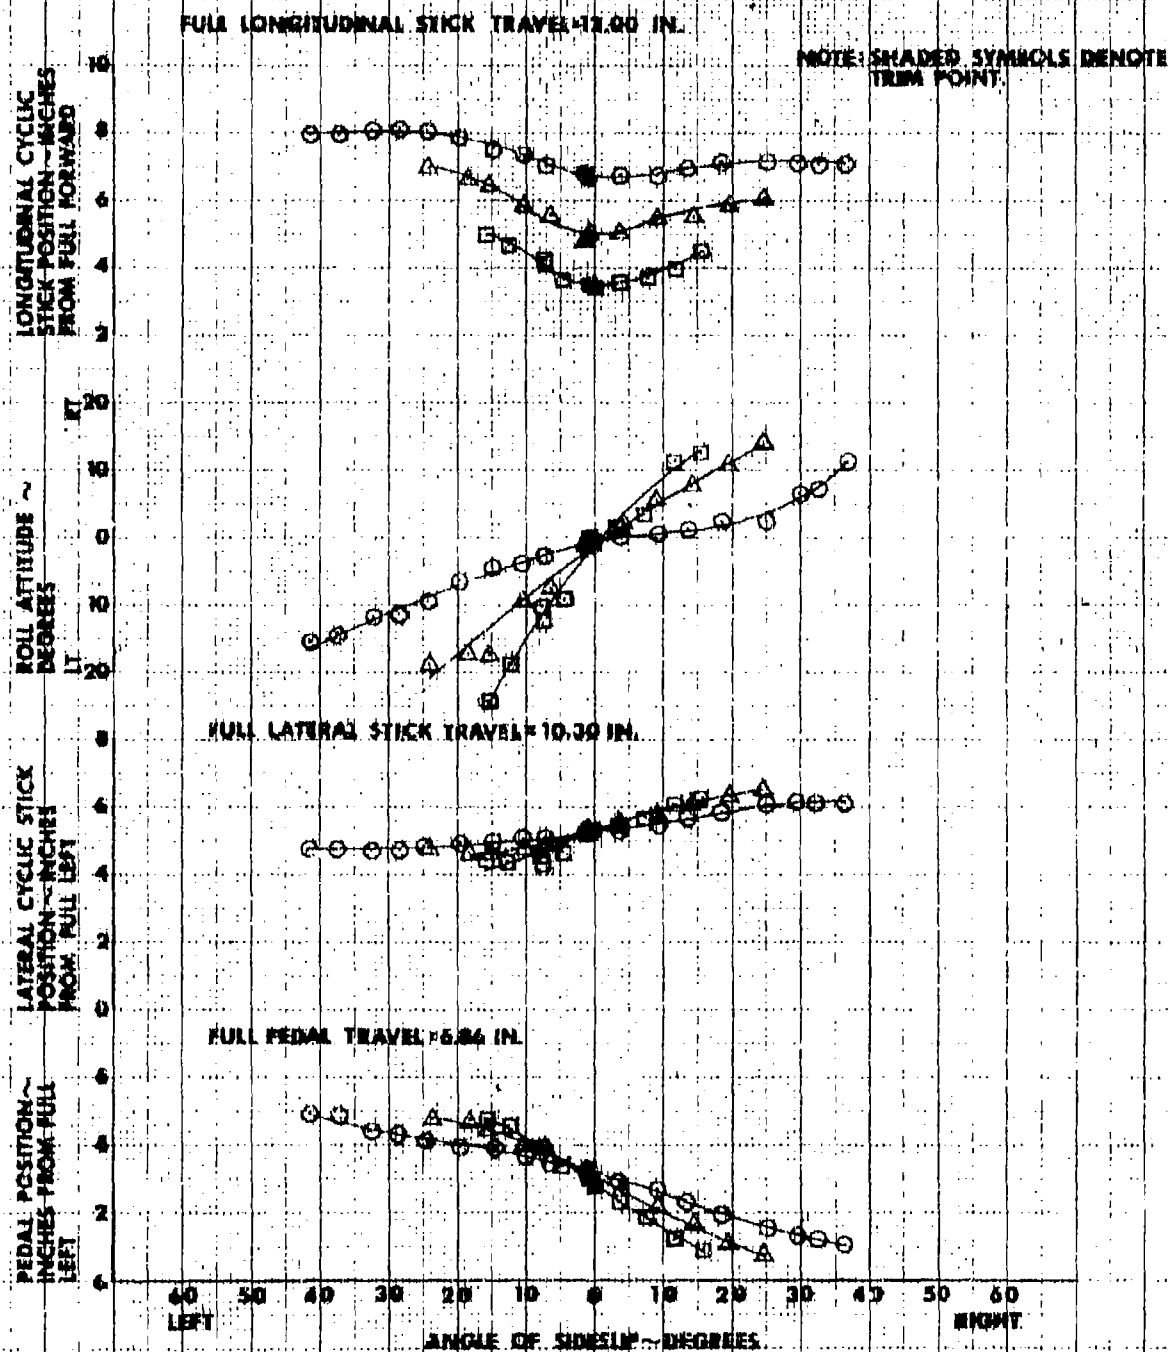
FIGURE 21  
STATIC LATERAL DIRECTIONAL STABILITY  
OH-58A USA S/N 68-16706

28. Lateral cyclic control position gradients approached zero at 53 KCAS in level flight and 49 KCAS in climb at sideslip angles greater than 30 degrees both right and left (fig. 21, app IV). Although effective dihedral was weak at the high-sideslip angle flight conditions, it was not an objectionable characteristic for normal, operational flying at low-sideslip angles. The effective dihedral was found to increase with increasing gross weights and increasing airspeeds. The effect of varying the cg was negligible (fig. 19).

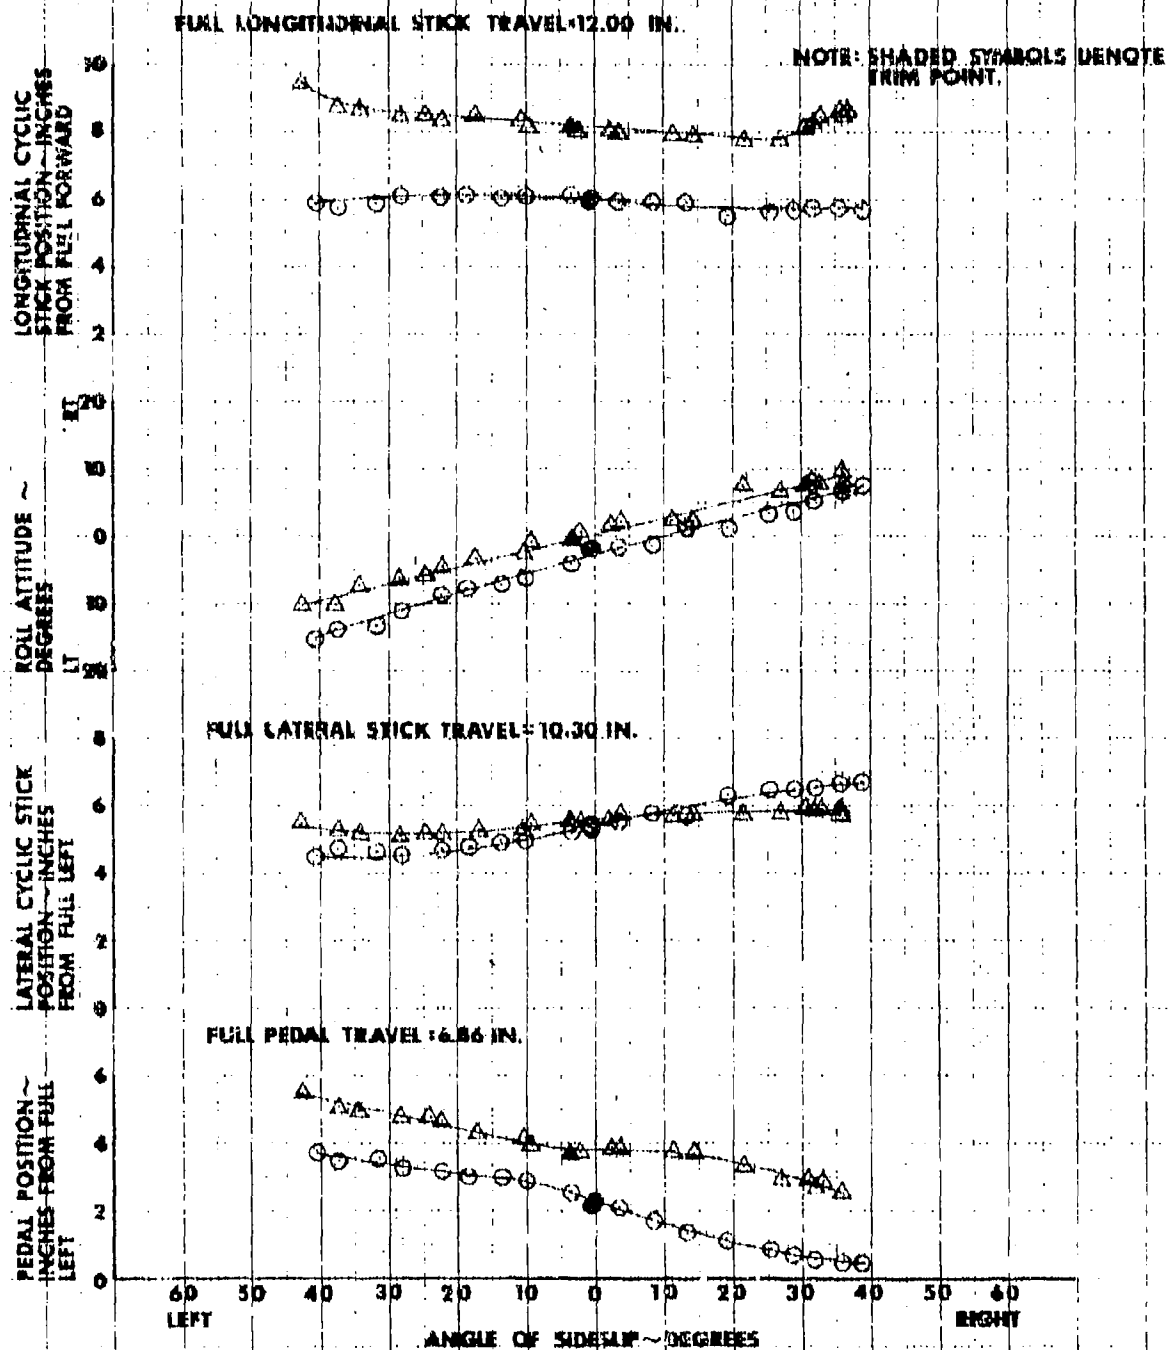
**FIGURE 22**  
**STATIC LATERAL DIRECTIONAL STABILITY**  
**OH-58, USA S/N 68-16706**

29. In autorotation at 49 KCAS, the pedal-position gradient (fig. 22, app IV) was essentially neutral at the zero-sideslip point. For the same flight condition, the lateral stick-position gradient and the dihedral effect were unstable (negative) for sideslip angles greater than 25 degrees left, slightly stable (positive) between 25 degrees left and 30 degrees right, and neutral above a 30-degree right sideslip. In autorotation at 85 KCAS, a reversal (from positive to negative) in the slope of the lateral control occurred at sideslip angles of approximately 15 degrees both right and left (fig. 23). Qualitatively, this gradient reversal would not be objectionable to the pilot during normal mission flying. Bank-angle gradients found during autorotation indicated the presence of a linear side force characteristic which increased in magnitude with airspeed. The operational pilot could fly the helicopter inadvertently in a small degree of sideslip in either direction, while performing a low airspeed autorotation, because of the combination of a weak positive dihedral effect and a weak pedal-position gradient (HQRS 3). This condition should not adversely affect mission accomplishment.

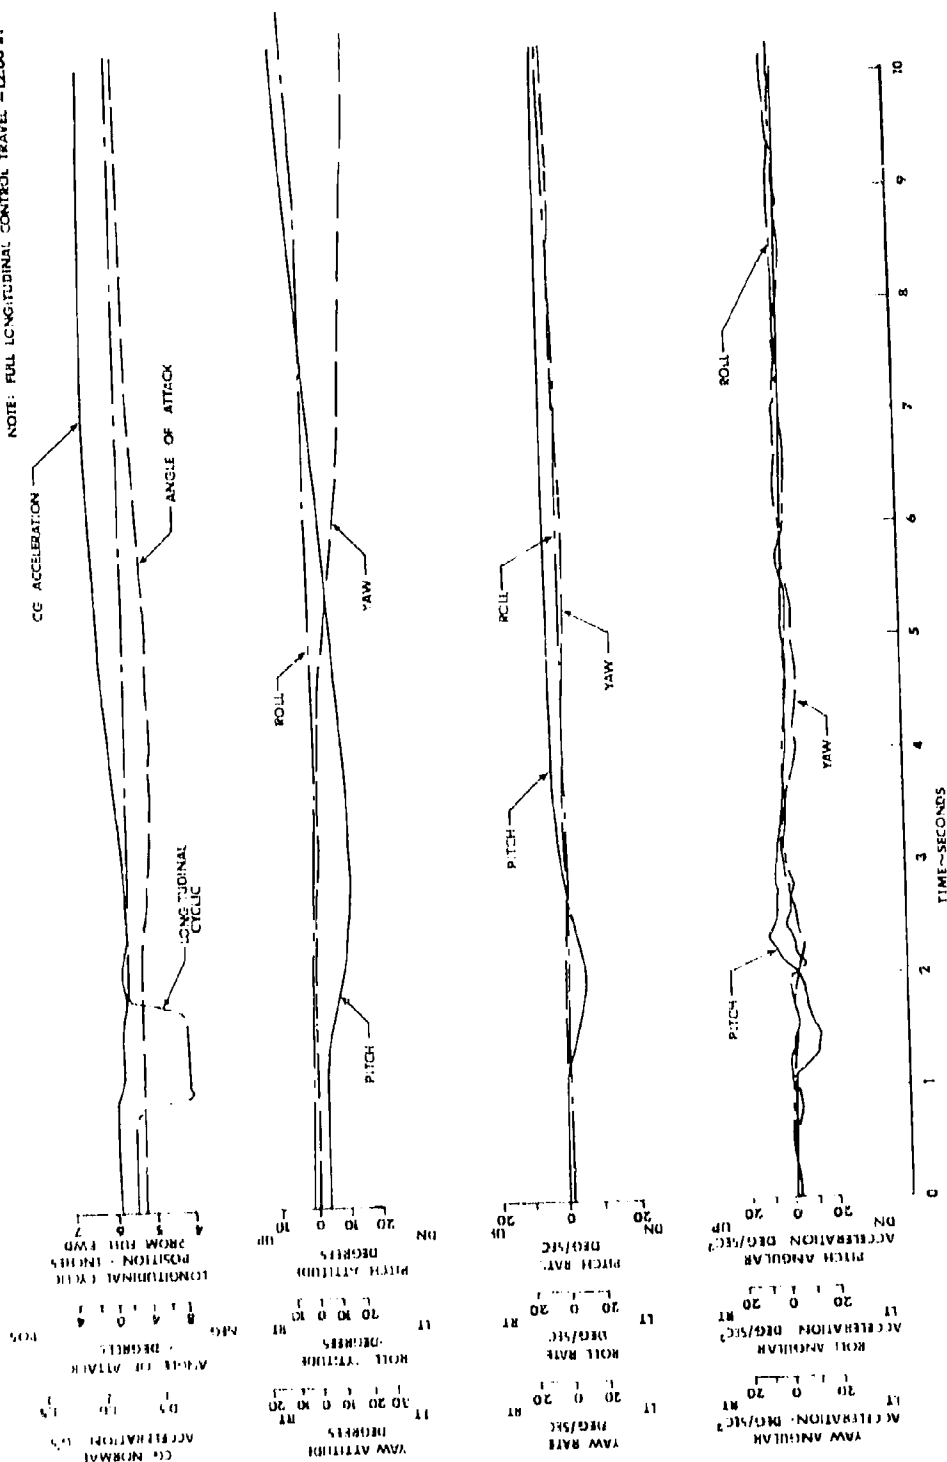
FIGURE 32  
LONGITUDINAL PULSE IN LOW SPEED LEVEL FLIGHT  
OH-58A USA S/N 68-16706

DENSITY ALTITUDE ~ 5720 FT  
CALIBRATED AIRSPEED ~ 38 KTS  
ROT R SPEED ~ 354 RPM  
GROSS WEIGHT ~ 2770 LB  
CG STATION ~ 105.6 IN (FWD)  
CONFIGURATION ~ CLEAN (DOORS ON)  
NOTE: FULL LONGITUDINAL CONTROL TRAVEL = 12.00 IN

35. The longitudinal gust response characteristics of the helicopter were tested by applying cyclic pulse inputs to excite the aircraft short-period mode. The test results are presented in figures 31 and 32, appendix IV. For all conditions tested, the short-period mode was heavily damped, and the requirements of paragraph 3.2.11 of the mil spec were met. The longitudinal dynamic stability of the helicopter was satisfactory (HQRS 2).

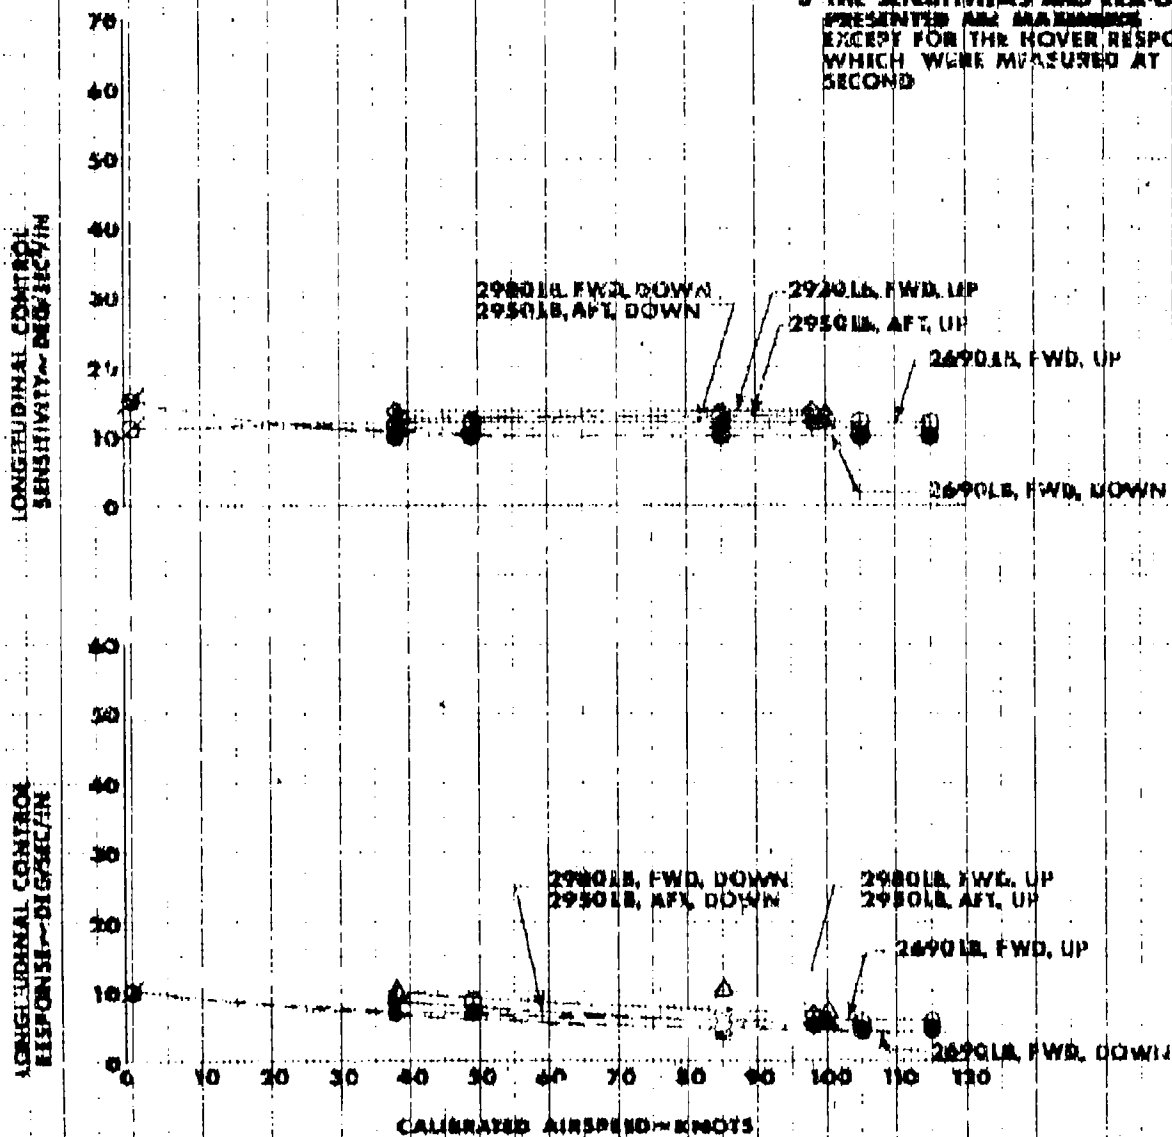
# FIGURE 37 LONGITUDINAL SENSITIVITY AND RESPONSE SUMMARY OH-58A USA S/N 68-16706

1. ARMED DOORS ON CONFIGURATION
2. OPEN SYMBOLS DENOTE PITCH UP  
SHADED SYMBOLS DENOTE PITCH DOWN
3. THE SENSITIVITIES AND RESPONSES PRESENTED ARE MAXIMUMS EXCEPT FOR THE HOVER RESPONSES WHICH WERE MEASURED AT 1 SECOND

(down) at a 5960-foot  $H_D$  and 115 KCAS. The effects of different gross weights, cg's, density altitudes and flight conditions (climb and autorotation) were negligible (figs. 37 and 38, app IV). The pitch-axis rate damping met the requirements of paragraph 3.2.14 of the mil spec. An Iyy of 1947 slugs/ft<sup>2</sup>, supplied by Bell Helicopter Company, was used to determine this specification compliance.

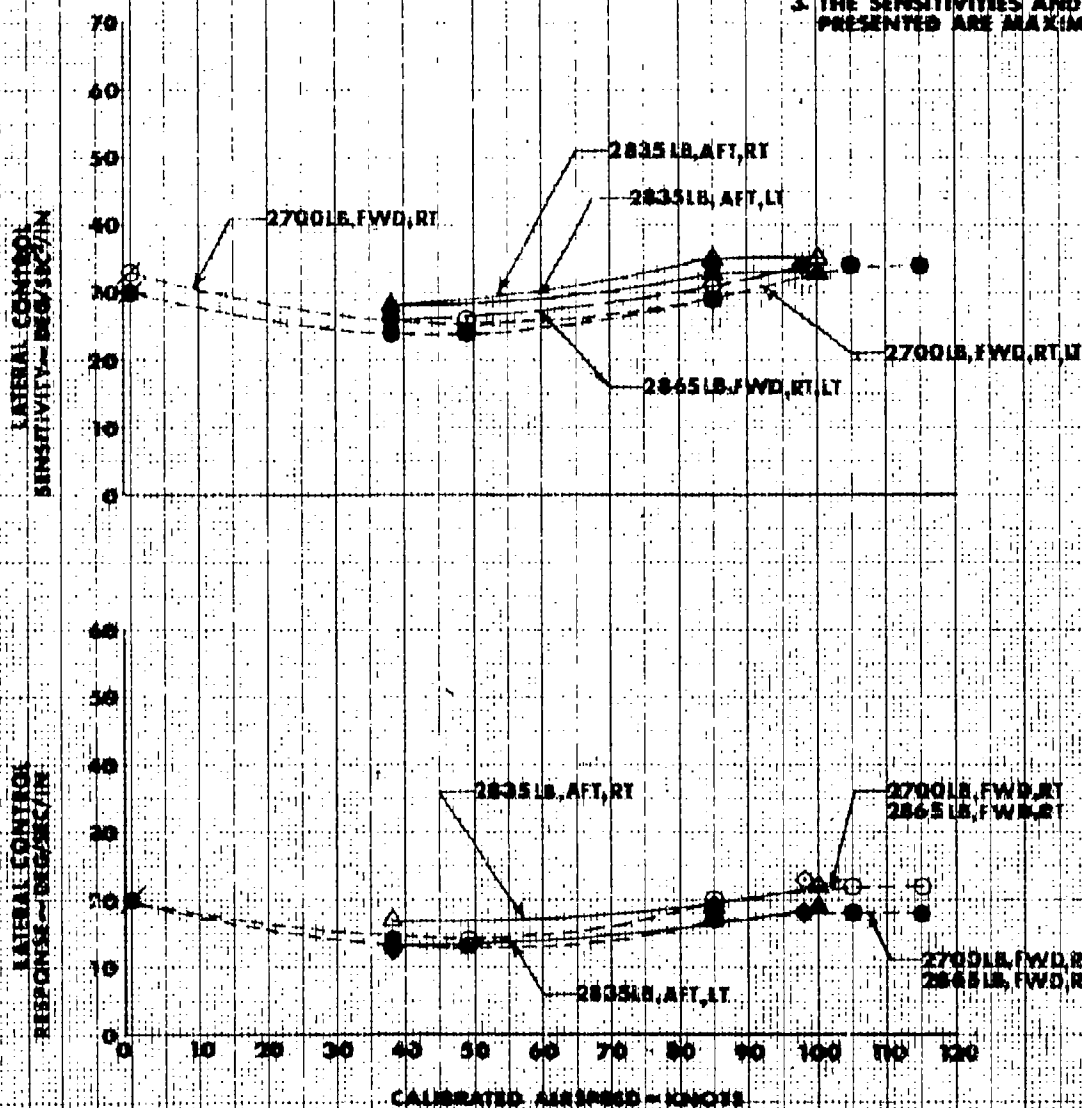
**FIGURE 39**  
**LATERAL SENSITIVITY AND RESPONSE SUMMARY**  
**OH-58A USA S/N 68-16706**

- NOTE:
1. ARMED DOORS ON CONFIGURATION
  2. OPEN SYMBOLS DENOTE RIGHT ROLL  
SHADED SYMBOLS DENOTE LEFT ROLL
  3. THE SENSITIVITIES AND RESPONSES PRESENTED ARE MAXIMUMS

41. The maximum lateral control response in hover was 24 deg/sec/in. at a minus 30-foot  $H_D$  and exceeded the 20-deg/sec/in. limitation of paragraph 3.3.15 of the mil spec (figs. 39 and 40, app IV). This limitation was exceeded at several other flight conditions but was not considered to be objectionable. At a 3910-foot  $H_D$ , it was 20 deg/sec/in. (both right and left). Lateral control response decreased at 49 KCAS to approximately 14 deg/sec/in. (both right and left) but increased with additional increases in airspeed and measured 22 deg/sec/in. (right) at 115 KCAS. In forward flight, the effects of different helicopter configurations, altitudes, gross weights and cg's were insignificant. In a hover, however, the lateral response decreased as density altitude increased. Changing the flight condition at a constant airspeed resulted in the most significant variation in lateral control response. At 49 KCAS, the rate varied from 10 deg/sec/in. (both right and left) in autorotation to 20 deg/sec/in. (both right and left) in climb. Level-flight response at 49 KCAS was 13 to 14 deg/sec/in. These variations are assumed to have resulted from the changes in rotor thrust. The control response increased as thrust increased. At greater airspeeds, the lateral response also varied more between right and left step inputs. The differences between the inputs ranged from zero in hover to 4 deg/sec/in. at 115 KCAS. Although the lateral rate damping did not meet the minimum requirement of paragraph 3.3.19 of the mil spec, it did comply with deviation 19 of the detail specification (ref 1, app I).

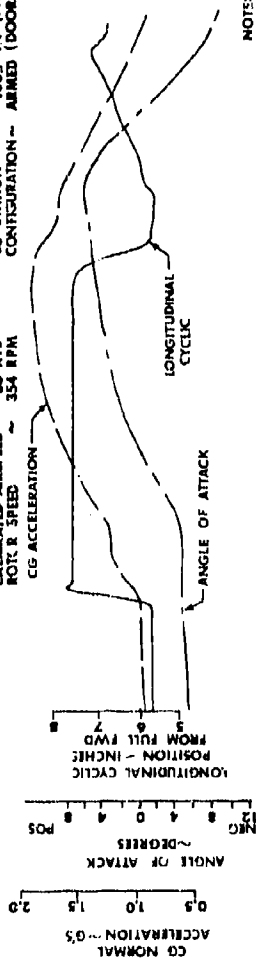
FIGURE 61  
MANEUVERING STABILITY IN SYMMETRICAL PULL-UP  
OH-58A USA S/N 68-16706

DENSITY ALTITUDE ~ 5000 FT  
CALIBRATED AIRSPEED ~ 80 KTS  
ROT R SPEED ~ 354 RPM  
GROSS WEIGHT ~ 2420 LB  
CG STATION ~ 106.7 IN (FWO)  
CONFIGURATION ~ ARMED (DOORS ON)
