RDTE PROJECT NO. 1R17919-D-685  
USATECOM PROJECT NO. 4-6-0201-02  
USAASTA PROJECT NO. 66-28

## **ARMY PRELIMINARY EVALUATION III AND IV YCH-47C MEDIUM TRANSPORT HELICOPTER**

### **FINAL REPORT**

**US ARMY AVIATION SYSTEMS TEST ACTIVITY  
EDWARDS AIR FORCE BASE, CALIFORNIA 93523**

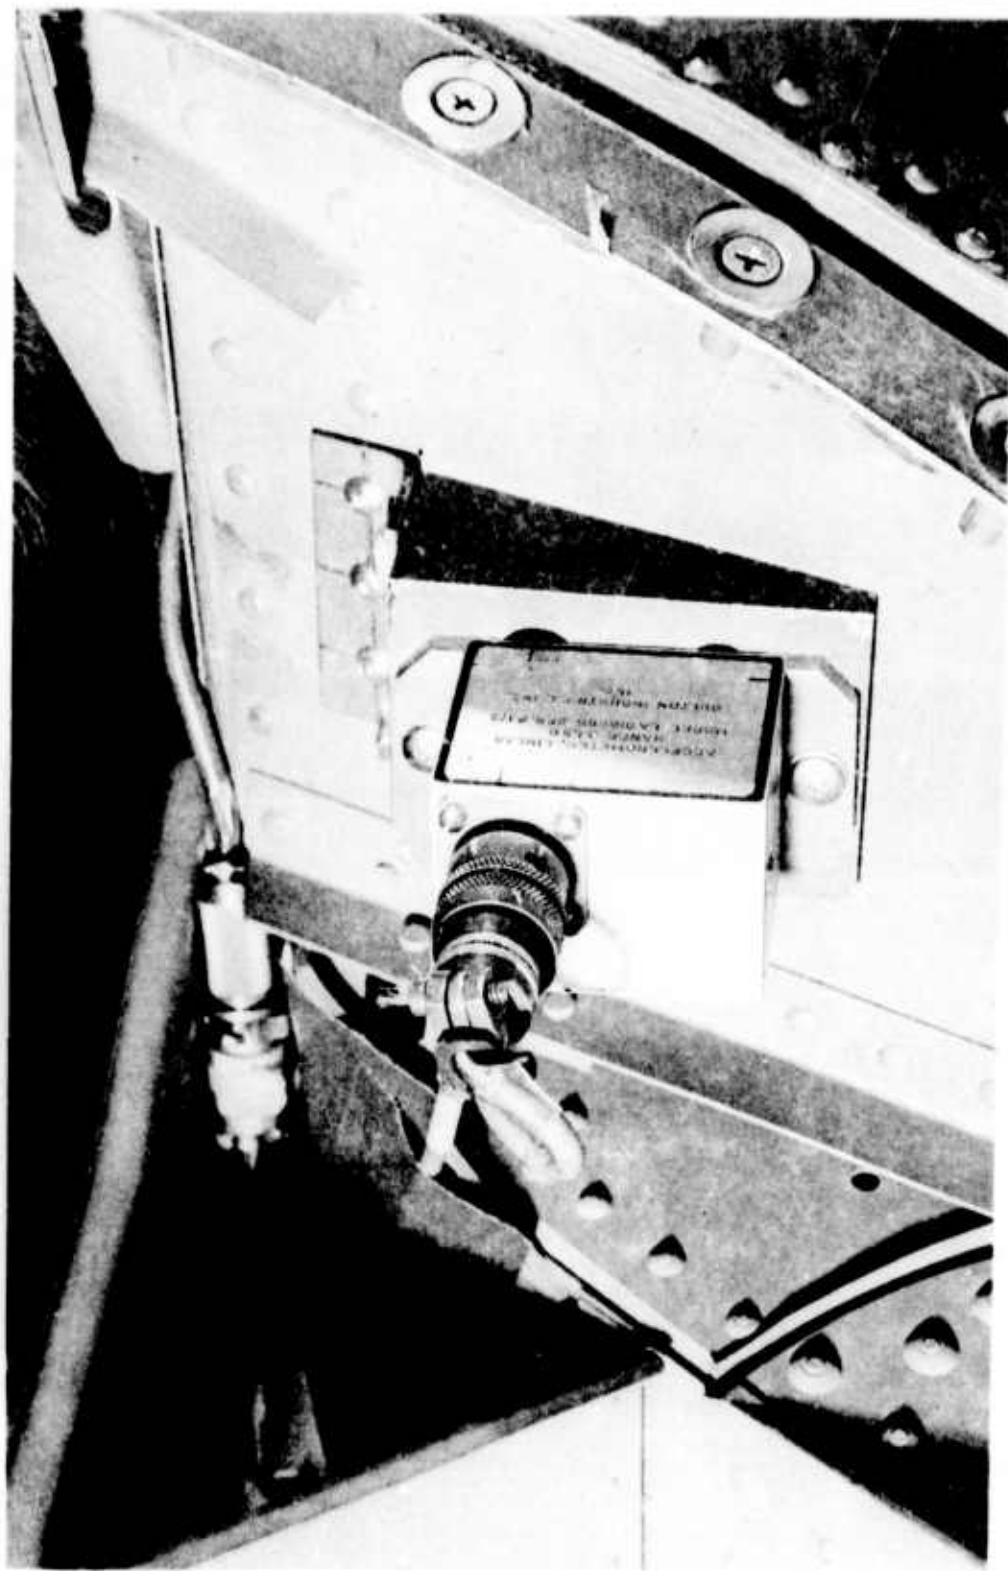
Photo 8. Vertical Accelerometer Installation FS 50 Left
