UNCLASSIFIED

LIMITATION CHANGES

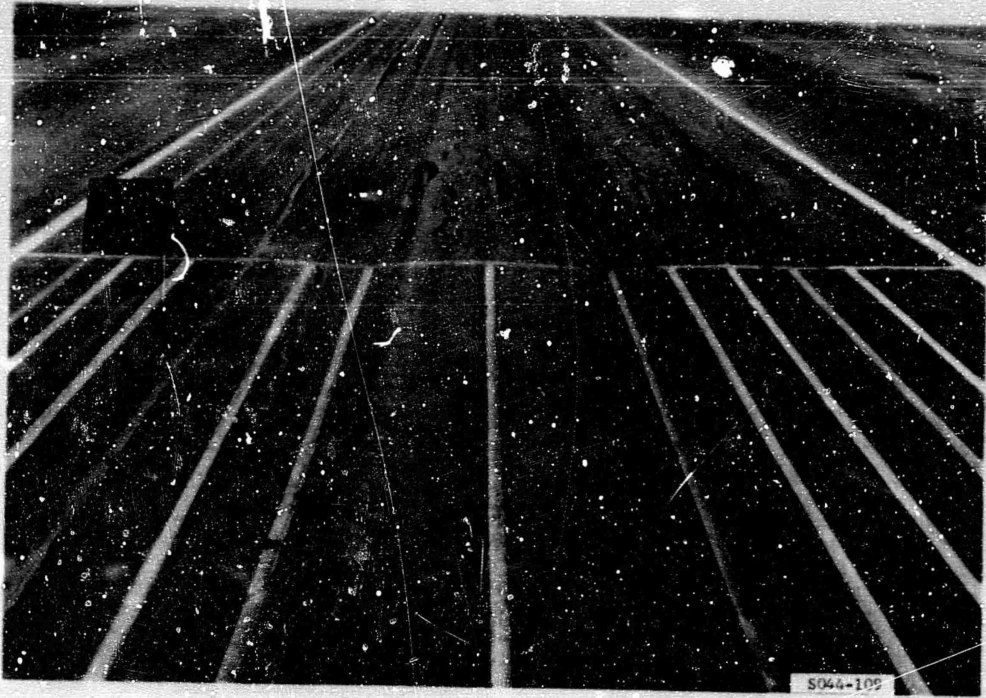
Figure 11. Failure of Flexible Pavement in Item 1, Lane 1, Caused by Subgrade Shear Deformation

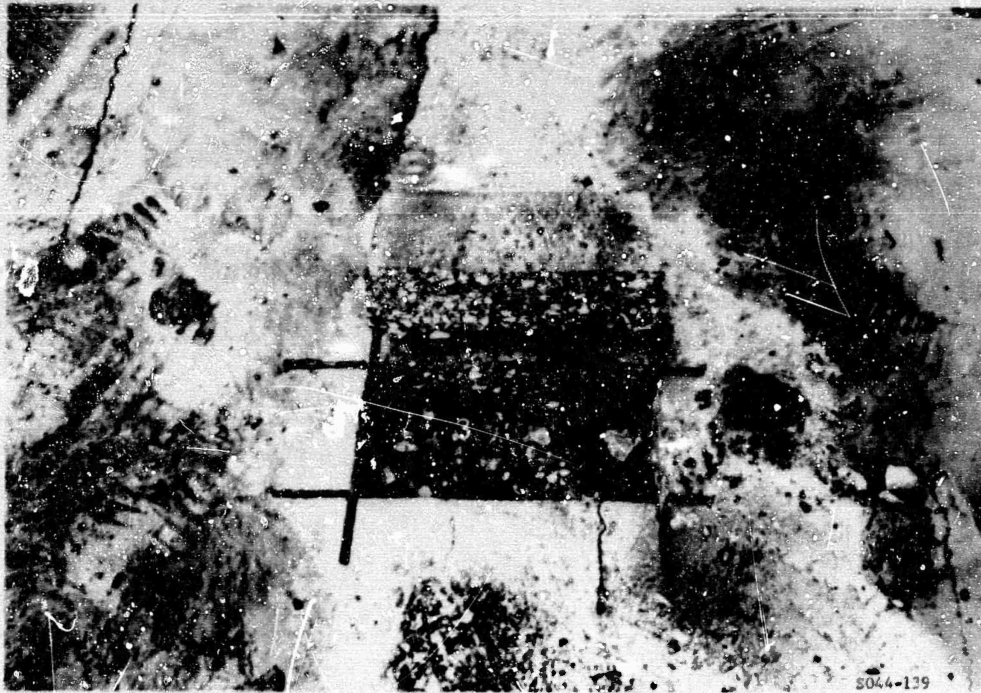
Figure 20. Slab Removed from Flexible Pavement, Item 3, Lane 1, After Failure, Showing Extent of Fatigue Cracking

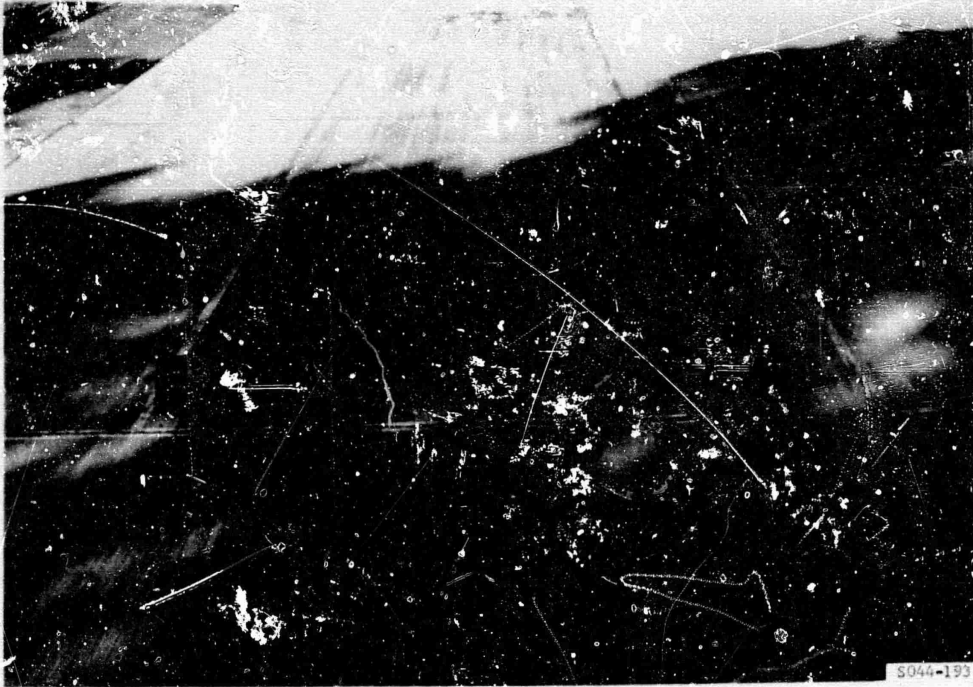
Figure 29. Condition of Item 4, South Lane, Prior to Placement of Nonrigid Overlay

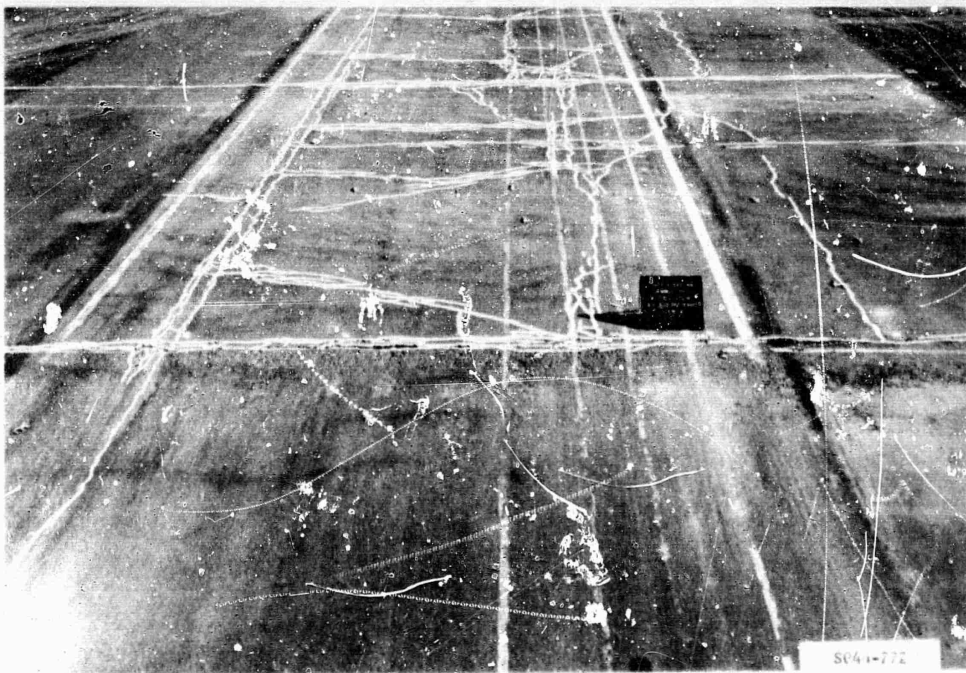
Figure 30. Crack Pattern in Nonrigid Overlay of Item 4, South Lane, at Conclusion of 12-Wheel-Assembly Traffic

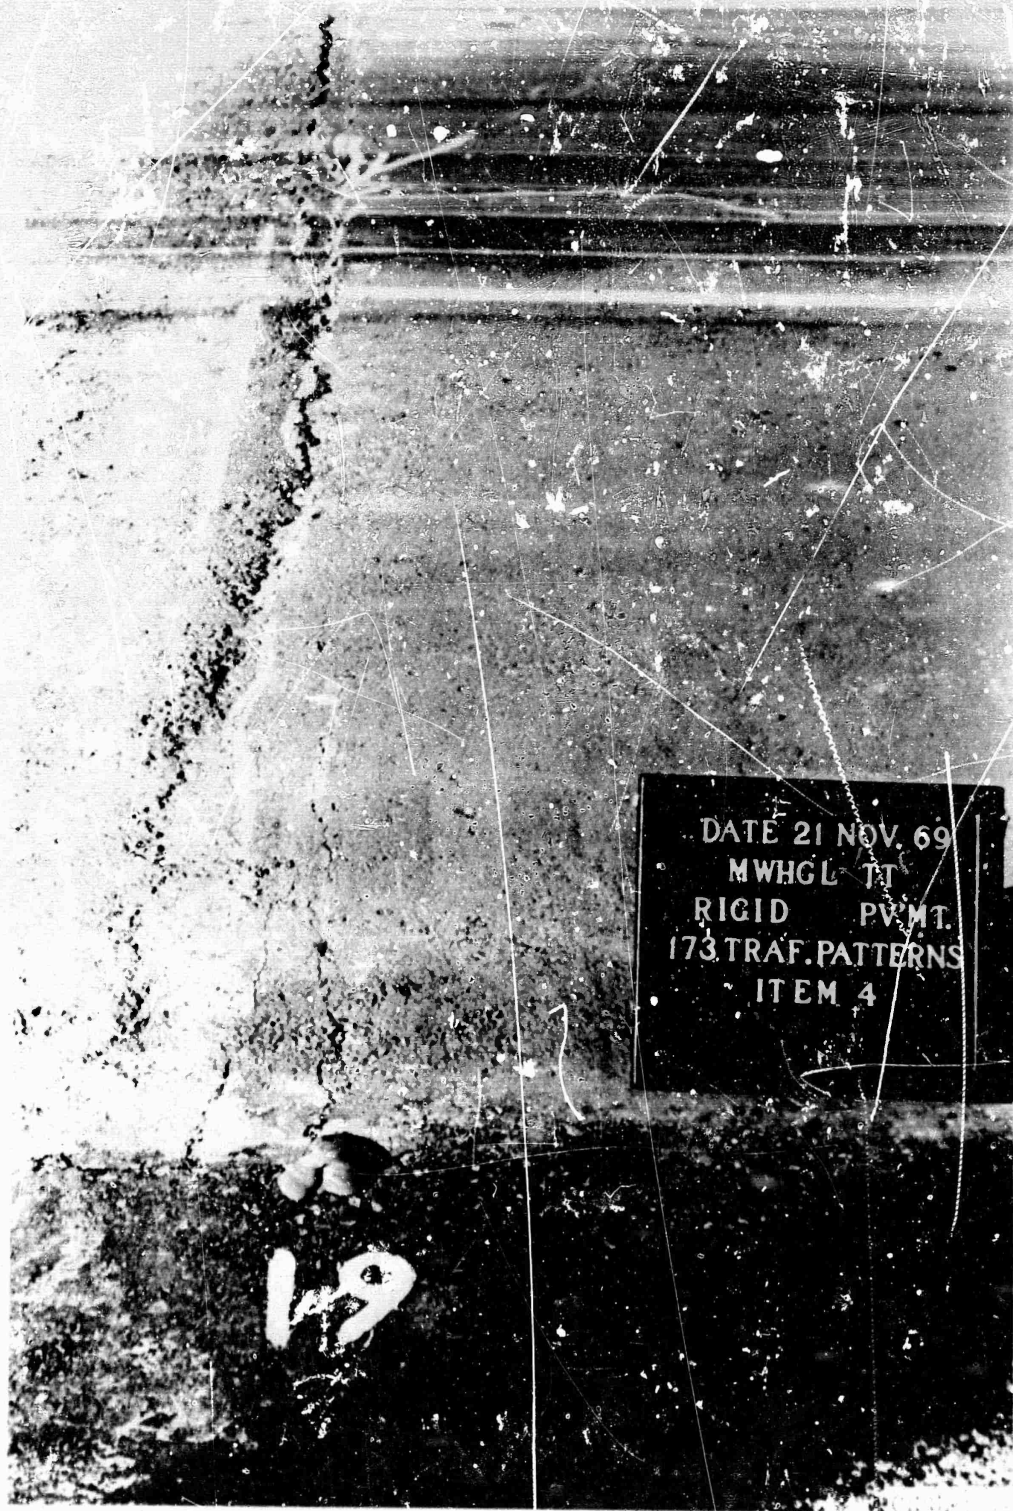
Figure 31. Heavy Mud Pumped at South Edge of Item 4 Overlay, South Lane, SE Slab, During 12-Wheel-Assembly Traffic
