**PERFORMANCE OF  
20MM ABLATIVE AMMUNITION**

**CORNELL AERONAUTICAL LABORATORY, INC.**

**TECHNICAL REPORT AFATL-TR-71-164**

**DECEMBER 1971**

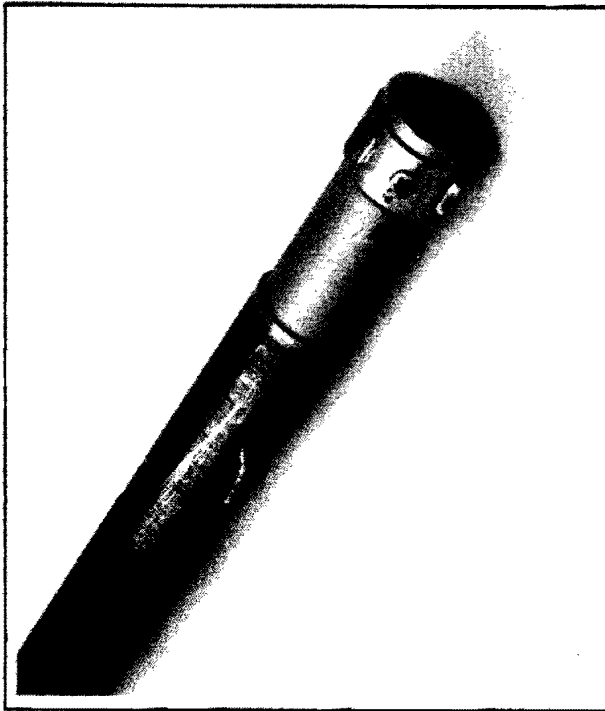
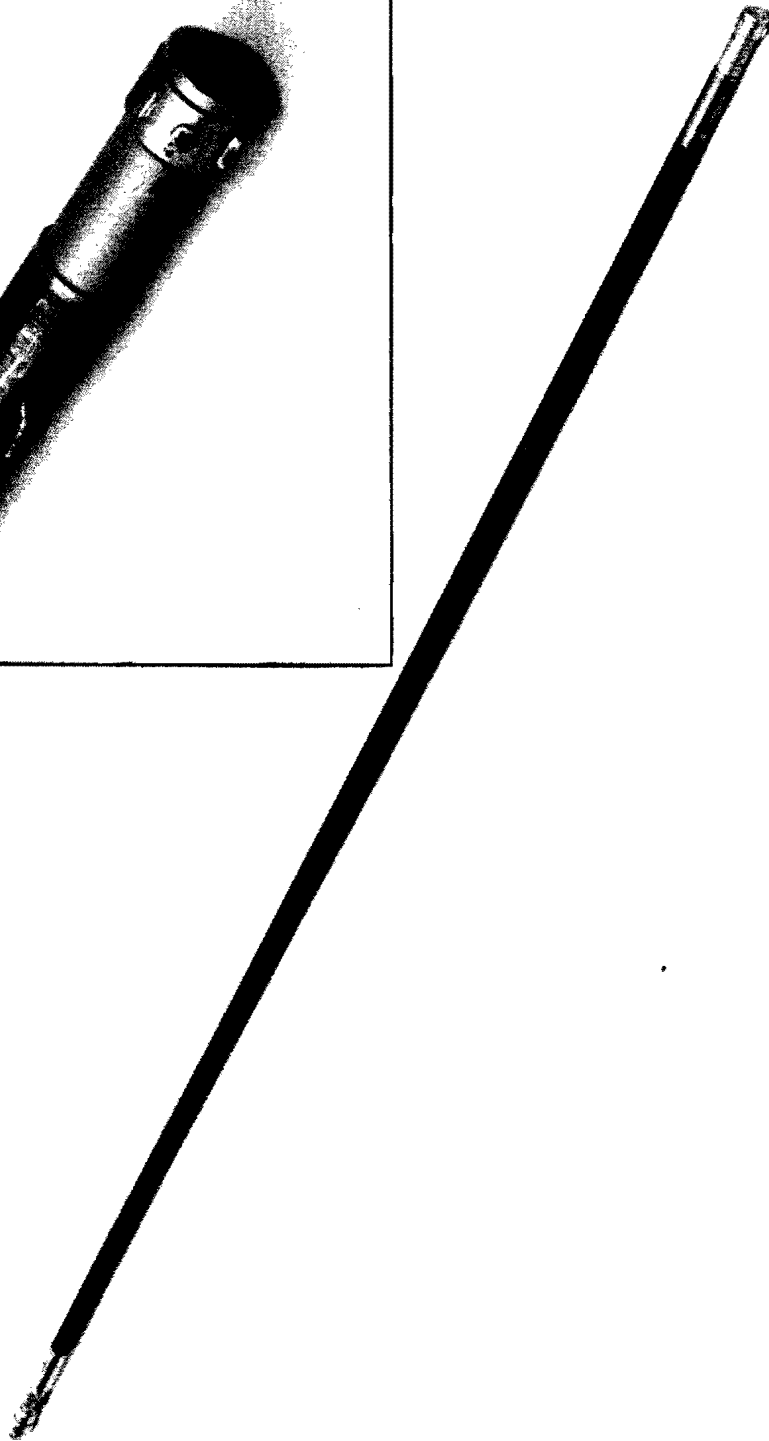
Figure 6. 20mm Bore Gauge

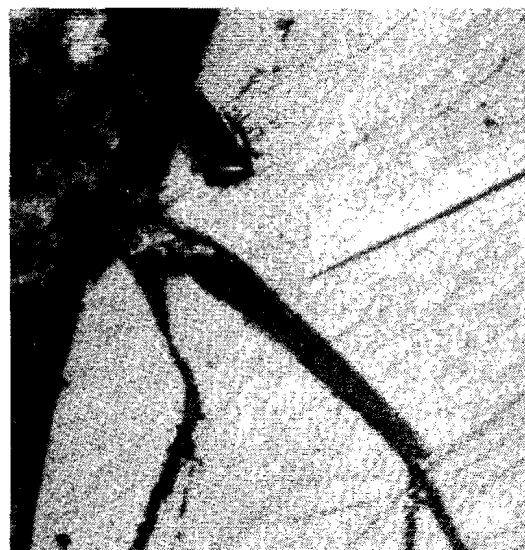
Figure I-7. Area Outlined In Fig. I-6 (325X)

A section adjacent to that pictured in Figure I-5 was analyzed qualitatively with an electron microprobe instrument for comparison with the barrel firing silicone-modified ammunition. Figure I-6 provides orientation to the area microprobed, believed to be the root of a rifling land. The same area at 325X magnification is shown by ordinary light microscopy in Figure I-7 and by

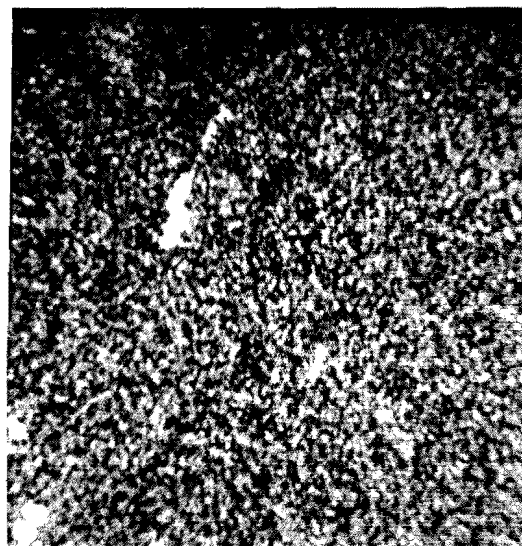
Figure I-9. Silicon Microprobe Image Of Area Of Fig. I-7 (325X)
