AMMRC CTR 74-26

BRITTLE MATERIALS DESIGN, HIGH TEMPERATURE GAS TURBINE

Interim Report Number 5, July 1, 1973 to December 31, 1973

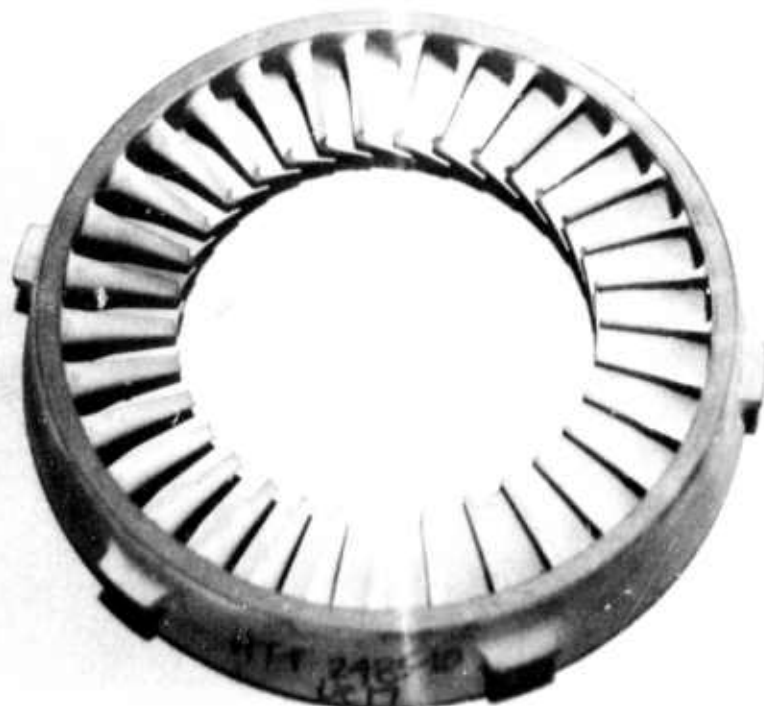
Figure 3.22 Second Stage Inverted Channel Stator Assembly

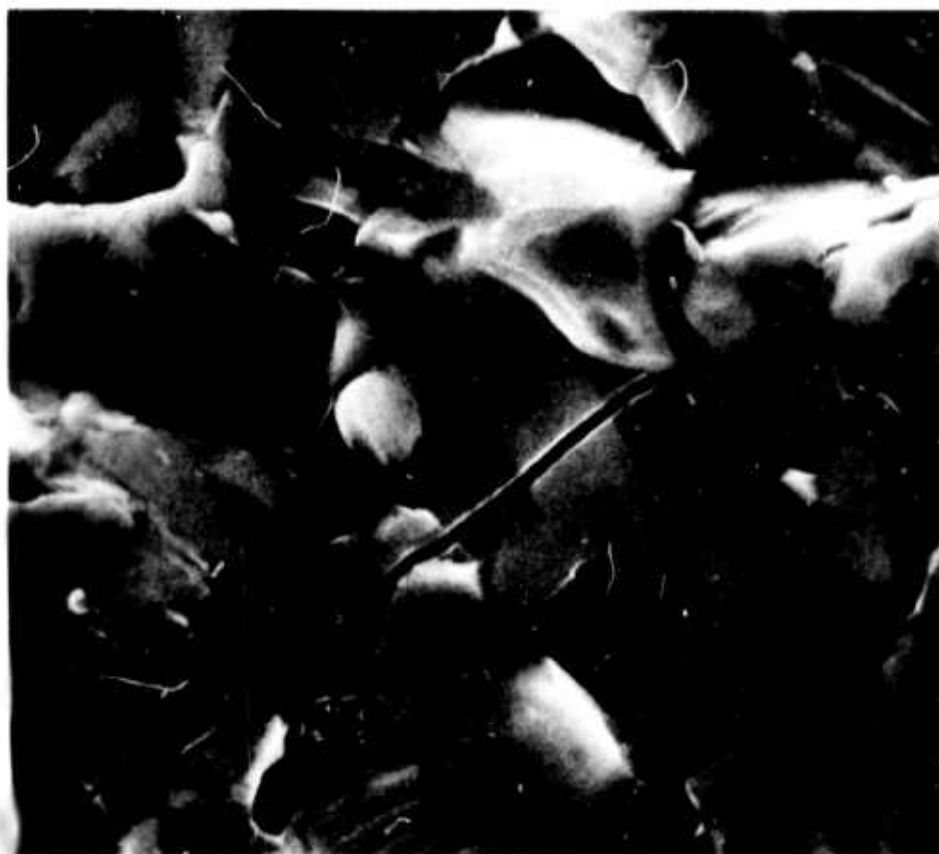
Figure 5.48 Transgranular Crack on the Fracture Surface of Reaction Sintered Silicon Carbide
