*Monitoring Completed Navigation Projects (MCNP) Program*

## **Evaluation of Sealing Materials and Techniques for Installing Quoin and Miter Block Backing Grout**

Final Report

Under Project No. 399320, "Sealing Techniques"

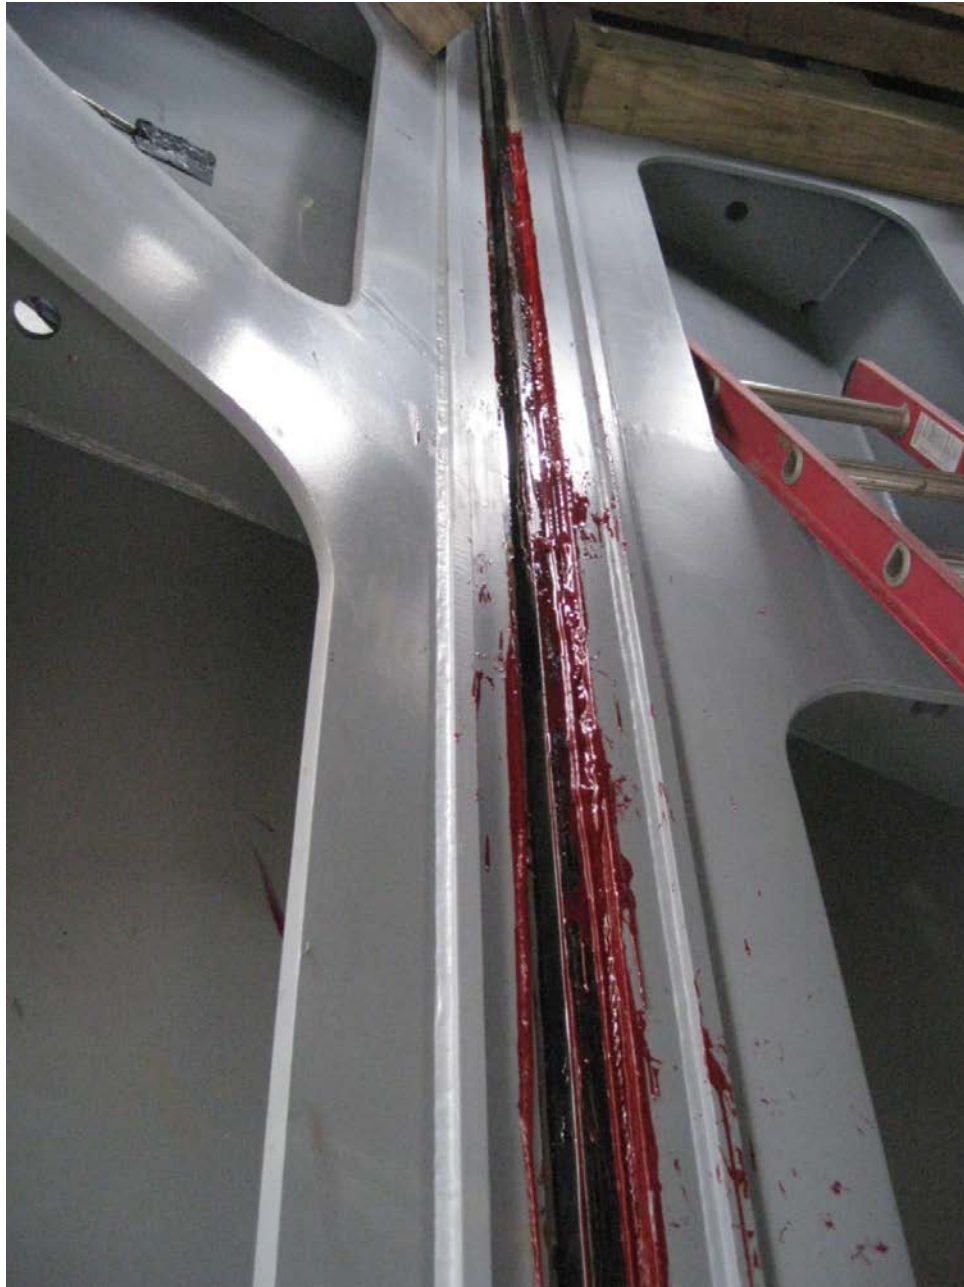
Figure 2-3. Backing material blowouts and leakage.

In February 2013, researchers visited L&D 27, which is operated by the St. Louis District and is located in Granite City, IL. At that time, the main lock chamber had been dewatered for replacement of the lower miter gates. Researchers observed the installation of the quoin and miter contact block backing material using Loctite® Nordbak® High Performance Backing, a two-part epoxy compound. The Nordbak® was stored in a heated gate-house until used. One bucket of Nordbak® was mixed and poured into each contact block void each hour from the top of the gates.

During application, outdoor temperatures were 25 to 35 °F (-4 to 2 °C) with periodic rain and snow. Heaters were used on the downstream side. Temporary shelter was provided to protect the work from the cold and wet. Plastic tarps were hung over the downstream and some upstream sides of the contact blocks. Canopies were placed on the gates over the tops of the blocks. There were no apparent problems with the Nordbak® backing, but numerous problems occurred with the sealants used to contain the backing until it hardened. Mainly, the use of a one-component caulk tube product resulted in numerous blowouts that released the backing material (see Figure 2-3). Although temperature was likely a factor, it was also likely that the failures were caused by pouring the Nordbak® while the sealing product was cured at the surface, but still soft and uncured in the middle.

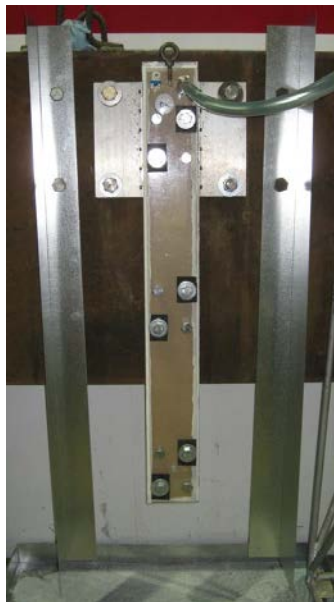
Figure 3-1. Plexiglass plate setup.

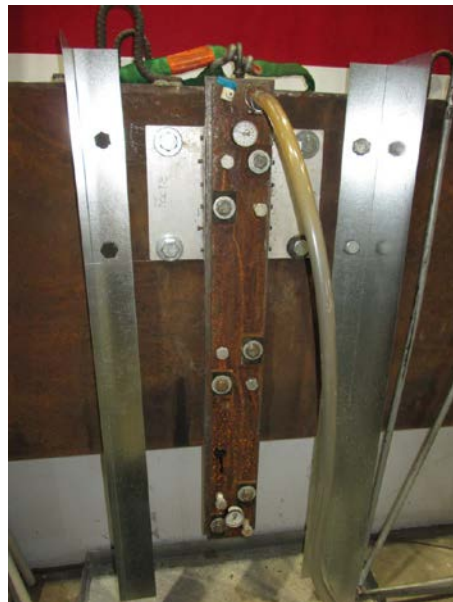
Figure 3-2. Steel plate setup.

Follow-on tests using steel plates were necessary because sealant adhesion would be different for the plastic and steel substrates. Figure 3-2 shows the steel plate test setup. Figure 3-3 shows the schematic drawings of the plastic and steel plates. Figure 3-4 shows the setup using actual contact blocks. Tests were run using the plastic, steel plates, and the C-channel with a stainless block. Cleanup of the steel after a test often required substantial abrasion that polished the steel. To make the tests more realistic, the cleaned plates were left covered by wet rags overnight. They were wiped off before the next test, but the steel was mildly corroded.

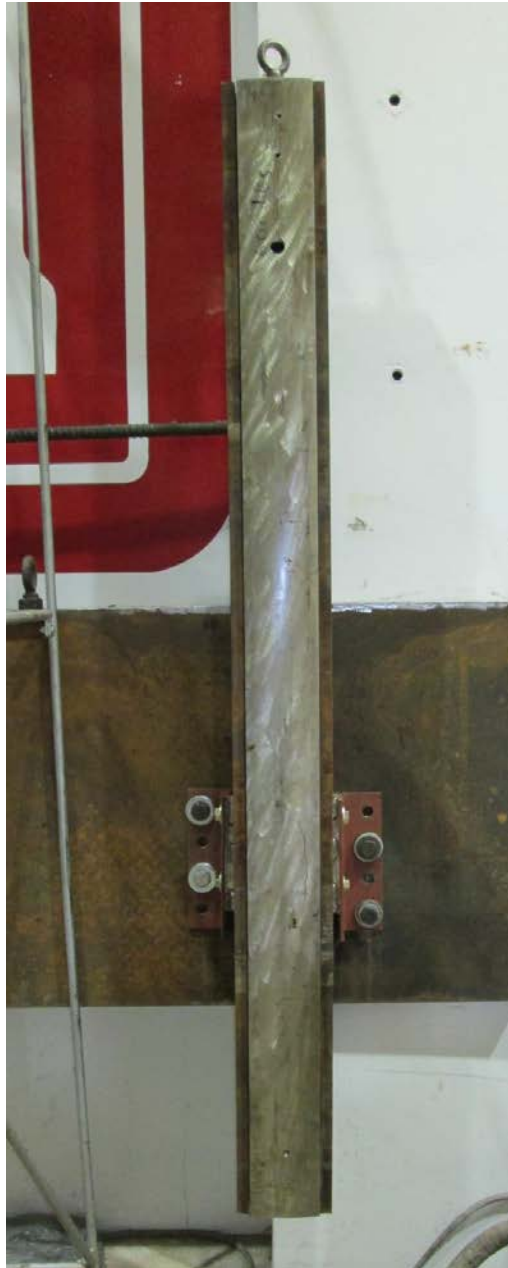
Figure 3-4. Stainless contact block and C-channel setup.

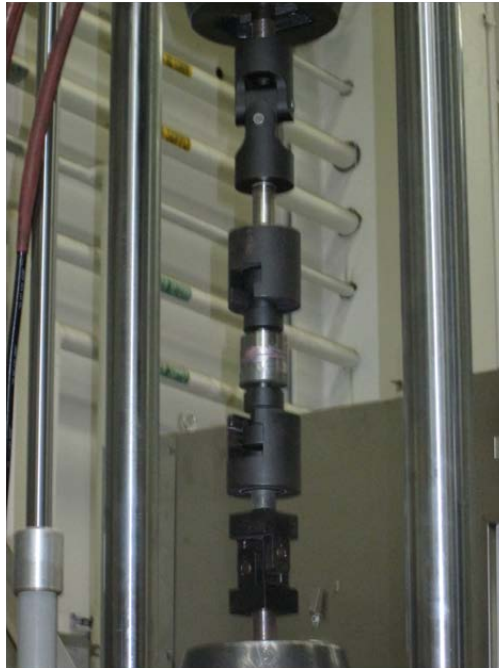
Figure 3-5. Tension test setup.

After most of the tests using the mock quoin blocks were completed, it was determined that a simpler test was needed. A tension test was designed and used. Figure 3-5 shows the test setup. Pucks of a 2 in. diameter were fabricated in both carbon and stainless steel.

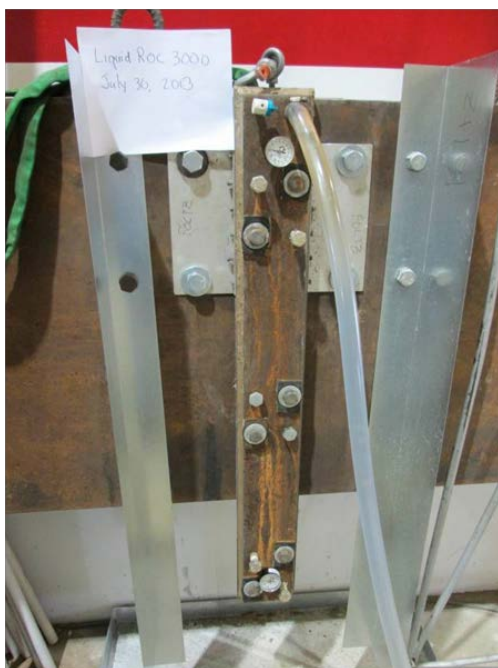
Figure 3-6. Test of Liquid Roc 300.

The performance of the cured material was similar to that of the A7 and Polygrip (i.e., it was exceptionally good). Liquid Roc 300 and Polygrip are both polyester-based so their similar performance is not surprising. After the pressure test, the seal was broken by tightening the push bolts (Figure 3-7). This took substantial wrench torque and actually broke the material bead through the center. It did not separate at the steel surface. Cleanup of the steel plates was difficult due to the strong adhesion to the surface.

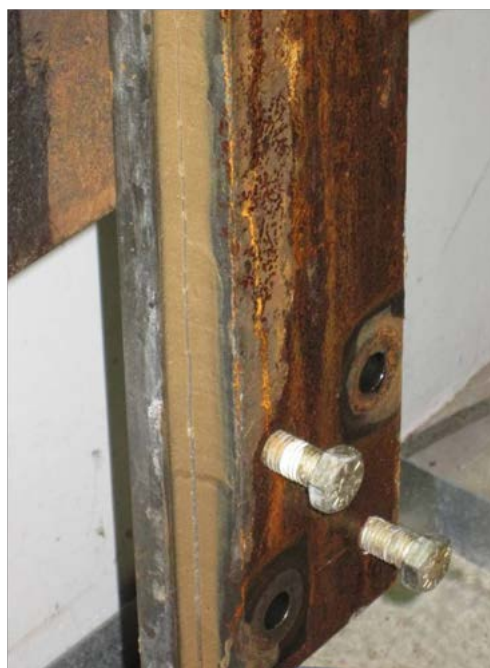
Figure 3-7. Breaking the Liquid Roc 300 seal.

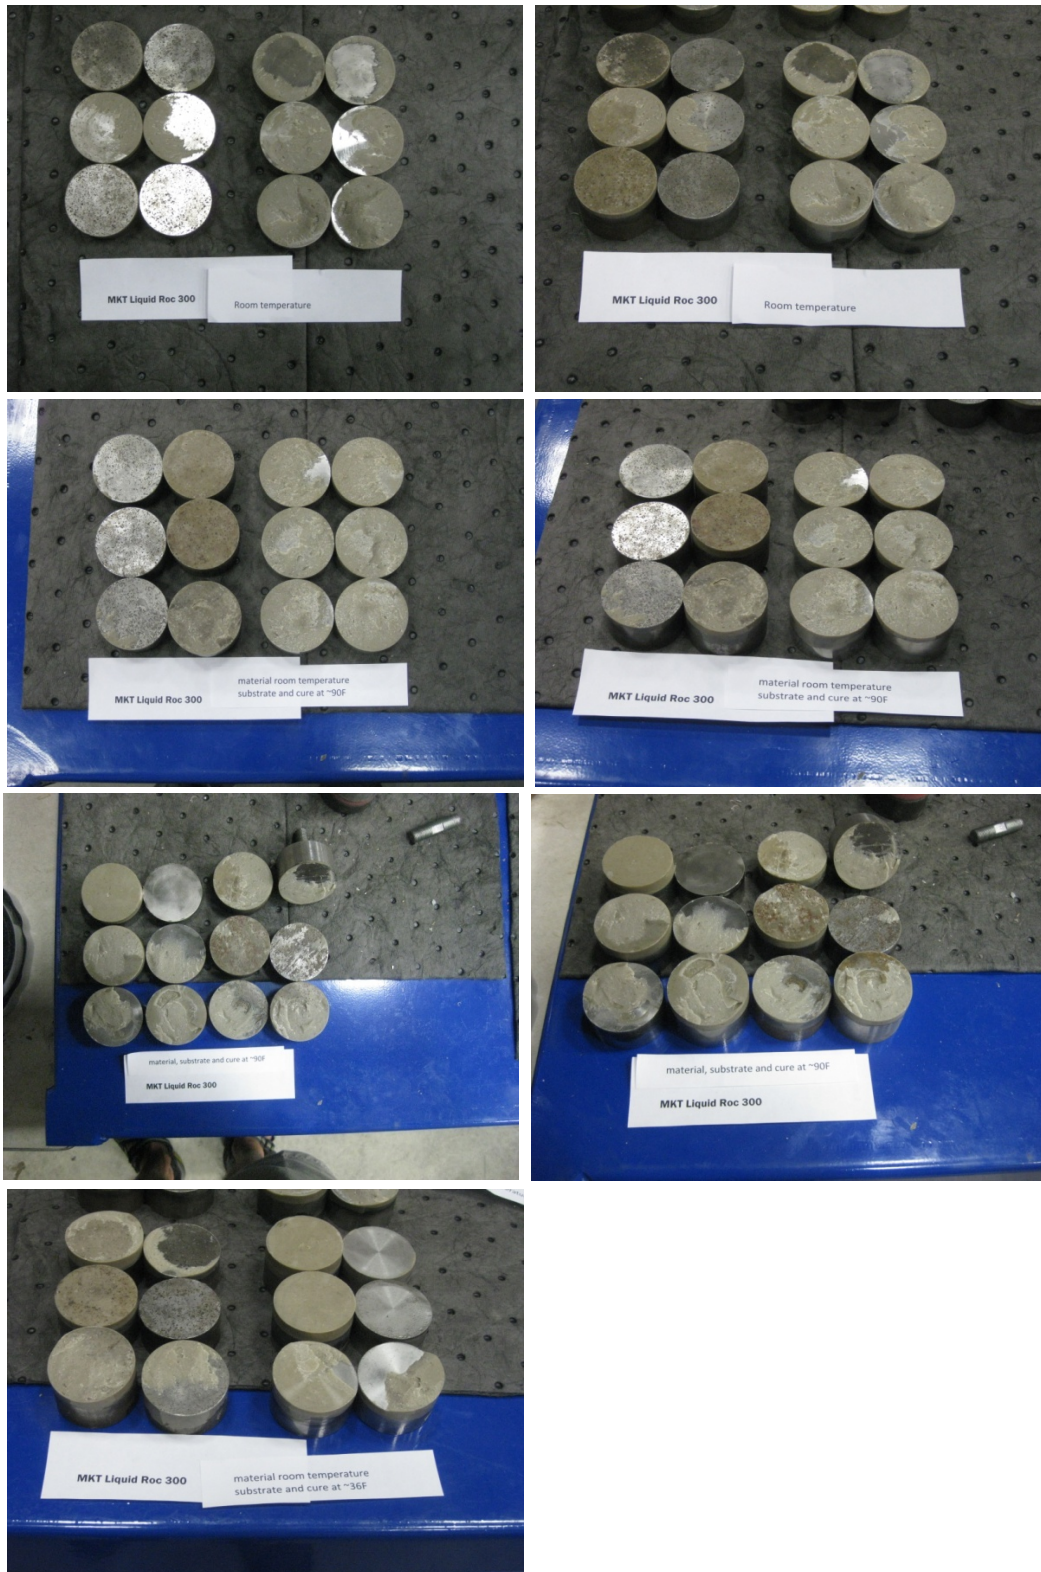
Figure 3-8. Pucks after tensile tests for Liquid Roc 300 twin tube.

This material performed well in tensile testing except for one puck that did not bond (Table 3-3 and Figure 3-8).

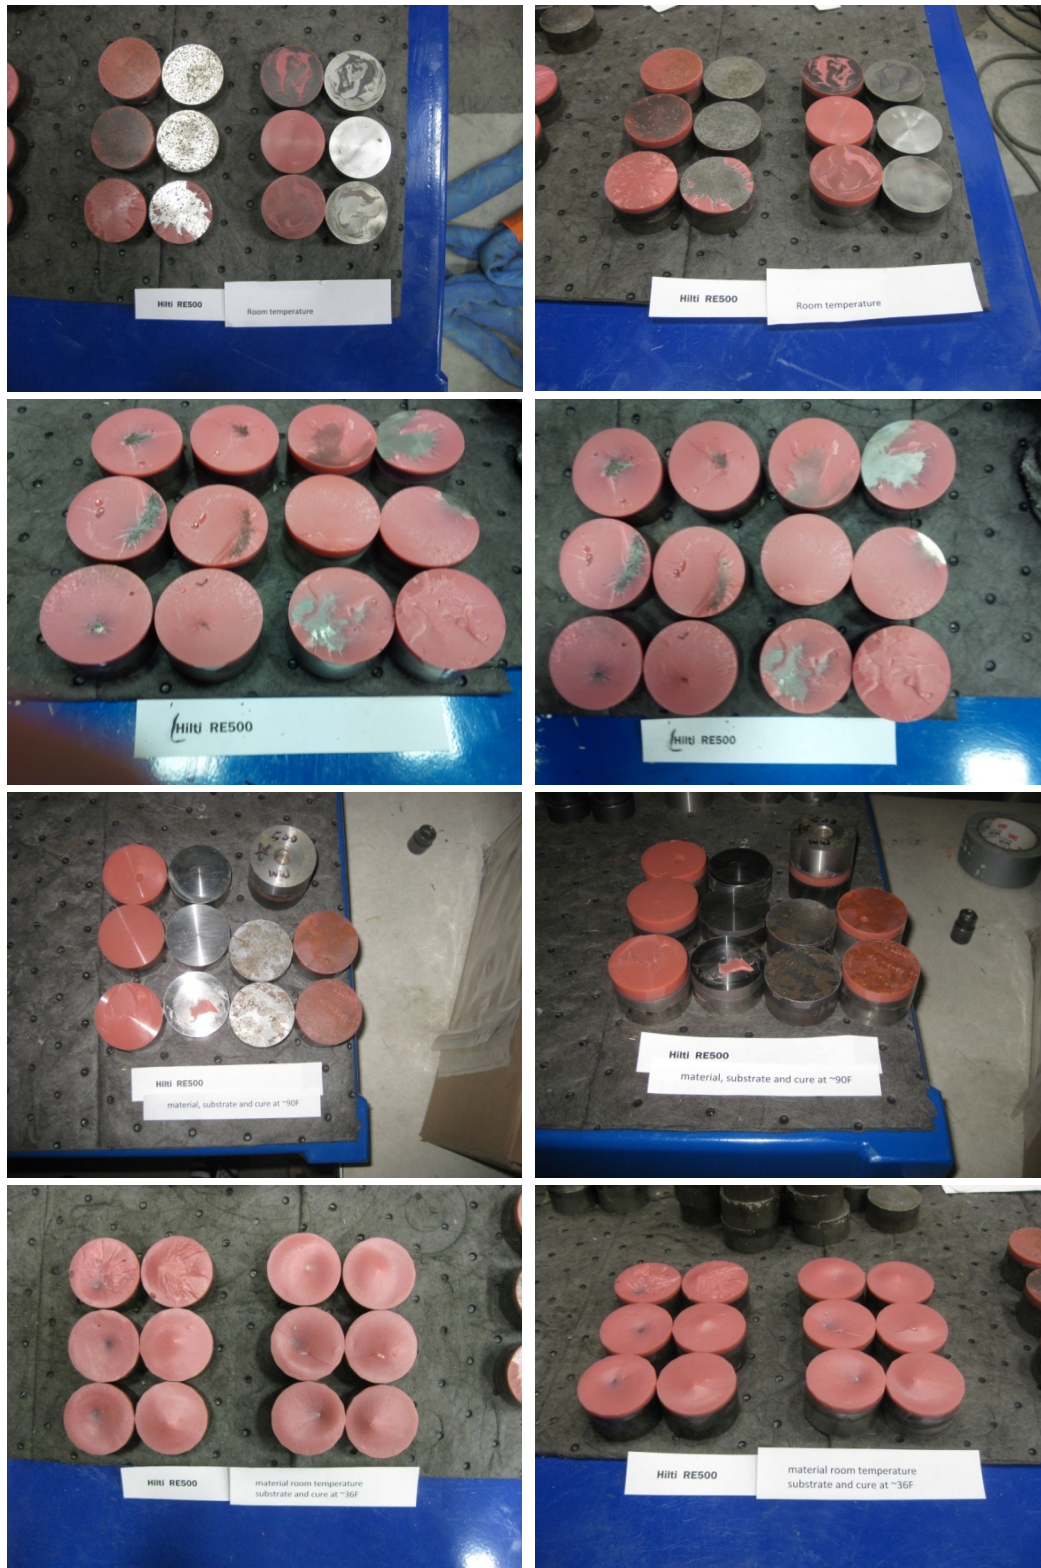
Figure 3-11. Pucks after tensile tests for Hilti HIT RE500.

Hilti HIT RE500 had some of the highest tensile strengths of any material. Although this material is recommended for use down to 23 °F (-5 °C), there was a noticeable reduction in strength at lower temperatures. Cure times also increase substantially at lower temperatures. This material is recommended for the application.

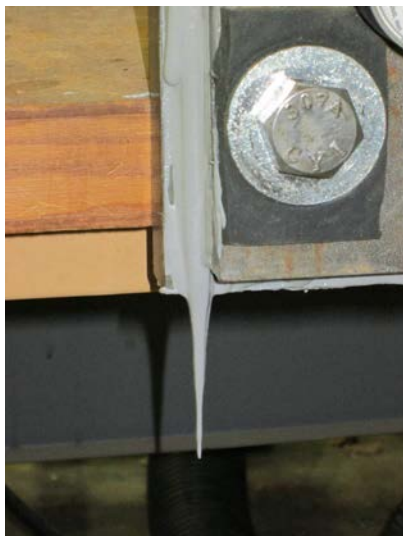
Figure 3-13. Loctite Fixmaster HP anchor grout dripping off application site.

The Loctite literature lists a working time of 20 minutes at 77 °F (25 °C). During CERL testing at 90 °F (32 °C), a test bead started to thicken slightly after 12 minutes. At 18 to 22 minutes, it had not yet gelled, but had stiffened further and was more difficult to work due to forming a “string” between the caulk bead and the tool as the tool was removed.

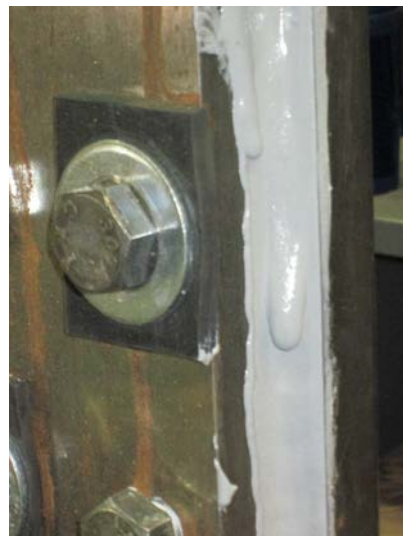
Figure 3-14. Loctite Fixmaster HP anchor grout application beginning to run.

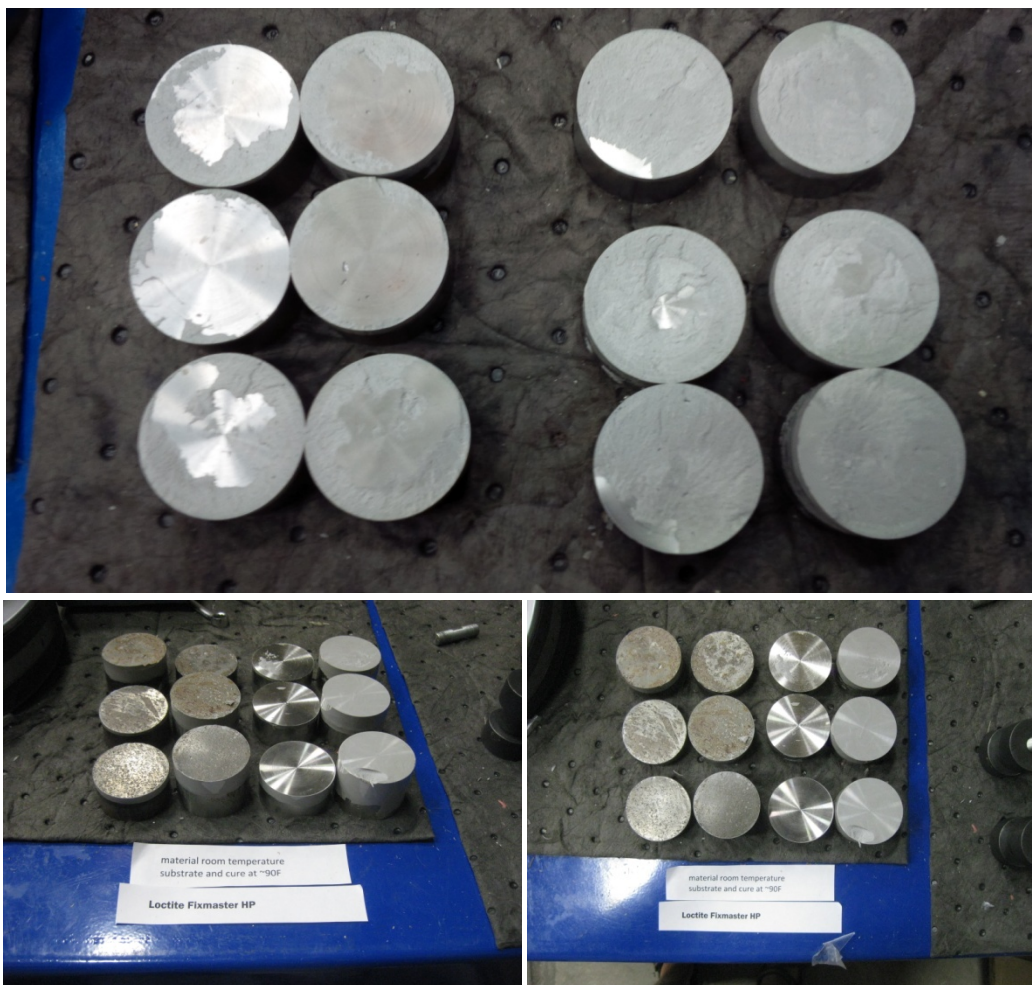
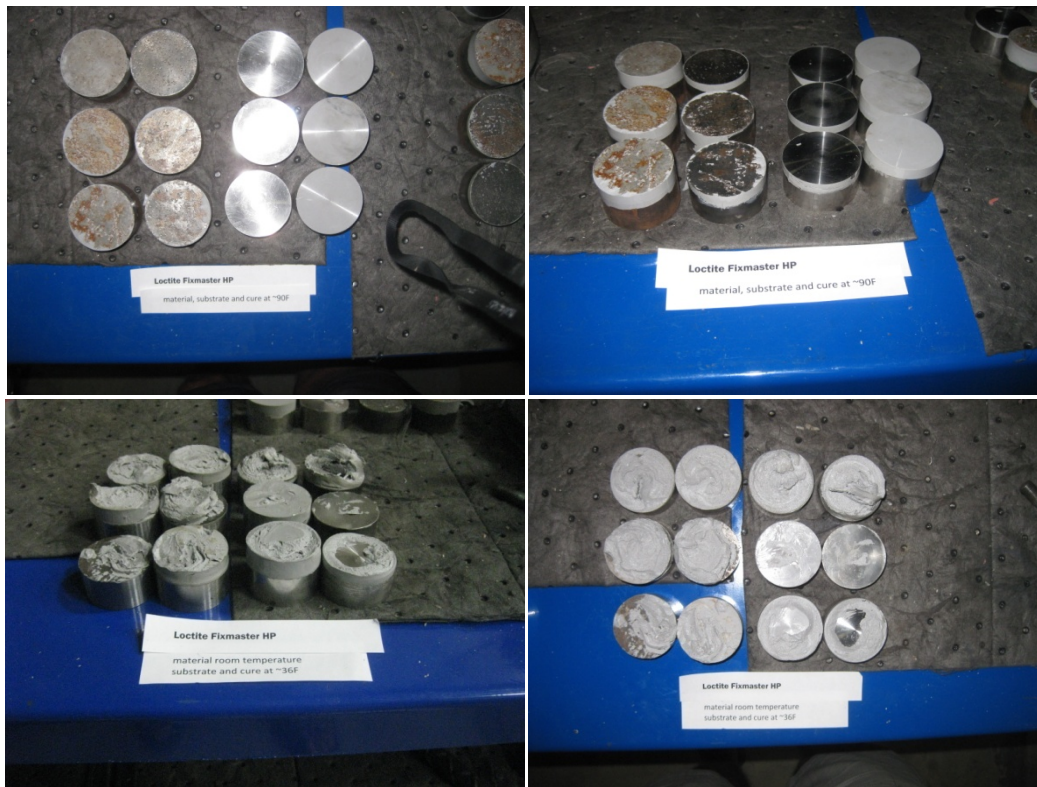
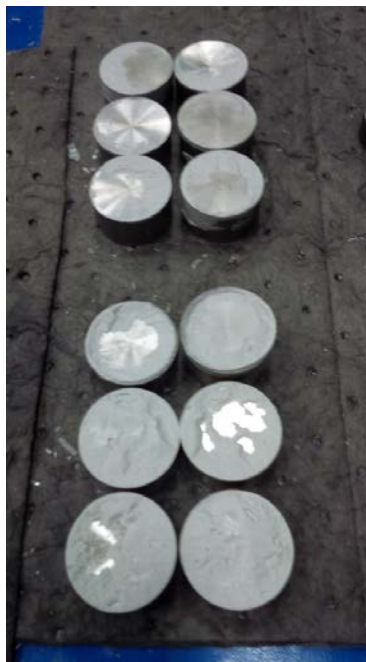
Figure 3-15. Pucks after tensile tests for Loctite Fixmaster® Anchor Bolt Grout HP.

Not fully cured

Substrate, material and cure at 36 °F (2 °C)

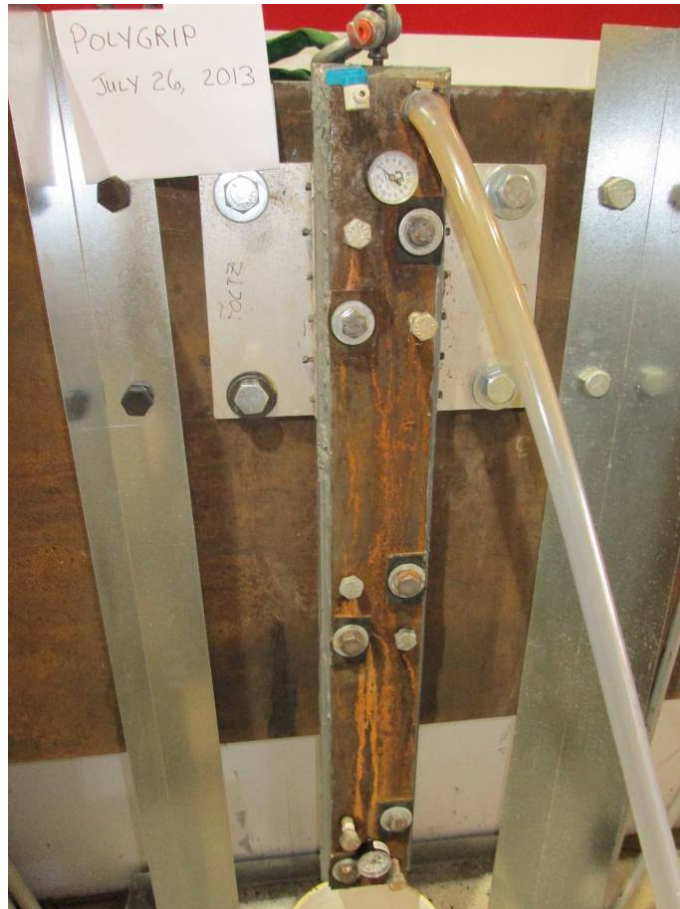
Figure 3-16. Test of W.R. Meadows Polygrip.

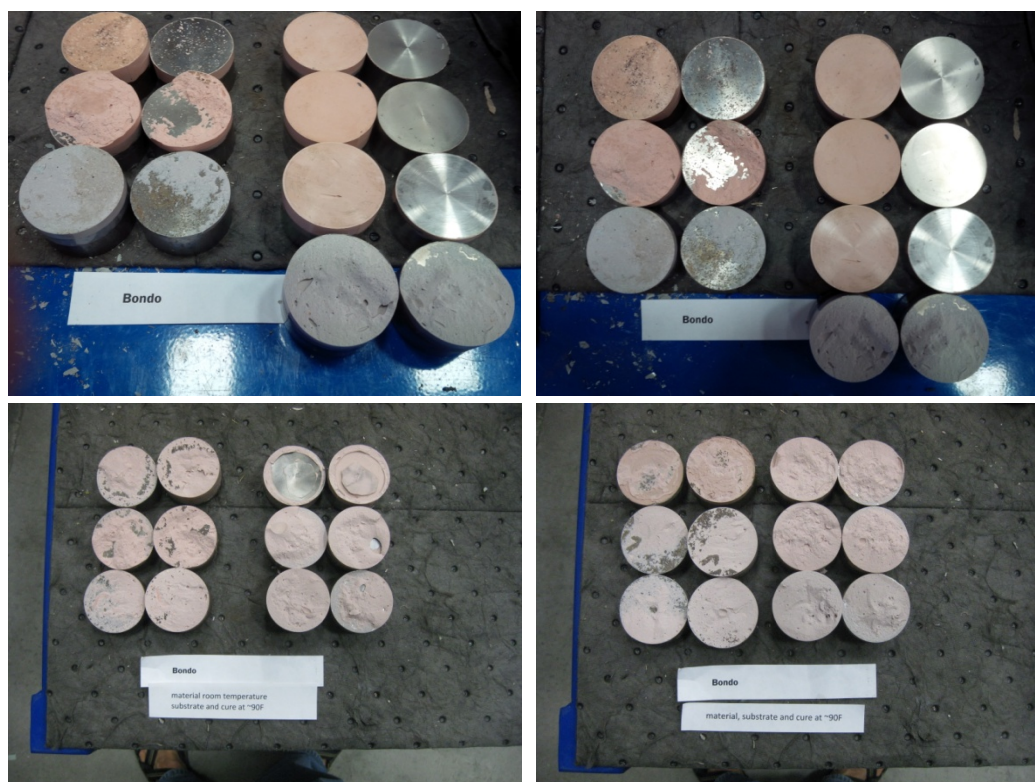
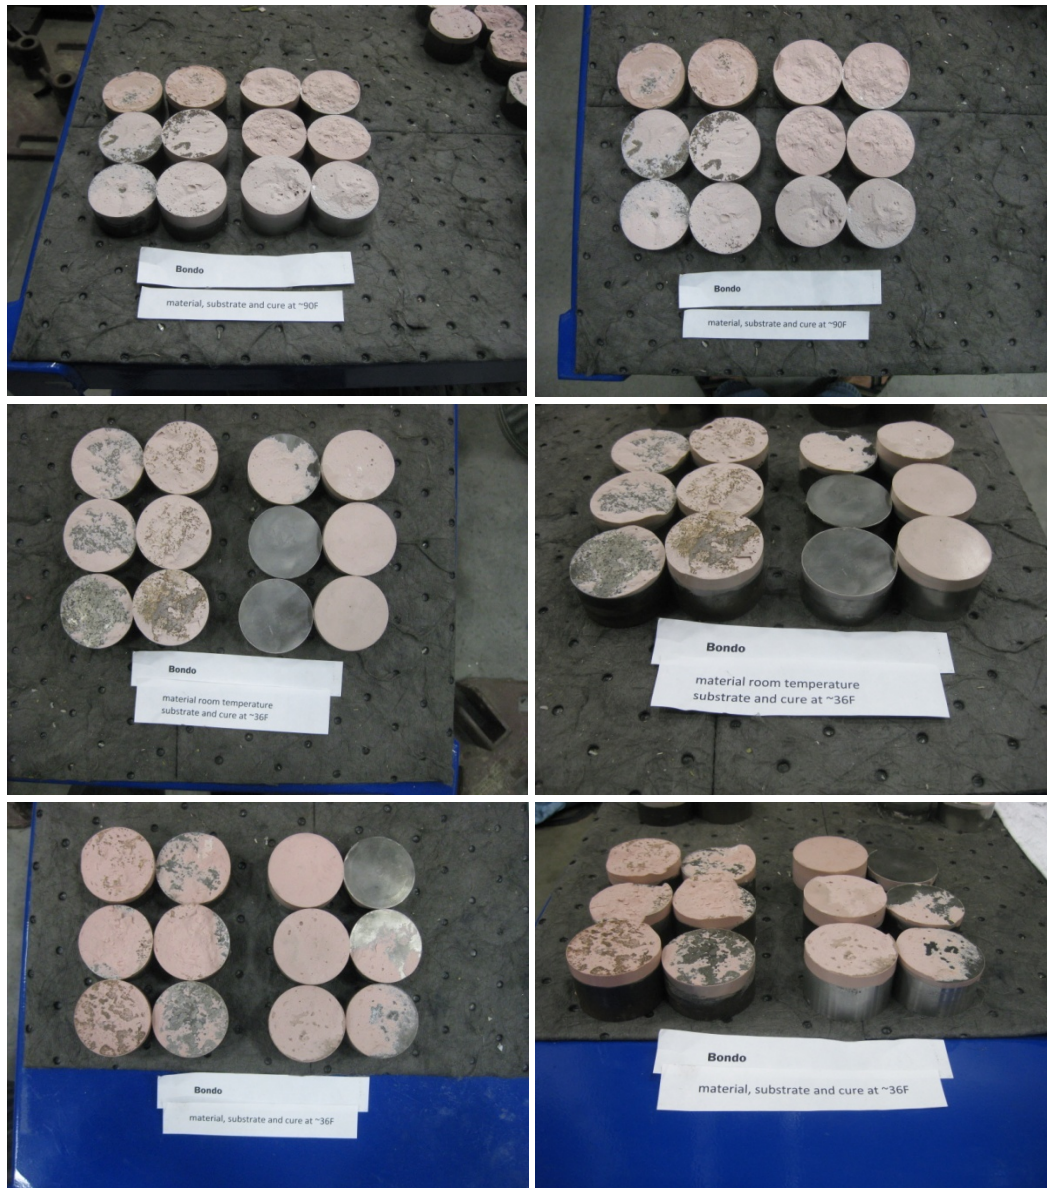
Figure 3-17. Pucks after tensile tests for Bondo®.

Bondo® appears to be a satisfactory material for this application, but it has distinct advantages and disadvantages. It is more time consuming to mix and apply than the two-part epoxy cartridge applied materials. Also, Bondo® has a relatively short working time, which decreases at higher temperatures.

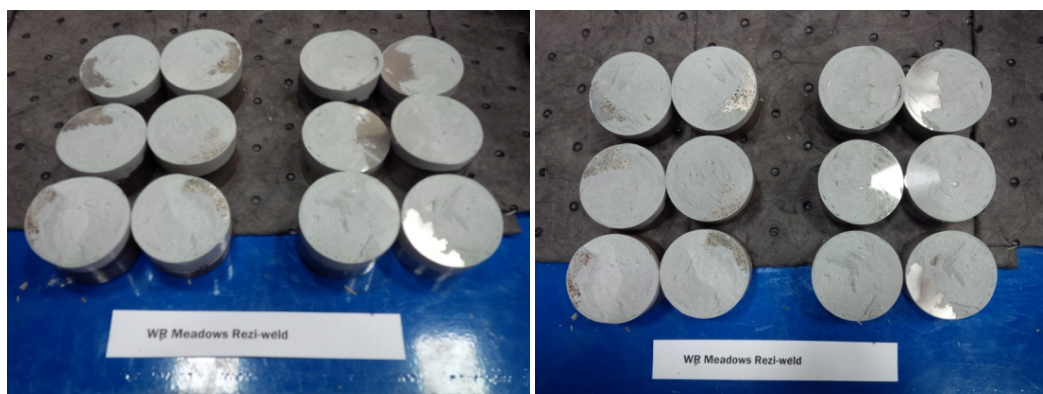
Figure 3-19. Pucks after tensile tests for WR Meadows Rezi-Weld Gel Paste State.

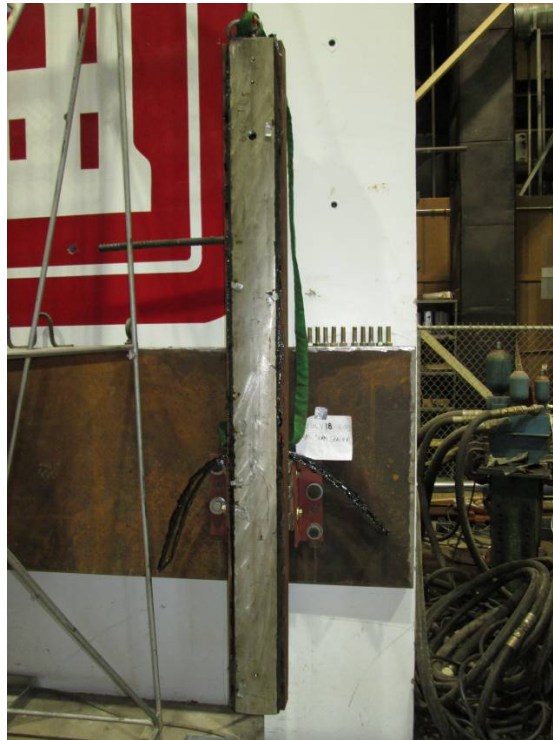
Figure 3-20. Application of 3M™ Factory-Match (automotive) seam sealer.

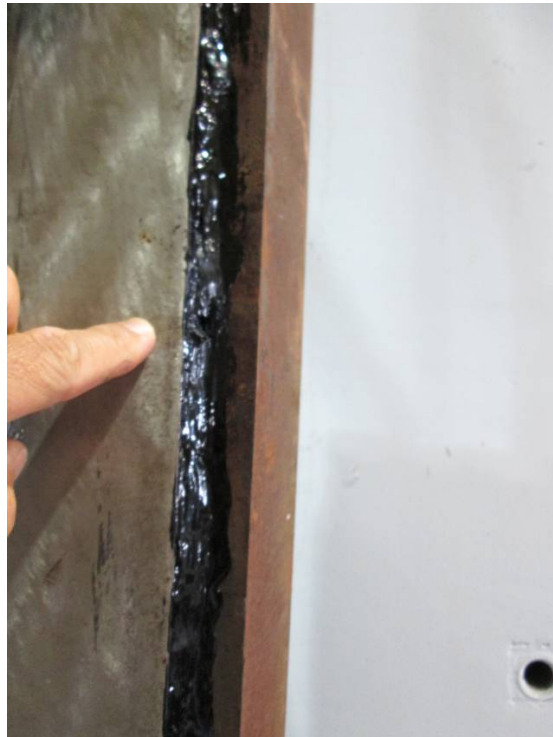
Figure 3-21. Material separation of application of 3M™ Factory-Match (automotive) seam sealer.

The proof test was not acceptable. Once disassembled, it was found that most of the material had set and had very good strength, but in numerous locations, the material was soft and sticky. Even months later, these locations did not set. Because the test sample was so big, and the seam sealer tubes are very small relative to other products tested, many tubes were used and the locations of the soft areas would clearly be from different tubes. Because one nozzle was used, it is possible that the nozzle was defective, that material had set in the nozzle, that the high temperature affected the material, or that some other unidentified variable affected the material's performance.

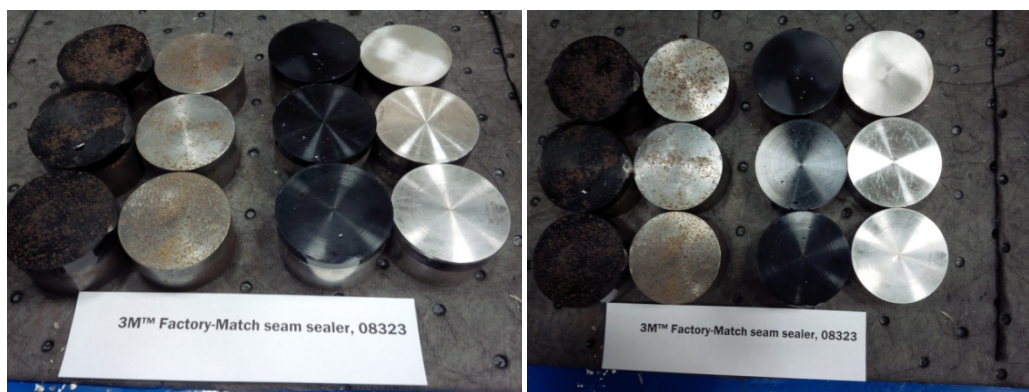
Figure 3-22. Pucks after tensile tests for 3M™ Factory-Match Seam Sealer, 08323.

Seam sealer 08323 is intended for automotive use. Based on the manufacturer literature, it appears to be intended for application at room temperature. Because the material is intended for application at room temperature, only limited tests were made using this material. The material is stronger than the bond to the steel. It is more elastic than the grouts and adhesives, but not as elastic as Loctite 5607.

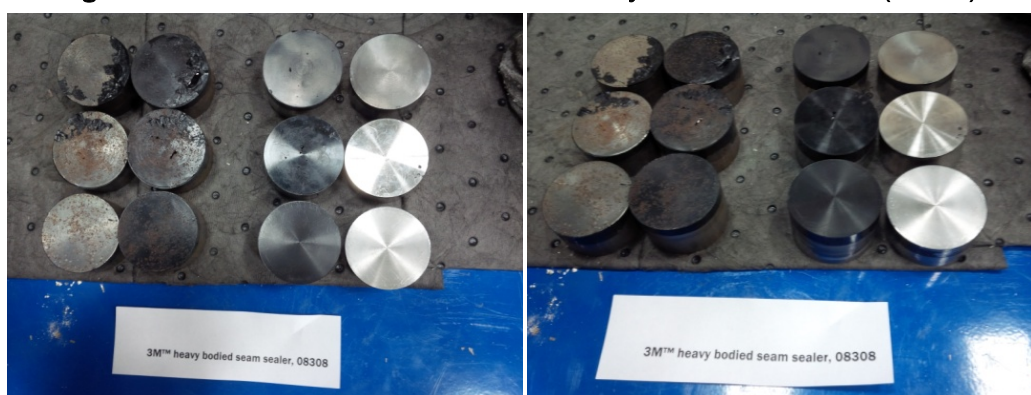
Figure 3-23. Pucks after tensile tests for 3M Heavy Bodied Seam Sealer (08308).

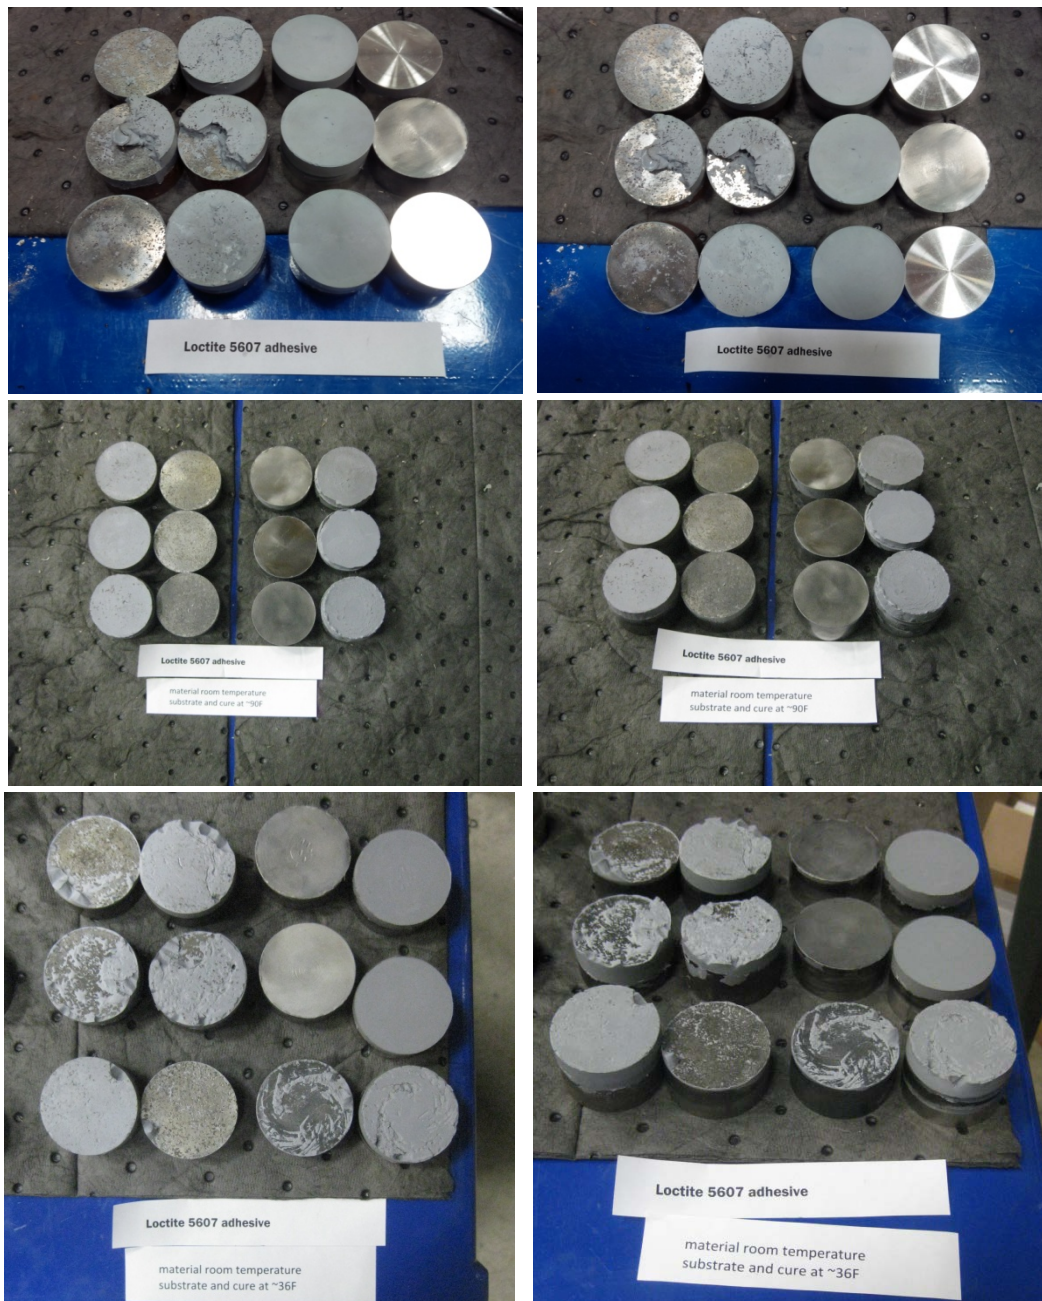
Figure 3-25. Pucks after tensile tests for Loctite 5607 Silicone Adhesive.

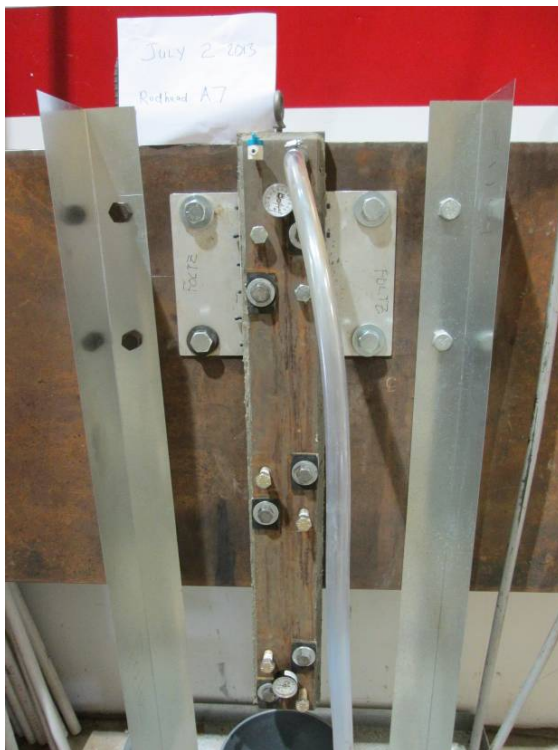
Figure 3-27. Application of Redhead Epcon A7 anchoring adhesive.

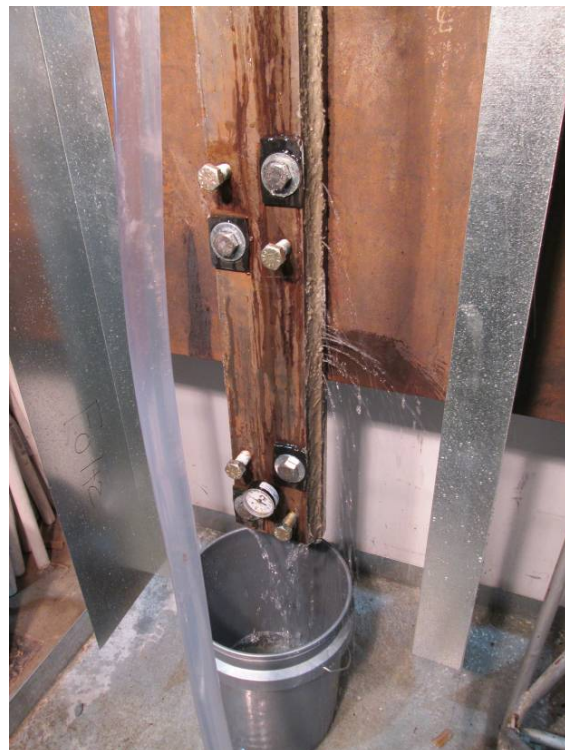
Figure 3-28. Leaks that appeared after applying water pressure to application of Redhead Epcon A7 anchoring adhesive.

Nevertheless, while other materials with fine aggregate also had marginal adhesion, Redhead A7 was generally better than other similar materials tested. One anomaly was that, although most of the Redhead A7 material showed poor adhesion, approximately 20% showed adhesion as good as or better than other materials with fine aggregate. It is possible that, if the material had been worked into the gap more thoroughly, the adhesion would have improved. Even if this were true, the uneven results suggest that this procedure is not dependable enough for use in the field.

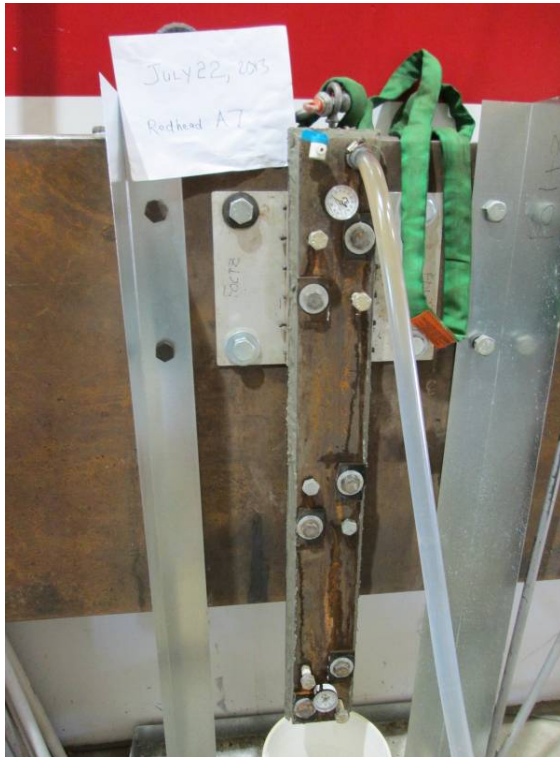
Figure 3-29. Test of Redhead Epcon A7 anchoring adhesive.

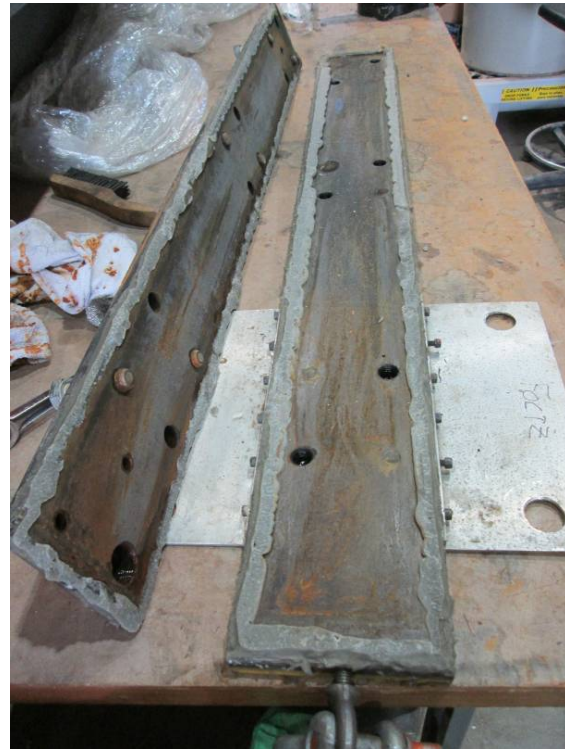
Figure 3-30. Broken seal of Redhead Epcon A7 anchoring adhesive following the test.

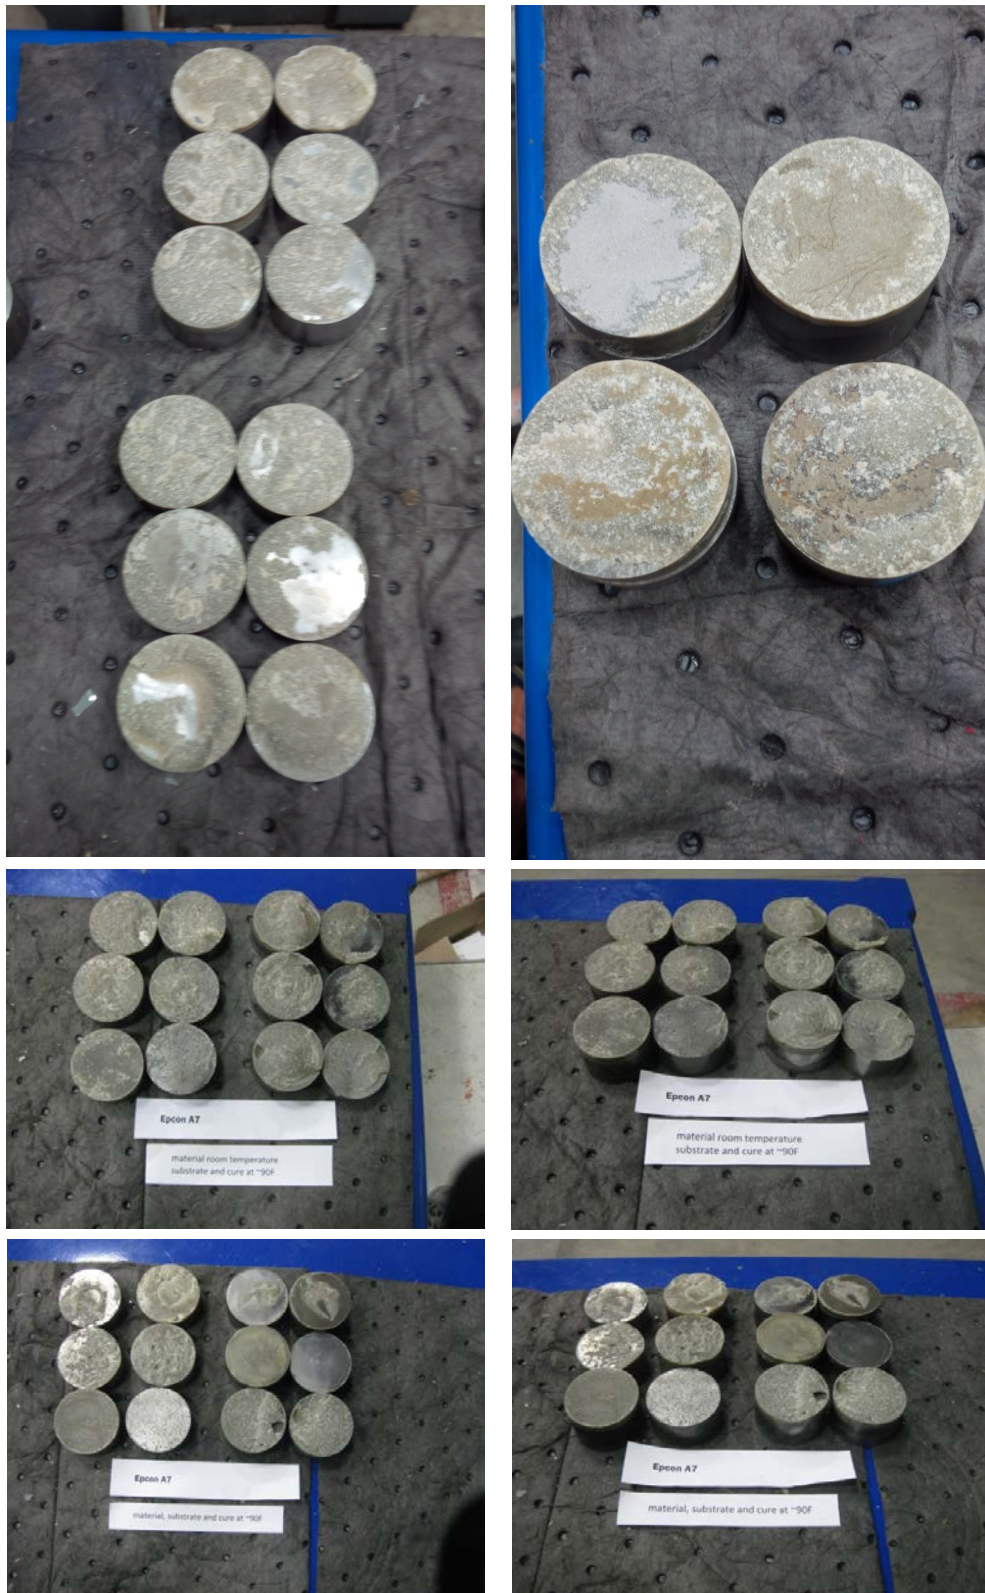
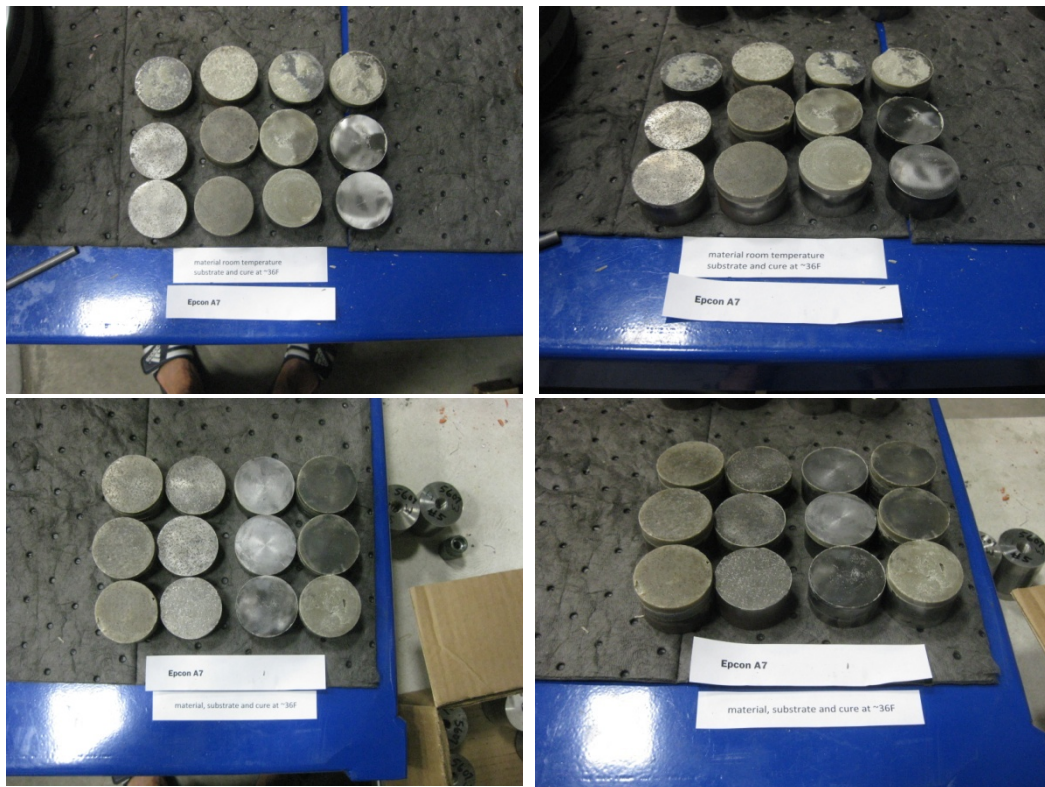
Figure 3-31. Pucks after tensile tests for Redhead Epon A7 Acrylic Adhesive.

At warm temperatures, the gel time for this product is shorter than desirable and at colder temperatures, the adhesion was not adequate. Epcon A7 is not recommended for this application.

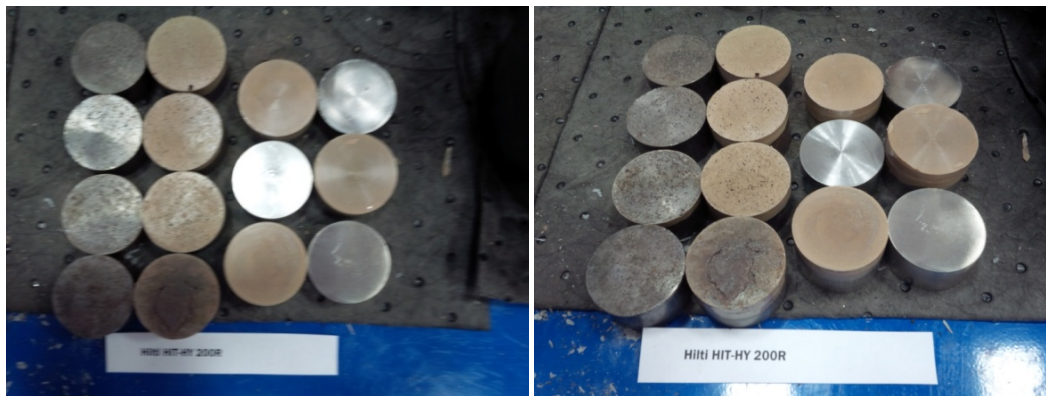
Figure 3-33. Pucks after tensile tests for Hilti HIT-HY 200R / HIT-HY 200A.

At warm temperatures, the gel time for this product was shorter than desirable and it was more difficult to tool this material than some other materials. At colder temperatures, the adhesion was not adequate. HIT-HY 200R is not recommended for this application.

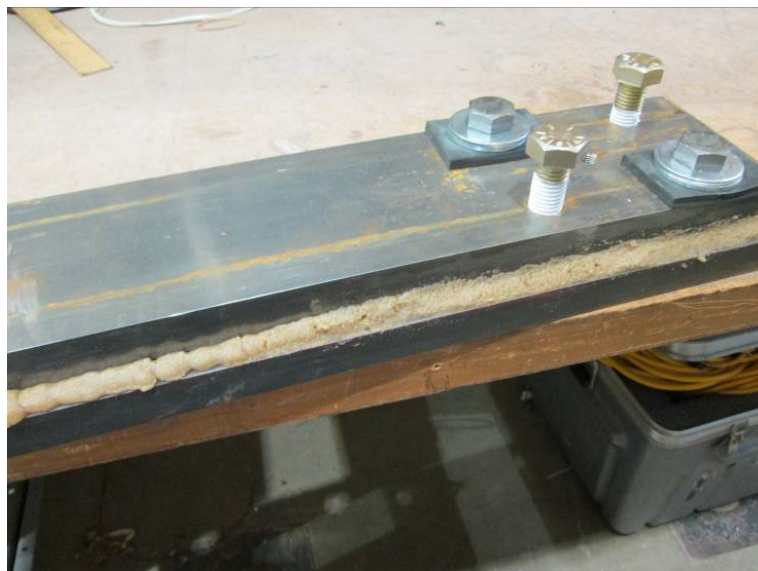
Figure 3-34. Application of Hilti HIT ICE on steel plates at room temperature.

Although it is likely that HIT ICE could be successfully used at room temperature, this is not recommended because:

- Test samples were found to gel in about 3 minutes. This includes time in nozzle if the caulk gun is not in use. If the entire tube is used at once (or the nozzle is changed after even short gaps in usage), it might be possible to apply successfully, but working time is very short.
- This product contains fine aggregate that likely reduces adhesion and makes it slightly more difficult to work.

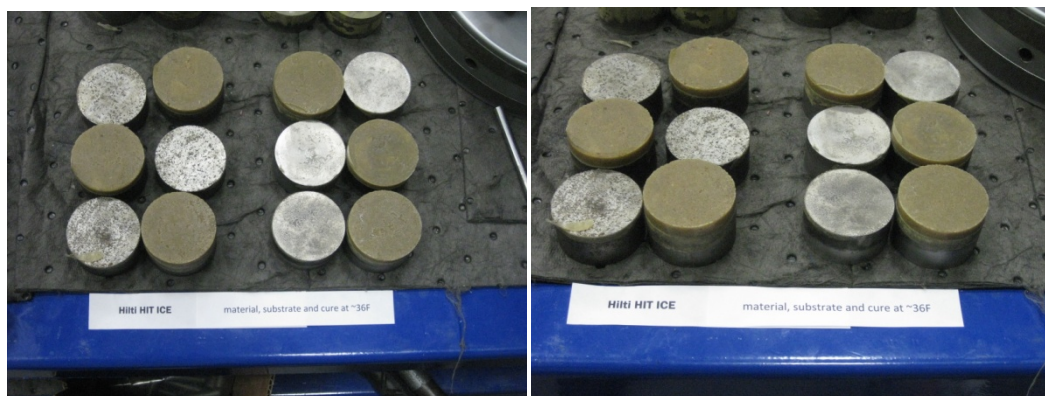
Figure 3-35. Pucks after tensile tests for Hilti HIT ICE.

At warm temperatures, the gel time for this product is far shorter than desirable and at colder temperatures, the adhesion was not adequate. Hilti ICE is not recommended for this application.
