*Monitoring Completed Navigation Projects (MCNP) Program*

## **Evaluation of Sealing Materials and Techniques for Installing Quoin and Miter Block Backing Grout**

Final Report

Under Project No. 399320, "Sealing Techniques"

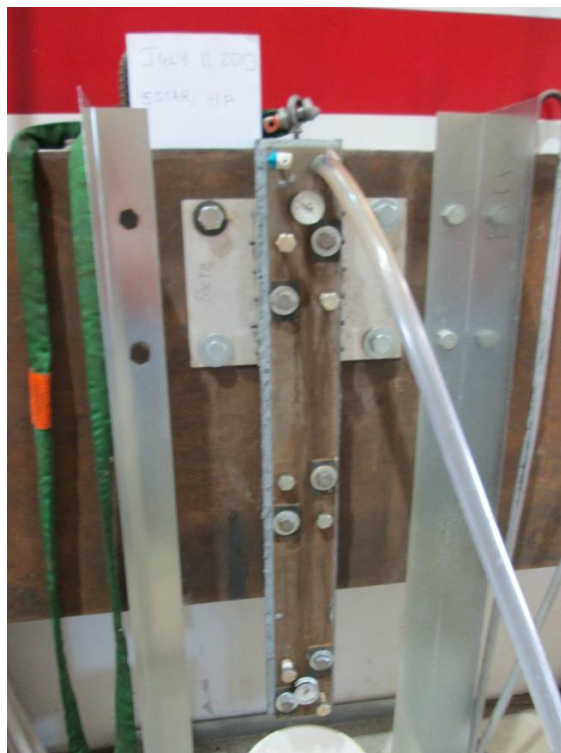
Figure 3-36. Test of Five Star HP Anchor Gel.

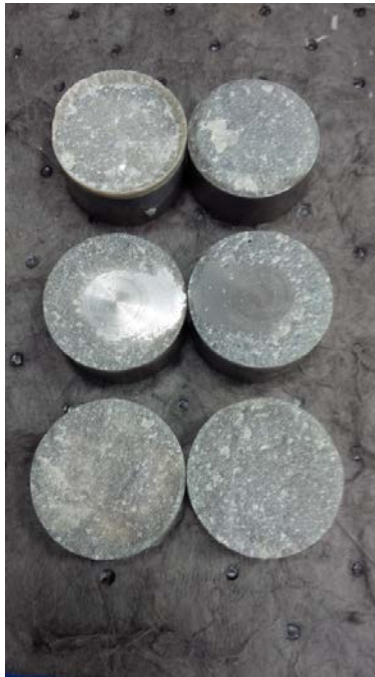
Figure 3-38. Pucks after tensile tests for Redhead Epcon G5 High Strength Epoxy.

At 84 °F (29 °C), this material did not have viscosity to hold position for this application. At 70 °F (21 °C), it was difficult to pump the material through the nozzle. The material is not recommended for this application.

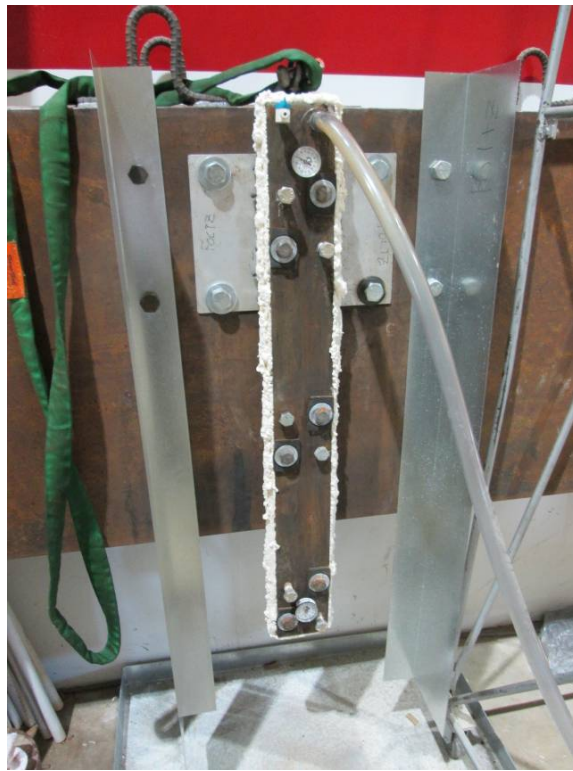
Figure 3-39. Test of Touch 'n Seal all season polyurethane foam.

With increasing head (~10 ft), a number of small leaks developed in other areas. On disassembly, it was clear that adhesion was variable. It is not clear whether this was due to surface conditions, application technique, or a combination of the two. Regardless, the foam does not appear to be a good candidate. It seems to work best when filling a three-sided void or deep cracks or joints. In this case, the primary location of the seal was a different configuration.

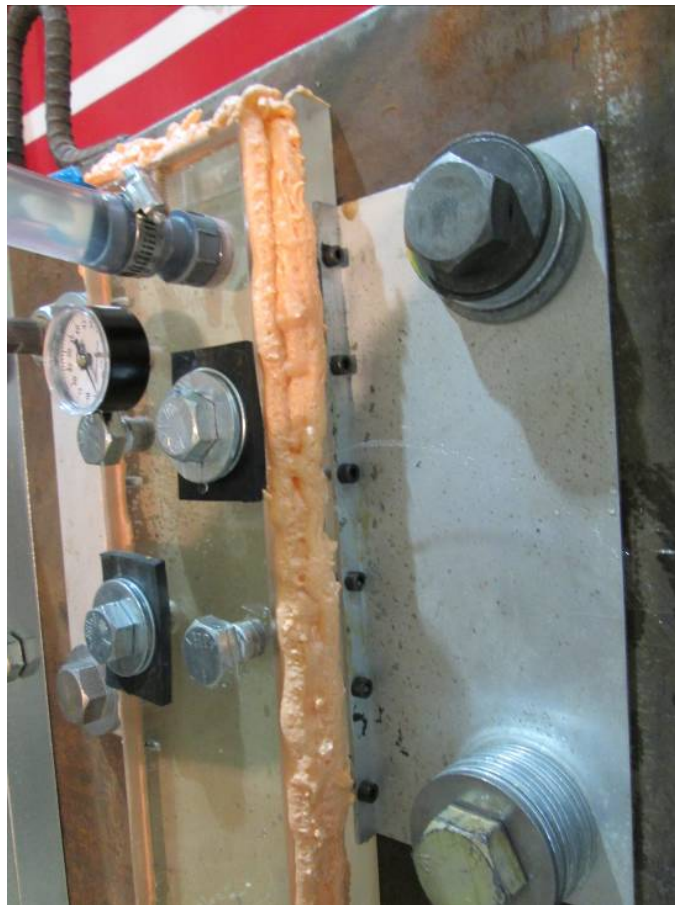
Figure 3-41. Application of Hilti foam CF-ASCJP to Plexiglas plates.

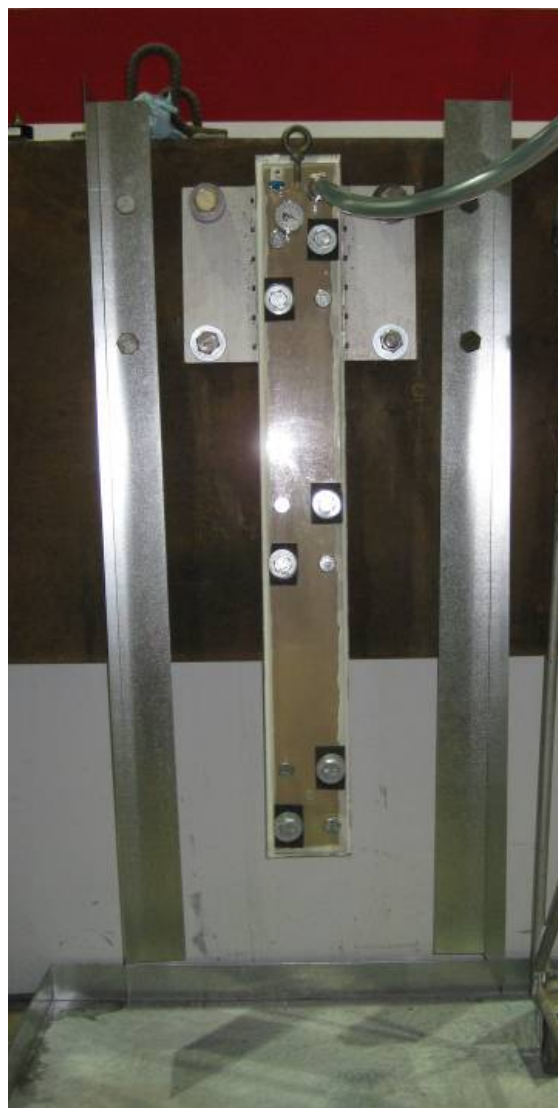
Figure 3-43. Setup for test of silicone caulk on Plexiglas plates.

This caulk was applied, but was not worked into the gap or the corner of the two plates (Figure 3-43). The test was run after approximately 20 hours. When head was applied, small leaks were immediately apparent and the caulk failed much more extensively with only minimal head pressure. When the caulk and plates were separated, it was determined that, while the exterior surface of the caulk was firm, dry, and generally cured, the interior was still soft and sticky. This raised concerns that a one-component product may not be the best choice for this application.
