**CREEP OF HI-NICALON<sup>TM</sup> S CERAMIC  
FIBER TOWS AT 800°C IN AIR AND IN  
SILICIC ACID-SATURATED STEAM**

DISSERTATION

AFIT-ENY-DS-15-S-067

***AIR FORCE INSTITUTE OF TECHNOLOGY***

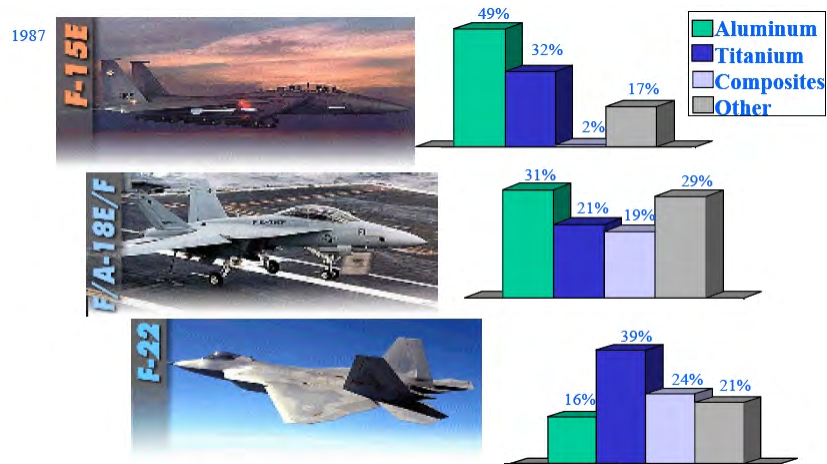
Figure 1. Composites Use in Military Aircraft. Note the dramatic increase in just 30 years. Reproduced from [11].

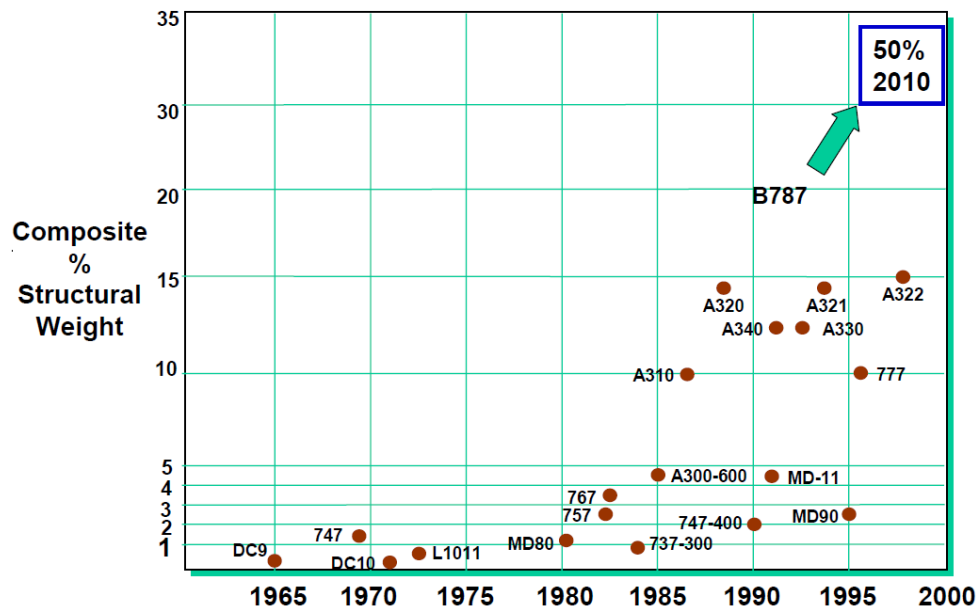
Figure 2. Composites Use in Commercial Transport Aircraft. Again, note the dramatic increase in the past 50 years. The Boeing 787 did indeed reach 50% composites by weight. Reproduced from [11].

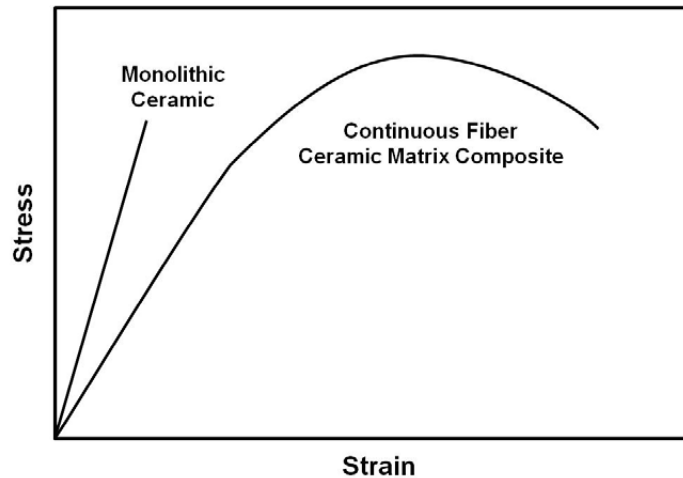
**Figure 3. Notional comparison of stress-strain behaviors of a monolithic ceramic and a CMC, reproduced from [4]**

CMCs have successfully bridged the gap, maintaining sufficient flaw tolerance (toughness or damage tolerance) to avoid sudden catastrophic failures and fail gracefully (Figure 3), while still providing the desired strength, weight, and high-temperature properties [13], as shown in Figure 4.

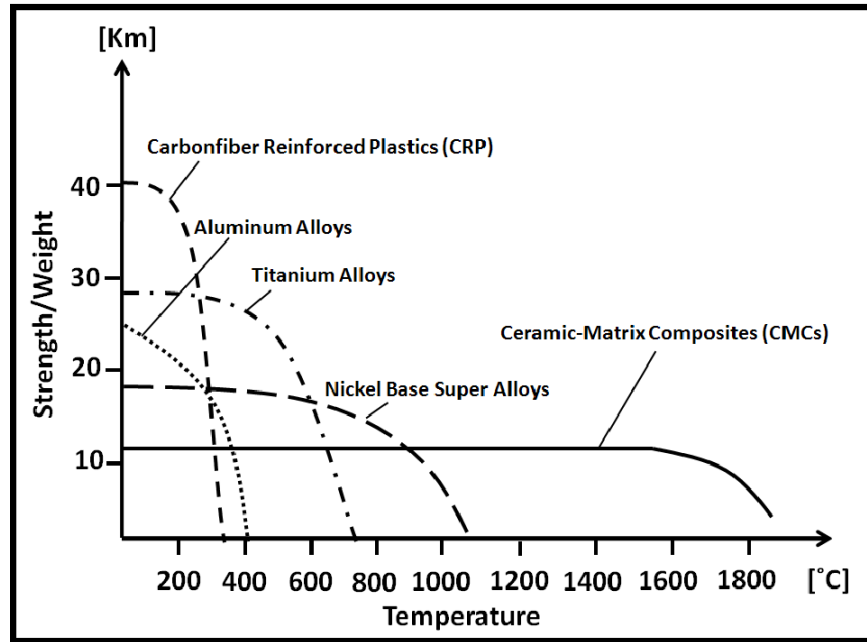
Figure 4. Strength-to-weight ratios of engineering materials for aerospace applications. Note the significant improvement of CMCs over traditional materials at high temperatures. Reproduced from [13], pg. 410, Copyright ©2004, with permission from Elsevier and from the original author [14].

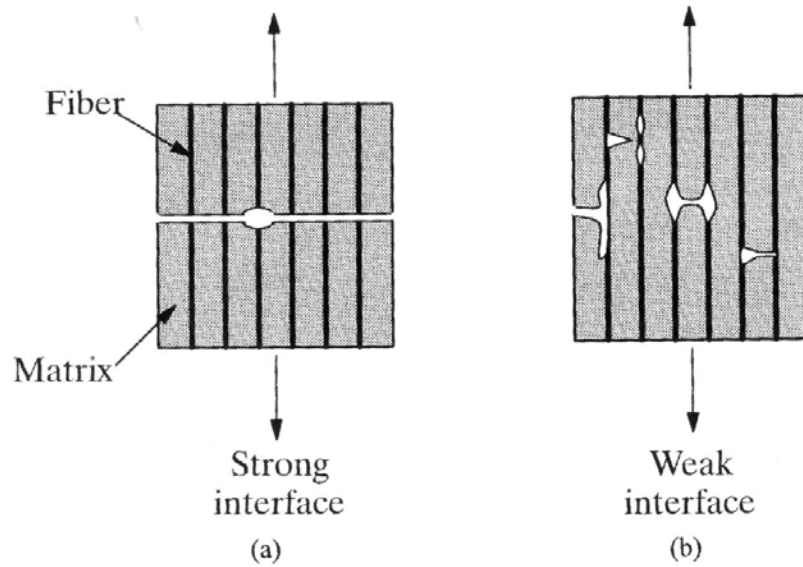
**Figure 5. Failure of CFCCs showing crack propagation for strong and weak interface bonding. Reproduced with kind permission from Springer Science & Business Media B.V. [12] pg. 148, Chapter 5: Interface, Figure 5.6. Copyright ©2003 by Kluwer Academic Publishers. All rights reserved. No part of this work may be reproduced, stored in a retrieval system, or transmitted in any form or by any means, electronic, mechanical, photocopying, microfilming, recording or otherwise, without the written permission from the Publisher, with the exception of any material supplied specifically for the purpose of being entered and executed on a computer system, for exclusive use by the purchaser of the work.**

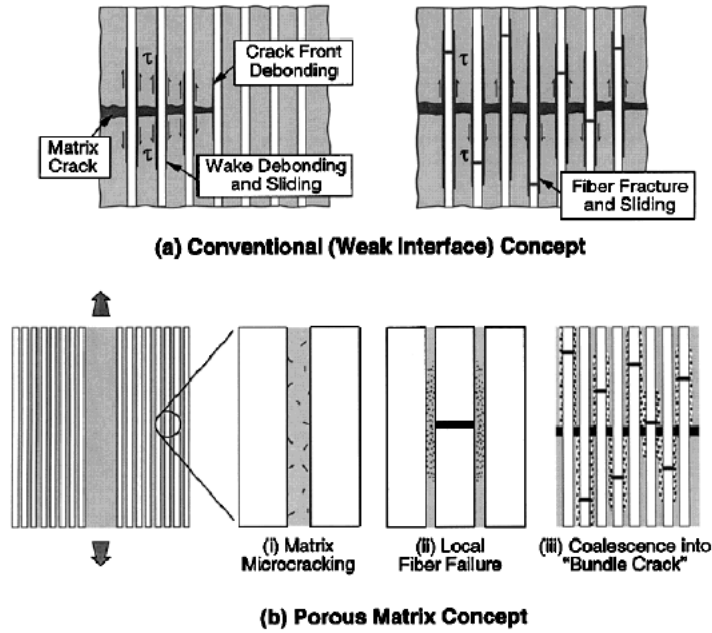
**Figure 6. Design Methods for Damage Tolerant CMCs: a) fiber coating with weak fiber/matrix interface and b) porous matrix [16], reproduced with permission from Wiley.**

fibers have not been widely developed [16]. This method employs a porous matrix, as seen in Figure 6b, rather than the dense matrix of the CMCs designed using the fiber coating approach. Here, a balance is struck such that the matrix is sufficiently strong to transfer load to the fibers and to support off-axis loads, but weak enough that it takes less energy for a propagating crack to deflect around a fiber, staying within the matrix, than it would to continue through the fiber [4, 16]. However, it is not straightforward to achieve this balance.

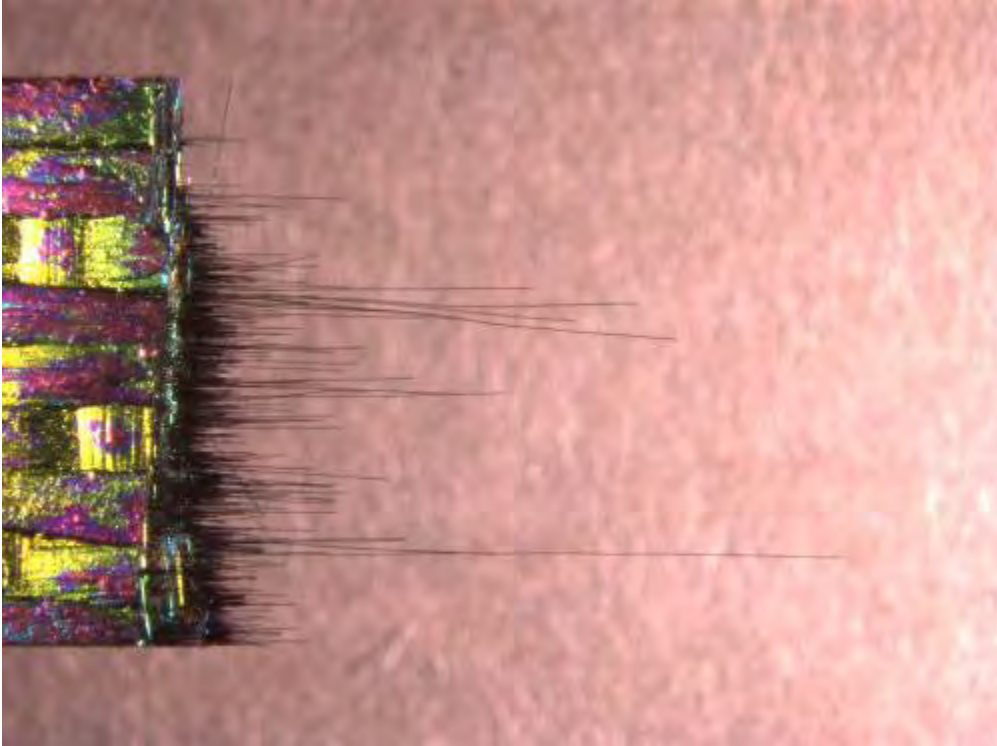
**Figure 7. Fiber pullout in SiC/BN/SiC CMC after a tensile fatigue test at 1200°C in air. Note the substantial amount of fiber pullout. Reproduced from [30].**

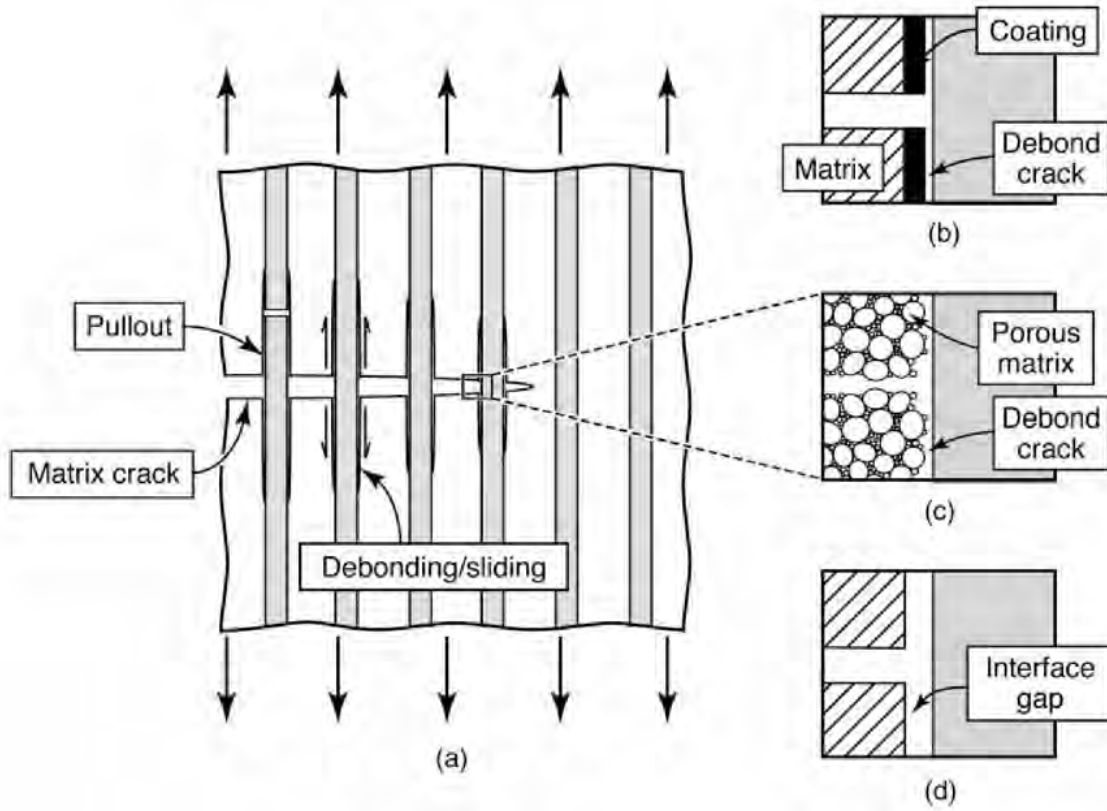
**Figure 8. Current Design Philosophies for Damage Tolerant CMCs:** a) damage tolerant design concept showing uncorrelated fiber failure, debonding, and pullout b) fiber coating with weak fiber/matrix interface, c) porous matrix, and d) fugitive coating [29], reproduced with permission from Wiley.

Figure 8b depicts a weak fiber/matrix interface bond, which deflects an advancing crack along or around the fiber and enables fiber pullout. This method is well documented [31–33]. Figure 8c depicts a strong fiber-matrix interface bond with a porous matrix. The porous matrix also enables cracks to deflect around the fiber and has been successfully demonstrated [34–38]. See Zok and Levi [16] and Zok [29] for an extensive review of the mechanisms and mechanical properties of porous-matrix

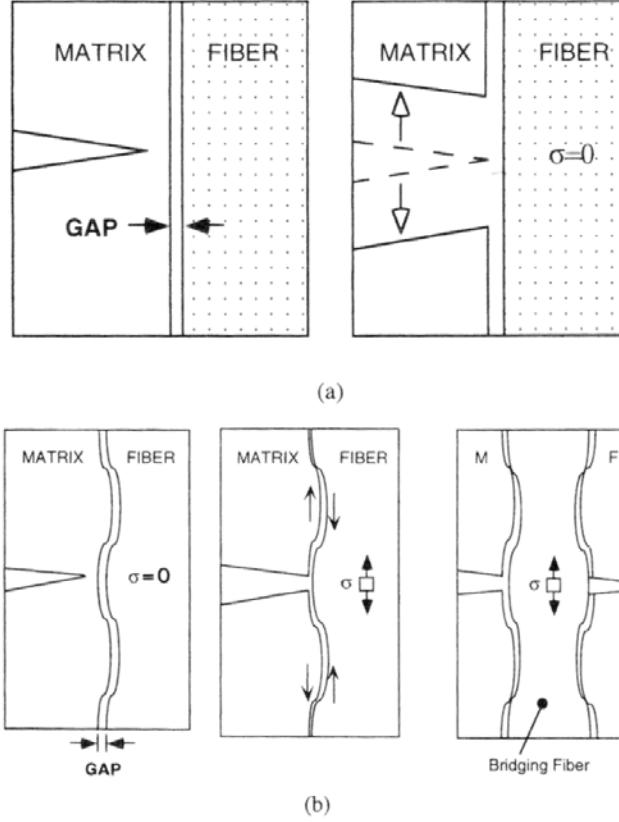
**Figure 9. Load Transfer at Fiber/Matrix Interfaces with a Fugitive Coating:** a) An idealized (smooth) interface would protect the fiber from the matrix crack, but no load transfer would occur, whereas b) in reality, the interface is rough and load transfer occurs while still protecting the fiber [39], reproduced with permission from Wiley.

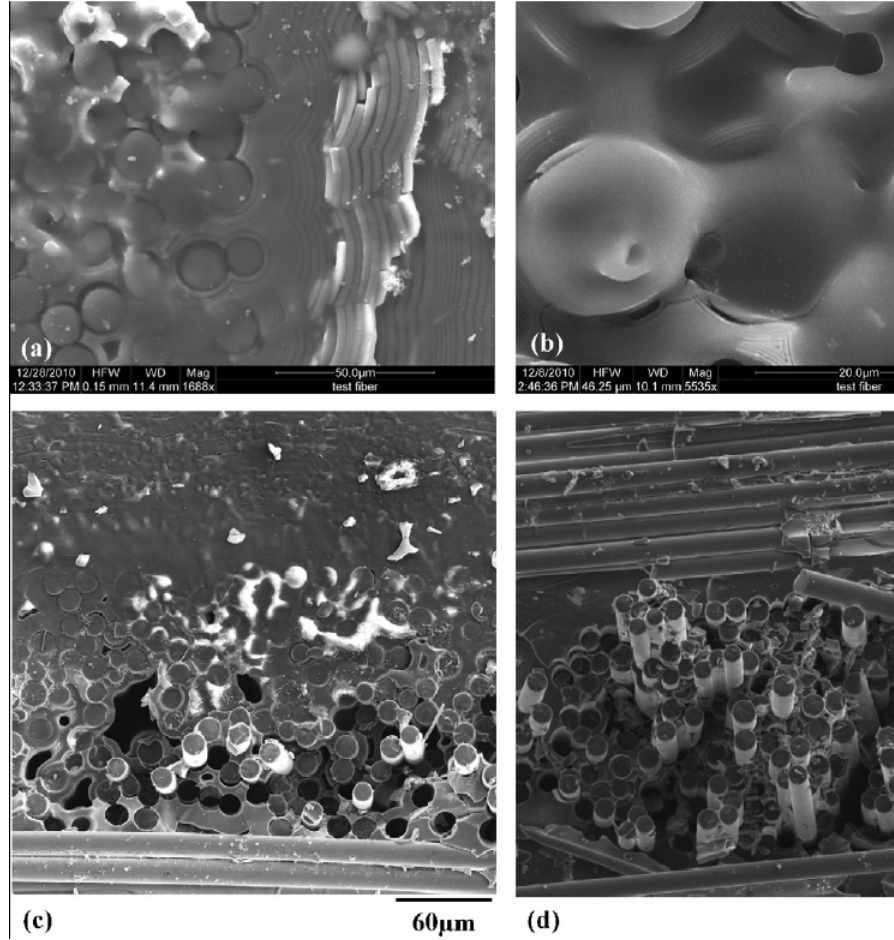
**Figure 10. Environmental Degradation due to Oxidation in a SiC/BN/SiC CMC. SEM images showing: (a) oxidation of fibers and matrix, (b) glassy phase in the oxidized region, (c) oxidized region in the top half of the image transitioning to the non-oxidized region in the bottom half of the image, and (d) fiber pull-out typical of the non-oxidized region. Reproduced from [30].**

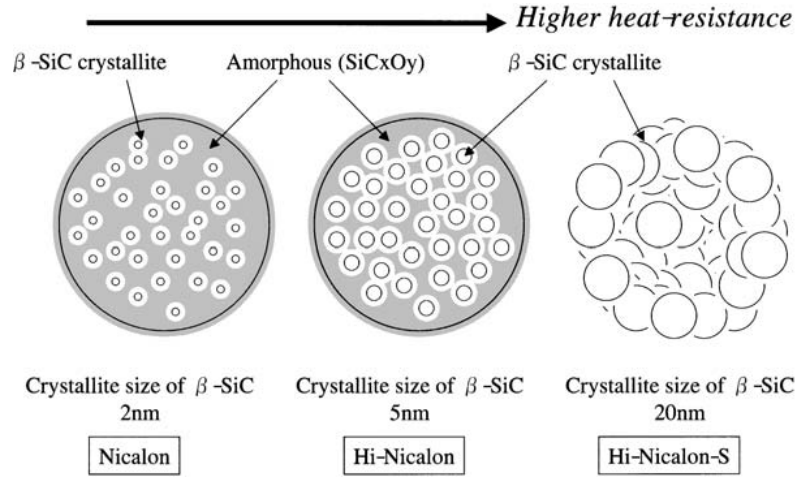
**Figure 12.** Microstructures of three generations of Nicalon<sup>TM</sup> fibers. Reproduced with kind permission from Springer Science & Business Media B.V. [20] pg. 118, Figure 9. Copyright ©2005 by Springer-Verlag Berlin Heidelberg.

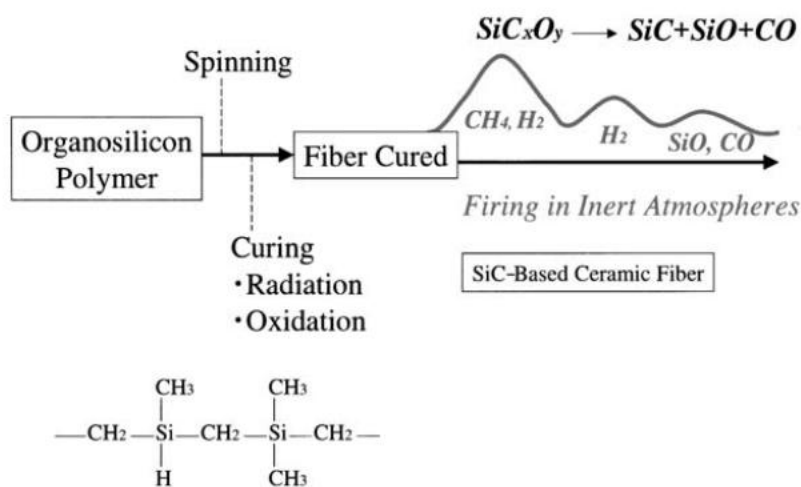
Figure 13. Production process for Hi-Nicalon<sup>TM</sup> S SiC fibers by electron irradiation curing and pyrolysis. Reproduced with kind permission from Springer Science & Business Media B.V. [20] pg. 117, Figure 8. Copyright ©2005 by Springer-Verlag Berlin Heidelberg.

Hi-Nicalon<sup>TM</sup> S achieves properties near those of bulk SiC. It has a stiffness of approximately 400 GPa (58 msi) and retains its strength and stiffness up to 1400°C [19]. The average nanocrystal grain size is 50 nm, leading to the excellent strength retention. The reduction in excess carbon and the treatment at high temperatures results in a fiber that has excellent chemical and thermal stability and is more oxidation and creep resistant than the previous generations [19, 113]. The production process of Hi-Nicalon<sup>TM</sup> S fibers is depicted in Figure 13.

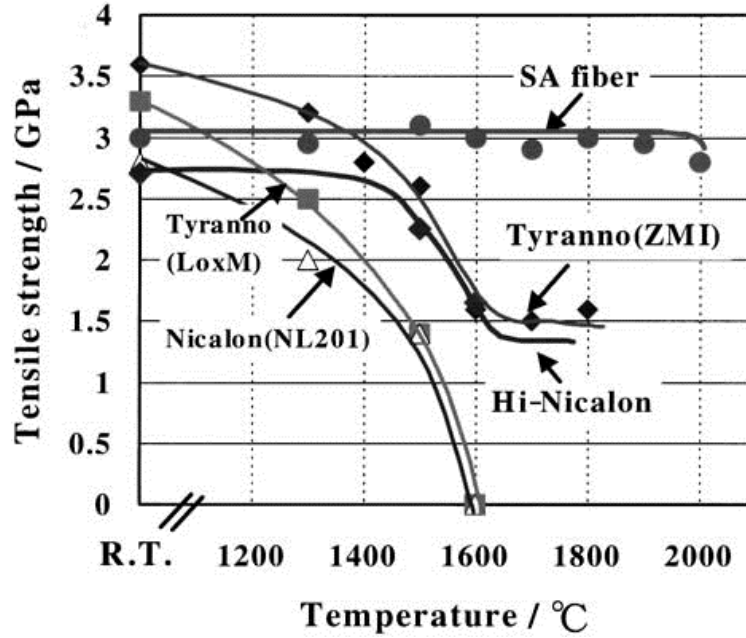
Figure 14. Temperature-dependent strength of third generation SiC fibers. Reproduced with kind permission from Springer Science & Business Media B.V. [20] pg. 121, Figure 14. Copyright ©2005 by Springer-Verlag Berlin Heidelberg.

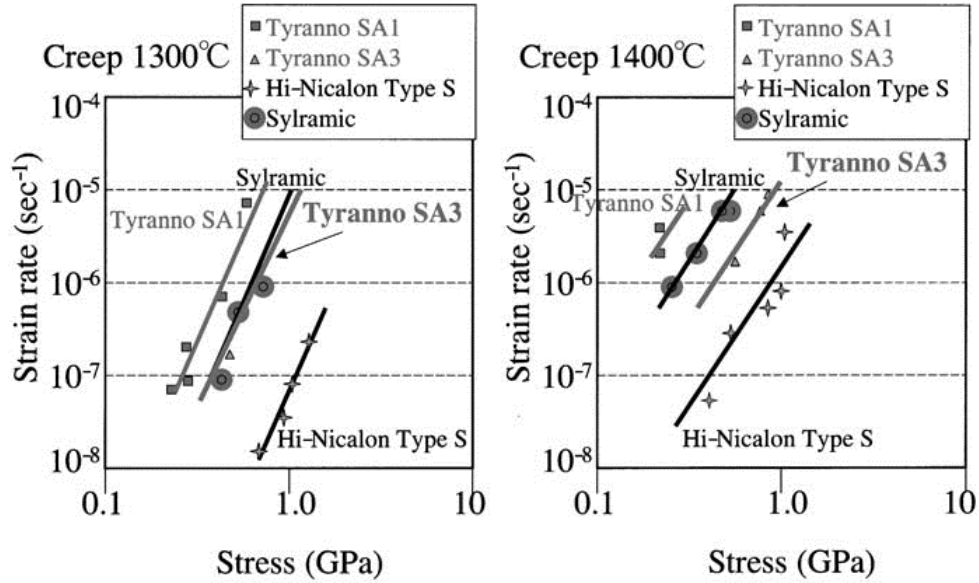
**Figure 15. Creep of third generation SiC fibers. Reproduced with kind permission from Springer Science & Business Media B.V. [20] pg. 122, Figure 15. Copyright ©2005 by Springer-Verlag Berlin Heidelberg.**

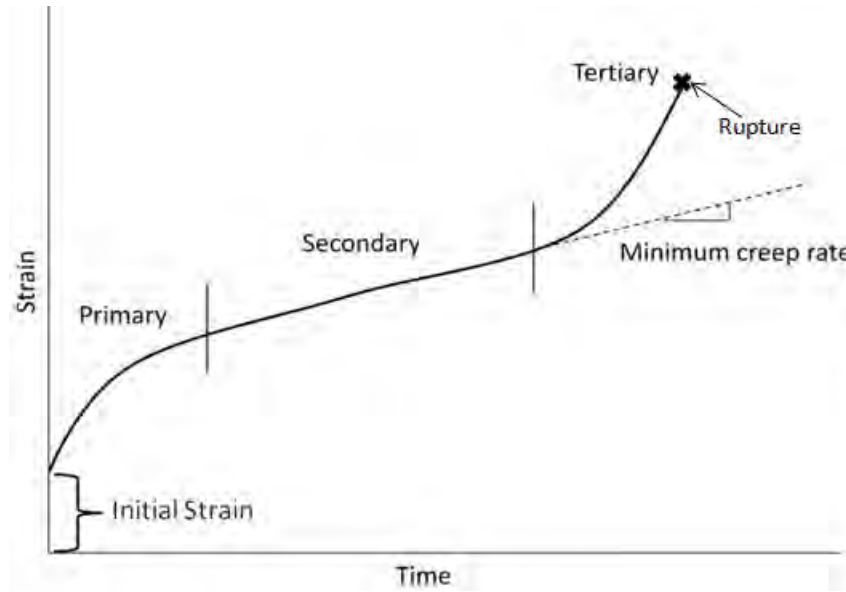
**Figure 16. Phases of a typical creep curve. Reproduced from [4], with initial strain and rupture notations added.**

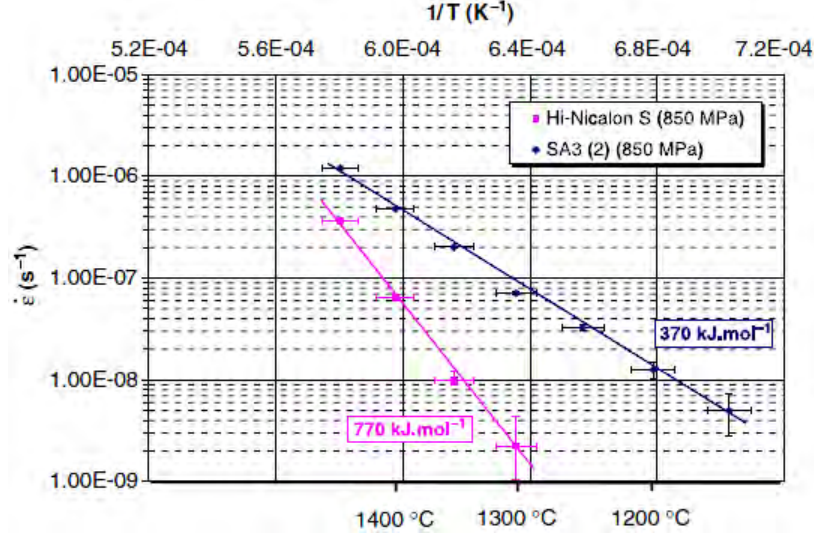
**Figure 17.** Creep of Tyranno<sup>TM</sup> SA3 and Hi-Nicalon<sup>TM</sup> S fibers at 850 MPa (123 ksi)[138], reproduced with permission from Wiley.

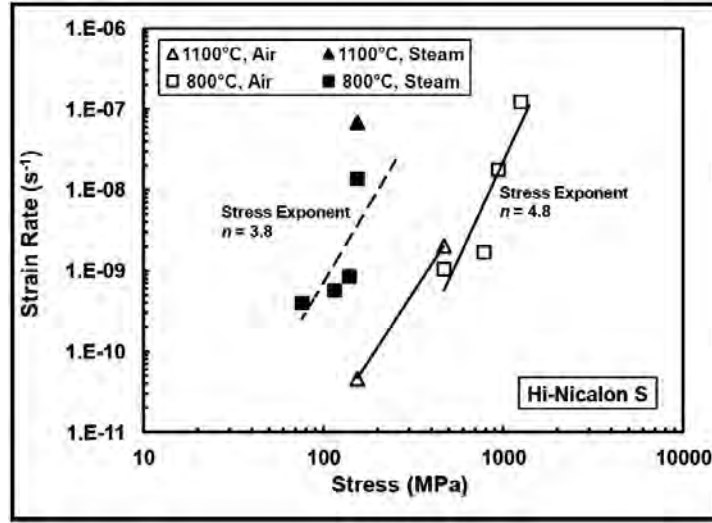
Figure 18. Creep of Hi-Nicalon<sup>TM</sup> S fibers at 800 and 1100°C in air and in steam, reproduced from [1]

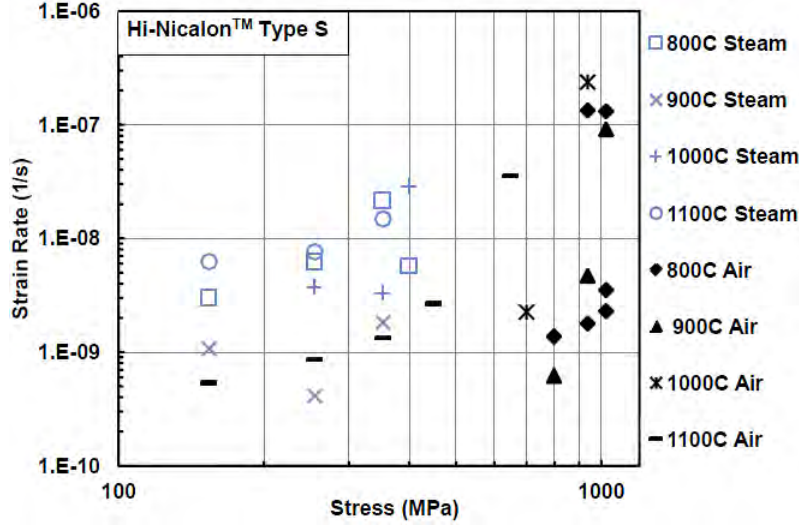
Figure 19. Creep of Hi-Nicalon<sup>TM</sup> S fibers at 800-1100°C in air and in steam. Note the considerable scatter in the data, making a reliable estimate of the stress exponents impractical. Reproduced from [23].

Shillig studied creep of Hi-Nicalon<sup>TM</sup> S fiber tows at temperatures ranging from 800 to 1100°C in air and in steam. The stress exponent,  $n$ , was also determined by fitting the data to Equation 3. However, due to the considerable scatter in the data, as can be seen in Figure 19, the author chose not to report those values.

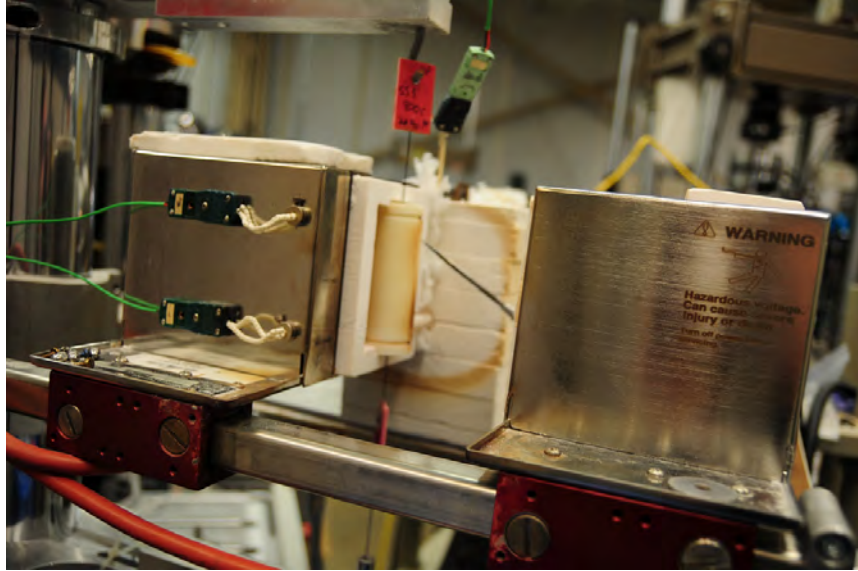
**Figure 20. Two-zone resistance-heated MTS 653.03A furnace with silicon carbide heating elements, R type control thermocouples and a 90 mm (3.5 in.) hot zone**

A compact two-zone resistance-heated MTS 653.03A furnace, shown in Figure 20, provided the high temperature environment. The furnace has silicon carbide heating elements and non-contacting R type control thermocouples, which supply feedback to an MTS 409.83 temperature controller. The furnace has a 90 mm (3.5 in.) hot zone. A high resolution Schaevitz M12-30 linear variable differential transformer (LVDT) was used to provide accurate displacement measurements. Methods to determine strain from displacement measurements are detailed later in this section. Data was acquired using an MTS FlexTest 40 digital controller.

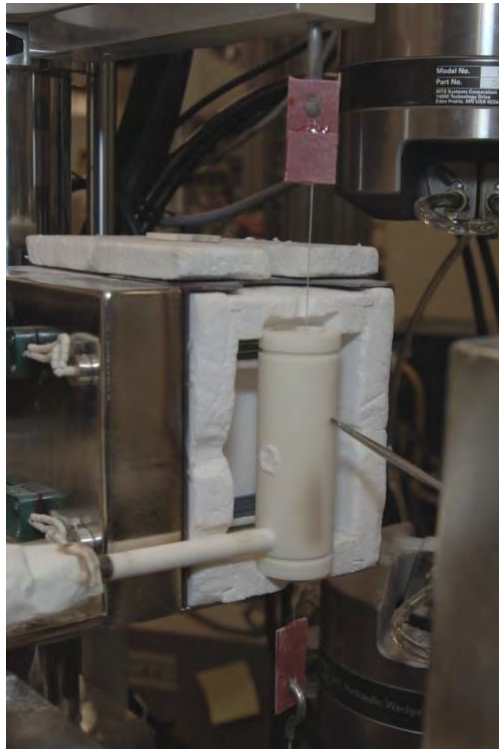
**Figure 21.** Alumina susceptor and feed tube assembled in one half of the furnace, reproduced from [4]

A detailed description of the specimen mounting procedure and of the creep test procedures is given by Armani [4] and Steffens [23]. Figure 21 shows the susceptor and feeding tube assembled in one half of the furnace. Figure 22 shows a fiber tow specimen mounted in the dead weight creep testing facility.

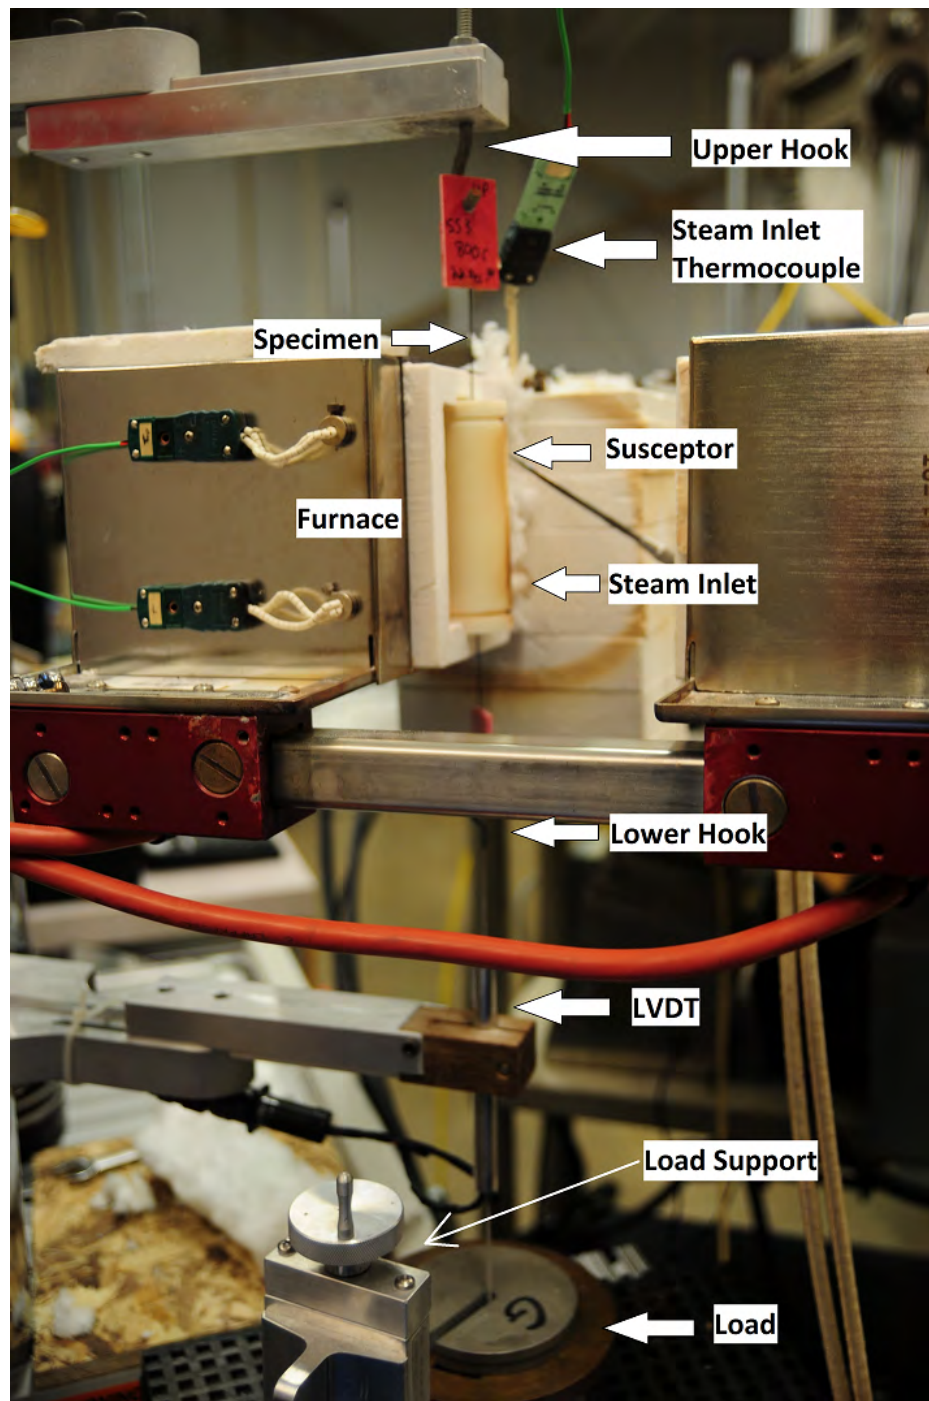
Figure 22. Fiber tow creep test setup

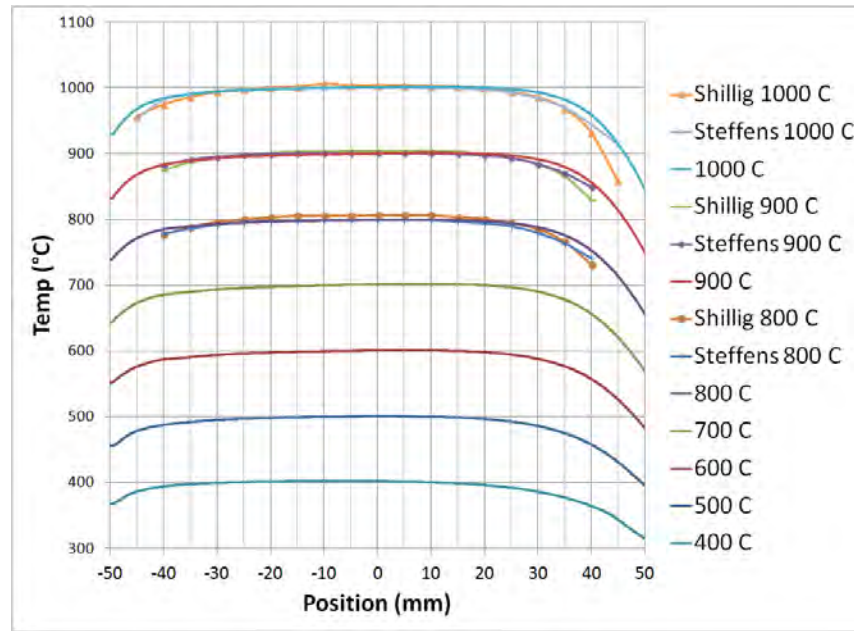
Figure 23. Temperature profiles in air for the current work with data from Steffens [1] and Shillig [23] for comparison.

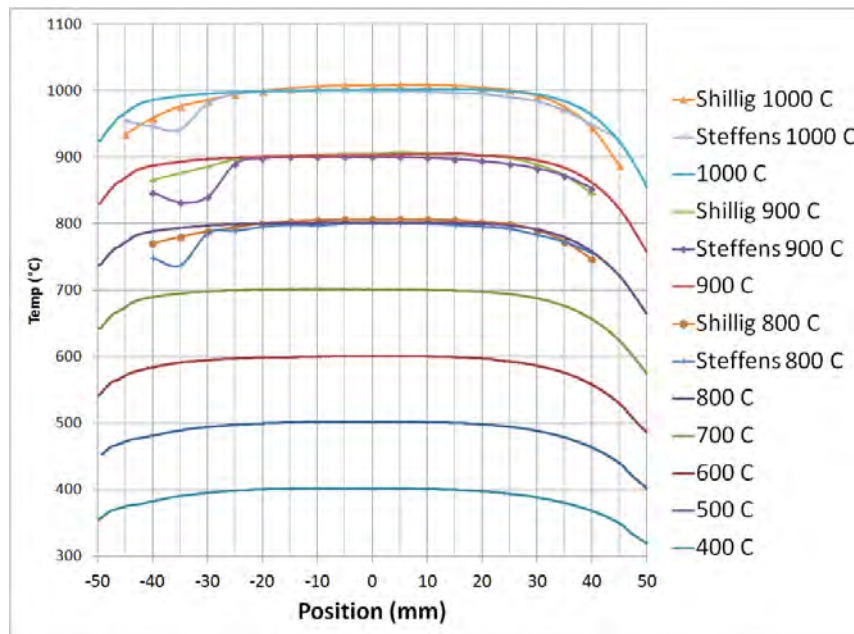
Figure 24. Temperature profiles in silicic acid saturated steam for the current work with data from Steffens [1] and Shillig [23] for comparison.

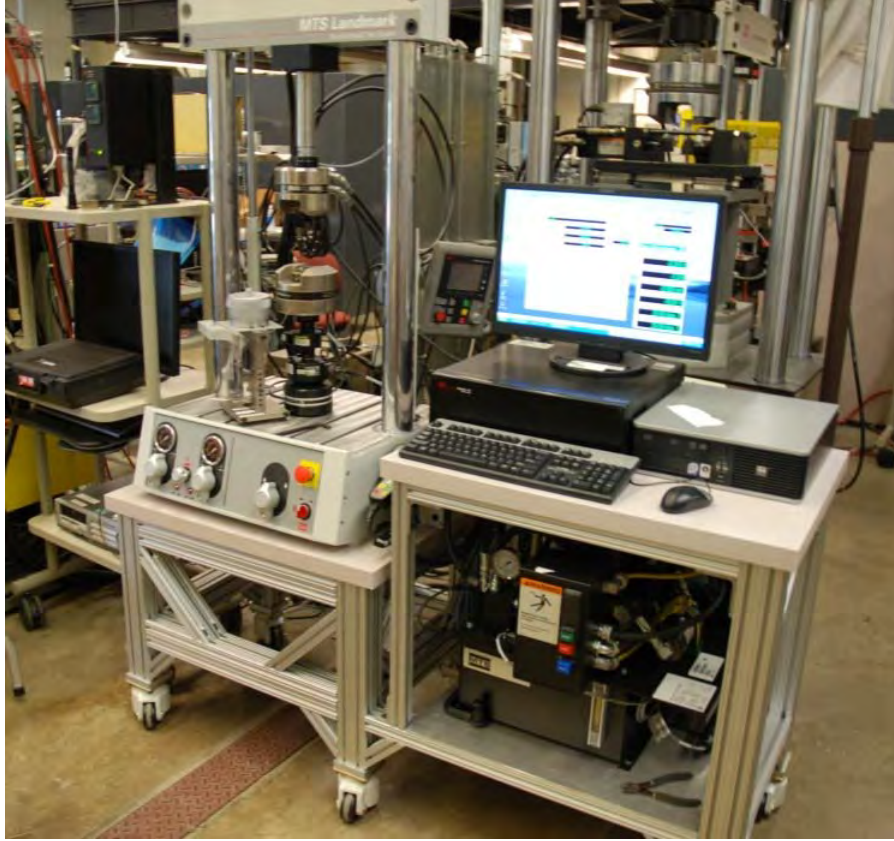
Figure 25. MTS Landmark<sup>TM</sup> 370.02 servohydraulic test facility, reproduced from [4]

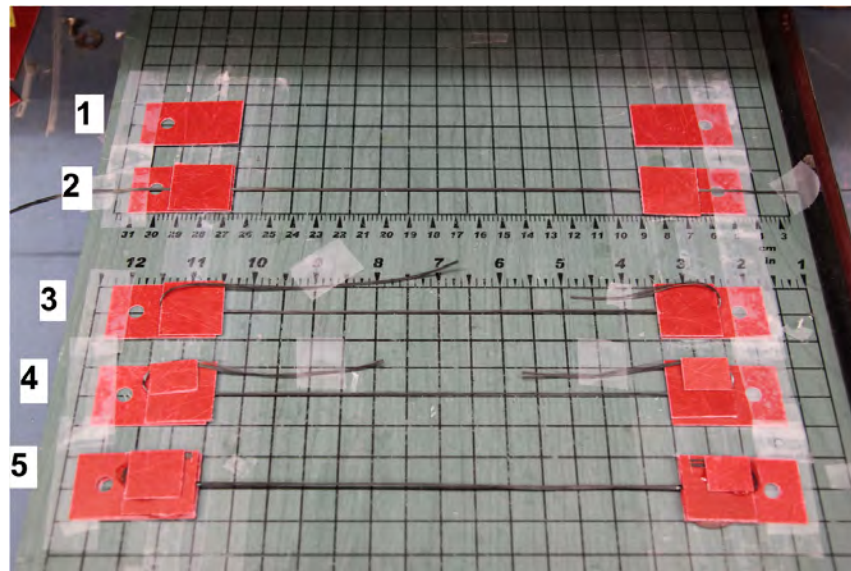
**Figure 26. Fiber tow creep test specimen preparation process, reproduced from [23]**

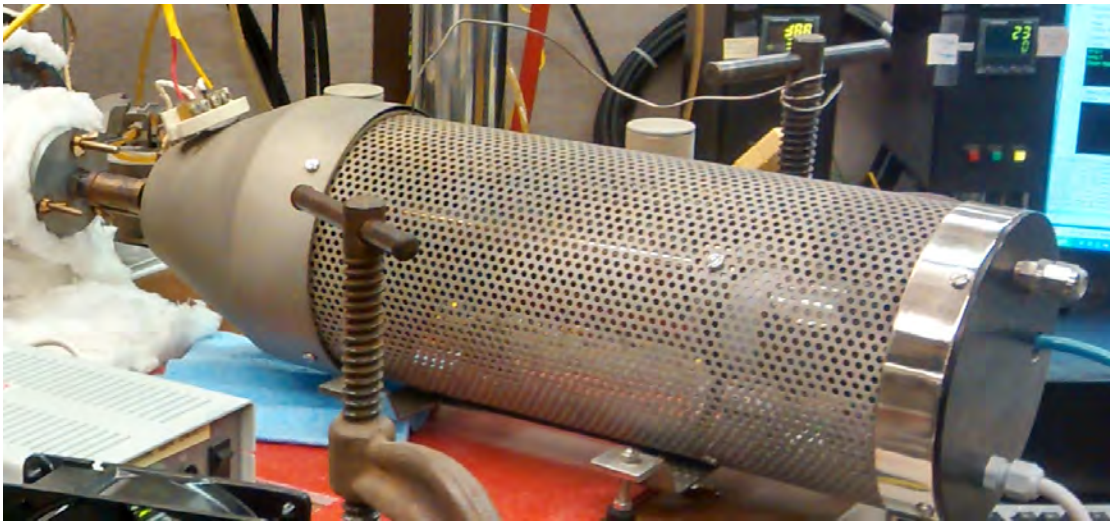
**Figure 27. HGA-H (MHI) steam generator.**

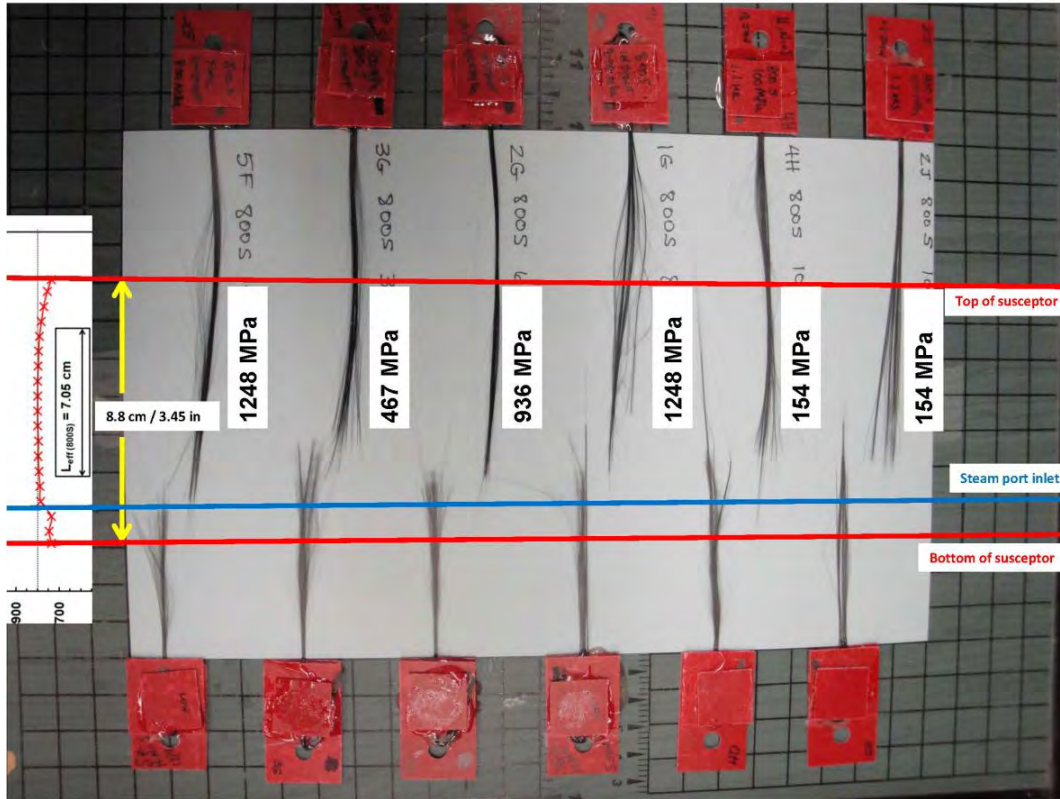
**Figure 28.** Effect of steam impinging on fiber tows upon entry into the test chamber, reproduced from [1]. Note that all specimens failed at the point of steam impingement.

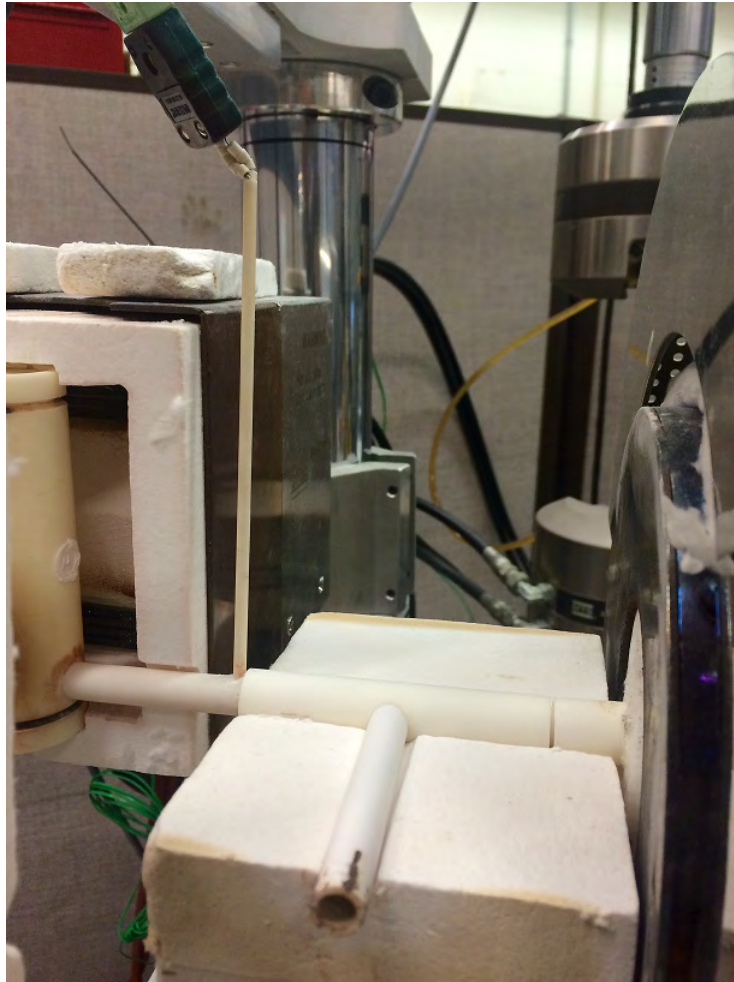
**Figure 29. Bleed-off assembly between CX1300 pre-heater and test chamber inside the furnace, with steam inlet thermocouple**

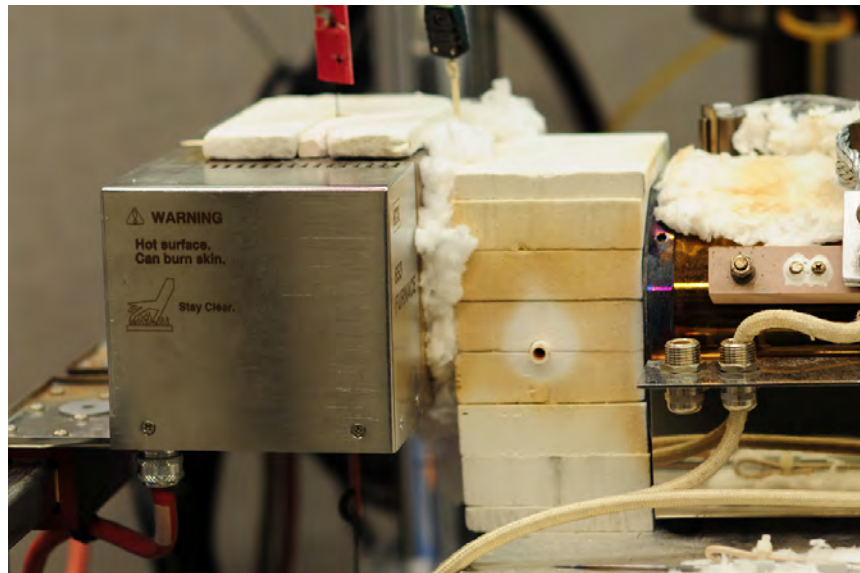
**Figure 30. Layered insulation between CX1300 pre-heater and furnace, with steam bleed-off tube**

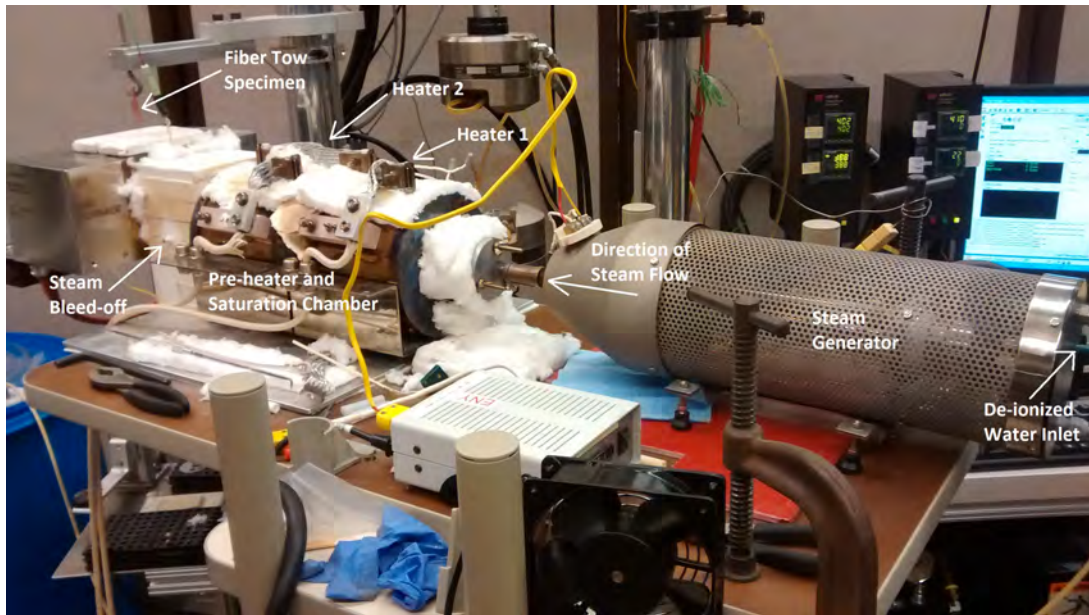
**Figure 31. Saturated steam creep test facility**

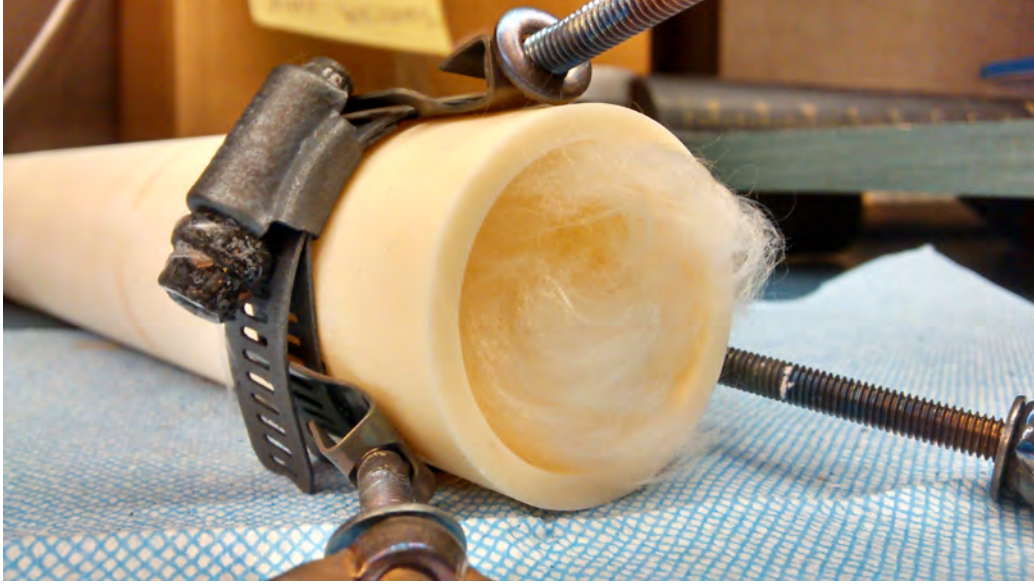
**Figure 32. Saturation chamber for silicic acid-saturated steam**

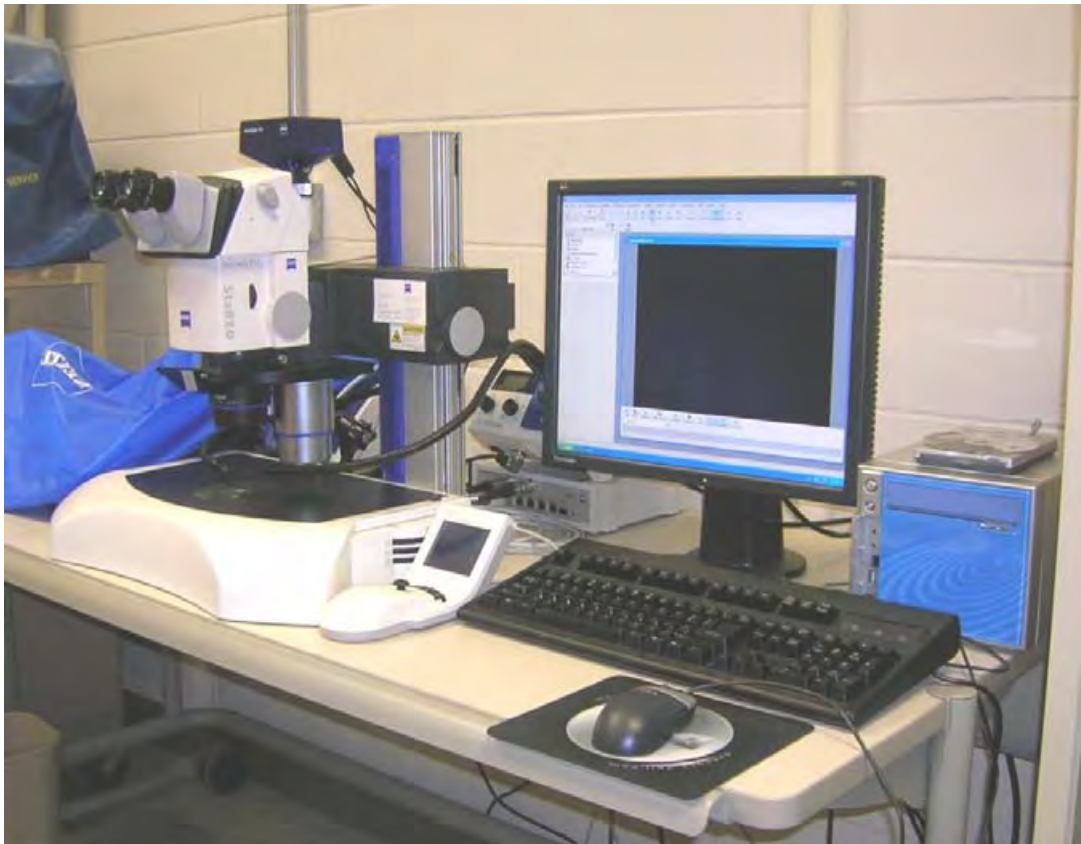
Figure 33. AFIT Zeiss optical microscope, reproduced from [4]

The post-test microstructure of test specimens were examined and damage and failure mechanisms investigated via optical microscopy, and SEM. TEM analysis of the oxide layer thickness of a limited number of specimens was made possible using facilities and expertise provided by the Air Force Research Laboratory (AFRL). Personnel in the Materials and Manufacturing Directorate at AFRL prepared the specimens for TEM analysis and obtained the TEM images used in this work. The analysis of the experimental data and the microstructural investigation provide insight into the creep and the environmental degradation mechanisms occurring in these materials. Figures 33 and 34 show the Zeiss optical microscope and SEM (FEI Quanta 450) located at AFIT, respectively.

One method of post-test analysis of oxide growth involves inspecting a fiber tow specimen via optical microscopy. A specimen is placed under an optical microscope, such as the one depicted in Chapter 3, Figure 33, with a light shining from the same side of the specimen as the lenses capturing the images so as to provide reflected light to the lenses, rather than transmitted light. If a sufficient thickness of oxide layer has developed on the surface, colored bands of light will be visible, as though transmitting the light through a prism. These colored bands are called interference fringes.

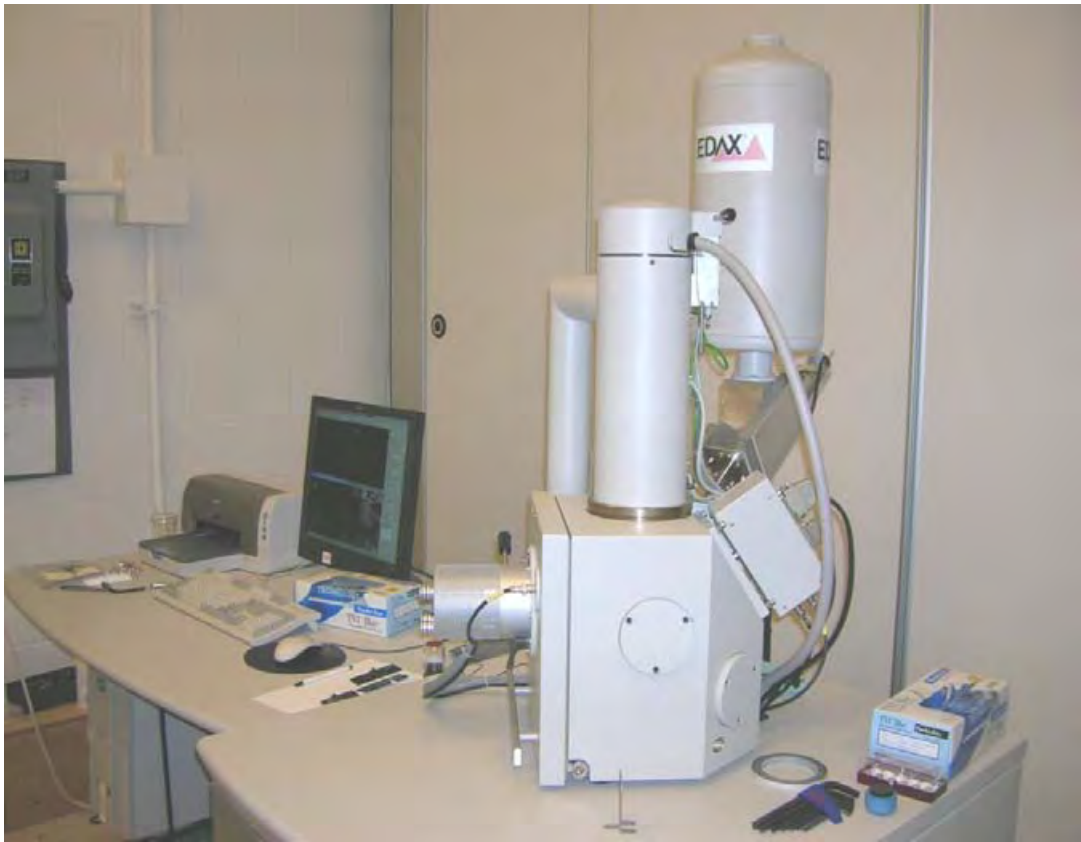
Figure 34. AFIT scanning electron microscope, reproduced from [4]

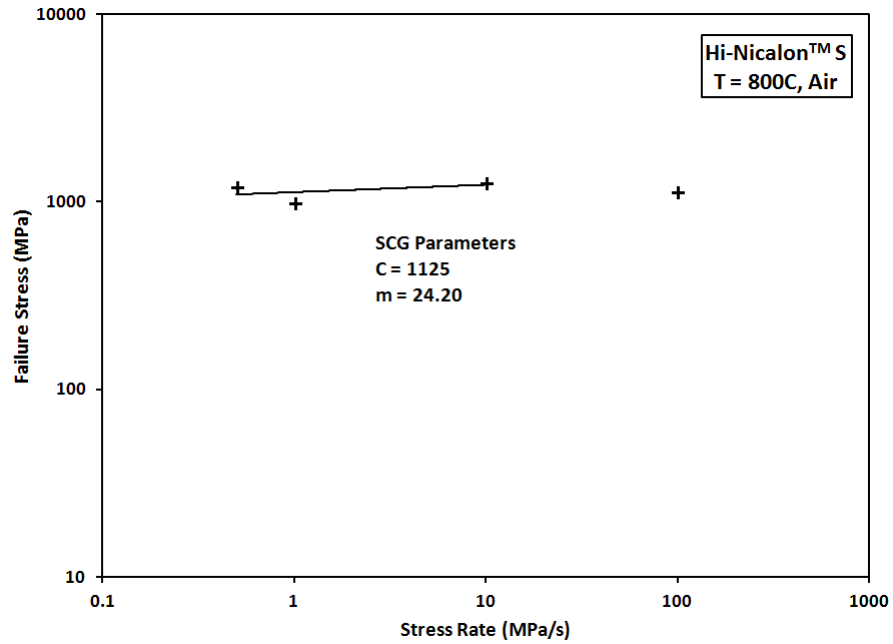
Figure 35. Failure Stress of Hi-Nicalon<sup>TM</sup> S fibers at 800°C in air as a function of stress rate. The effect of loading rate is minimal.
