**CREEP OF HI-NICALON<sup>TM</sup> S CERAMIC  
FIBER TOWS AT 800°C IN AIR AND IN  
SILICIC ACID-SATURATED STEAM**

DISSERTATION

AFIT-ENY-DS-15-S-067

***AIR FORCE INSTITUTE OF TECHNOLOGY***

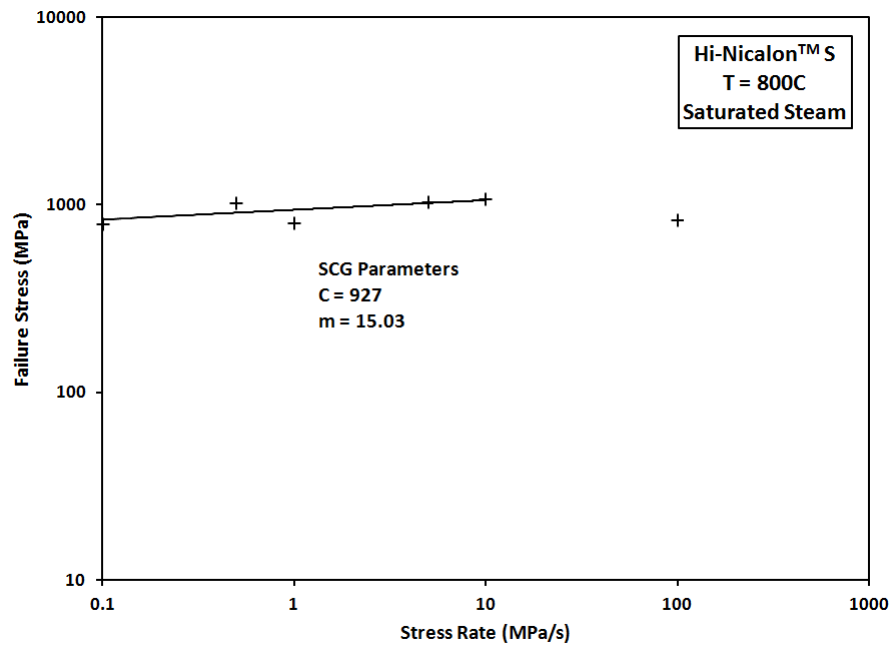
Figure 36. Failure Stress of Hi-Nicalon<sup>TM</sup> S fibers at 800°C in silicic acid-saturated steam as a function of stress rate. The effect of loading rate is minimal.

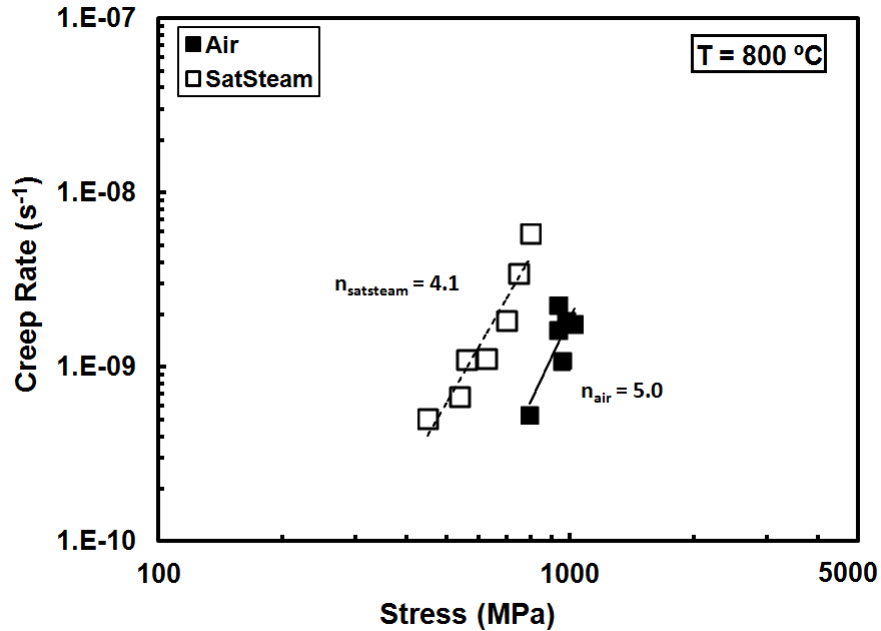
Figure 37. Creep strain rate vs. applied stress for Hi-Nicalon<sup>TM</sup> S fibers tows at 800°C in air and in steam, with associated creep exponents

Norton-Bailey form of the power law creep equation shown in Equation 3. The values of stress exponents for the current effort were  $n \approx 5.0$  and  $n \approx 4.1$  for air and steam, respectively, which is consistent with climb-controlled dislocation creep in air and grain boundary sliding, with cavity nucleation and growth. The results match well with those of Steffens [23], who reported similar values for the stress exponent. It is significant to note, however, that though the creep exponent for steam was comparable, the fiber tows were capable of maintaining stresses as much as five times higher than those in unsaturated steam. Creep run-out was obtained at stress 625 MPa in saturated steam, whereas Steffens reported creep run-out at 139 MPa in unsaturated steam and Shillig's longest test in unsaturated steam was at 154 MPa and lasted 72 h. Creep rates were an order of magnitude lower than those reported by Steffens and Shillig for the same applied stress. Figure 37 shows the creep strain rate data.

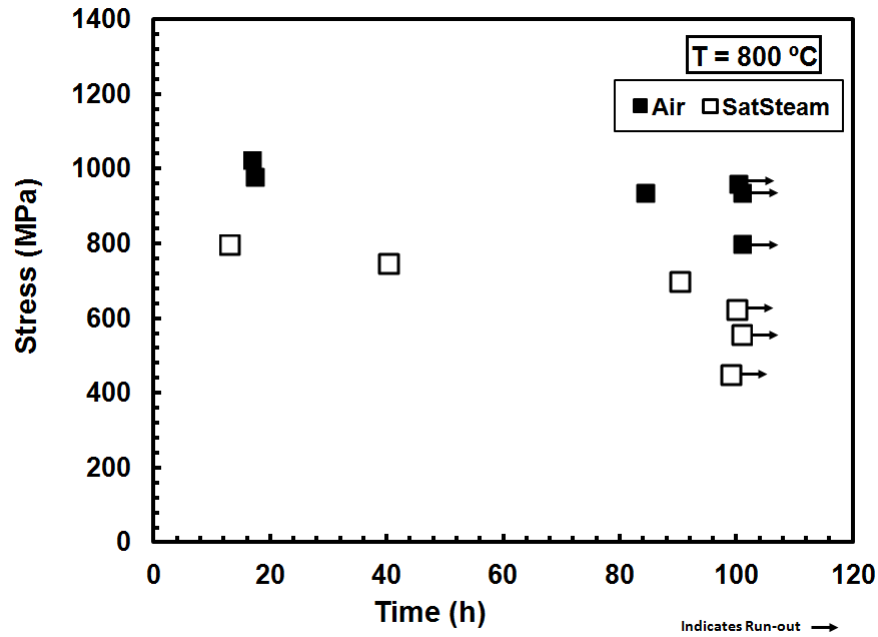
Figure 38. Creep Lifetimes of Hi-Nicalon<sup>TM</sup> S fibers at 800°C in air and in steam

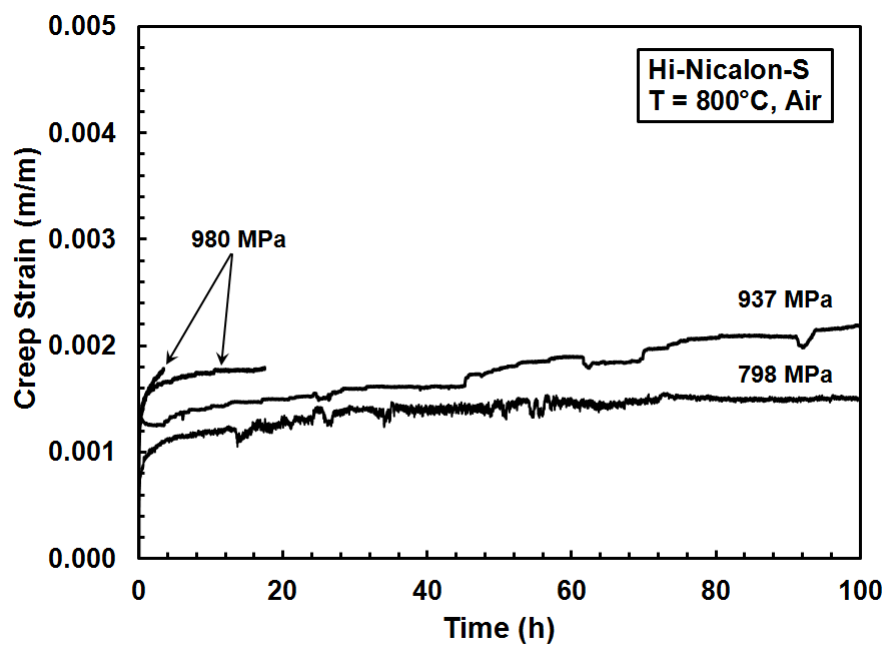
Figure 39. Representative creep curves for Hi-Nicalon<sup>TM</sup> S fibers at 800°C in air

in saturated steam for considerable time. Of note is that in both air and saturated steam, the transition from fast fracture to run-out is fairly sharp, though less so for saturated steam. Figures 39 - 42 show selected creep curves for air and silicic acid-saturated steam, respectively, that are representative of the tested specimens.

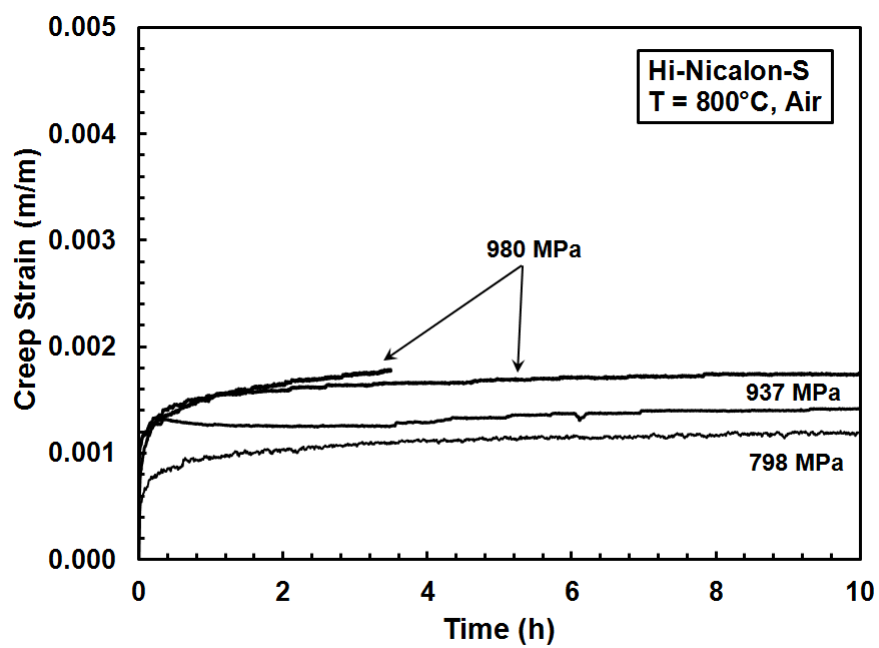
Figure 40. Representative creep curves for early stages of creep of Hi-Nicalon<sup>TM</sup> S fibers at 800°C in air

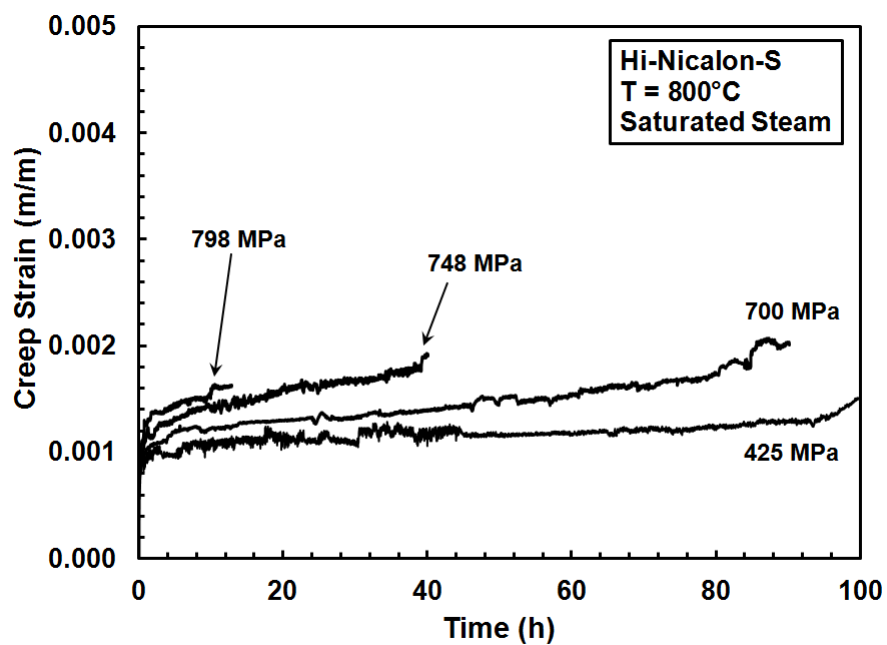
Figure 41. Representative creep curves for Hi-Nicalon<sup>TM</sup> S fibers at 800°C tested in silicic acid-saturated steam

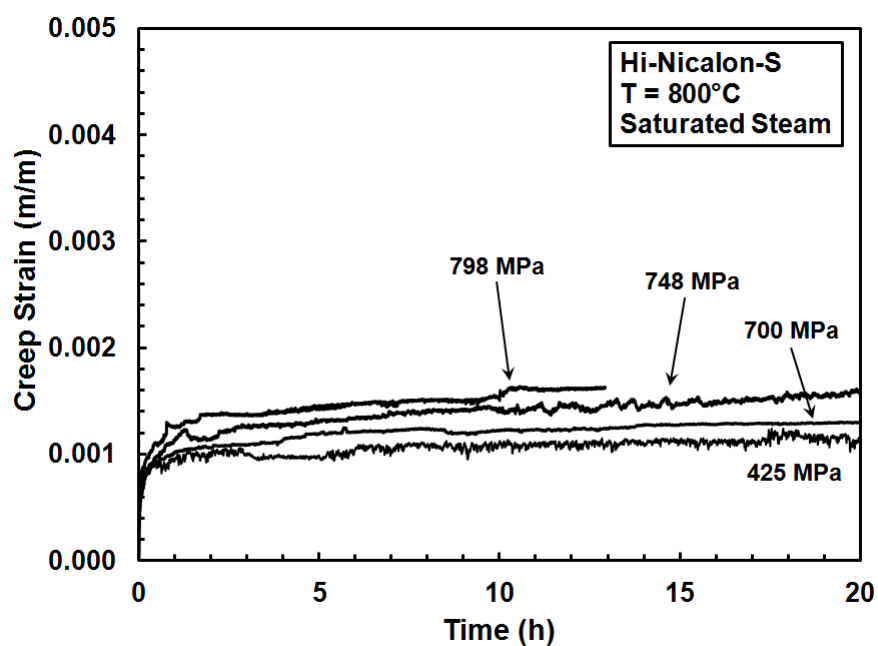
Figure 42. Representative creep curves for early stages of creep of Hi-Nicalon<sup>TM</sup> S fibers at 800°C tested in silicic acid-saturated steam

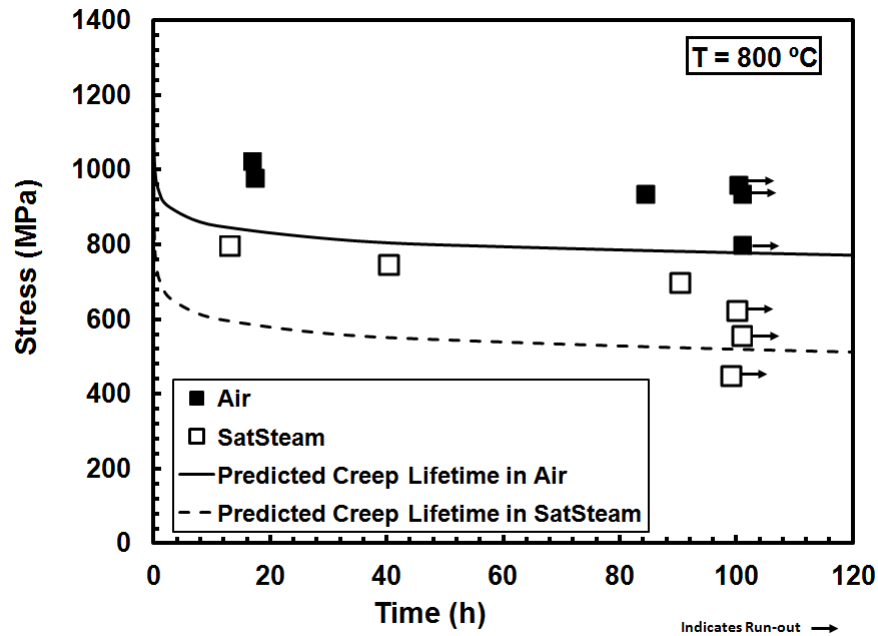
Figure 43. Model predictions of creep lifetime compared to actual creep lifetime data for Hi-Nicalon<sup>TM</sup> S SiC fiber tow specimens tested at 800°C in dry air and in silicic acid-saturated steam.

Using the subcritical crack growth parameters determined in section 4.1.1, the creep lifetime of Hi-Nicalon<sup>TM</sup> S fiber tows in air and steam was predicted and compared to the experimental creep lifetimes reported in section 4.2. Table 12 lists the predicted lifetimes for stresses from 450 - 1250 MPa (65.3 - 181.3 ksi), and these values are plotted with the actual creep lifetime data in Figure 43.

The predictions for both air and silicic acid-saturated steam under-predict the experimental data. The shape of the curve matches fairly well in both cases, capturing

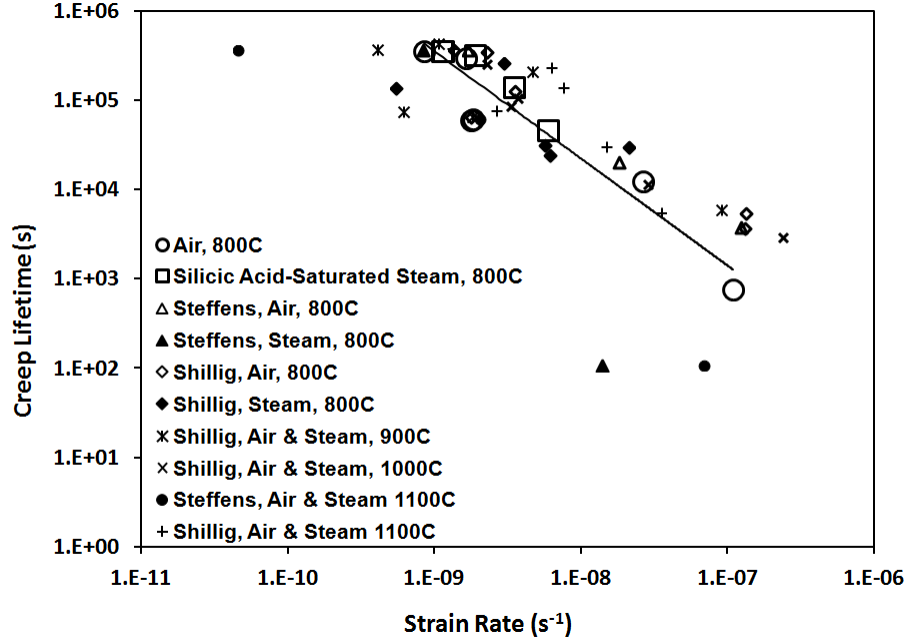
Figure 44. Monkman-Grant plot of creep lifetime vs. steady-state strain rate for Hi-Nicalon<sup>TM</sup> S SiC fiber tow specimens tested at 800°C in dry air, in steam, and in silicic acid-saturated steam. Data is from the current work and reproduced from Steffens [1] and Shillig [23]

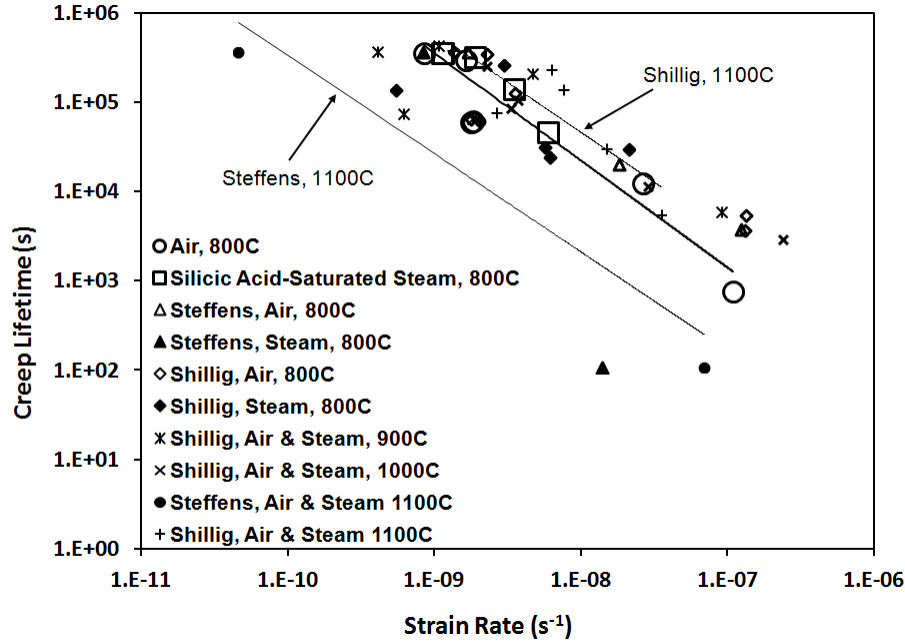
Figure 45. Monkman-Grant plot of creep lifetime vs. steady-state strain rate for Hi-Nicalon<sup>TM</sup> S SiC fiber tow specimens tested at 800°C in dry air, in steam, and in silicic acid-saturated steam with regression fits for 1100°C data. Data is from the current work and reproduced from Steffens [1] and Shillig [23]

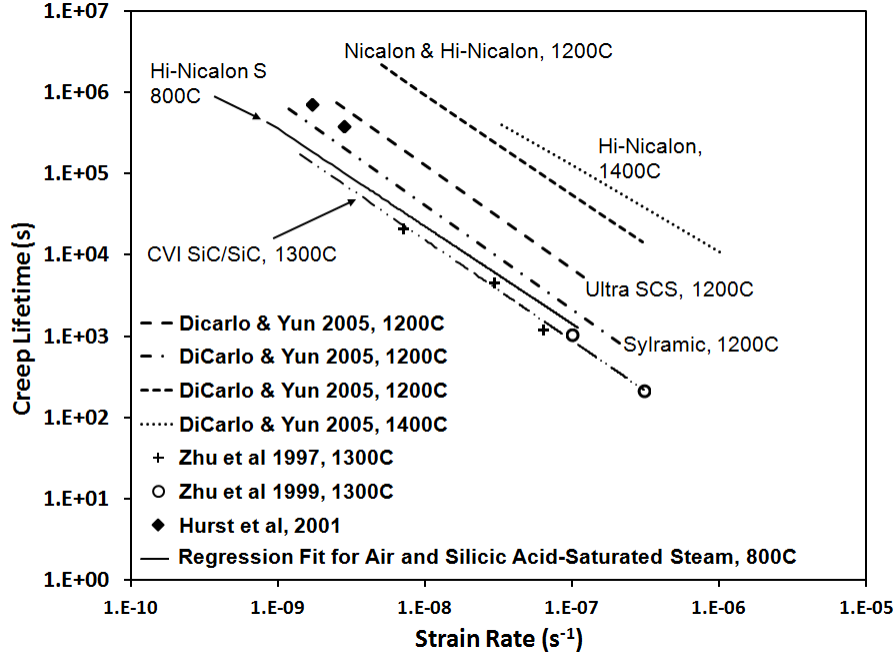
Figure 46. Monkman-Grant plot of creep lifetime vs. steady-state strain rate for Hi-Nicalon<sup>TM</sup> S SiC fiber tow specimens tested at 800°C in dry air and in silicic acid-saturated steam compared with data for various other SiC fibers and SiC/SiC CMCs. Data is from the current work and reproduced from DiCarlo et al [46], Zhu et al [191, 197], and Hurst et al [196]

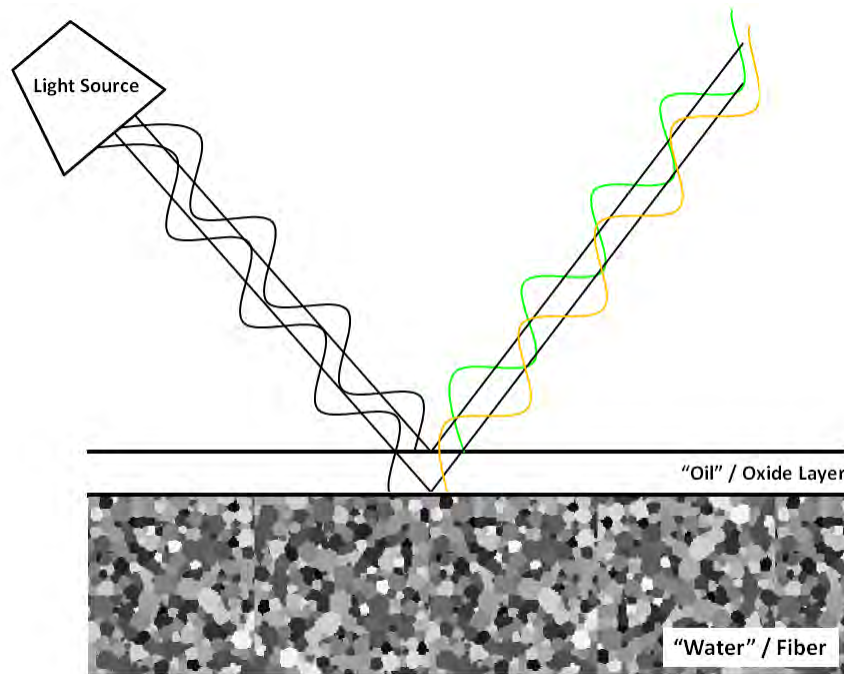
**Figure 47. Schematic of constructive and destructive interference of light that causes interference fringes to be present during optical microscopy of oxidized fiber tows**

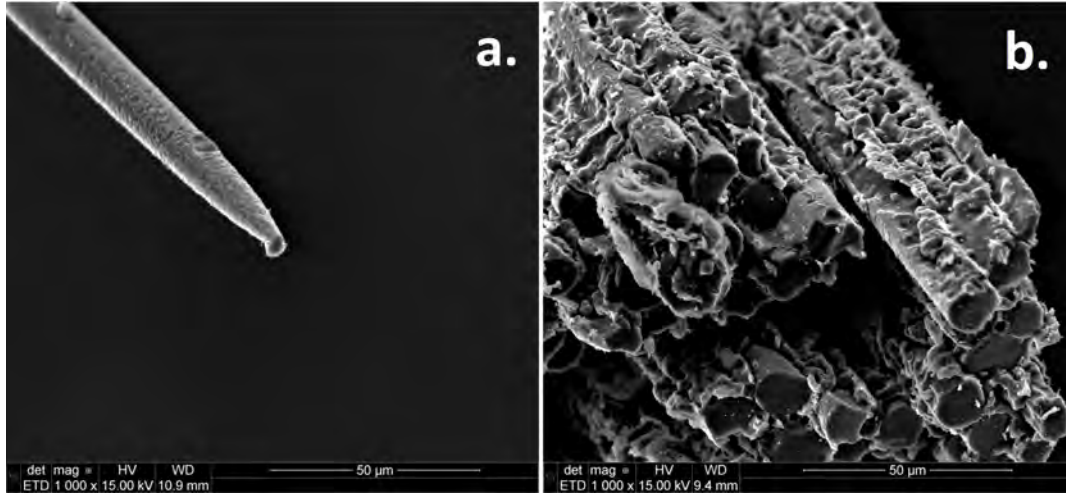
Figure 48. Variations along the fiber tow due to testing in unsaturated steam. a.) Fiber degradation due to active oxidation, typically found in sections of the fiber tow near the bottom of the test chamber. b.) Silica (SiO<sub>2</sub>) scale growth typically found in sections of the fiber tow near the top of the test chamber. Reproduced from [23]

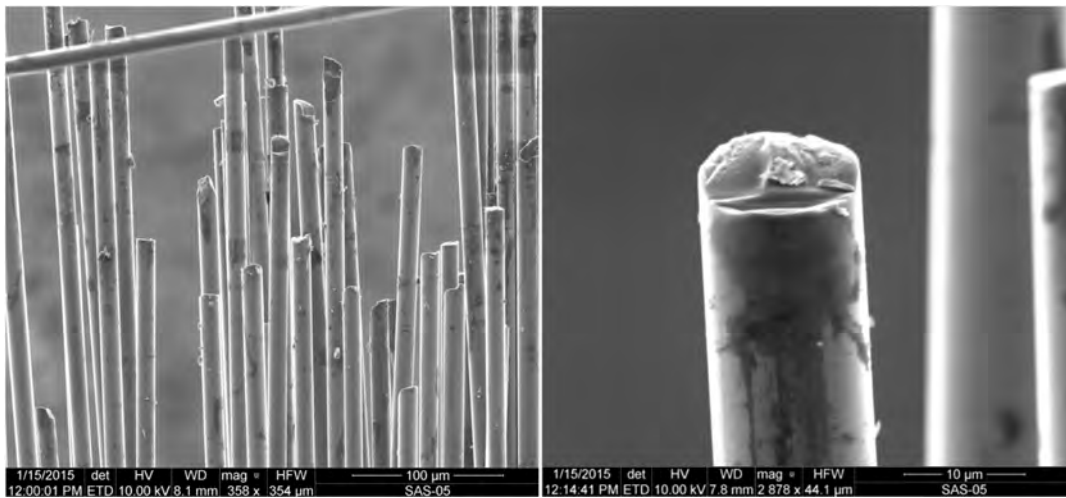
Figure 49. Lower section of Hi-Nicalon<sup>TM</sup> S SiC fiber tow specimen subjected to the saturated steam environment at 800°C and to a load of 2.96 MPa (429.3 psi)

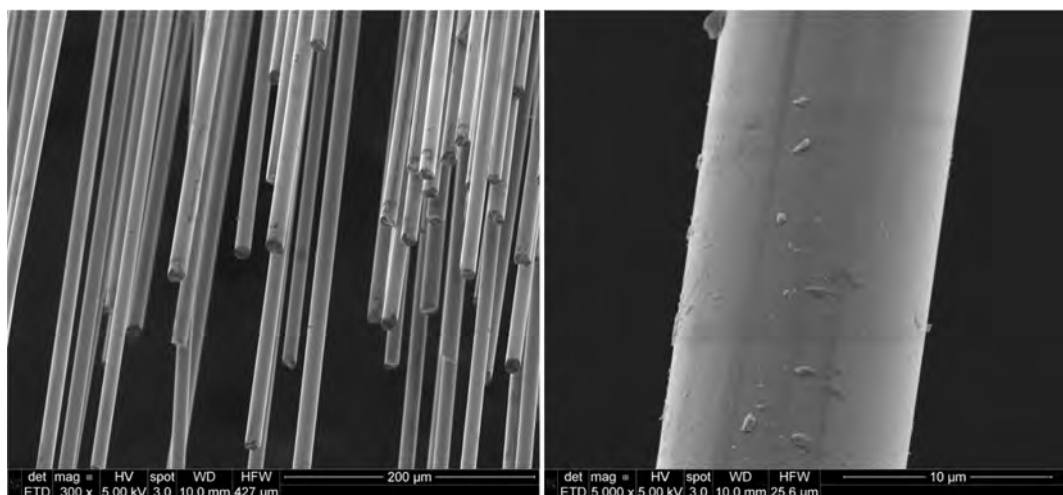
Figure 50. Center section of Hi-Nicalon<sup>TM</sup> S SiC fiber tow specimen subjected to the saturated steam environment at 800°C and to a load of 2.96 MPa (429.3 psi)

The various features evident in Figures 49-51 are characteristic of the fibers at all locations studied. The most prominent feature is the smooth, somewhat mottled surface, which has a thin layer of oxidation. Areas that appear lighter in the SEM images have decreased carbon content with an accompanying increase in silicon and oxygen, as shown in the representative spectrograph shown in Figure 52. The decreased carbon content is attributable to the release and vaporization of the carbon

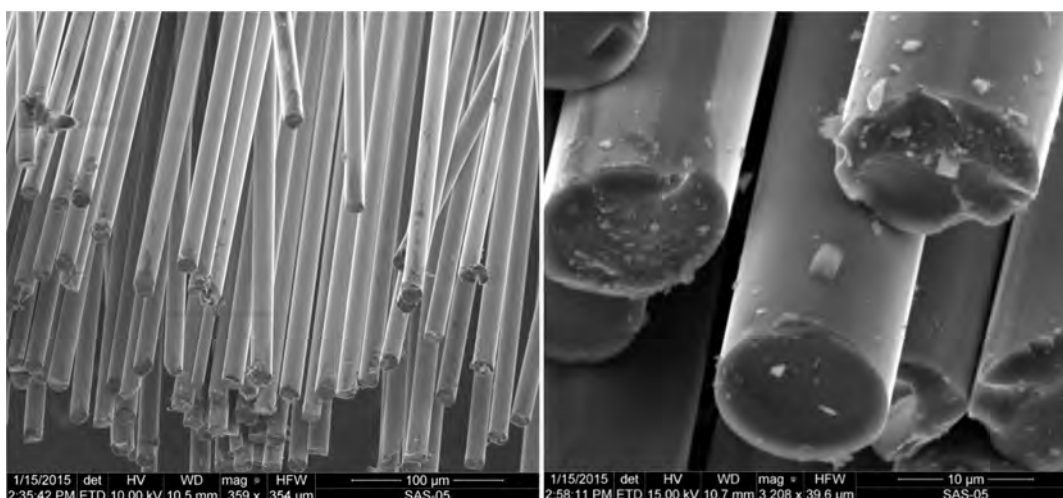
Figure 51. Upper section of Hi-Nicalon<sup>TM</sup> S SiC fiber tow specimen subjected to the saturated steam environment at 800°C and to a load of 2.96 MPa (429.3 psi)

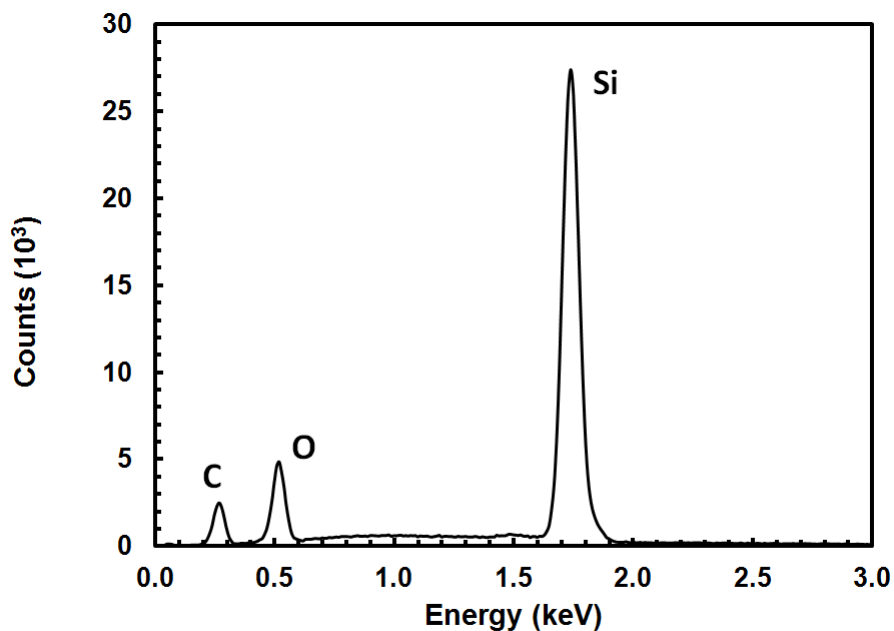
Figure 52. Energy dispersive spectrograph representative of the lighter areas of the surface of Hi-Nicalon<sup>TM</sup> S SiC fiber tow specimen subjected to the saturated steam environment at 800°C and to a load of 2.96 MPa (429.3 psi). The composition shows an increase in silicon content from stoichiometric SiC, an accompanying decrease in carbon, and some oxygen. The content was 72.96% silicon, 16.29% carbon, and 9.72% oxygen by atomic percent.

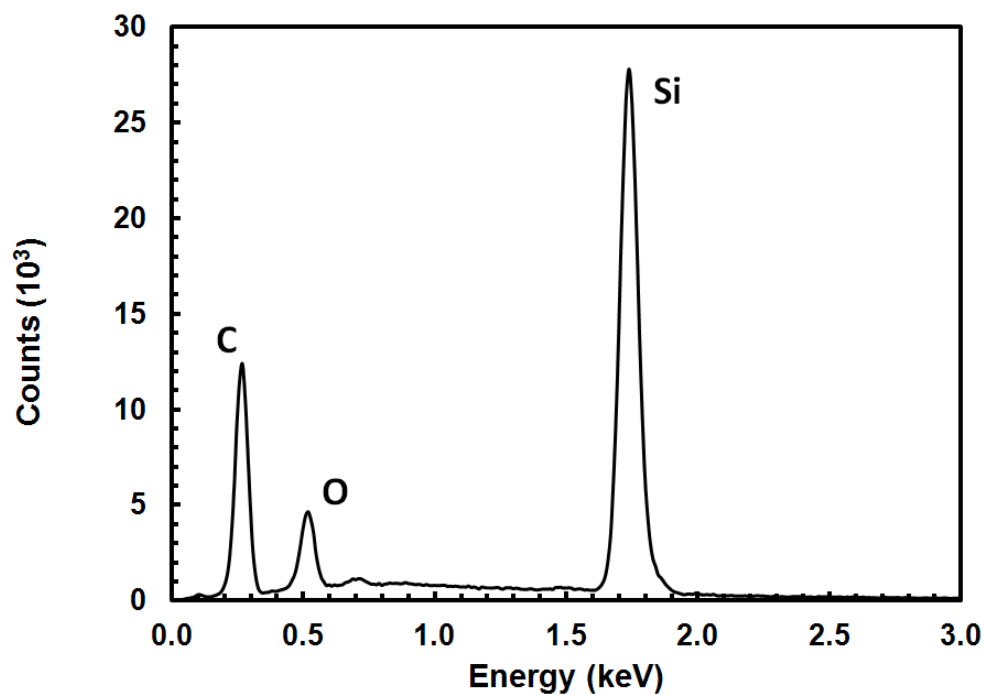
Figure 53. Energy dispersive spectrograph representative of the darker areas of the surface of Hi-Nicalon<sup>TM</sup> S SiC fiber tow specimen subjected to the saturated steam environment at 800°C and to a load of 2.96 MPa (429.3 psi). The composition is near stoichiometric SiC and a smaller amount of oxygen than the lighter areas. The content was 46.53% silicon, 45.25% carbon, and 7.06% oxygen by atomic percent.

during the oxidation process. The darker areas showed less oxygen content and a more stoichiometric SiC composition, as seen in Figure 53. Figure 54 shows a representative spectrograph for the interior of the fibers, obtained in the cross-section of a cut fiber, where very little oxygen is present and the SiC is near-stoichiometric.

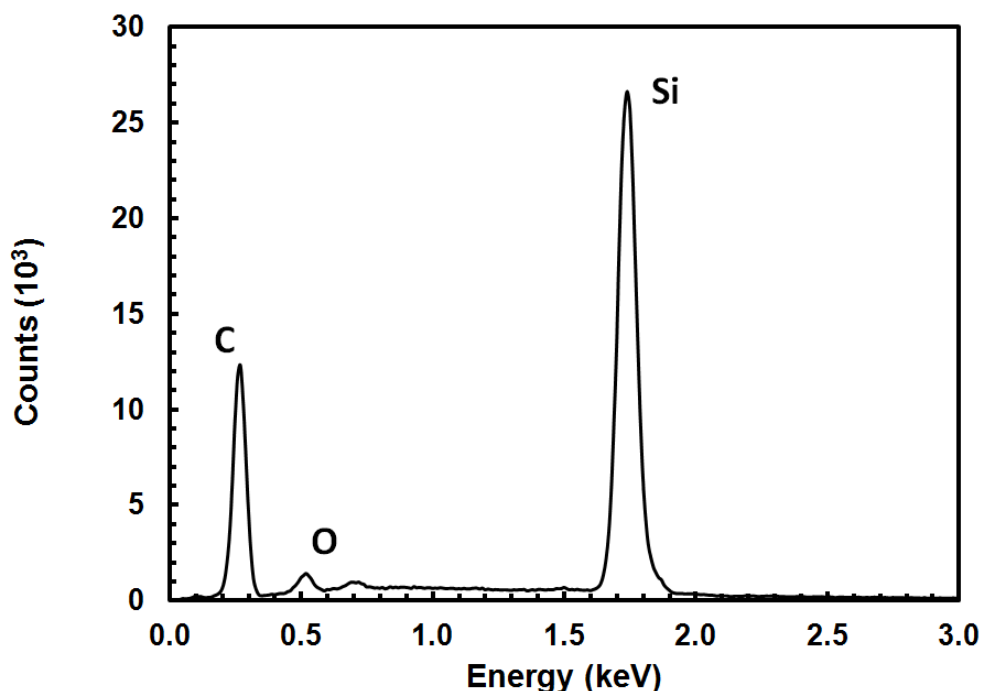
Figure 54. Energy dispersive spectrograph representative of the darker areas of the surface of Hi-Nicalon<sup>TM</sup> S SiC fiber tow specimen subjected to the saturated steam environment at 800°C and to a load of 2.96 MPa (429.3 psi). The composition is near stoichiometric SiC and a very small amount of oxygen. The content was 48.87% silicon, 49.09% carbon, and 1.51% oxygen by atomic percent.

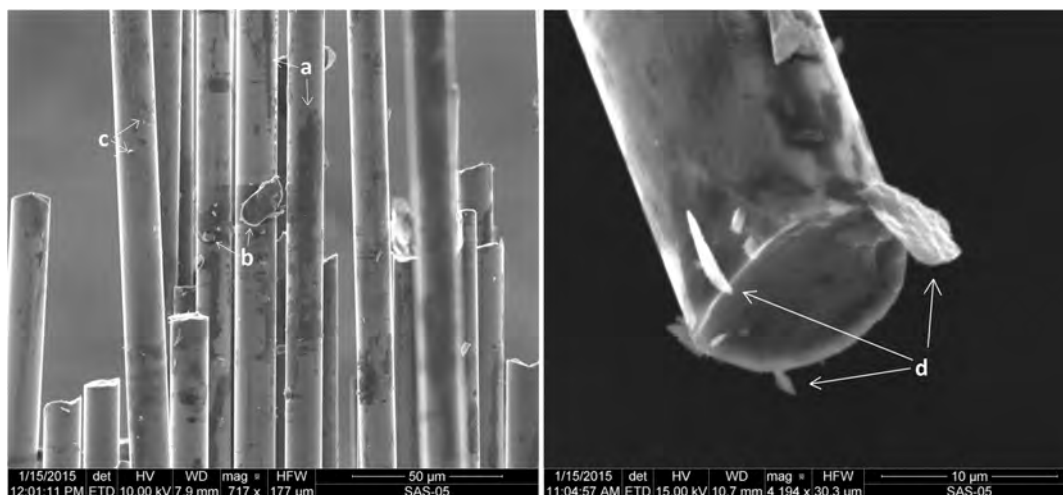
**Figure 55.** Common surface features of Hi-Nicalon<sup>TM</sup> S SiC fiber tow specimens subjected to the saturated steam environment at 800°C and to a load of 2.96 MPa (429.3 psi). Note the a) smooth, mottled surface, b) large chunks of fiber, c) small precipitates of silica, and d) small flakes of the silica oxide layer.

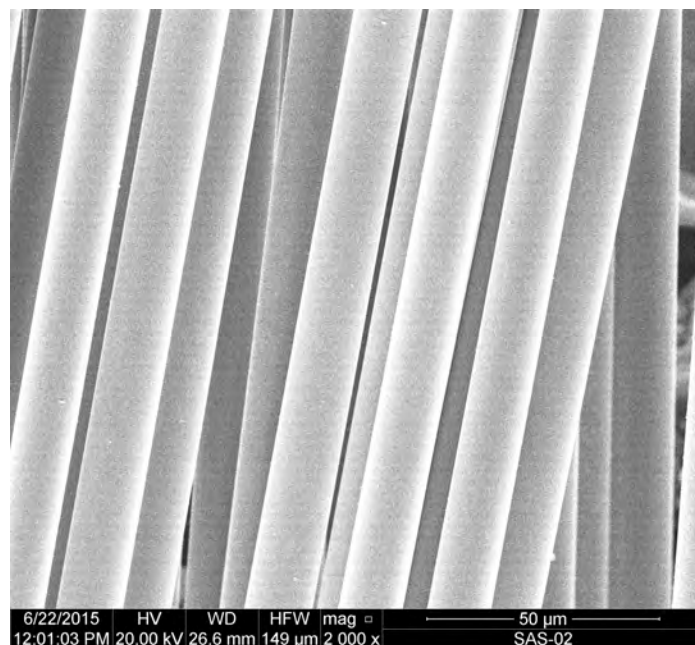
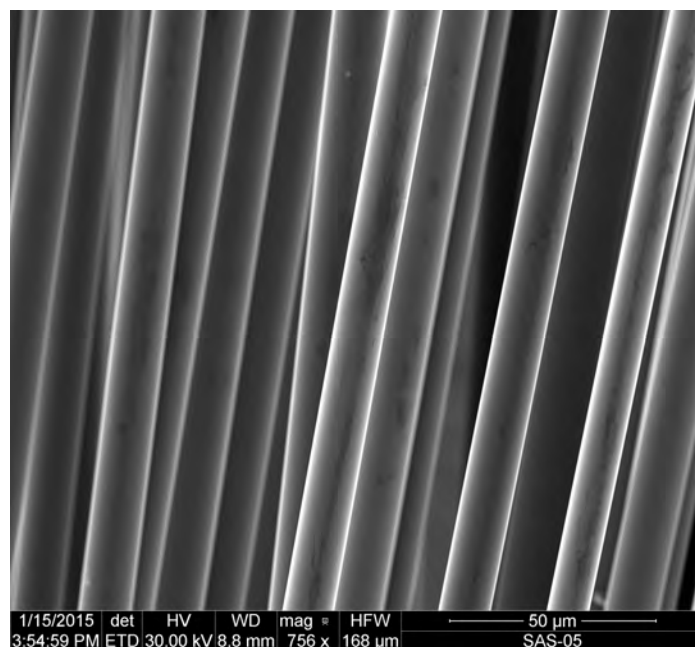
**Figure 56.** Hi-Nicalon<sup>TM</sup> S SiC fibers have a smooth surface and light hue that is still readily observable after being subjected to air or a saturated steam environment at 800°C.

The most common feature among all of the specimens is the smooth surface and light hue of the fibers. As can be seen in the representative images shown in Figure 56, the fibers appear smooth, but not glassy. Areas of darker hue are evident, but not ubiquitous, and often have a linear appearance, as noted in Section 5.1.2.

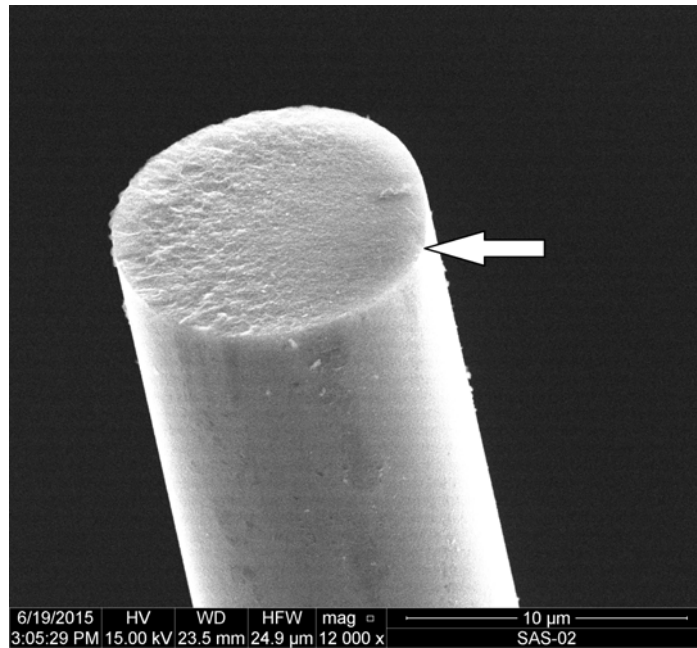
**Figure 57. Brittle fracture of Hi-Nicalon<sup>TM</sup> S fiber tow specimens after creep rupture in air at 800°C.**

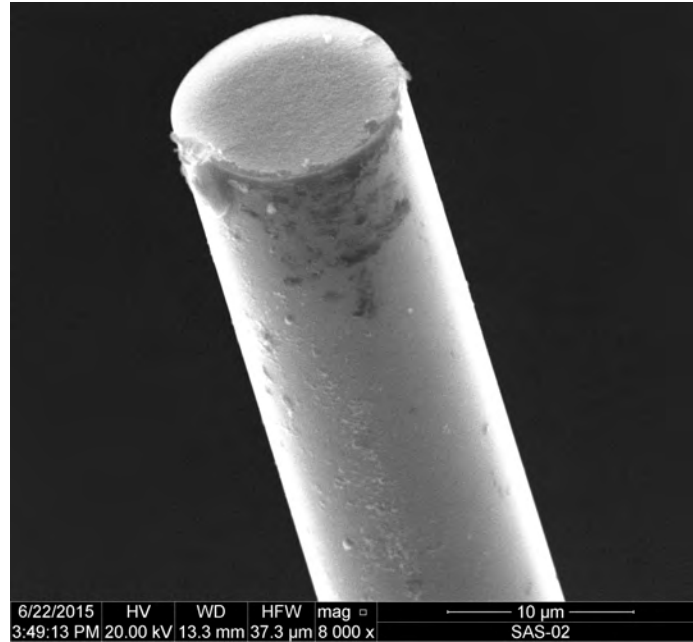
**Figure 58. Brittle fracture of Hi-Nicalon<sup>TM</sup> S fiber tow specimens after creep rupture in silicic acid-saturated steam at 800°C.**

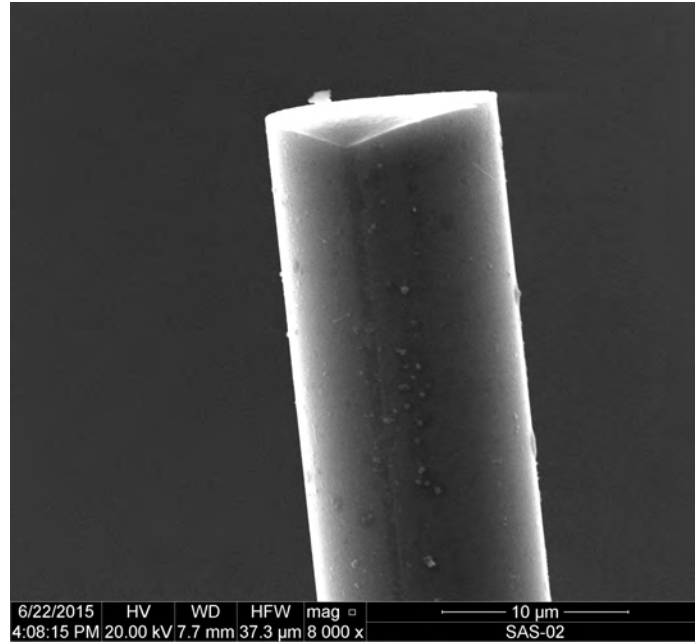
Some brittle fractures clearly initiated at points of interaction with other fibers. Figure 59 shows examples of two such fibers. Note the initiation site of the fracture coincides with the axial line of darker (a) or recessed (b) portion of the fiber. Figure 60 shows two fibers still bonded together and the line of interaction where a portion of one of the fibers has been dislodged. It is instructive to note that the fiber interactions that were not simply incidental, i.e. interactions that “cemented” fibers together and that caused fracture, occurred mostly in specimens subjected to silicic acid-saturated steam. This is likely due to the increased oxidation as compared to specimens tested in air.

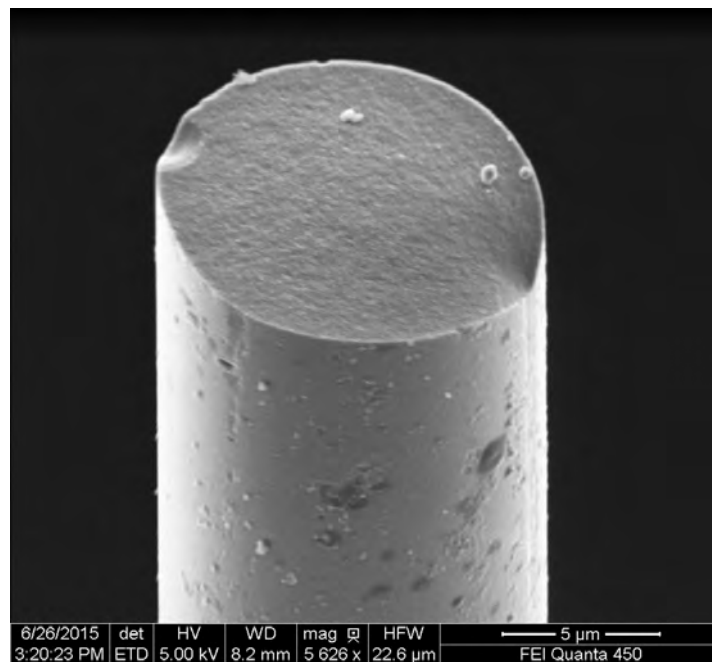
**Figure 59.** Evidence of fiber interactions as a cause of crack initiation in Hi-Nicalon<sup>TM</sup> S fiber tow specimens subjected to creep in silicic acid-saturated steam at 800°C.

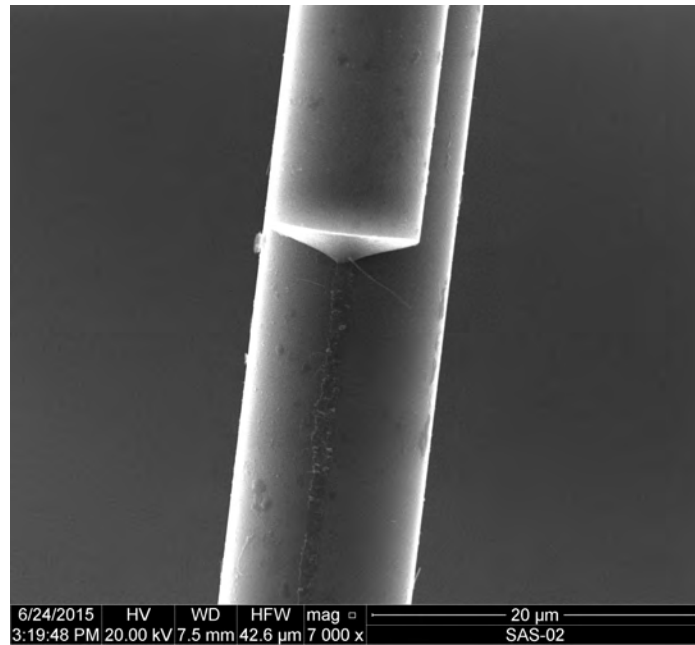
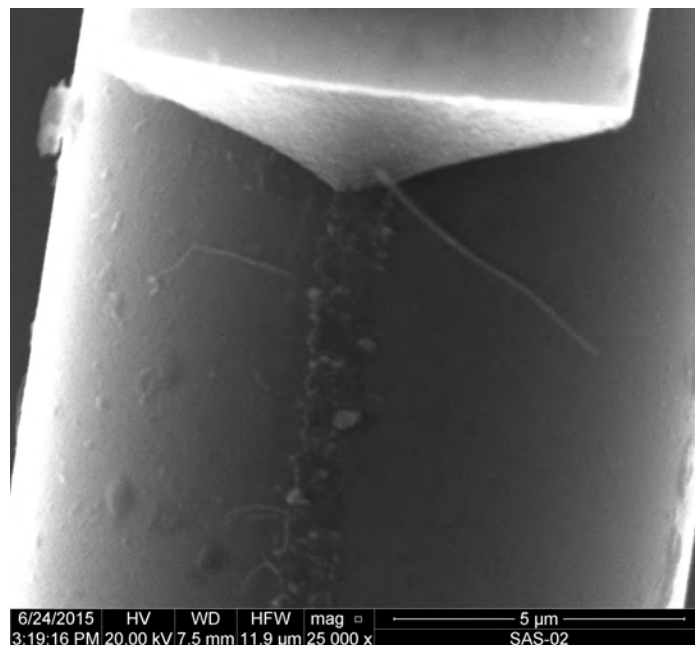
Figure 60. Evidence of fiber interactions of Hi-Nicalon<sup>TM</sup> S fiber tow specimens after being subjected to creep in silicic acid-saturated steam at 800°C.

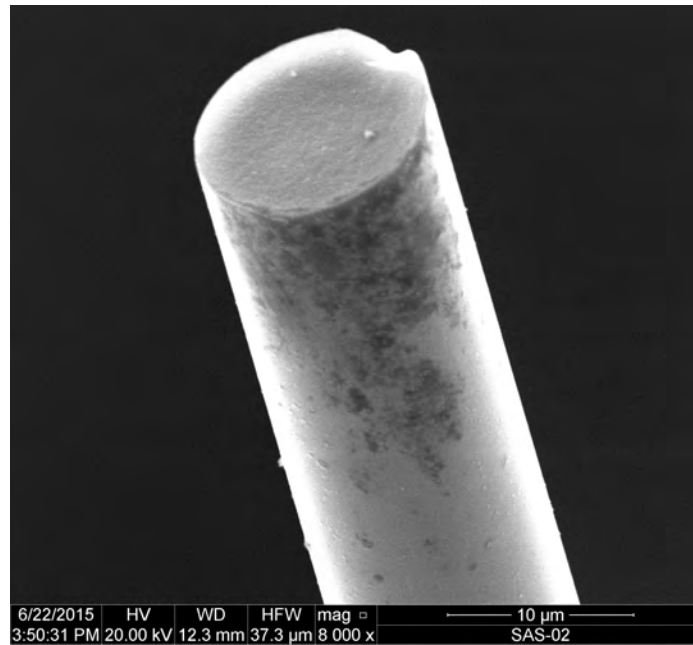
**Figure 61.** Rough, dark areas seen around fractures of Hi-Nicalon<sup>TM</sup> S fiber tow specimens subjected to creep in silicic acid-saturated steam at 800°C are likely the crack initiation sites.

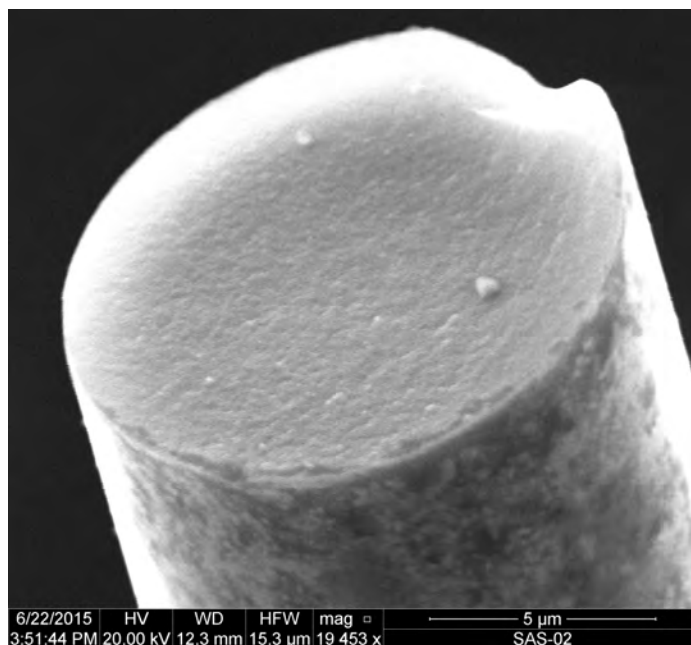
**Figure 62.** Rough, dark areas seen around fractures of Hi-Nicalon<sup>TM</sup> S fiber tow specimens subjected to creep in silicic acid-saturated steam at 800°C are likely the crack initiation sites.

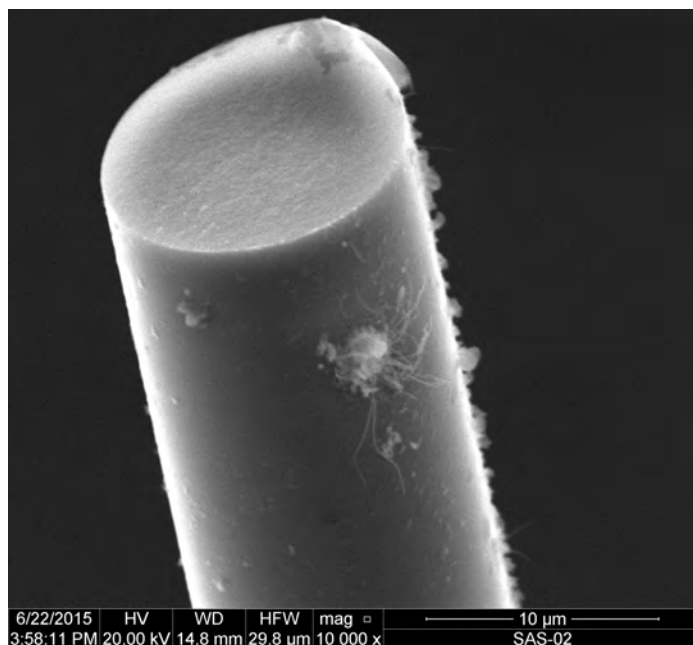
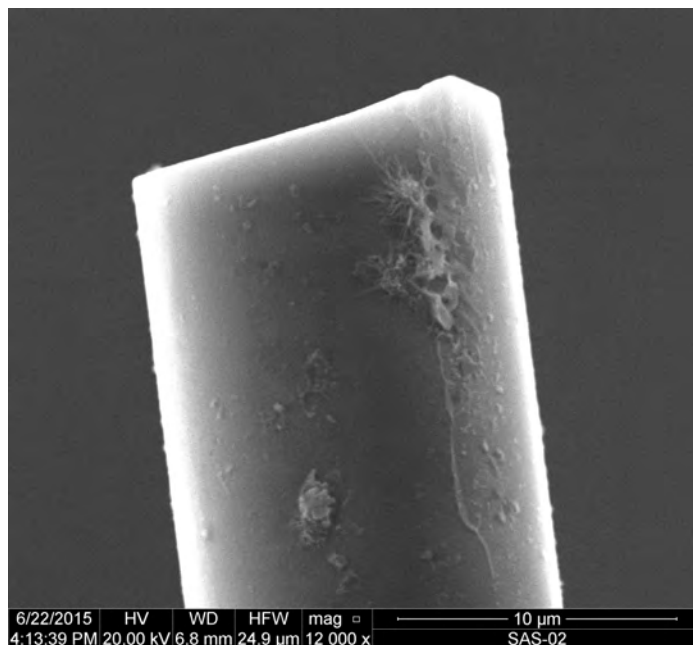
Figure 63. Spidery tendrils of deposits of silica likely precipitated out of the silicic acid-saturated steam environment during creep tests of Hi-Nicalon<sup>TM</sup> S fiber tow specimens at 800°C.

In section 5.1.2, it was mentioned that there was evidence of small particles on the surface of the fibers. It is assumed that these are precipitates of silica left behind as the steam cools. These were fairly common. Spidery tendrils, as seen in Figure 63, and crystalline growths, as seen in Figure 64, were not frequent but were noted on some fibers tested in silicic acid-saturated steam. These are also likely to be silica precipitation from the steam. These features were not observed on specimens tested in air.

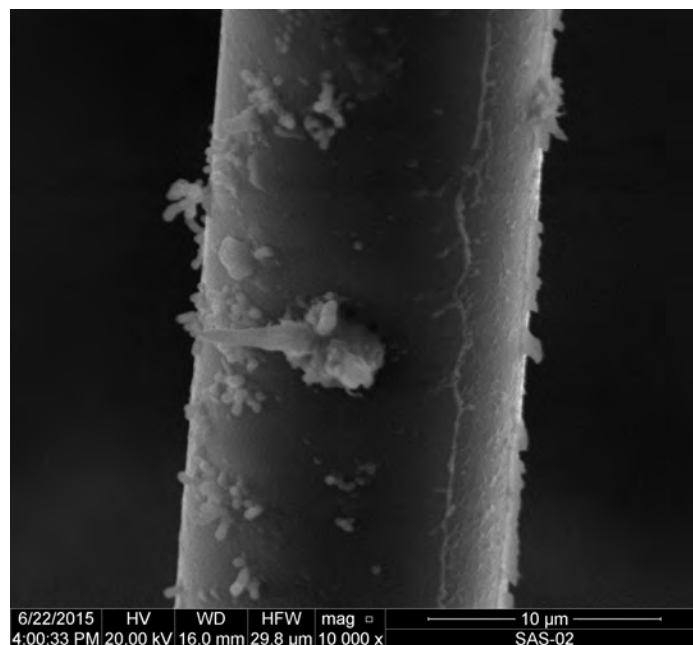
**Figure 64.** Crystalline deposits of silica likely precipitated out of the silicic acid-saturated steam environment during creep tests of Hi-Nicalon<sup>TM</sup> S fiber tow specimens at 800°C.

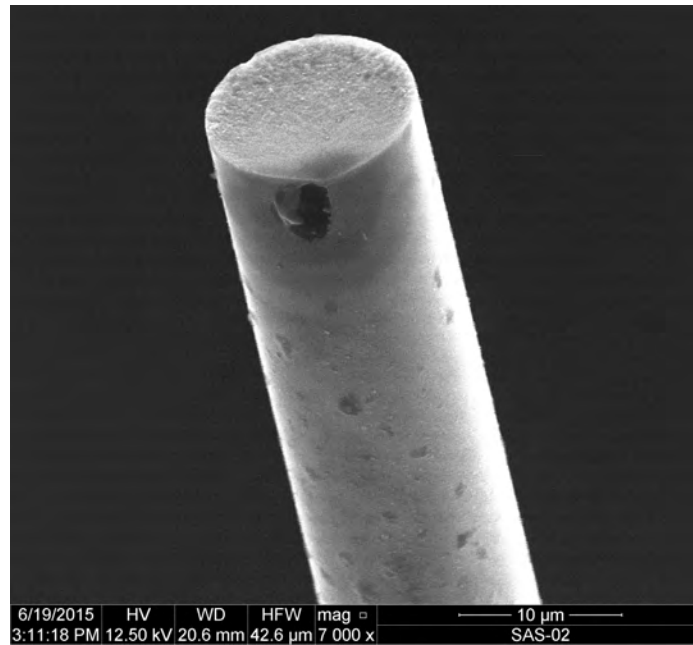
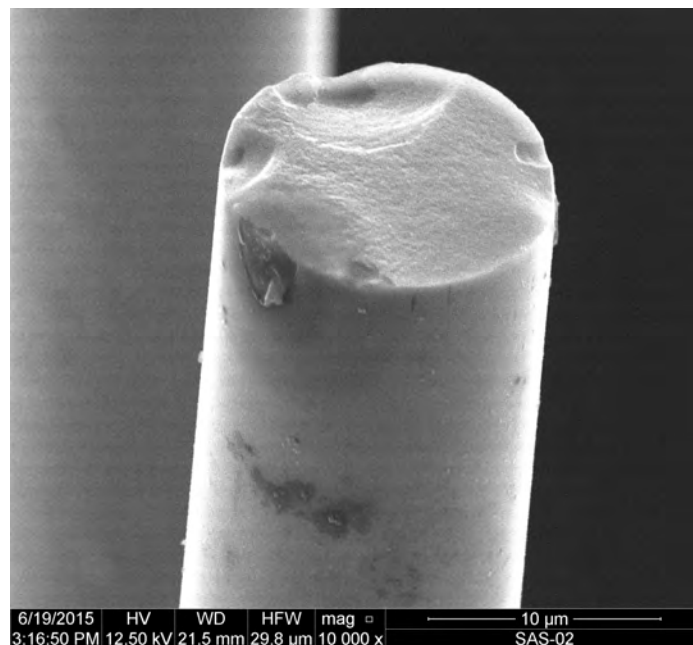
Figure 65. Contaminants introduced during fabrication, preparation, or testing of Hi-Nicalon<sup>TM</sup> S fiber tow specimens subjected to creep in air at 800°C can cause increased localized oxidation, often resulting in failure of the fiber at or near the location of the contaminant. Here the fracture surface clearly shows that the crack formed at the site of the contaminant.

Another less common, but noteworthy feature was evidence of contaminants or inclusions. A contaminant is a foreign substance not intended to be part of the fiber. An inclusion is a contaminant that becomes part of the crystal structure of the fiber, typically during the manufacturing process. Figures 65 and 66 show examples of possible inclusions or contaminants in fiber tow specimens tested in air that were at or near the fracture surface of the fiber, likely causing the fracture, while Figure 67 shows an example in a specimen tested in silicic acid-saturated steam. Note the concentric rings of discoloration in the fiber surface and similar discoloration in the fracture surface. This discoloration is an indication of the change in the crystal structure of the fiber caused by the inclusion or contaminant. Inclusions and contaminants can accelerate oxidation by acting as nucleation sites where the chemical energy necessary to break bonds and conduct the oxidation reaction is less than the surrounding area.

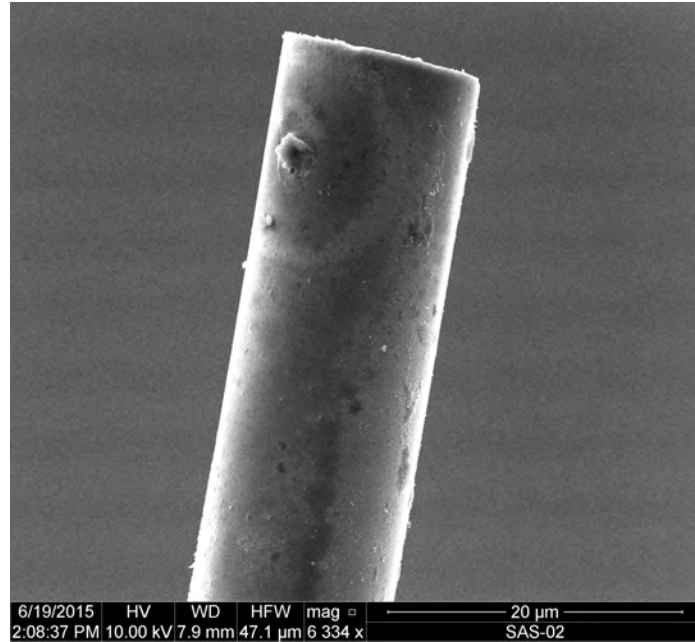
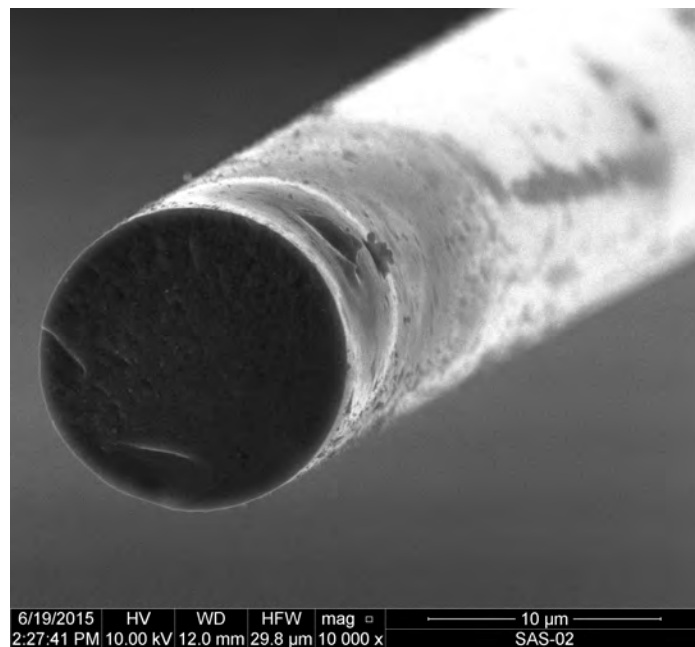
Figure 66. Contaminants introduced during fabrication, preparation, or testing of Hi-Nicalon<sup>TM</sup> S fiber tow specimens subjected to creep in air at 800°C can cause increased localized oxidation, often resulting in failure of the fiber at or near the location of the contaminant.
