**CREEP OF HI-NICALON<sup>TM</sup> S CERAMIC  
FIBER TOWS AT 800°C IN AIR AND IN  
SILICIC ACID-SATURATED STEAM**

DISSERTATION

AFIT-ENY-DS-15-S-067

***AIR FORCE INSTITUTE OF TECHNOLOGY***

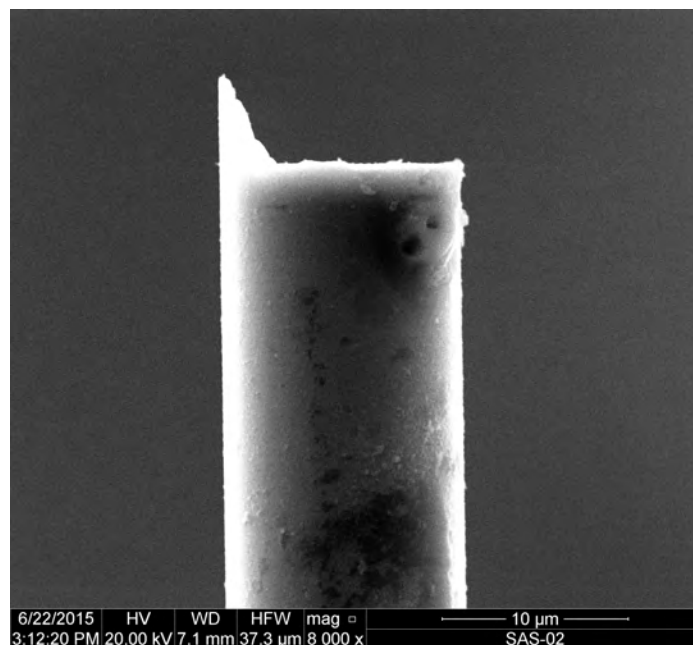
**Figure 67.** Contaminants introduced during fabrication, preparation, or testing of Hi-Nicalon<sup>TM</sup> S fiber tow specimens subjected to creep in silicic acid-saturated steam at 800°C can cause increased localized oxidation, often resulting in failure of the fiber at or near the location of the contaminant.

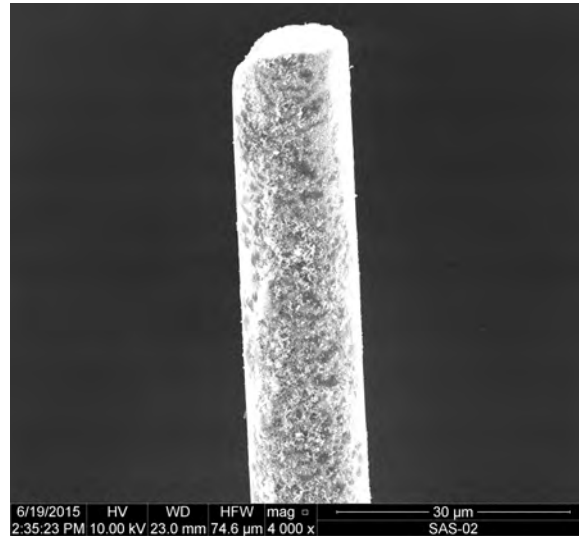
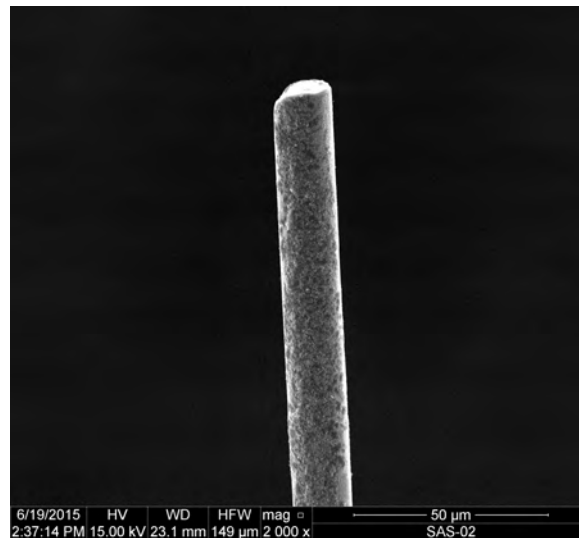
**Figure 68.** One or two “rogue” fibers with excessive oxide scale growth were observed in most specimens of Hi-Nicalon<sup>TM</sup> S fiber tow specimens subjected to creep in air at 800°C. Though difficult to say definitively, these appeared to always be on the outer edge of the fiber tow.

One of the most interesting and inexplicable features was also the least common. In most of the saturated steam specimens analyzed via SEM, and in one air specimen, there was one or two “rogue” fibers that had an extremely rough surface similar to

that of a crystallized oxide layer, as shown in Figures 68 - 69. This layer is clearly thicker than any other observed oxide layer. It is unclear what causes these “rogue” fibers to exhibit this morphology, but it has been noted in other oxidation tests [198].

Recall the “rogue” fibers discussed previously and shown in Figures 68 and 69. The surface morphology of these fibers is consistent with that of a thick crystallized scale. Though unclear at this time, it is possible that these are the same “rogue”

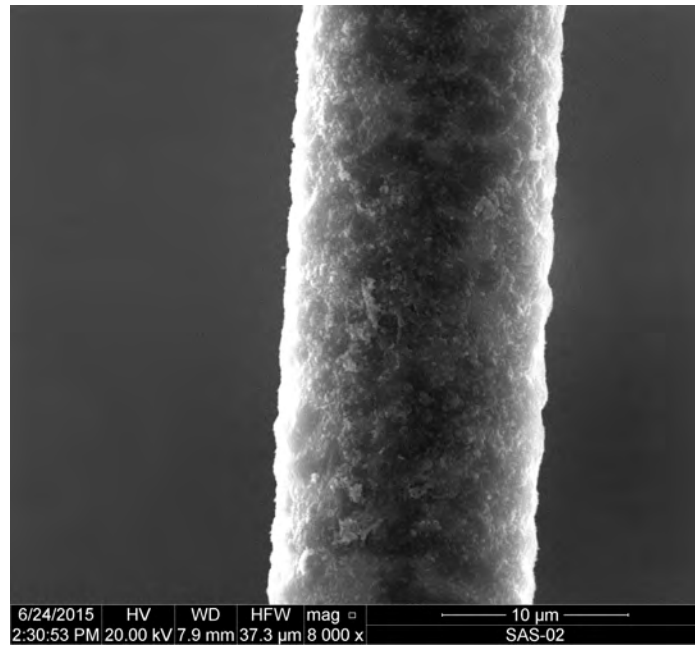
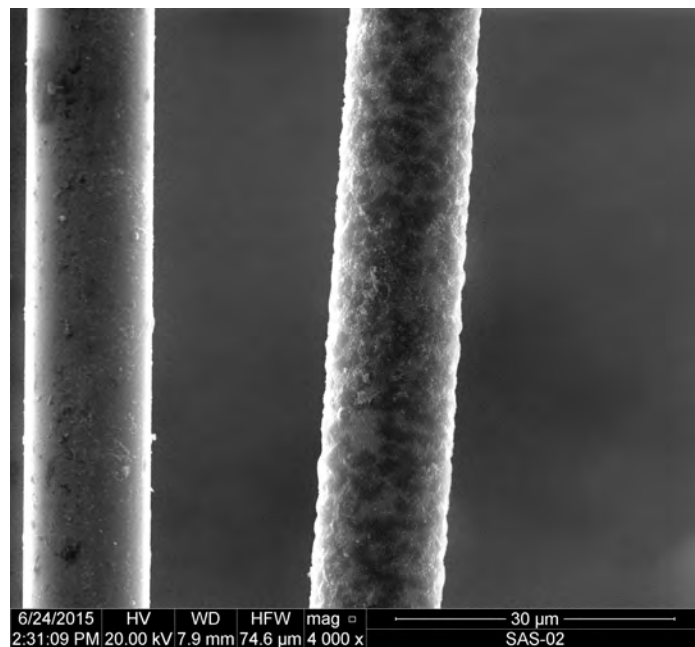
Figure 69. One or two “rogue” fibers with excessive oxide scale growth were observed in most specimens of Hi-Nicalon<sup>TM</sup> S fiber tow specimens subjected to creep in silicic acid-saturated steam at 800°C. Though difficult to say definitively, these appeared to always be on the outer edge of the fiber tow.

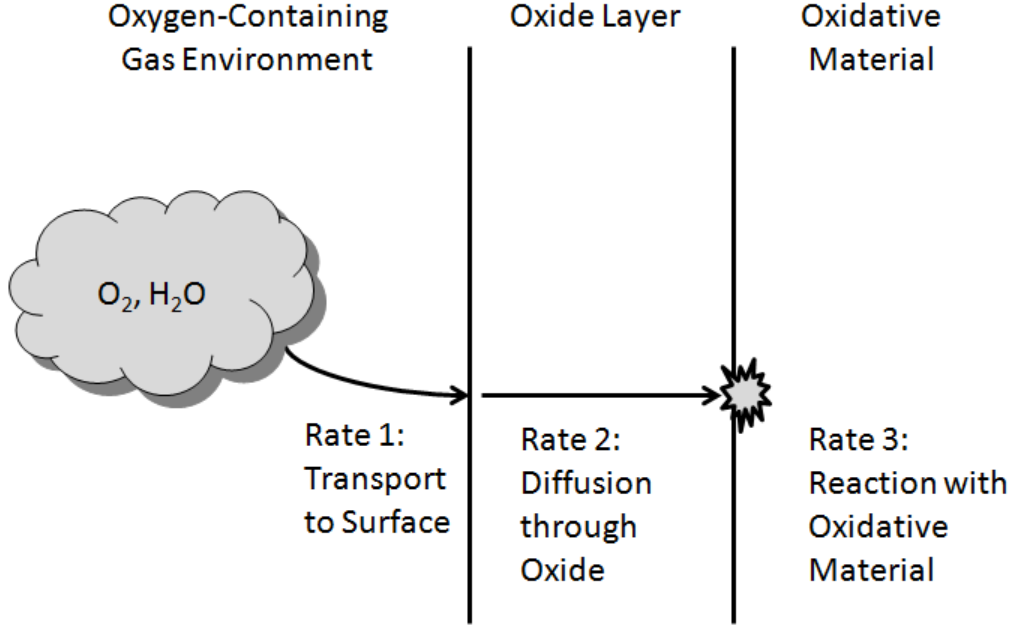
**Figure 70.** Schematic of oxidation dependence on mass transport, diffusion, and reaction rates.

Oxidation is controlled by the rate of delivery of oxygen to the surface of the oxidizing material and the rate of reaction of the oxygen with that material. Whichever rate is slower will drive the oxidation rate. However, this is only true for a very brief time at the outset of oxidation. As oxidation proceeds, a layer of oxide forms over the surface of the material, causing the oxidation rate to become a function of the rate of diffusion of oxygen through the oxide layer to the oxide-material interface where further oxidation can occur in addition to the rate of transport to the surface and the reaction rate. Over time, as the oxide layer gets thicker the time required for diffusion of the oxygen through the oxide layer increases. Regardless of the rate of transport to the surface and the oxidation reaction rate, eventually, the oxide layer will become thick enough (assuming sufficient size of the oxidizing material) that the diffusion rate will be lower than the other rates and will be the driving factor in the overall oxidation rate of the material. This diffusion-dependent oxidation rate continues to decrease as the oxidation layer, or scale, grows thicker. Figure 70 shows a schematic of this oxidation process.

Deal and Grove developed a mathematical relationship describing this oxidation process for silicon [28] and it is reviewed here. Rates one, two, and three depicted in Figure 70 are denoted as fluxes  $F_1$ ,  $F_2$ ,  $F_3$ , respectively.

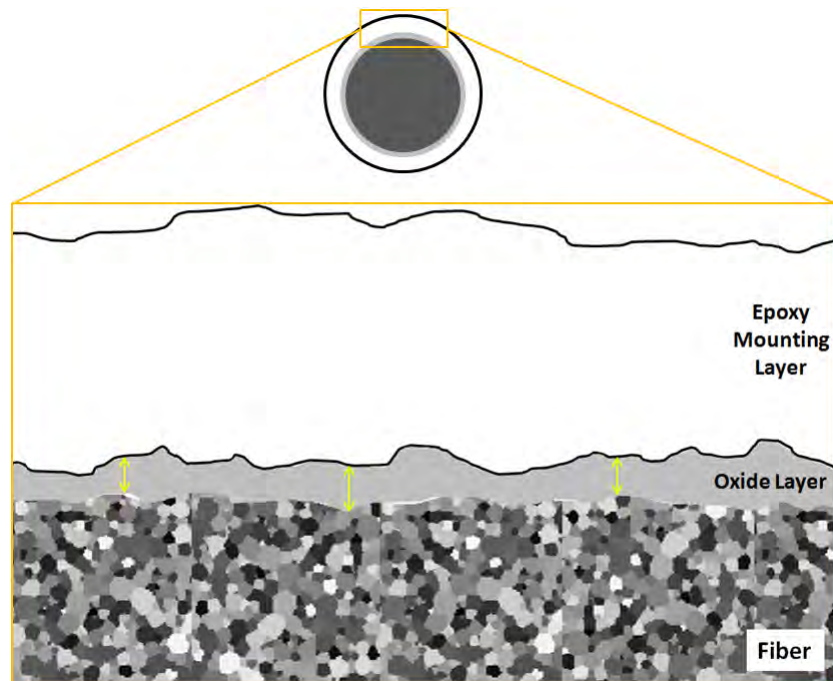
**Figure 71.** Schematic of a typical TEM image. Yellow arrows indicate multiple measurements taken and averaged to determine oxide thickness.

sections suitable for mounting in a TEM and polished to remove debris from the sectioning. Figure 71 is a schematic of a typical TEM image of a fiber tow. A portion of the fiber cross-section is selected and an image is taken at high magnification, as indicated by the colored box. The magnified image, as depicted at the bottom of the schematic, clearly shows the fiber cross-section, the oxide layer, and the epoxy. The oxide scale appears as a layer between the epoxy and the fiber cross section and can be measured directly while imaging, or at a later time using a scale bar saved with each image. Multiple measurements are taken, as depicted by the arrows in the schematic, at different locations in order to get a more accurate idea of the scale thickness. The measurements can then be averaged to determine an overall scale thickness for a given fiber tow specimen. Preliminary results of TEM analysis are shown below in Table 13, however, there was an insufficient number of data points to calculate the rate constants with any confidence.

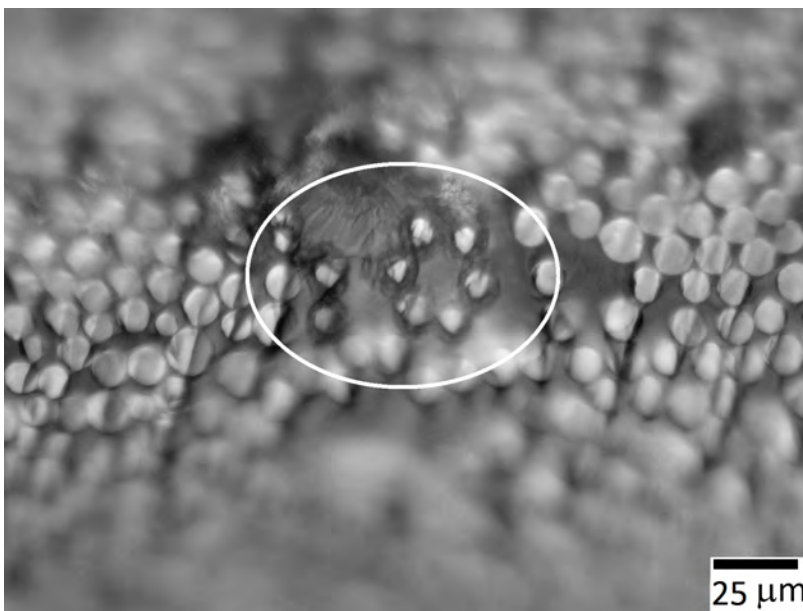
Figure 72. Optical micrograph of Hi-Nicalon<sup>TM</sup> S fiber tow specimens subjected to creep in silicic acid-saturated steam at 800°C and 625 MPa. Note the region in the center with a few fibers showing very large oxide scale.

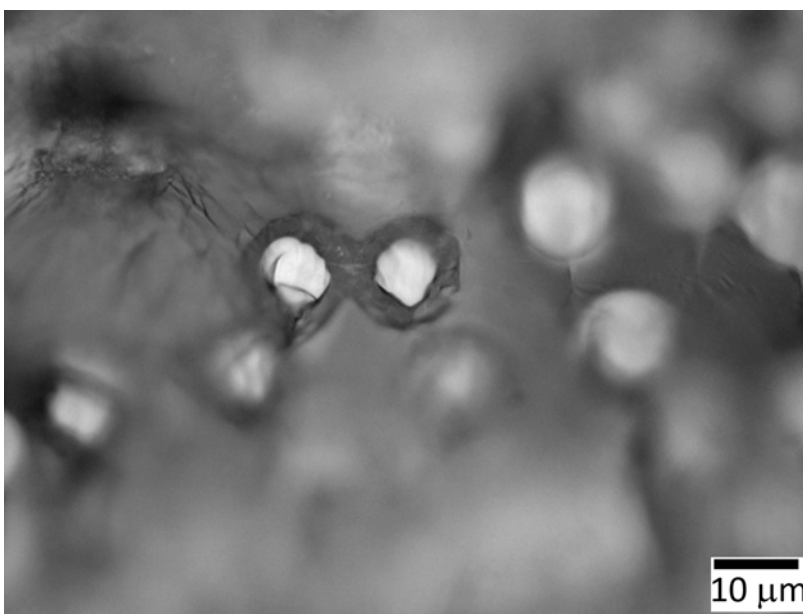
Figure 73. Optical micrograph of Hi-Nicalon<sup>TM</sup> S fiber tow specimens subjected to creep in silicic acid-saturated steam at 800°C and 625 MPa.

Contaminants and inclusions are known to act as nucleation sites for scale growth, and have been seen to cause crystallization at temperatures below the normal for crystallization. The “rogue” fibers may have been exposed to contaminants or developed inclusions during the manufacturing process, causing them to be preferentially susceptible to this crystalline oxide formation. This idea is supported by the observation that these “rogue” fibers appear in close proximity to one another within the fiber tow, as can be seen in Figures 72 through 75. Similar groupings were observed in SEM analysis.

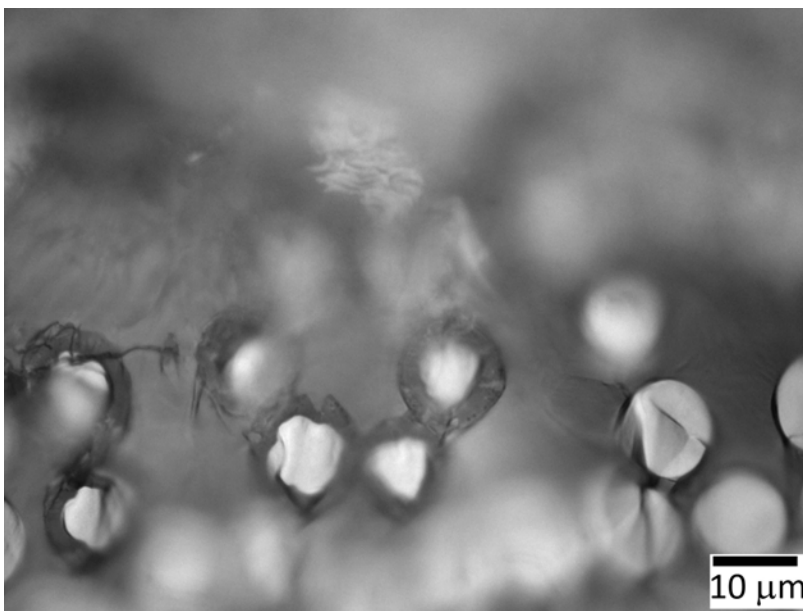
**Figure 74.** Optical micrograph of Hi-Nicalon<sup>TM</sup> S fiber tow specimens subjected to creep in silicic acid-saturated steam at 800°C and 625 MPa.

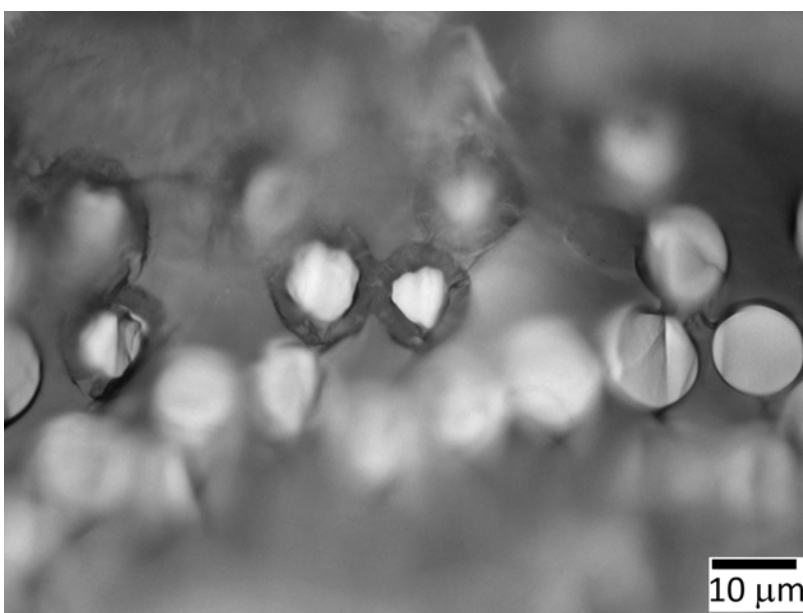
**Figure 75.** Optical micrograph of Hi-Nicalon<sup>TM</sup> S fiber tow specimens subjected to creep in silicic acid-saturated steam at 800°C and 625 MPa.

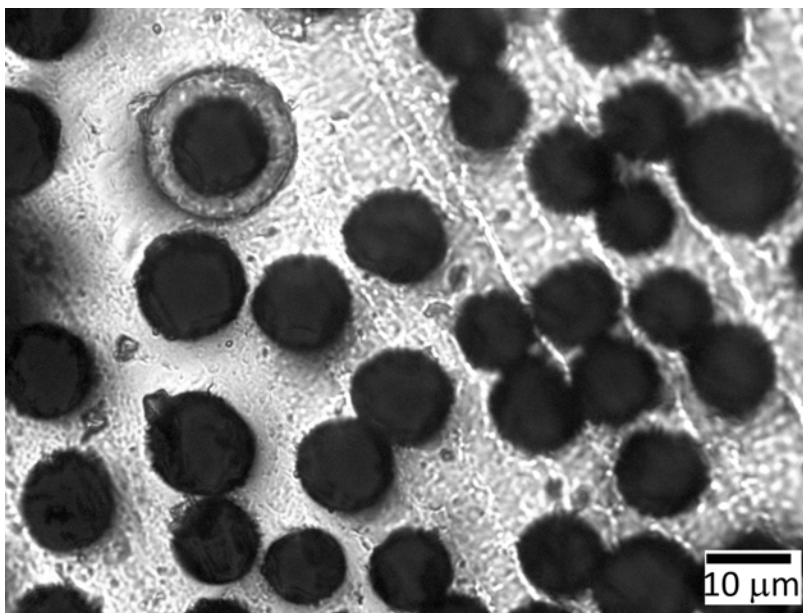
Figure 76. Optical micrograph of Hi-Nicalon<sup>TM</sup> S fiber tow specimen subjected to oxidation for 100 h at 700°C [198], used with permission.

fibers seen in the SEM images. However, this phenomenon is not isolated to the present work. Ongoing studies of oxidation of Hi-Nicalon<sup>TM</sup> S fiber tows by Hay at AFRL have also shown evidence of this phenomenon [198]. The AFRL tests were also conducted in silicic acid-saturated steam, based on the design developed for this research effort, with the key difference that specimens were not tested under load. All specimens were laid horizontally in a quartz tube and exposed to an oxidizing environment. Figures 76 and 77 are optical micrographs of specimens exposed to silicic acid-saturated steam for 100 hours. Note the similar ring of oxide and, in the 800°C specimens, similar fiber degradation. In these specimens, it was confirmed via TEM that the thick oxide was crystallized SiO<sub>2</sub> [198]. It was also observed that the other fibers had 1 - 2 nm of scale growth at most for the 700°C test specimens, with many having no measurable scale at all, and only nominally thicker scales at 800°C. Also of interest in the 800°C specimens is the evidence of the oxide wicking to one side of the fiber, leaving almost no oxide elsewhere. Though this was not captured in the limited optical and TEM images of specimens from the current work, SEM analysis did show fibers exhibiting the morphology of the “rogue” fibers on only one side or a limited portion of the fiber. An example of this can be seen in Figures B.91c and B.91d in Appendix B. This may be the same kind of wicking phenomenon, though the evidence is insufficient at this time to say definitively one way or the other.

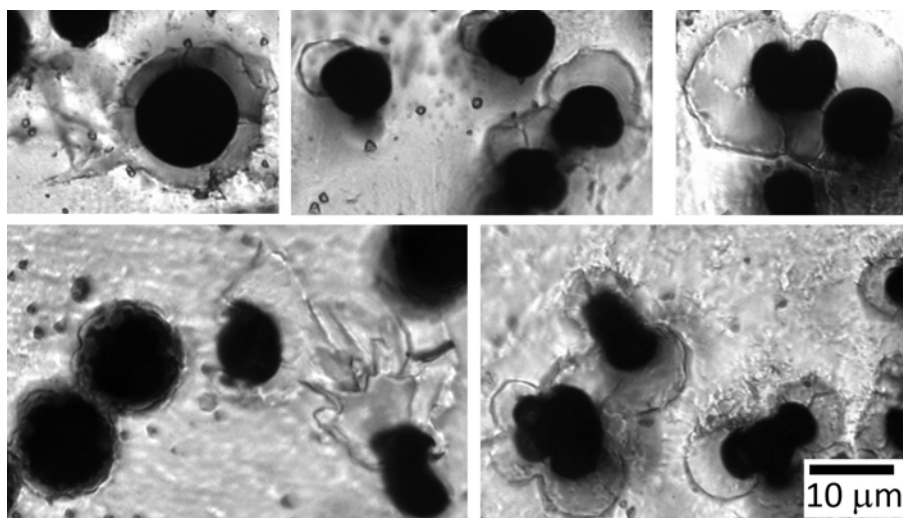
Figure 77. Optical micrograph of Hi-Nicalon<sup>TM</sup> S fiber tow specimen subjected to oxidation for 100 h at 800°C [198], used with permission.

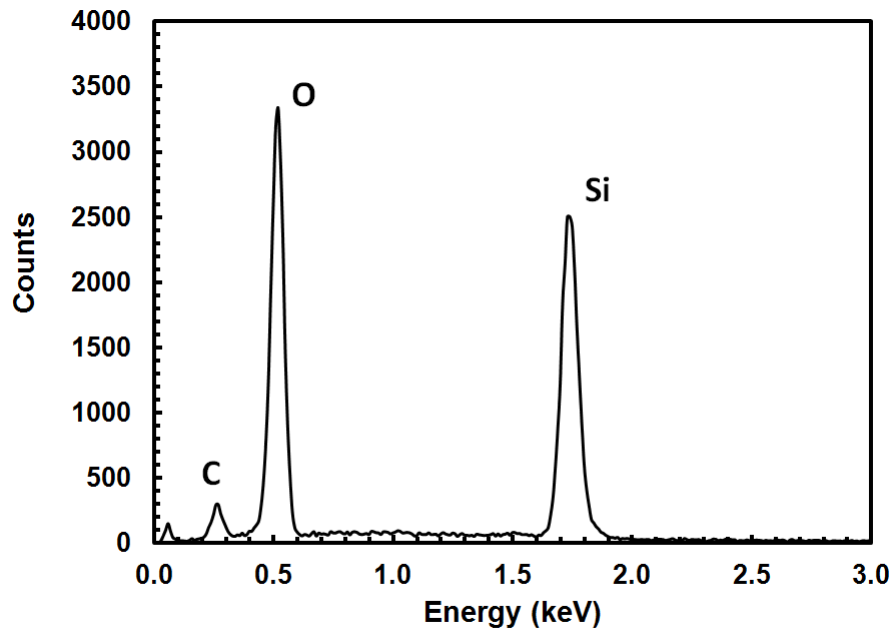
Figure 78. Energy dispersive spectrograph of the surface of “rogue” fiber from a Hi-Nicalon<sup>TM</sup> S SiC fiber tow specimen subjected to the saturated steam environment at 800°C and to a load of 450 MPa (65.3 ksi). The composition is representative of all EDS conducted on this morphology and is consistent with significant oxidation of the fiber to form a silica scale. The content was 42.86% silicon, 10.68% carbon, and 45.81% oxygen by atomic percent.

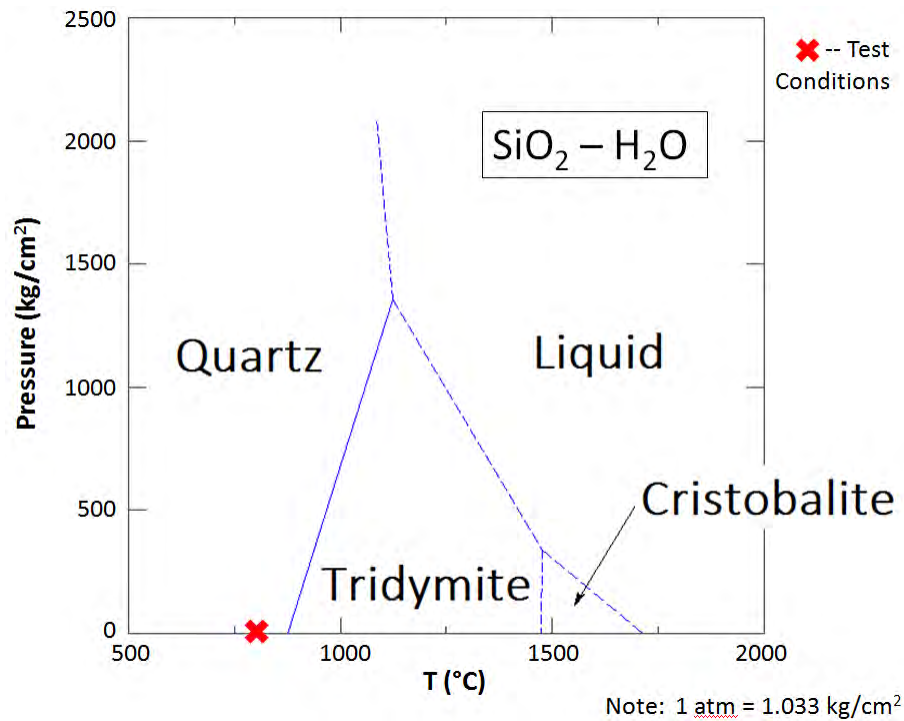
**Figure 79.** Phase Diagram for silica formation in a water environment. Note the red X depicting the test conditions during this research effort. Data reproduced from [201].

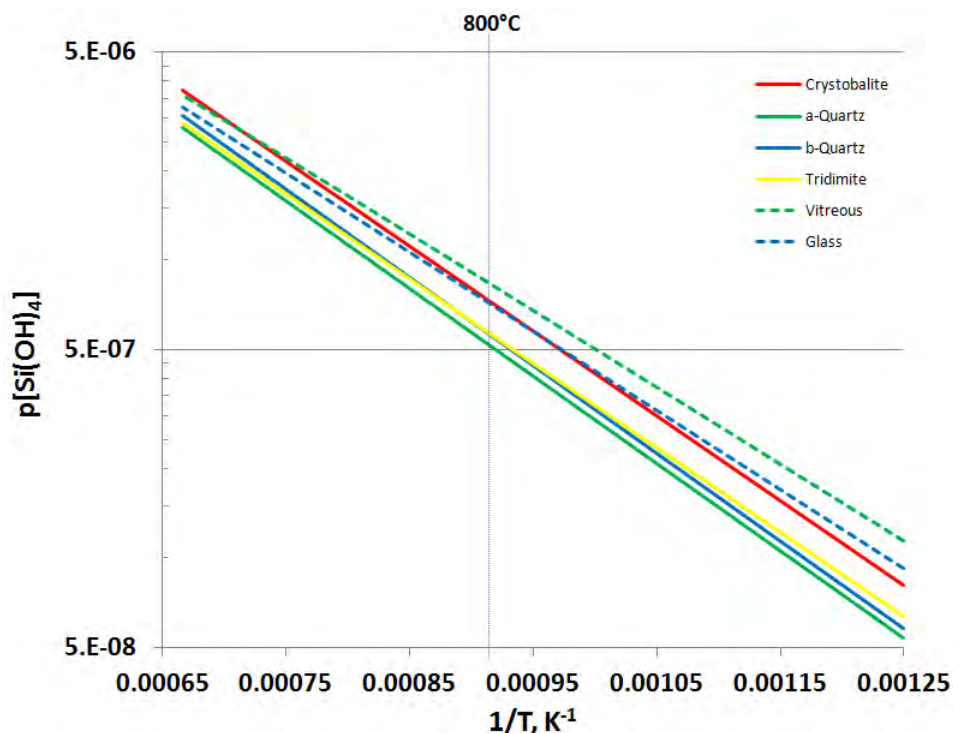
**Figure 80.** Equilibrium partial pressures of silicic acid in steam over various morphologies of silica. Data reproduced from [202] by Mogilevsky [203].

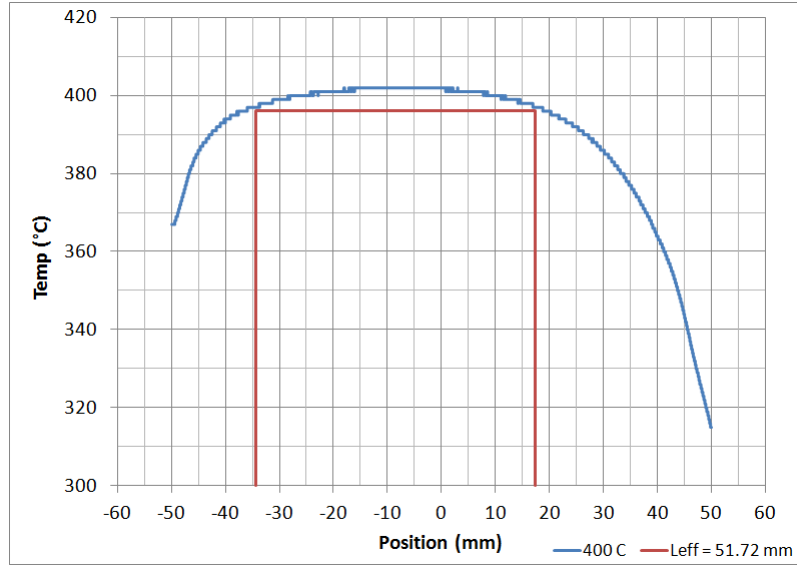
Figure A.1. Effective gauge length and temperature profile in Air for 400°C.

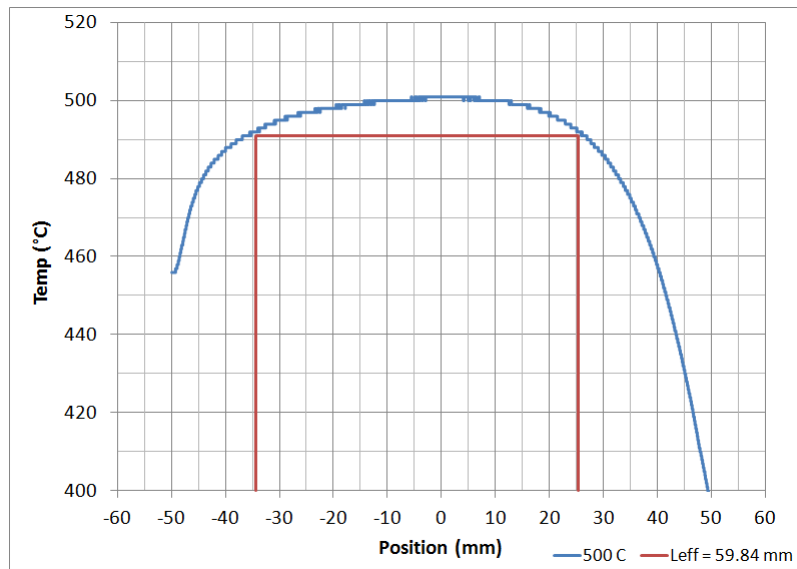
Figure A.2. Effective gauge length and temperature profile in Air for 500°C.

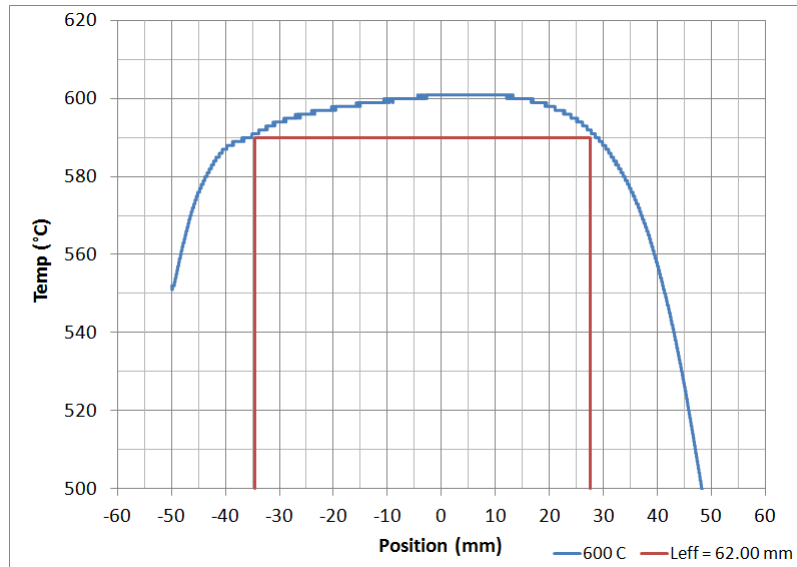
Figure A.3. Effective gauge length and temperature profile in Air for 600°C.

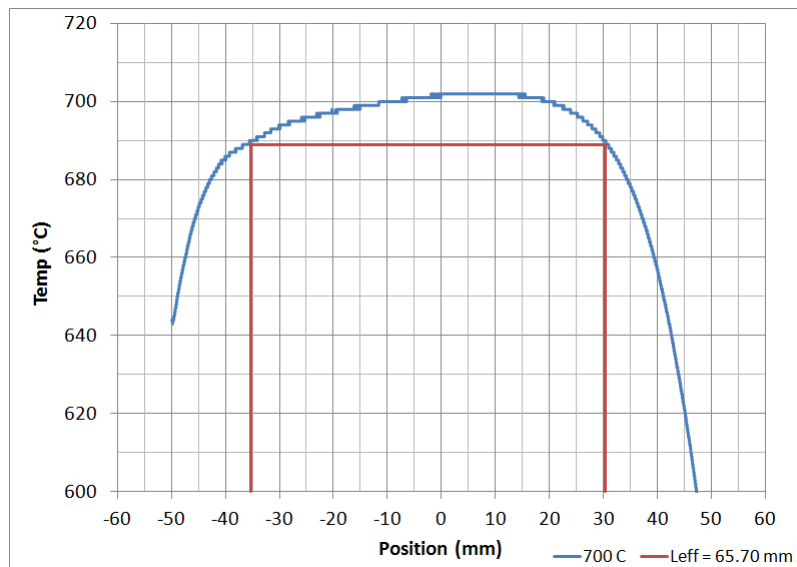
Figure A.4. Effective gauge length and temperature profile in Air for 700°C.

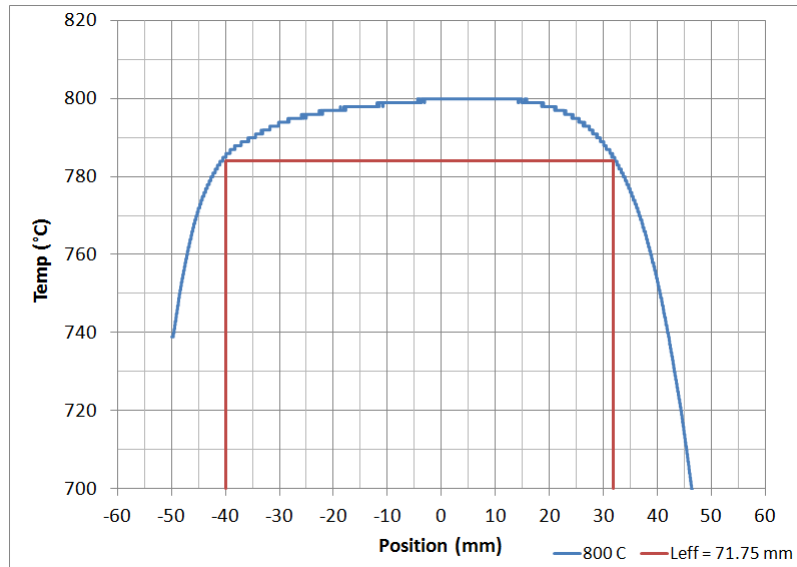
Figure A.5. Effective gauge length and temperature profile in Air for 800°C.

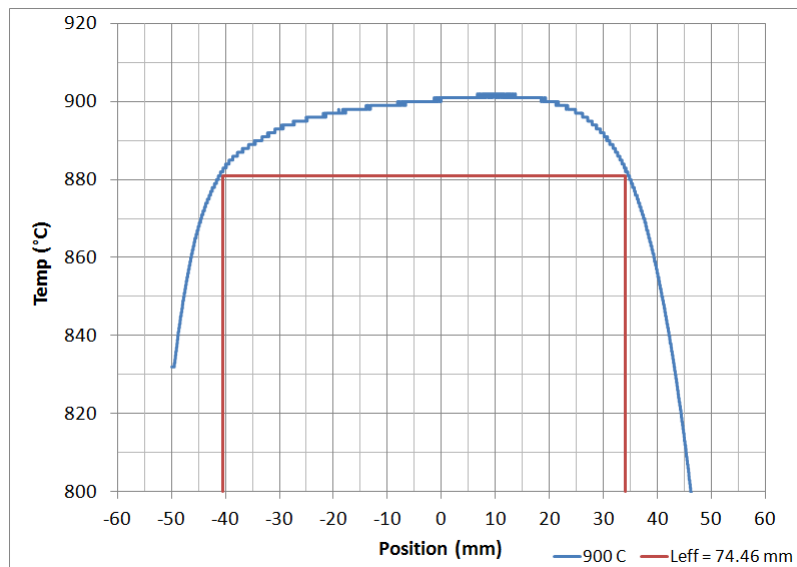
Figure A.6. Effective gauge length and temperature profile in Air for 900°C.

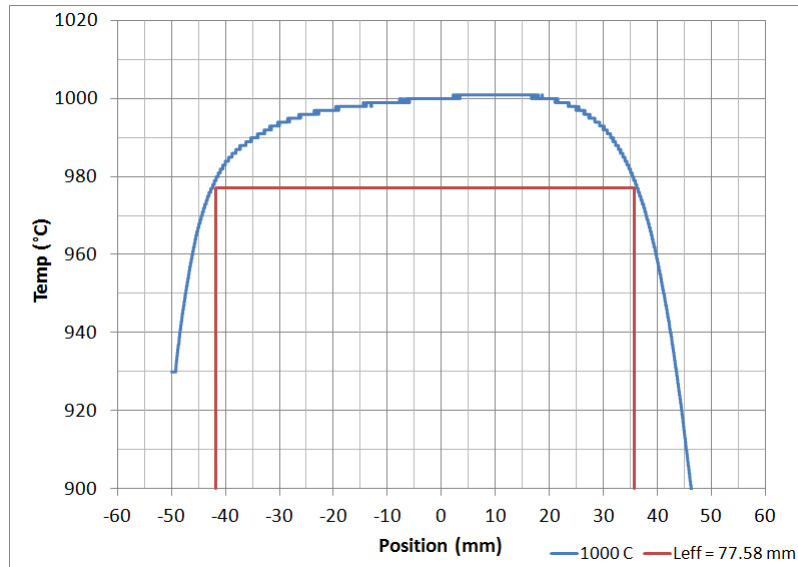
Figure A.7. Effective gauge length and temperature profile in Air for 1000°C.

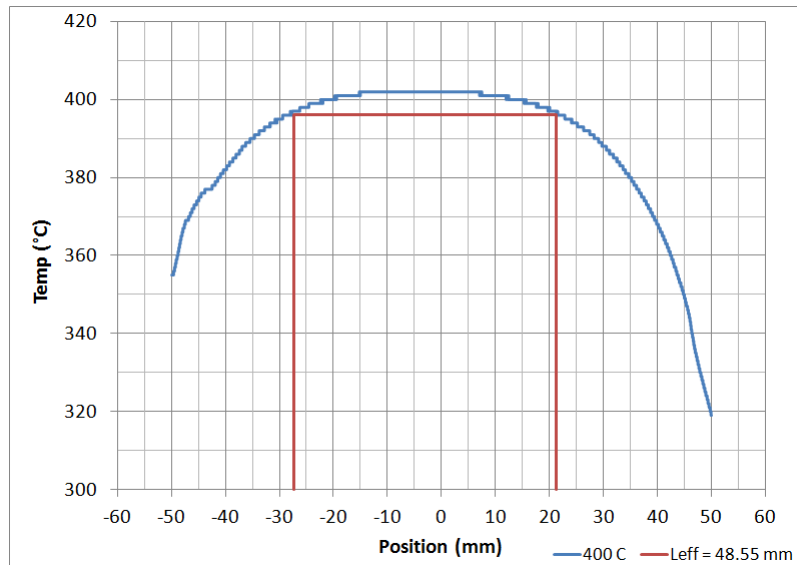
Figure A.8. Effective gauge length and temperature profile in silicic acid saturated steam for 400°C.

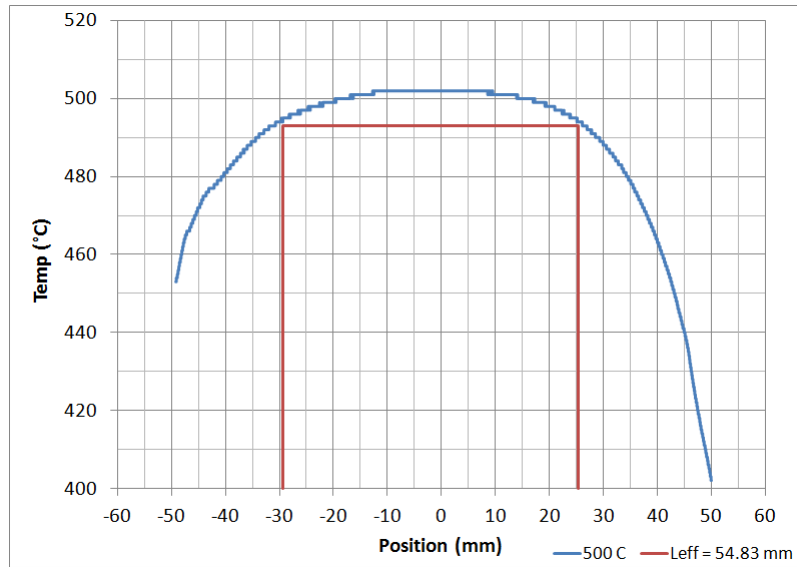
Figure A.9. Effective gauge length and temperature profile in silicic acid saturated steam for 500°C.

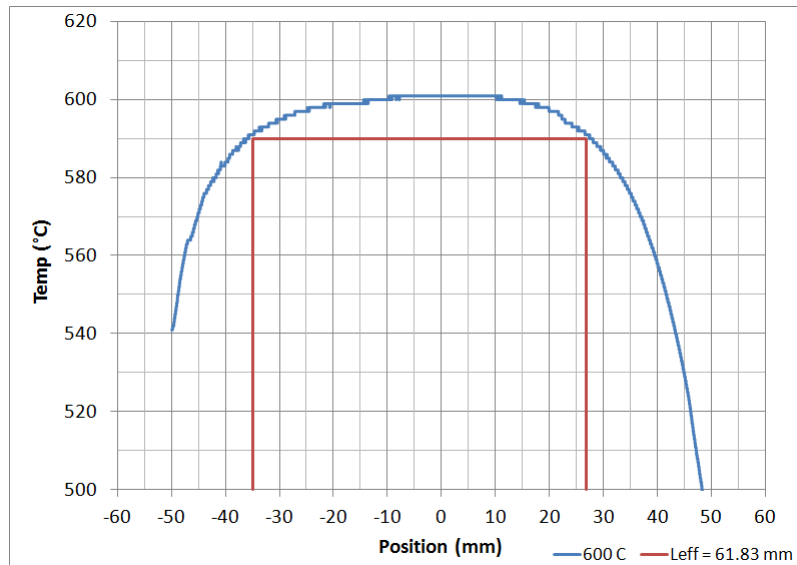
Figure A.10. Effective gauge length and temperature profile in silicic acid saturated steam for 600°C.

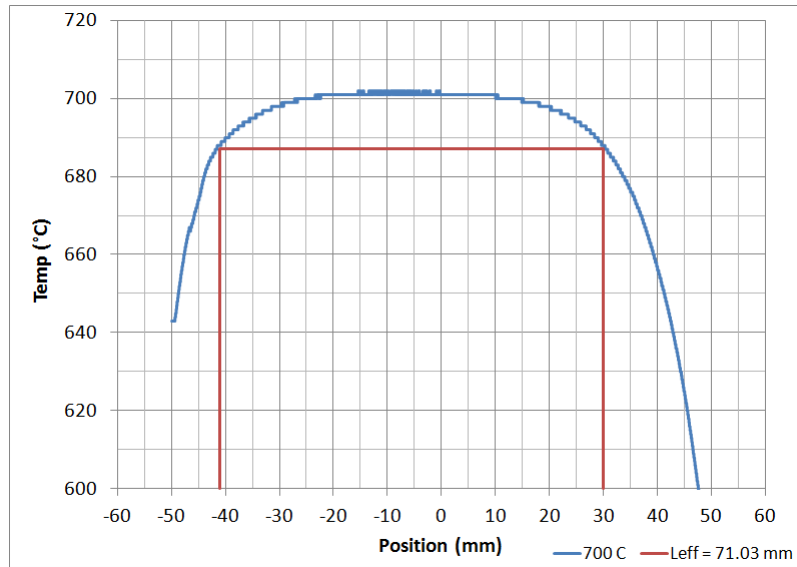
Figure A.11. Effective gauge length and temperature profile in silicic acid saturated steam for 700°C.

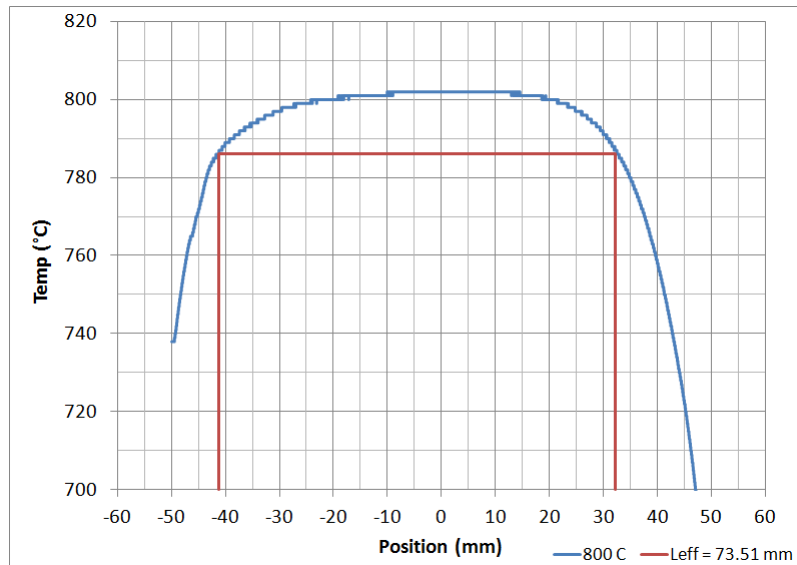
Figure A.12. Effective gauge length and temperature profile in silicic acid saturated steam for 800°C.

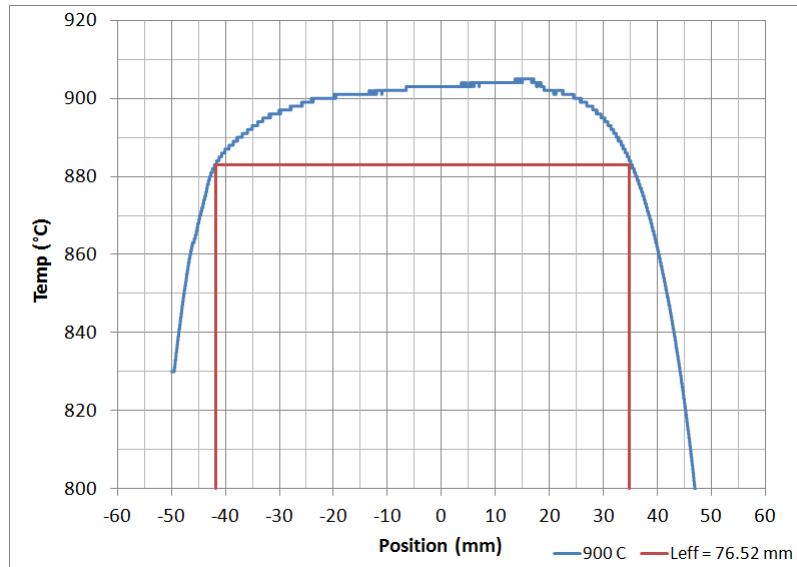
Figure A.13. Effective gauge length and temperature profile in silicic acid saturated steam for 900°C.

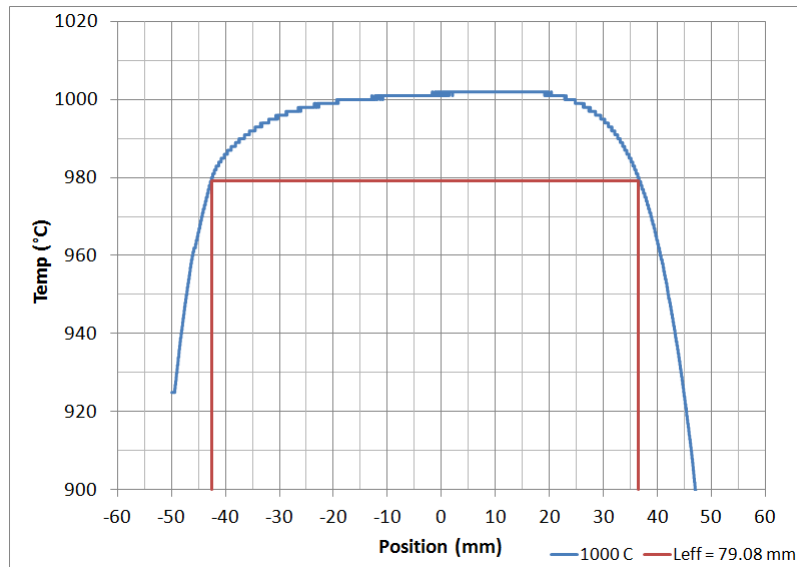
Figure A.14. Effective gauge length and temperature profile in silicic acid saturated steam for 1000°C.

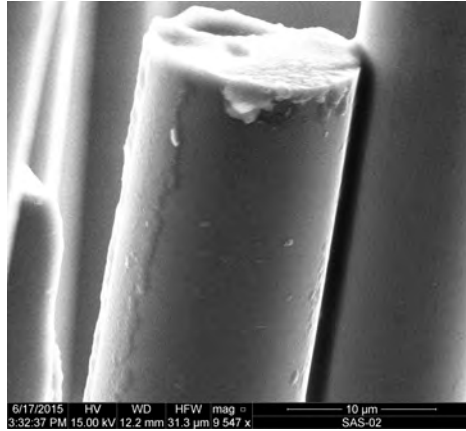
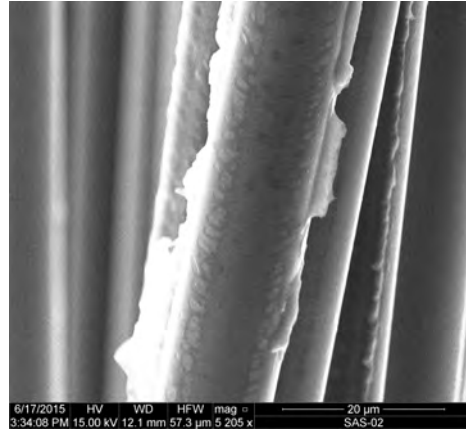
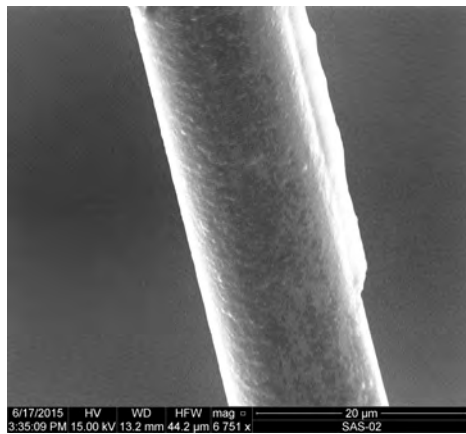
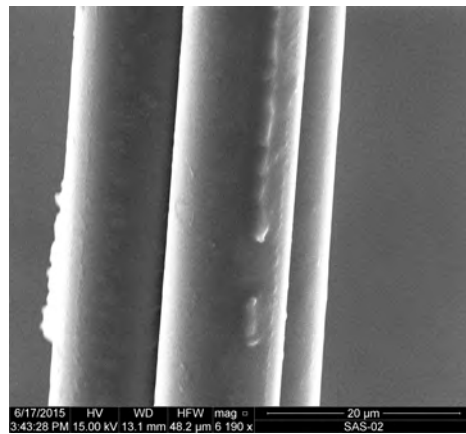
Figure B.1. Hi-Nicalon<sup>TM</sup> S fiber tow untested specimen

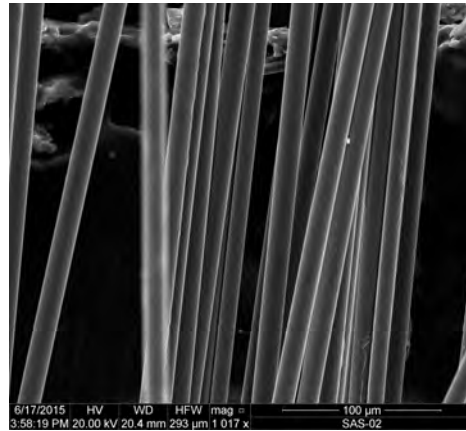
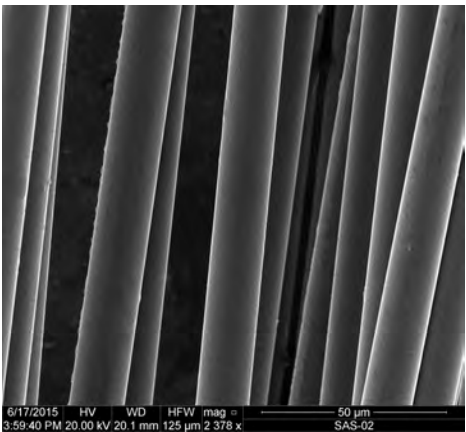
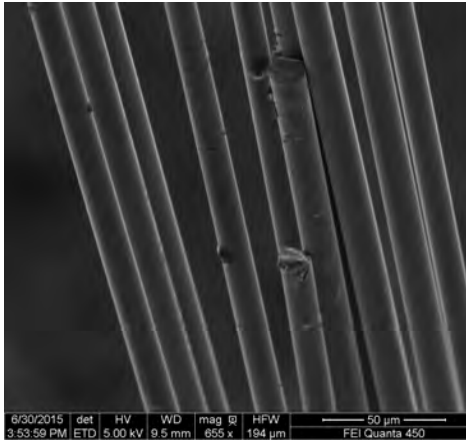
Figure B.2. Hi-Nicalon<sup>TM</sup> S fiber tow untested specimen

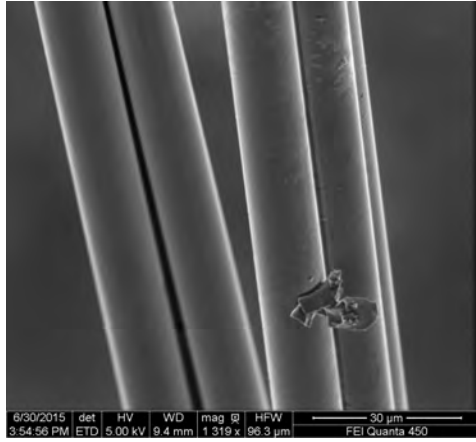
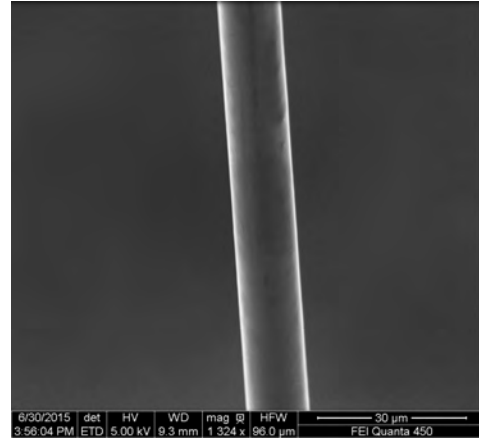
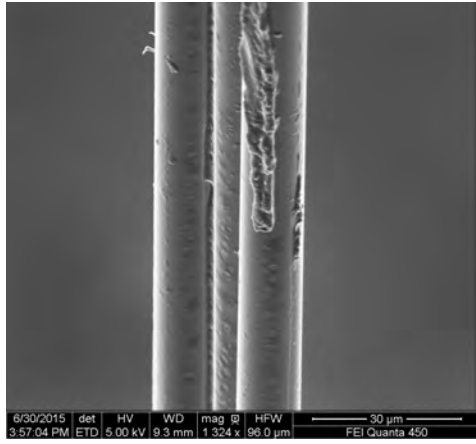
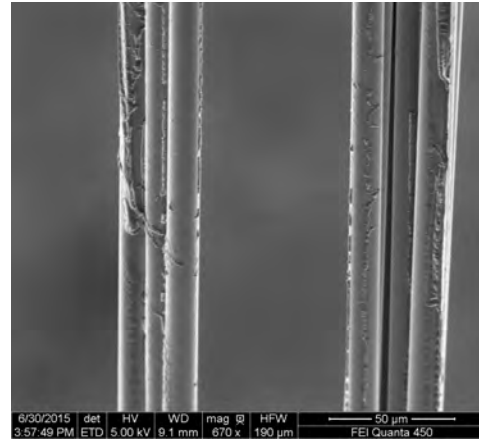
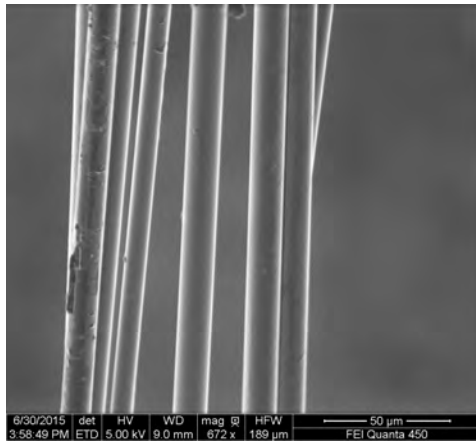
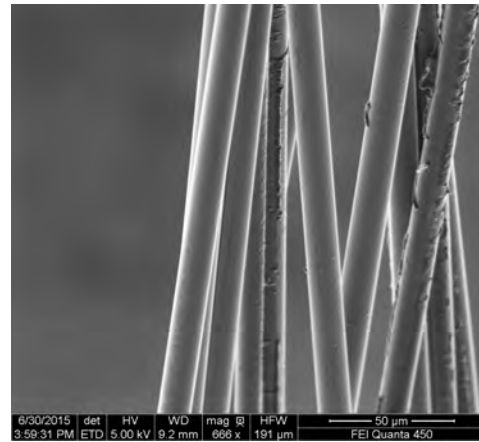
Figure B.3. Hi-Nicalon<sup>TM</sup> S fiber tow untested specimen

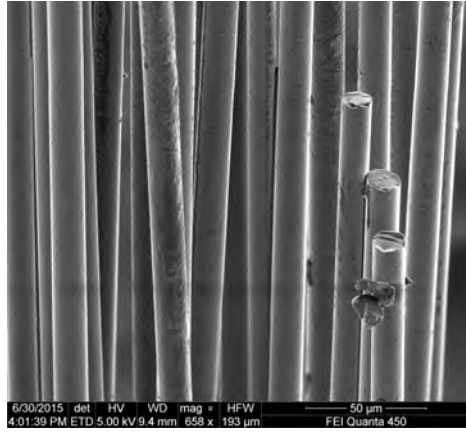
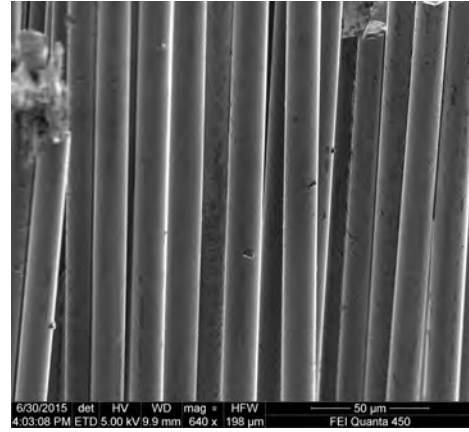
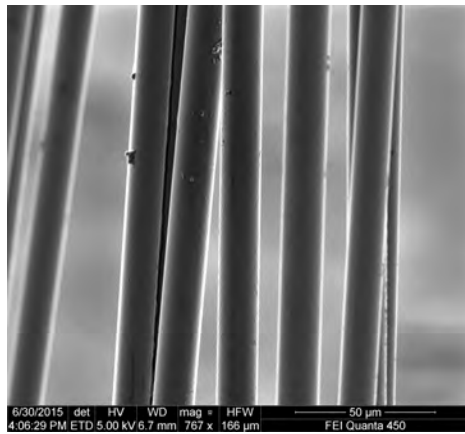
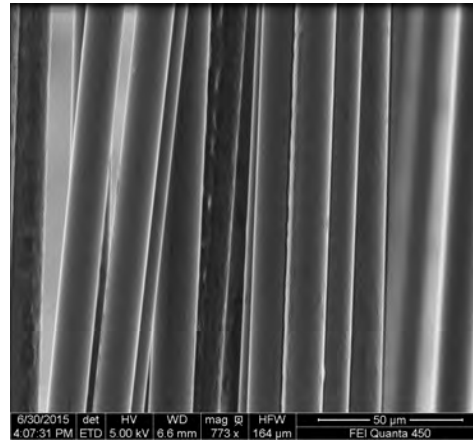
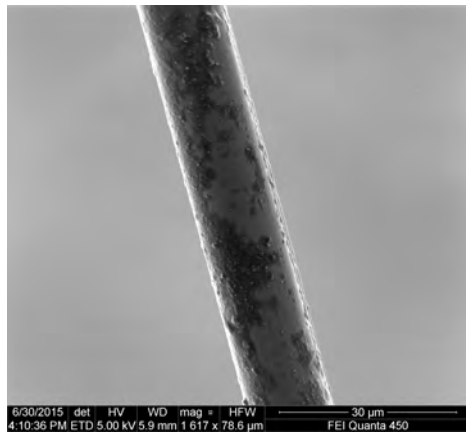
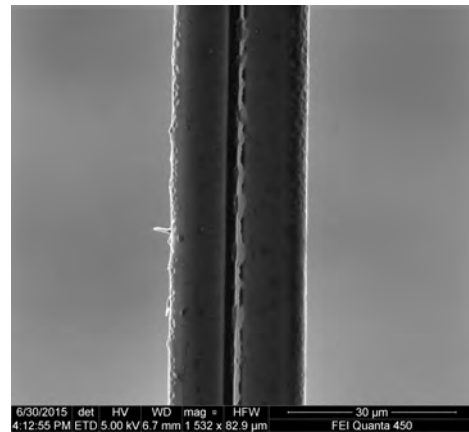
Figure B.4. Hi-Nicalon<sup>TM</sup> S fiber tow untested specimen

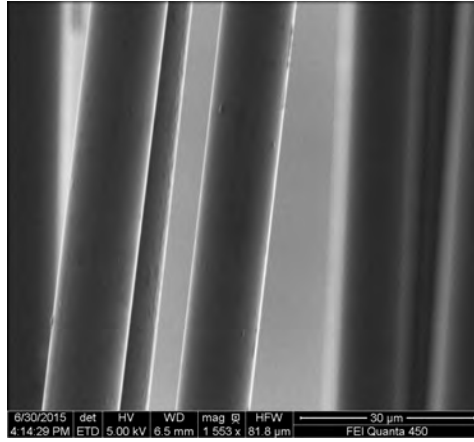
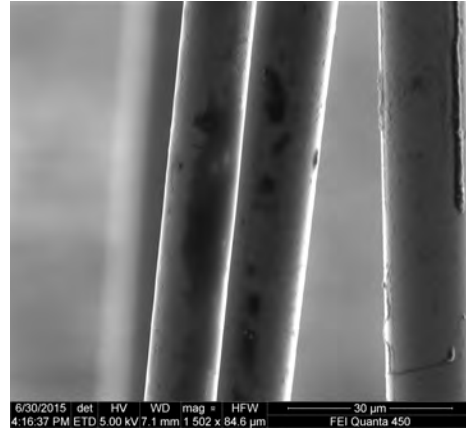
Figure B.5. Hi-Nicalon<sup>TM</sup> S fiber tow untested specimen

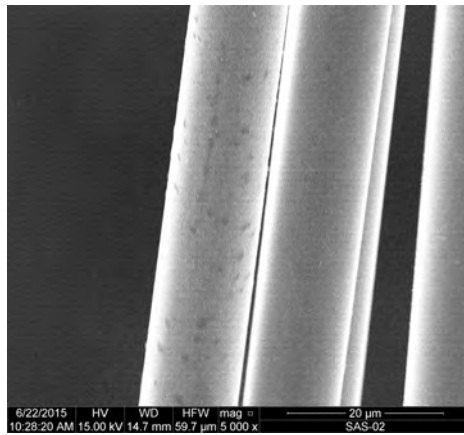
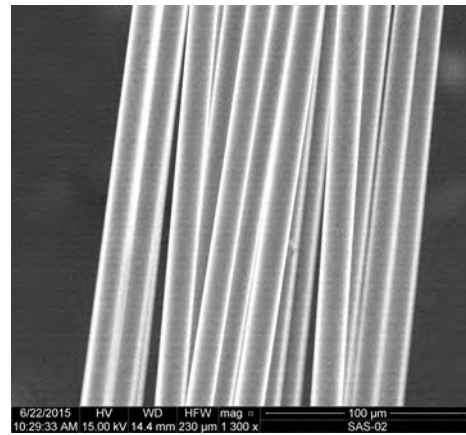
Figure B.6. Hi-Nicalon<sup>TM</sup> S fiber tow specimen A12, center section, (800°C,  $\sigma = 937$  MPa,  $t = 84.3$  h)
