**CREEP OF HI-NICALON<sup>TM</sup> S CERAMIC  
FIBER TOWS AT 800°C IN AIR AND IN  
SILICIC ACID-SATURATED STEAM**

DISSERTATION

AFIT-ENY-DS-15-S-067

***AIR FORCE INSTITUTE OF TECHNOLOGY***

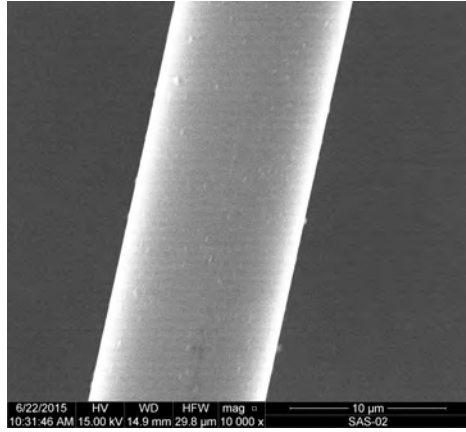
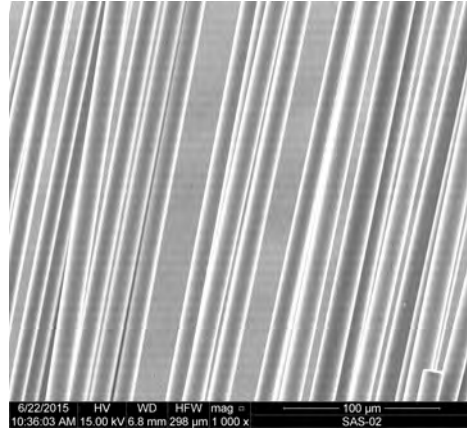
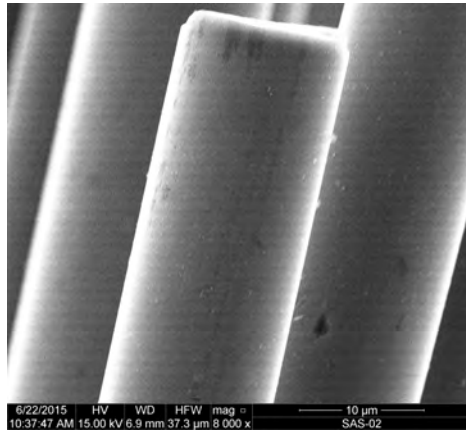
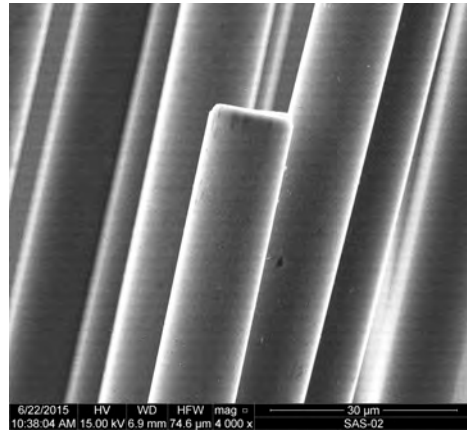
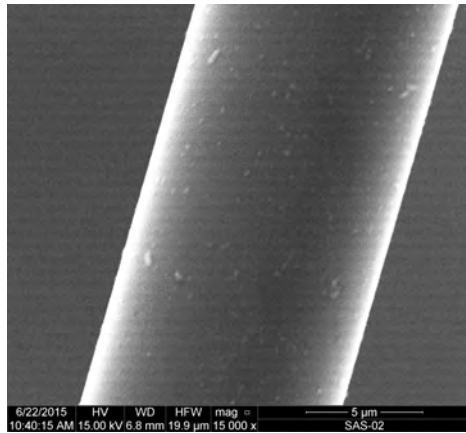
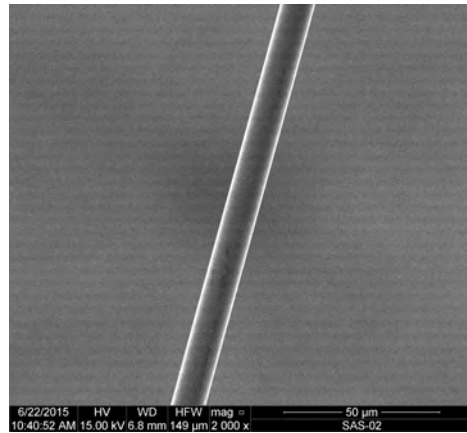
Figure B.7. Hi-Nicalon<sup>TM</sup> S fiber tow specimen A12, center section, (800°C,  $\sigma = 937$  MPa,  $t = 84.3$  h)

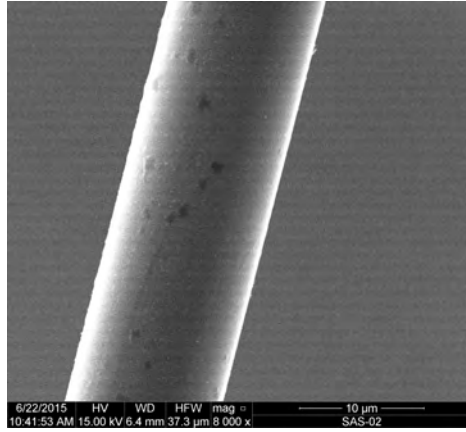
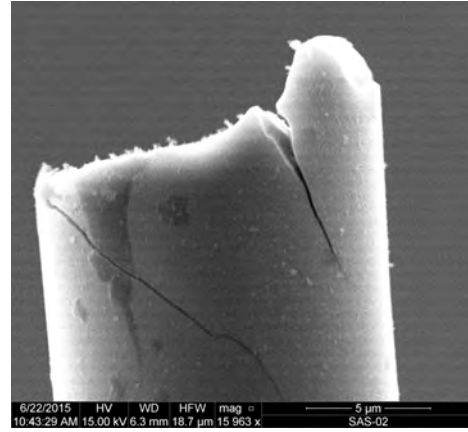
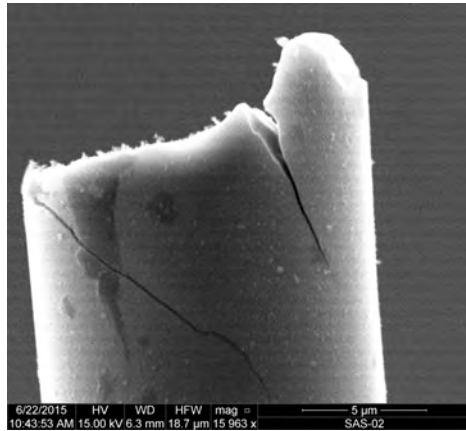
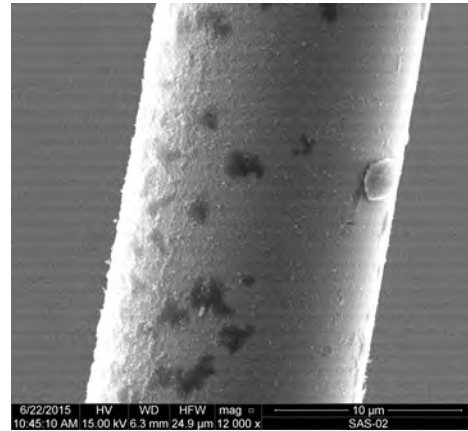
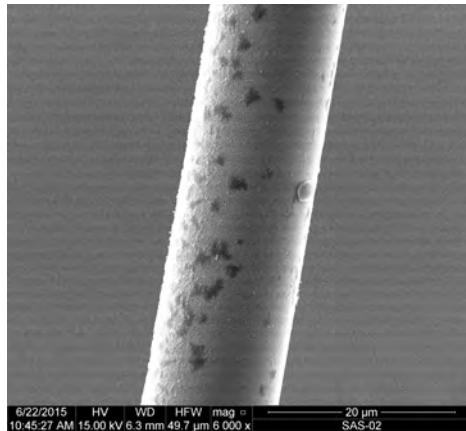
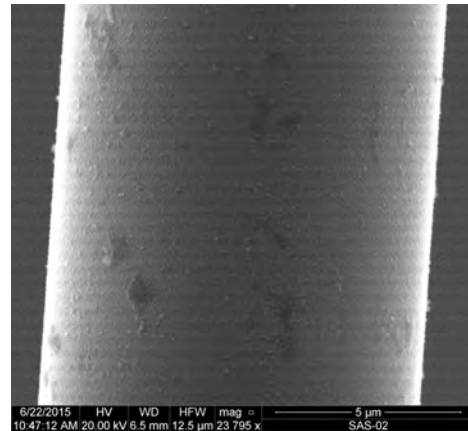
Figure B.8. Hi-Nicalon<sup>TM</sup> S fiber tow specimen A12, center section, (800°C,  $\sigma = 937$  MPa,  $t = 84.3$  h)

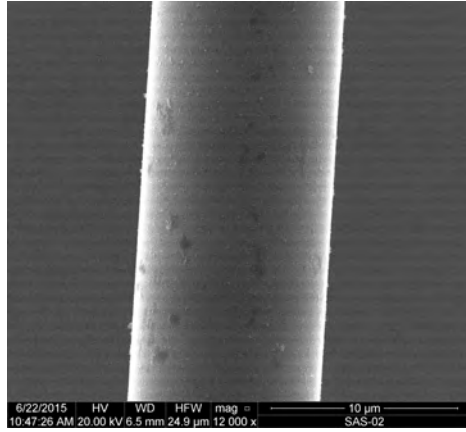
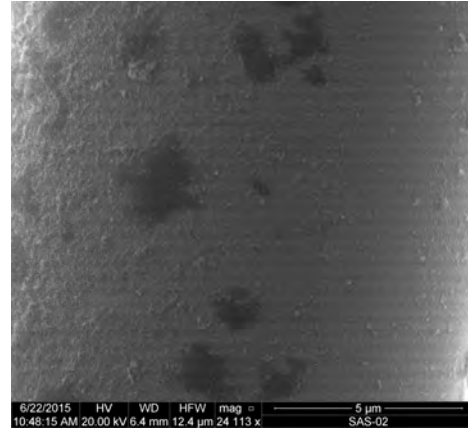
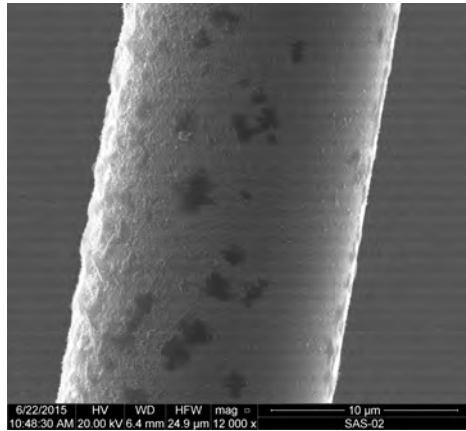
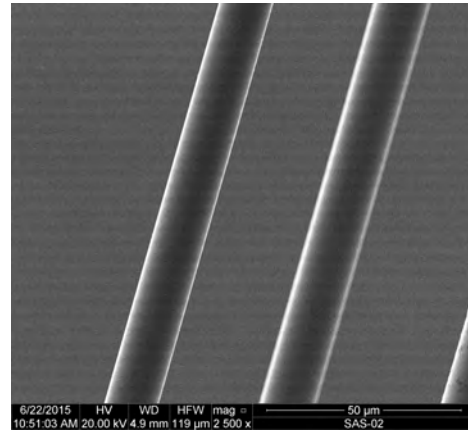
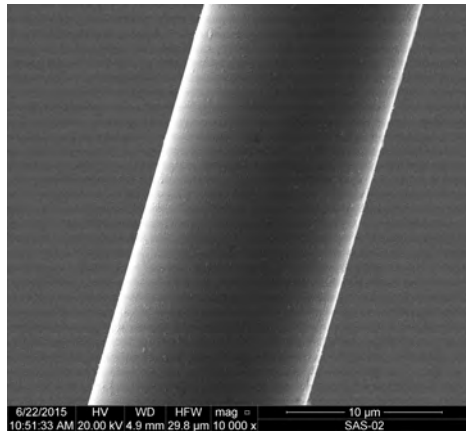
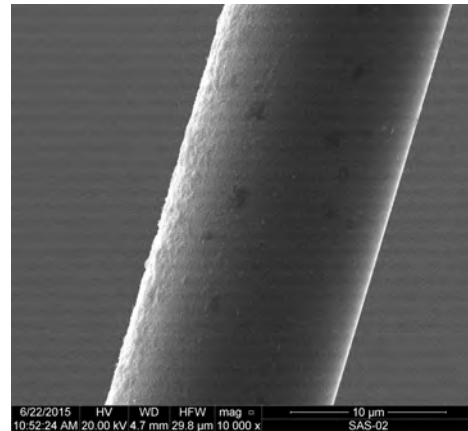
Figure B.9. Hi-Nicalon<sup>TM</sup> S fiber tow specimen A12, center section, (800°C,  $\sigma = 937$  MPa,  $t = 84.3$  h)

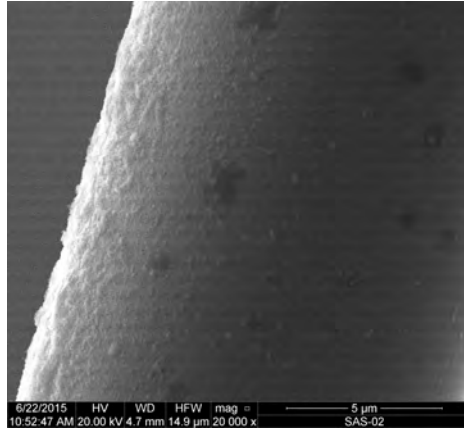
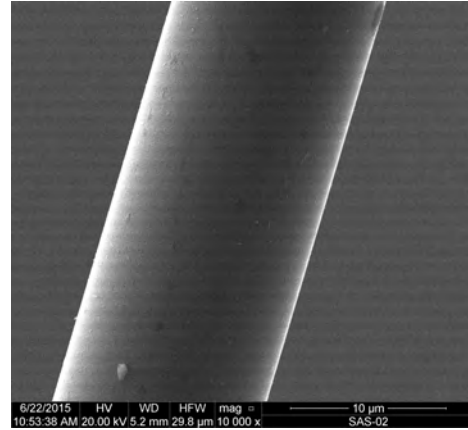
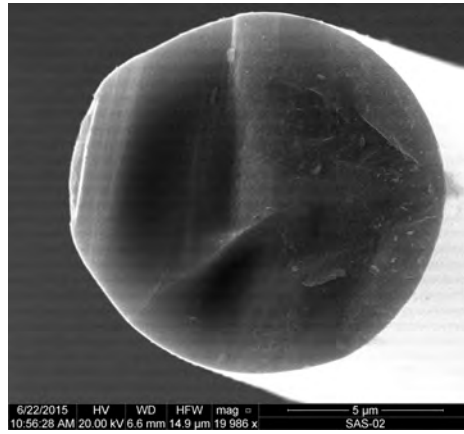
Figure B.10. Hi-Nicalon<sup>TM</sup> S fiber tow specimen A12, center section, (800°C,  $\sigma = 937$  MPa,  $t = 84.3$  h)

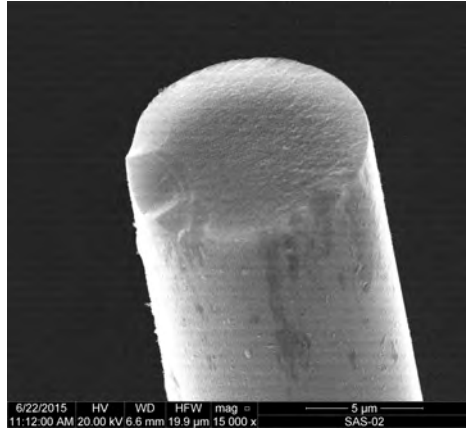
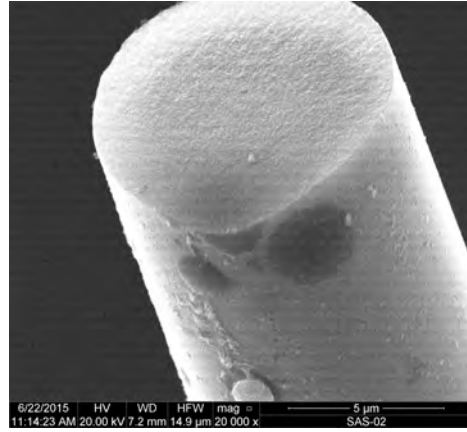
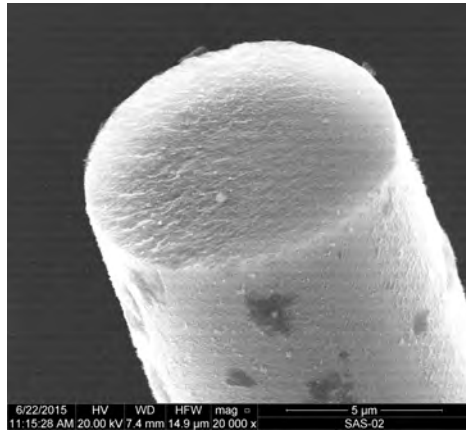
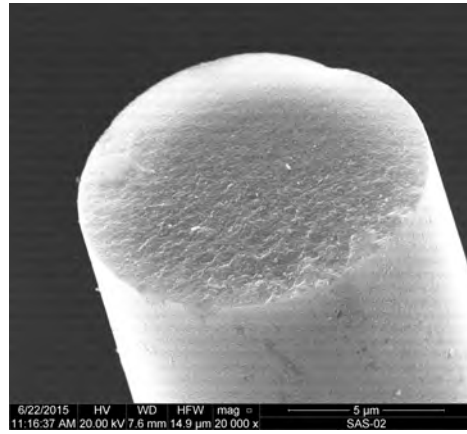
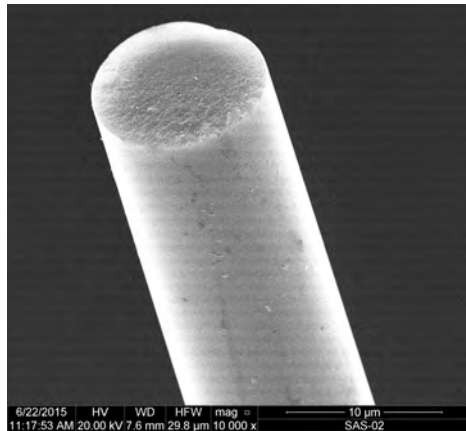
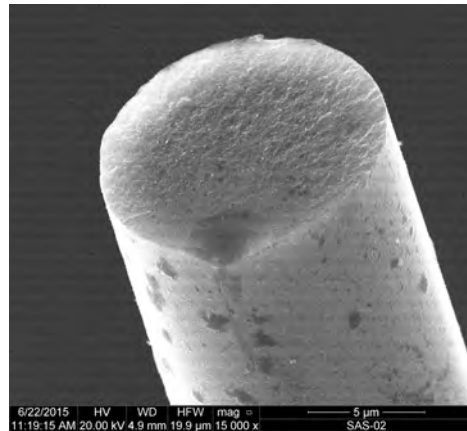
Figure B.11. Hi-Nicalon<sup>TM</sup> S fiber tow specimen A12, fracture surfaces, (800°C,  $\sigma = 937$  MPa,  $t = 84.3$  h)

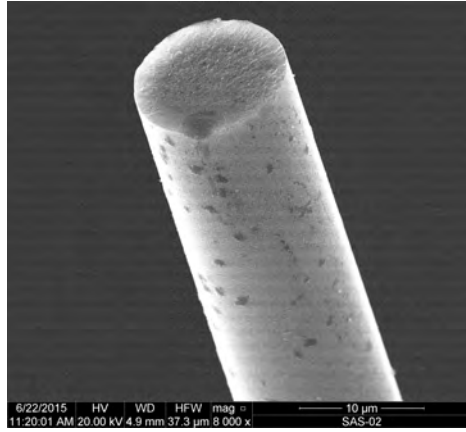
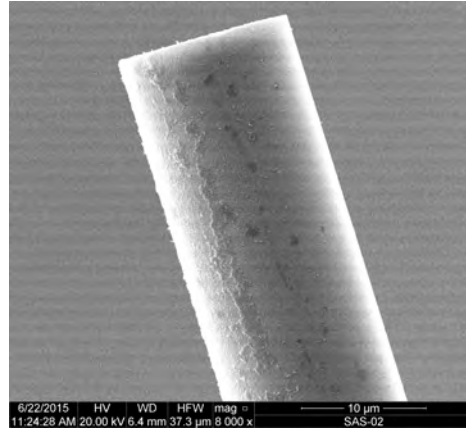
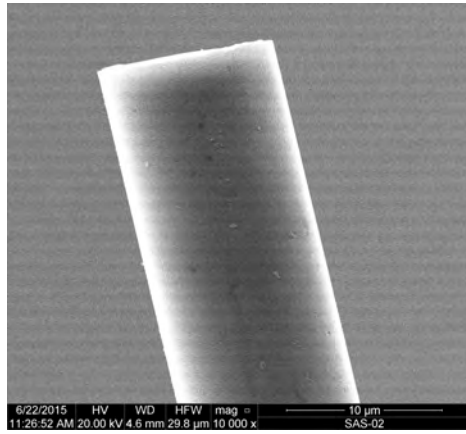
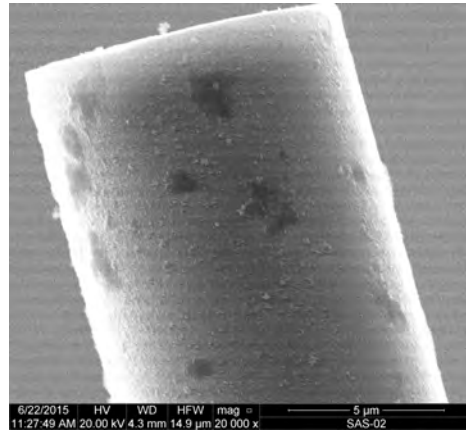
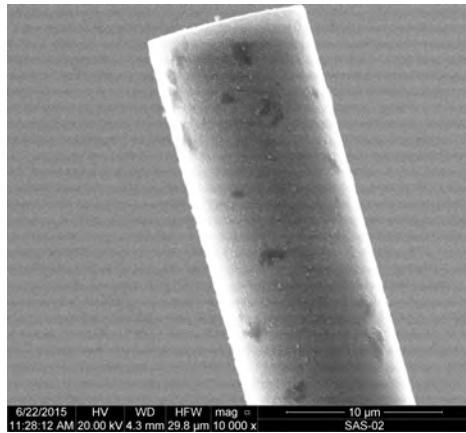
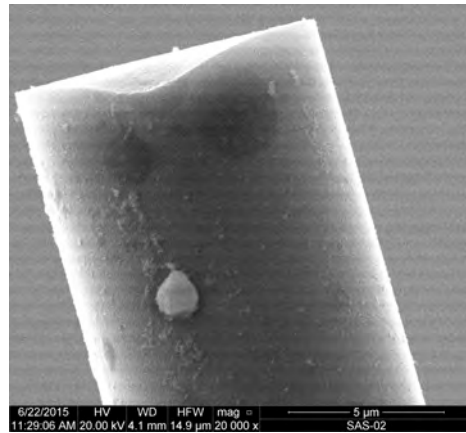
Figure B.12. Hi-Nicalon<sup>TM</sup> S fiber tow specimen A12, fracture surfaces, (800°C,  $\sigma = 937$  MPa,  $t = 84.3$  h)

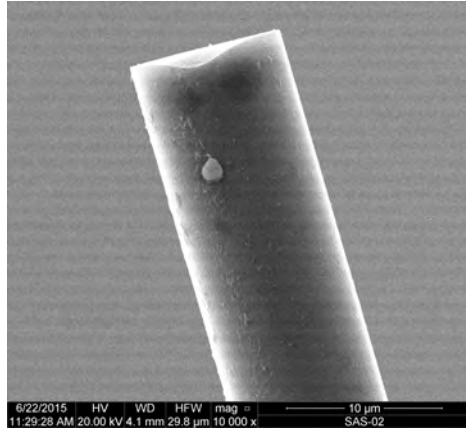
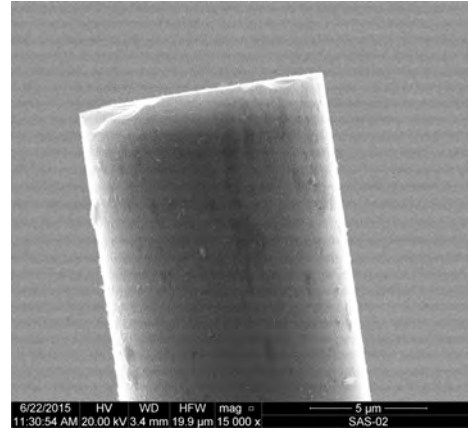
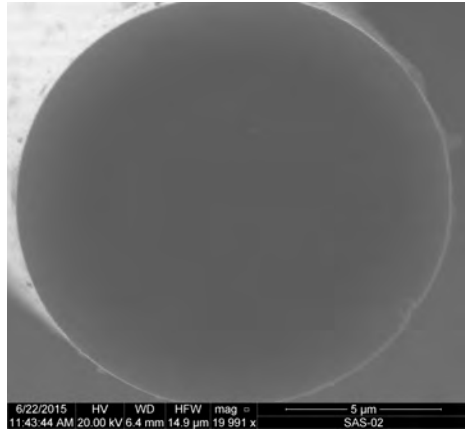
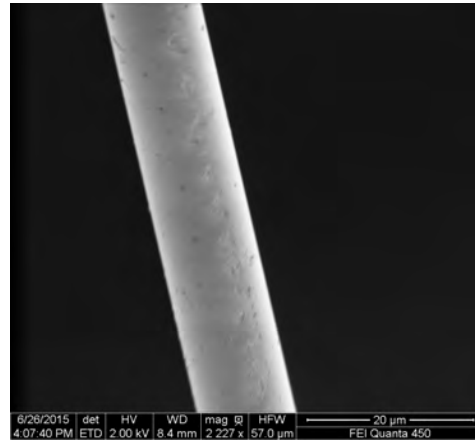
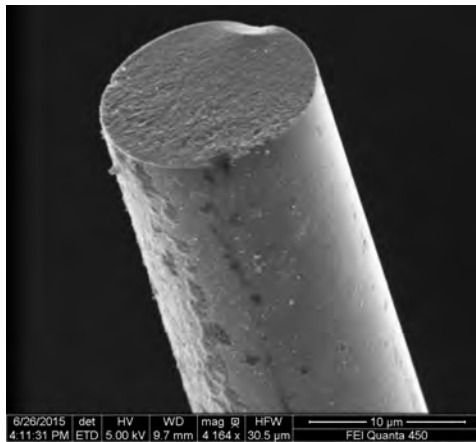
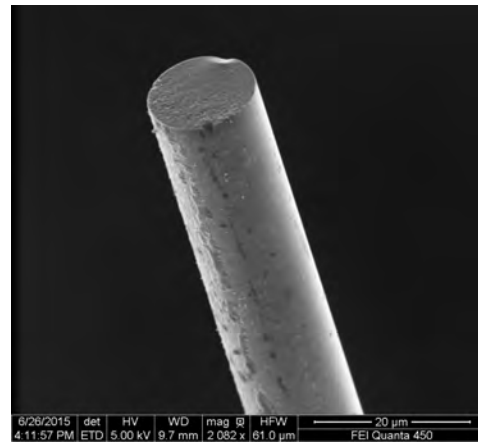
Figure B.13. Hi-Nicalon<sup>TM</sup> S fiber tow specimen A12, fracture surfaces, (800°C,  $\sigma = 937$  MPa,  $t = 84.3$  h)

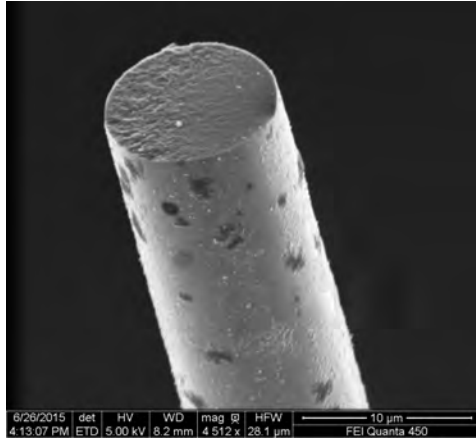
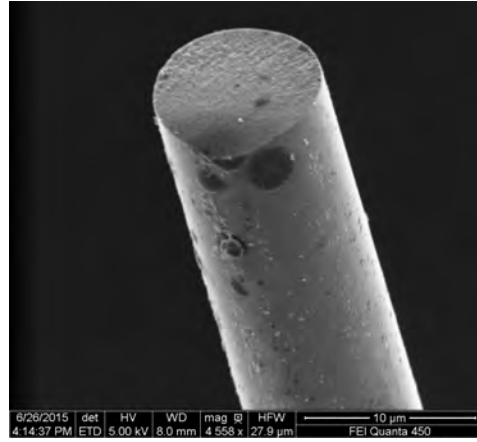
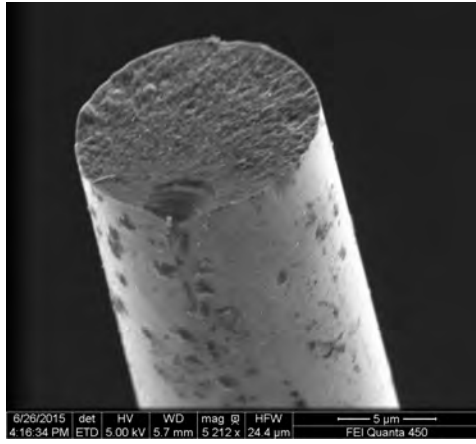
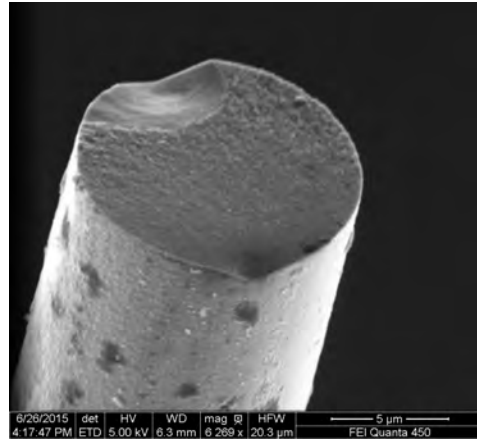
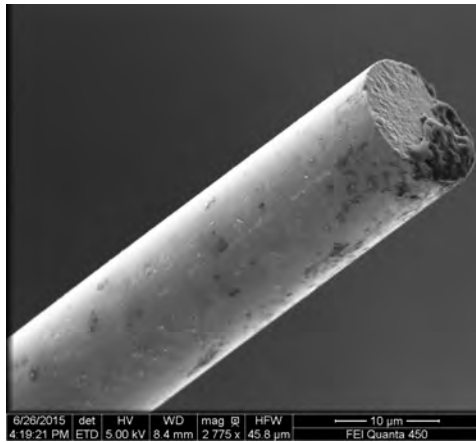
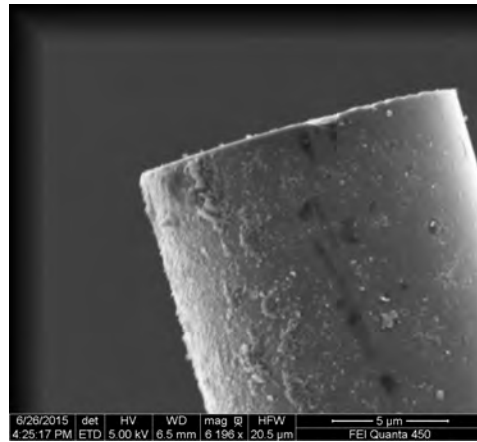
Figure B.14. Hi-Nicalon<sup>TM</sup> S fiber tow specimen A12, fracture surfaces, (800°C,  $\sigma = 937$  MPa,  $t = 84.3$  h)

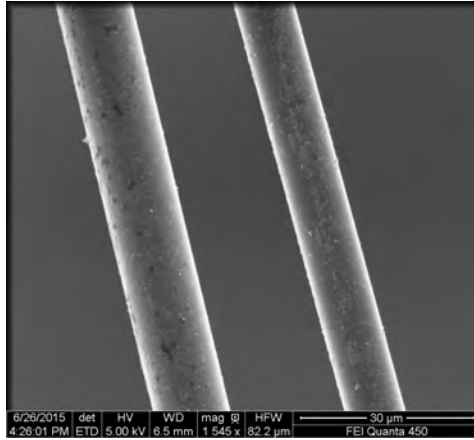
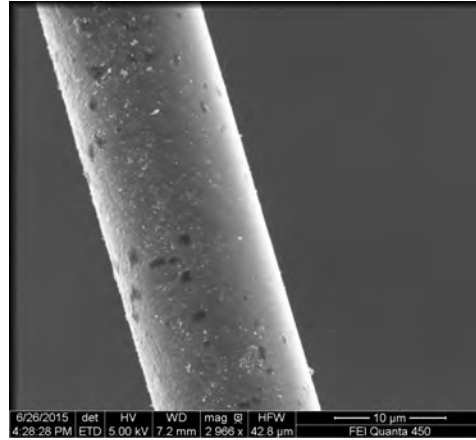
Figure B.15. Hi-Nicalon<sup>TM</sup> S fiber tow specimen A12, fracture surfaces, (800°C,  $\sigma = 937$  MPa,  $t = 84.3$  h)

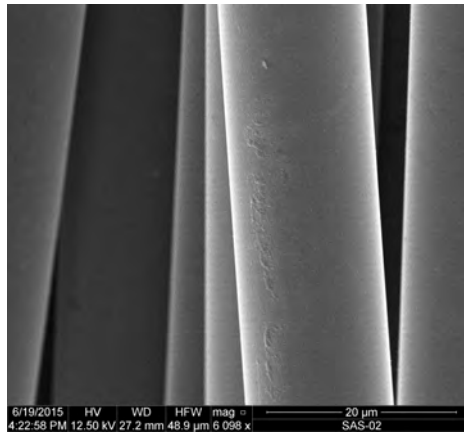
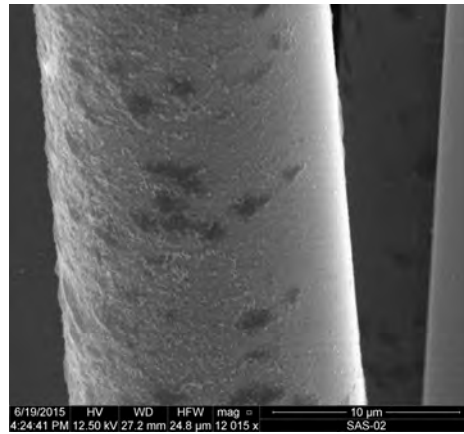
Figure B.16. Hi-Nicalon<sup>TM</sup> S fiber tow specimen A15, center section, (800°C,  $\sigma = 798$  MPa,  $t = 100$  h)

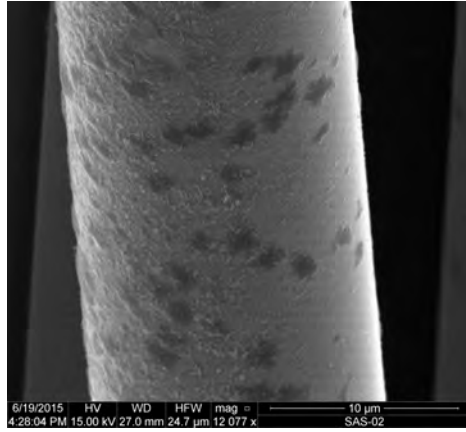
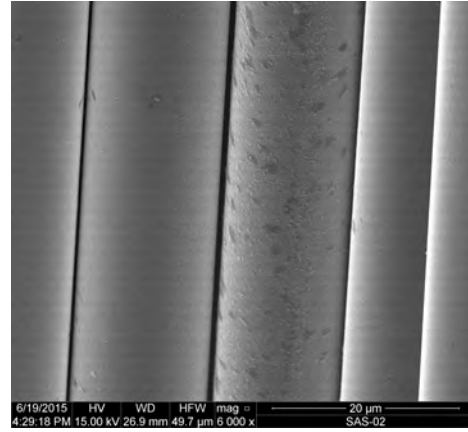
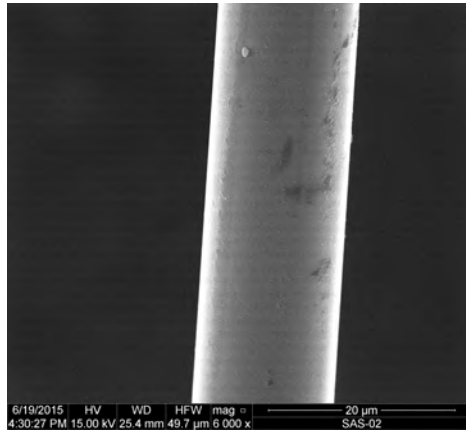
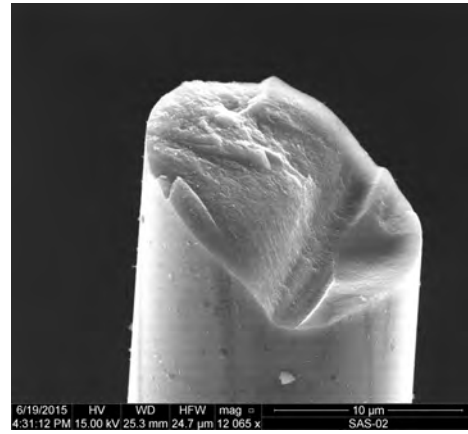
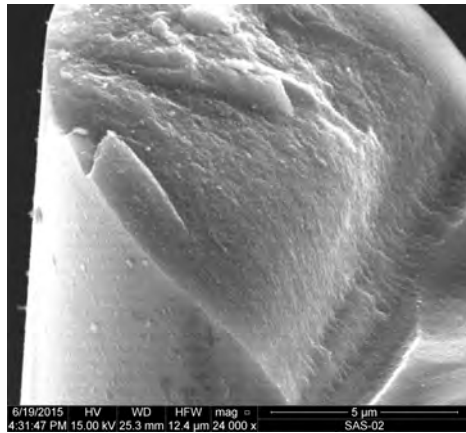
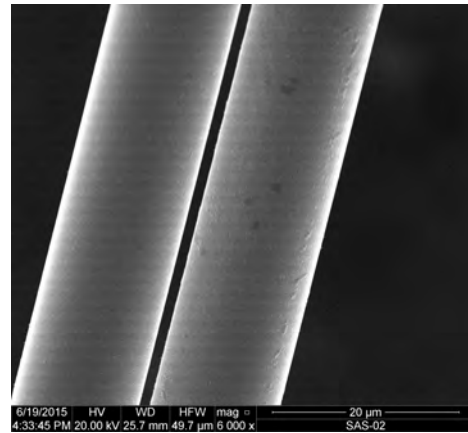
Figure B.17. Hi-Nicalon<sup>TM</sup> S fiber tow specimen A15, center section, (800°C,  $\sigma = 798$  MPa,  $t = 100$  h)

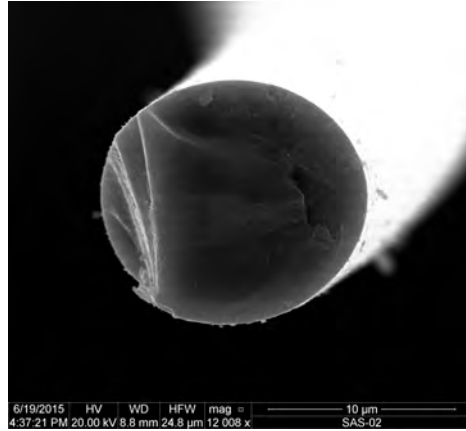
Figure B.18. Hi-Nicalon<sup>TM</sup> S fiber tow specimen A15, center section, (800°C,  $\sigma = 798$  MPa,  $t = 100$  h)

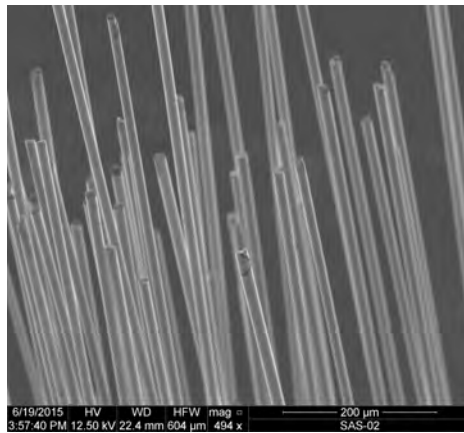
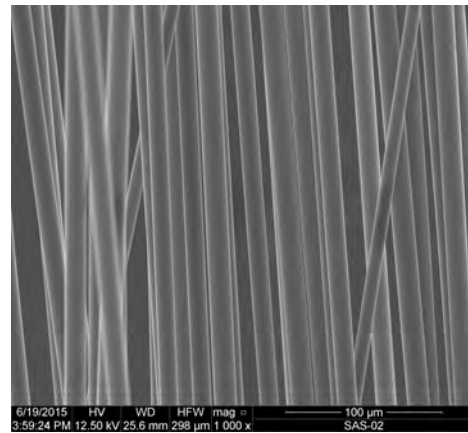
Figure B.19. Hi-Nicalon<sup>TM</sup> S fiber tow specimen A16, center section, (800°C,  $\sigma = 1023$  MPa,  $t = 16.9$  h)

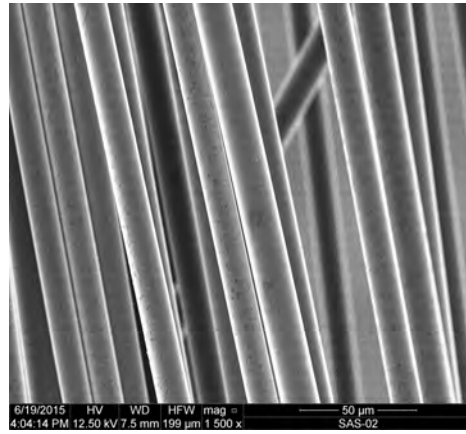
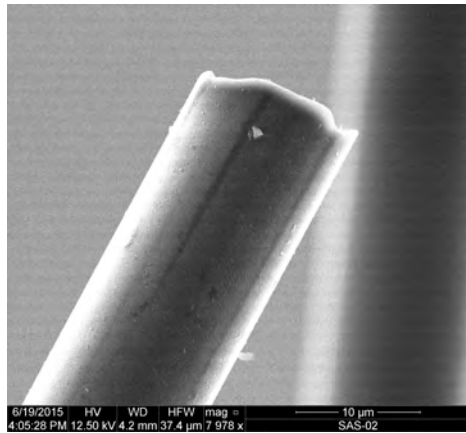
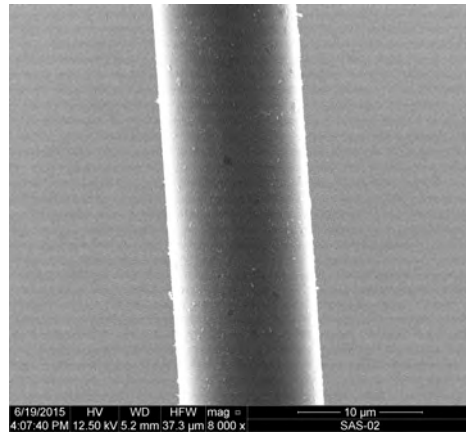
Figure B.20. Hi-Nicalon<sup>TM</sup> S fiber tow specimen A16, center section, (800°C,  $\sigma = 1023$  MPa,  $t = 16.9$  h)

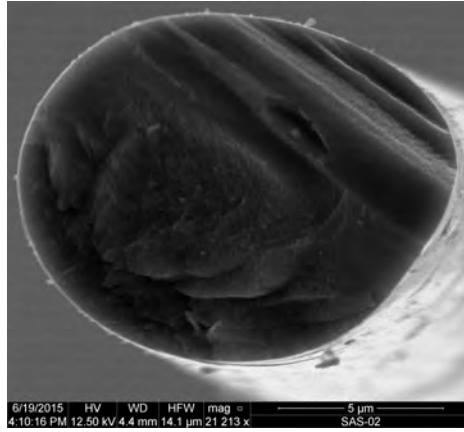
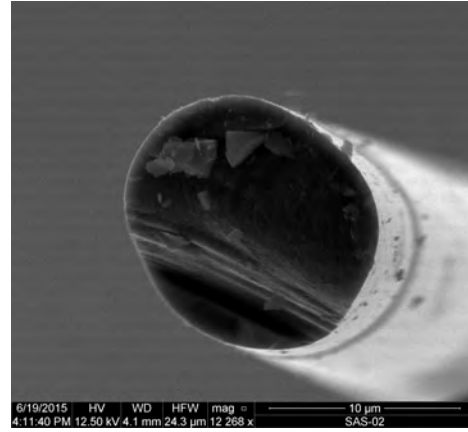
Figure B.21. Hi-Nicalon<sup>TM</sup> S fiber tow specimen A16, center section, (800°C,  $\sigma = 1023$  MPa,  $t = 16.9$  h)

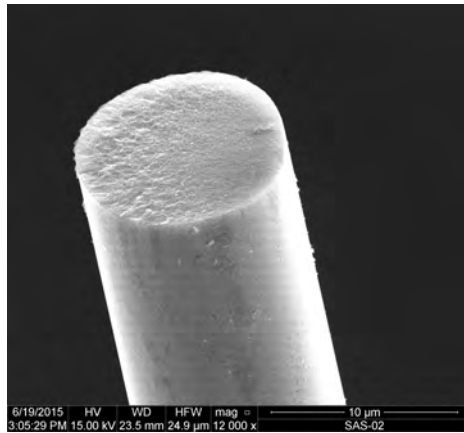
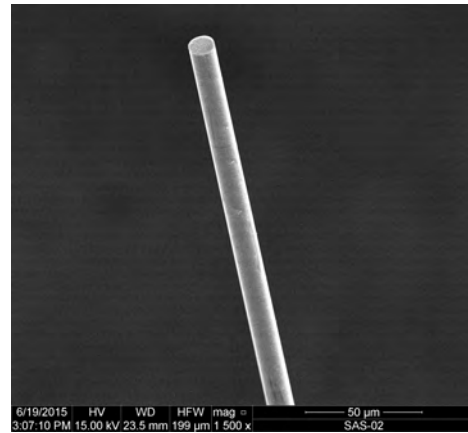
Figure B.22. Hi-Nicalon<sup>TM</sup> S fiber tow specimen A16, fracture surfaces, (800°C,  $\sigma = 1023$  MPa,  $t = 16.9$  h)

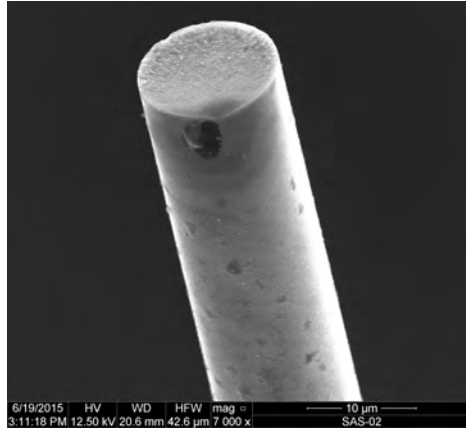
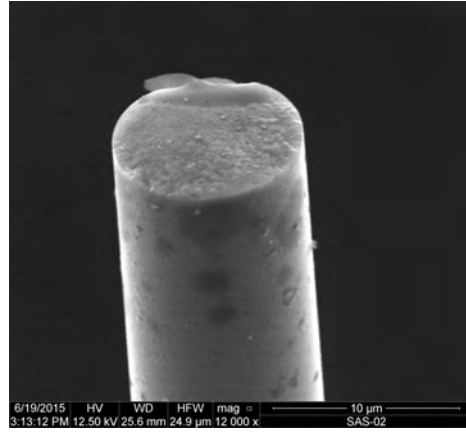
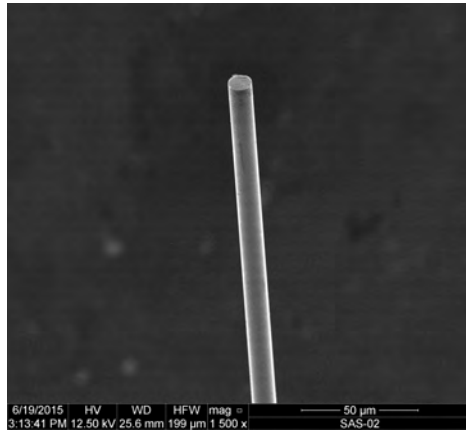
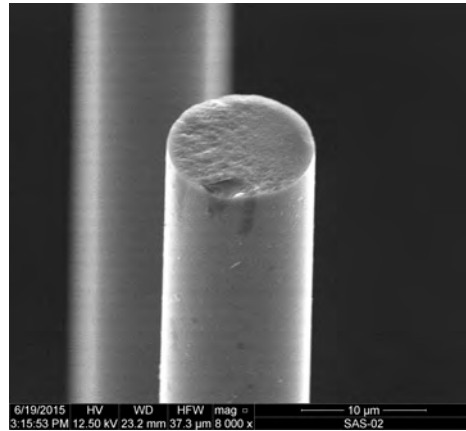
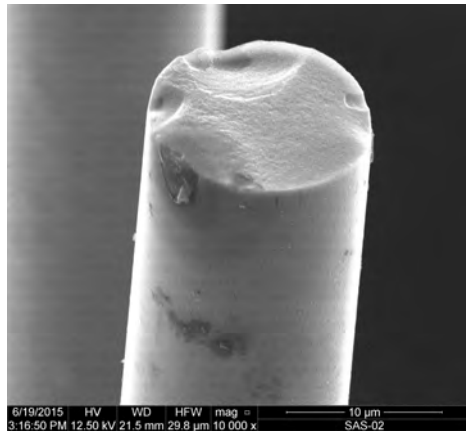
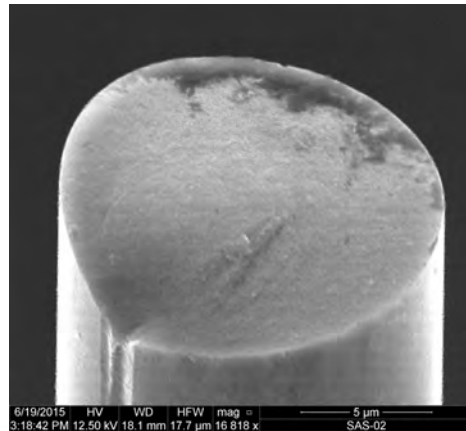
Figure B.23. Hi-Nicalon<sup>TM</sup> S fiber tow specimen A16, fracture surfaces, (800°C,  $\sigma = 1023$  MPa,  $t = 16.9$  h)

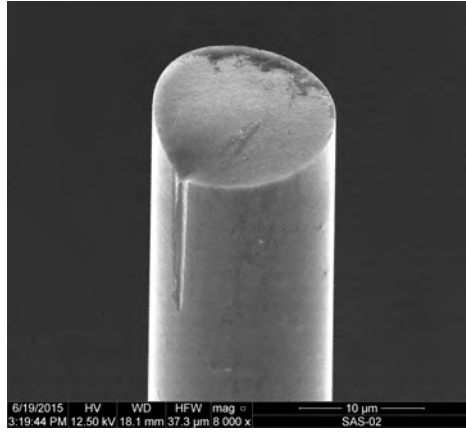
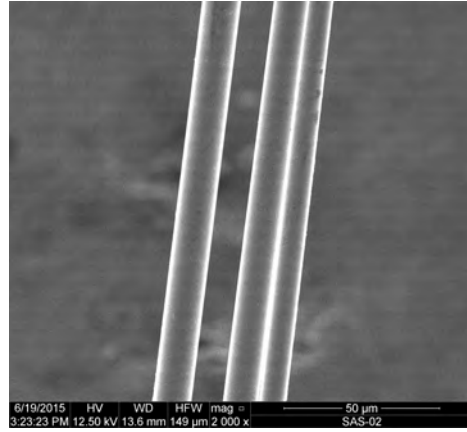
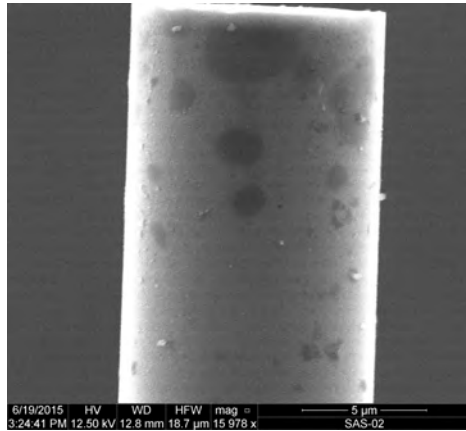
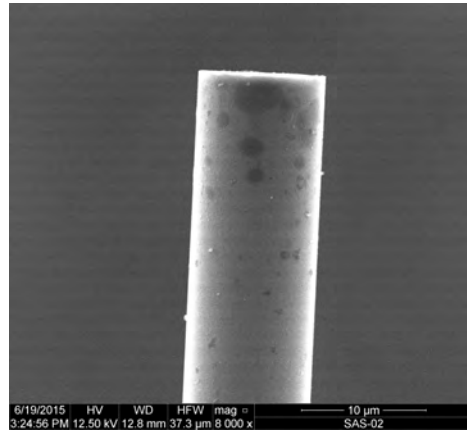
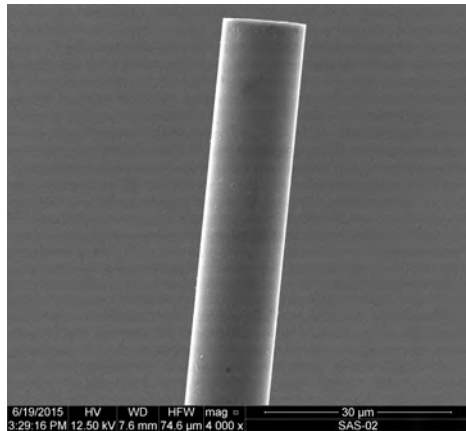
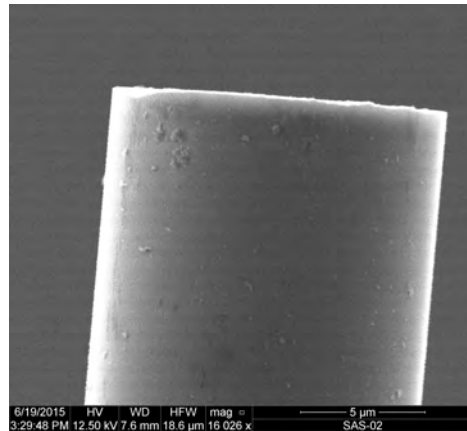
Figure B.24. Hi-Nicalon<sup>TM</sup> S fiber tow specimen A16, fracture surfaces, (800°C,  $\sigma = 1023$  MPa,  $t = 16.9$  h)

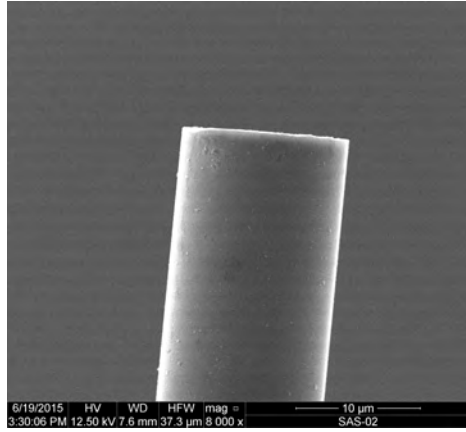
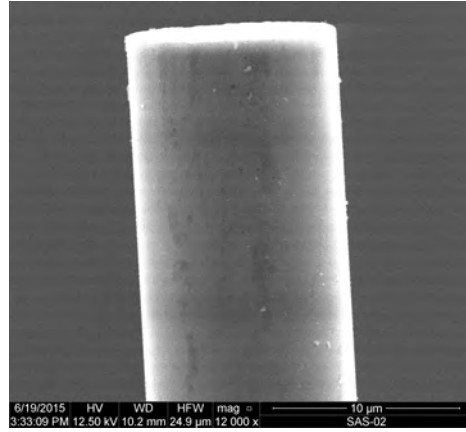
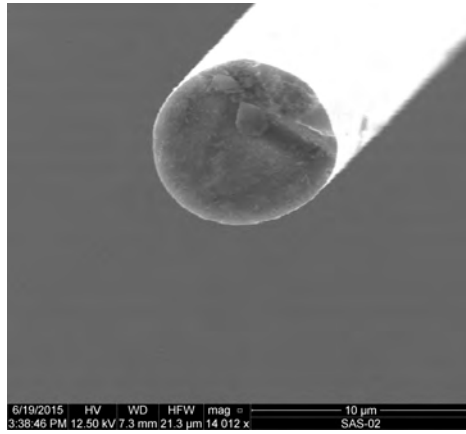
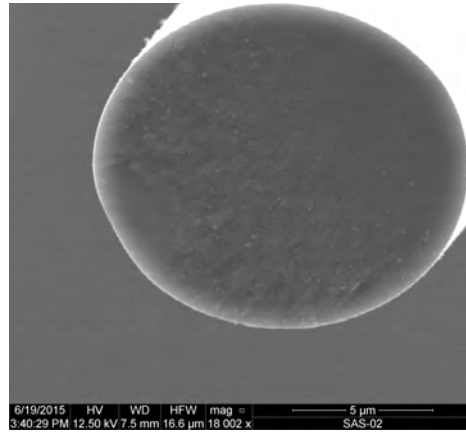
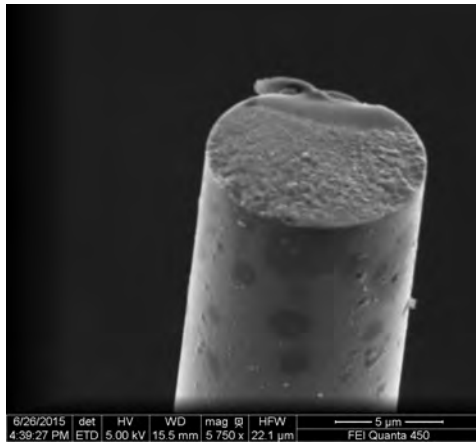
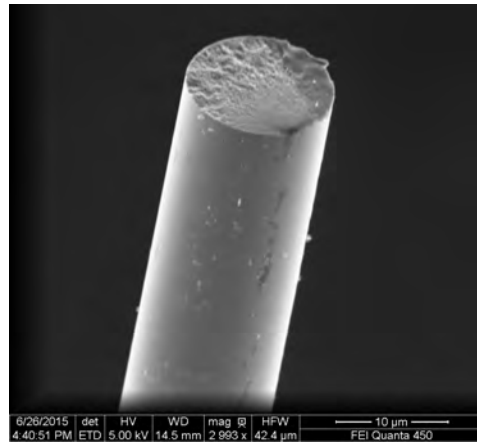
Figure B.25. Hi-Nicalon<sup>TM</sup> S fiber tow specimen A16, fracture surfaces, (800°C,  $\sigma = 1023$  MPa,  $t = 16.9$  h)

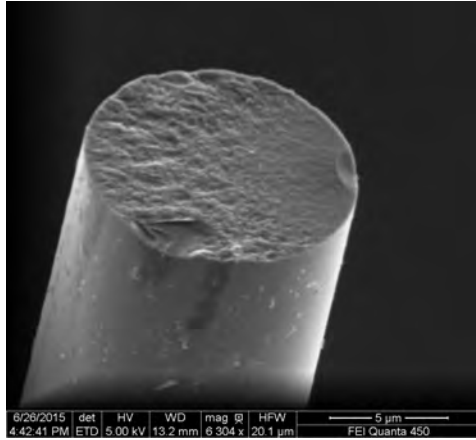
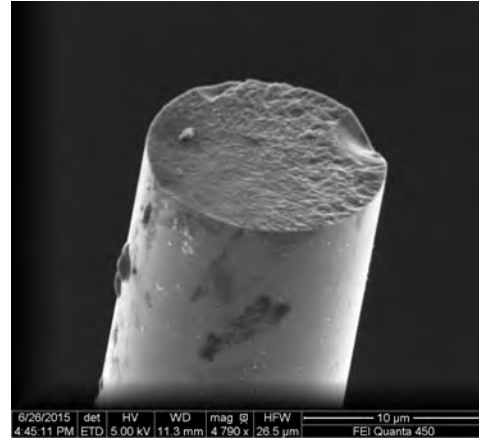
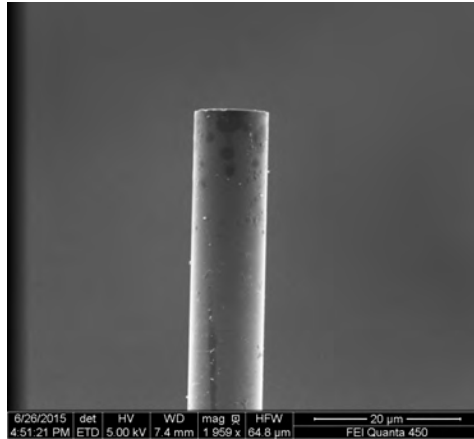
Figure B.26. Hi-Nicalon<sup>TM</sup> S fiber tow specimen A16, fracture surfaces, (800°C,  $\sigma = 1023$  MPa,  $t = 16.9$  h)

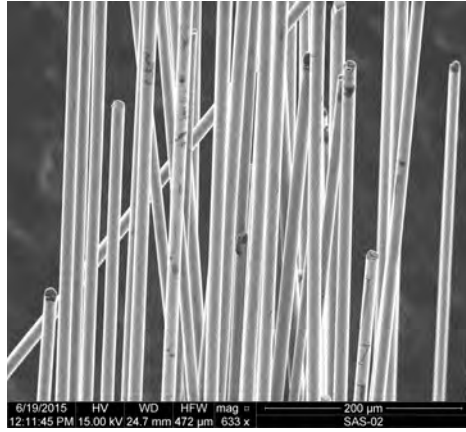
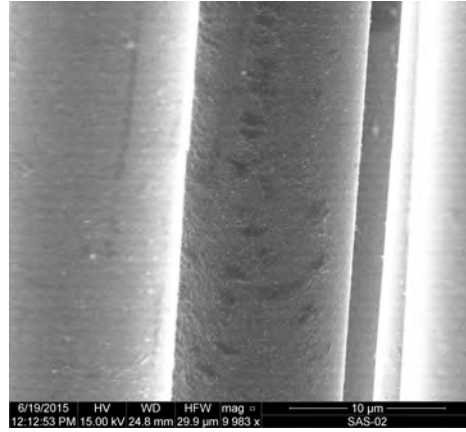
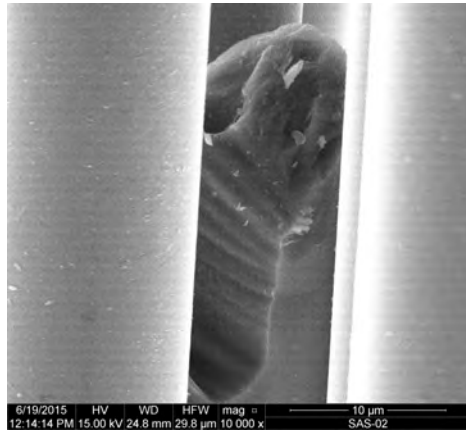
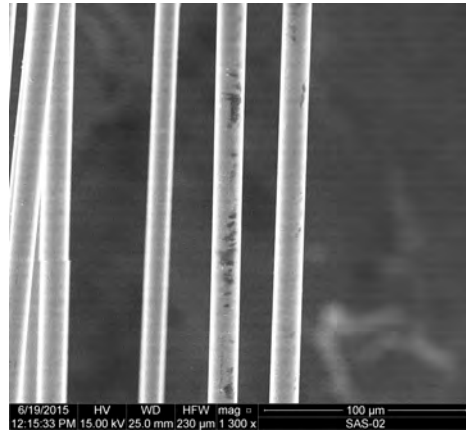
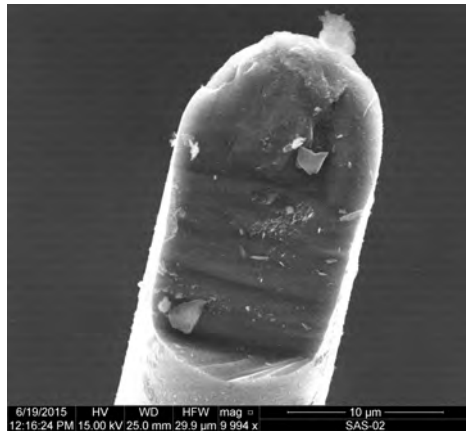
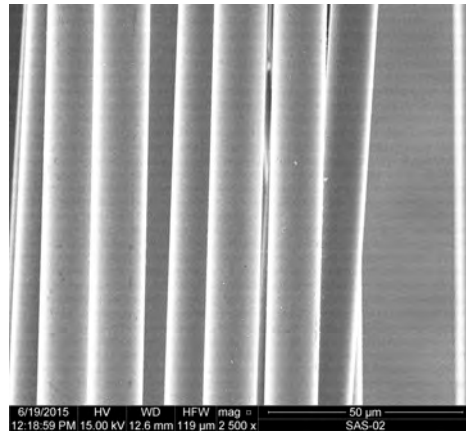
Figure B.27. Hi-Nicalon<sup>TM</sup> S fiber tow specimen A17, center section, (800°C,  $\sigma = 980$  MPa,  $t = 17.4$  h)

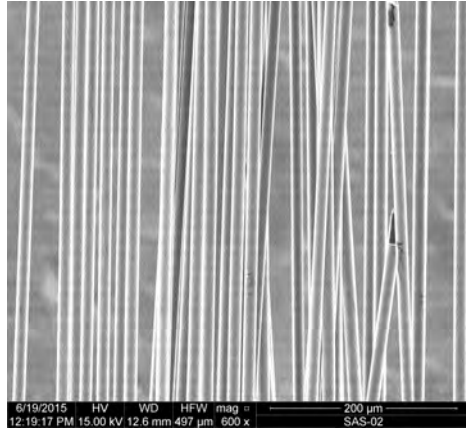
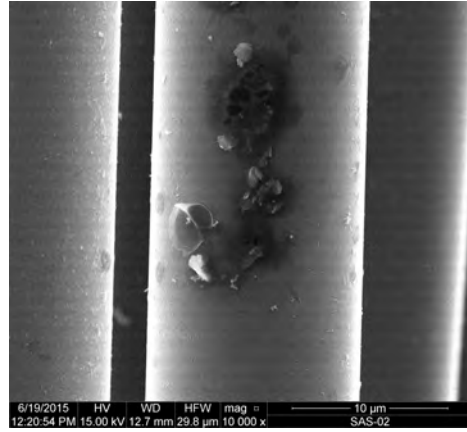
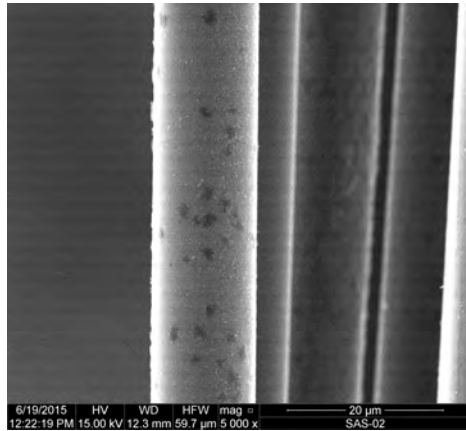
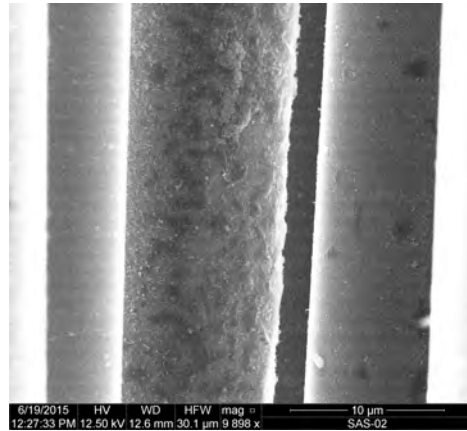
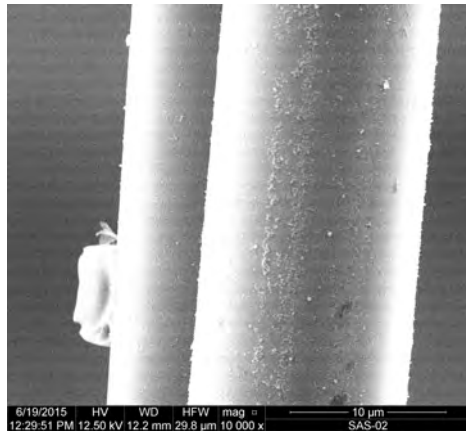
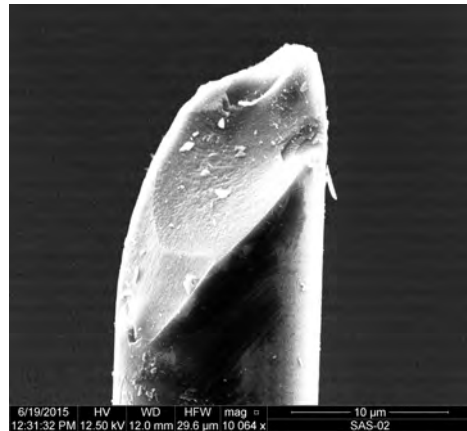
Figure B.28. Hi-Nicalon<sup>TM</sup> S fiber tow specimen A17, center section, (800°C,  $\sigma = 980$  MPa,  $t = 17.4$  h)

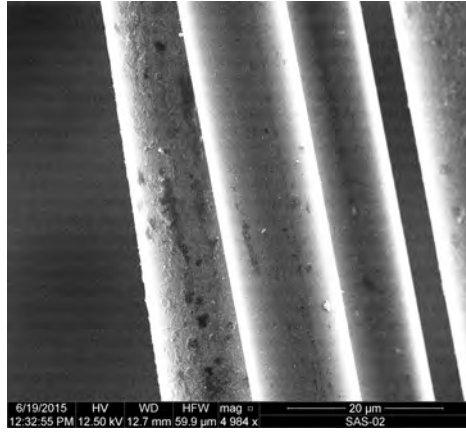
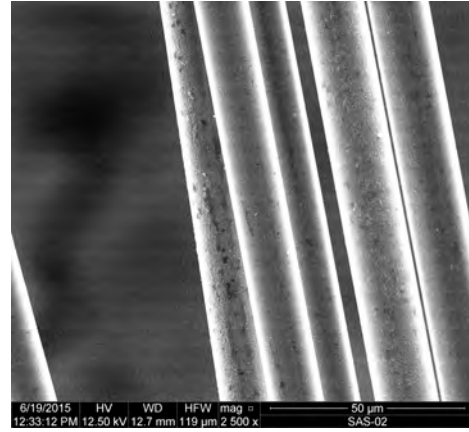
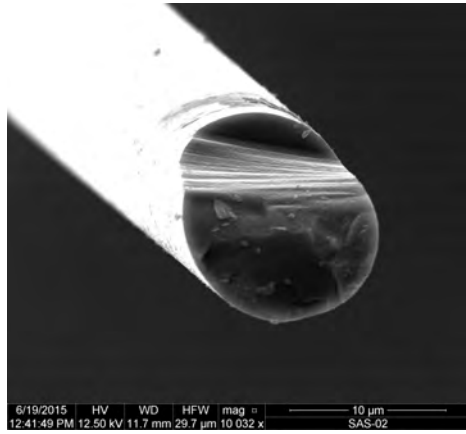
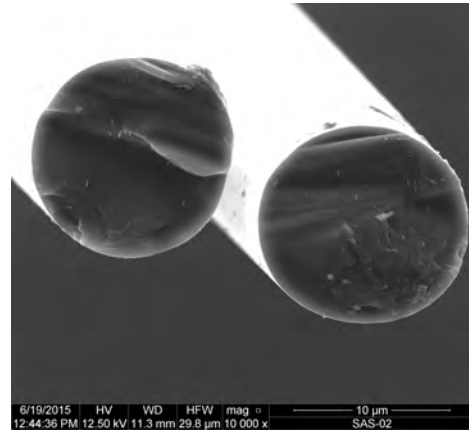
Figure B.29. Hi-Nicalon<sup>TM</sup> S fiber tow specimen A17, center section, (800°C,  $\sigma = 980$  MPa,  $t = 17.4$  h)

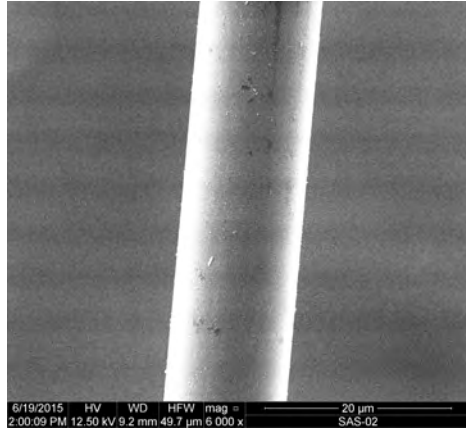
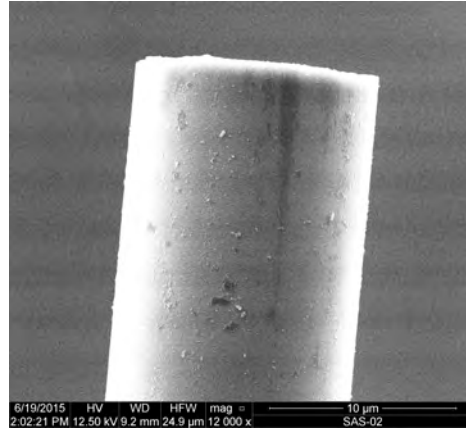
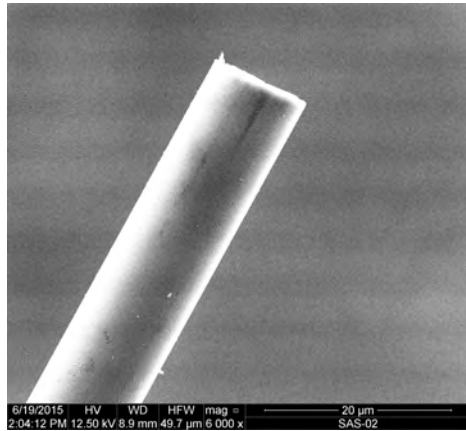
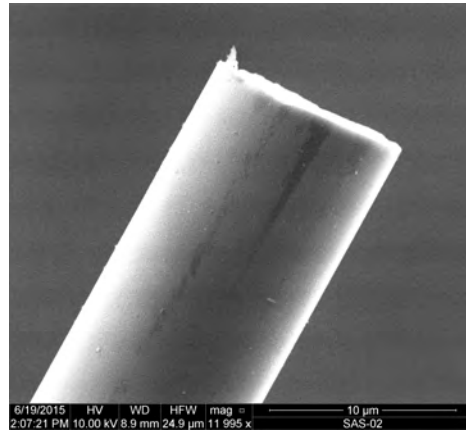
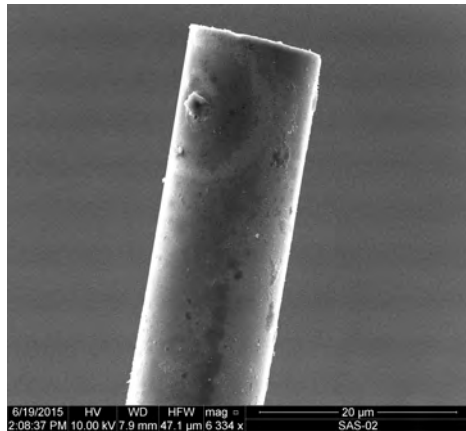
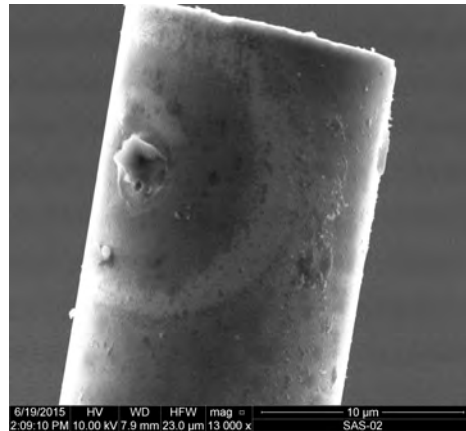
Figure B.30. Hi-Nicalon<sup>TM</sup> S fiber tow specimen A17, fracture surfaces, (800°C,  $\sigma = 980$  MPa,  $t = 17.4$  h)
