**CREEP OF HI-NICALON<sup>TM</sup> S CERAMIC  
FIBER TOWS AT 800°C IN AIR AND IN  
SILICIC ACID-SATURATED STEAM**

DISSERTATION

AFIT-ENY-DS-15-S-067

***AIR FORCE INSTITUTE OF TECHNOLOGY***

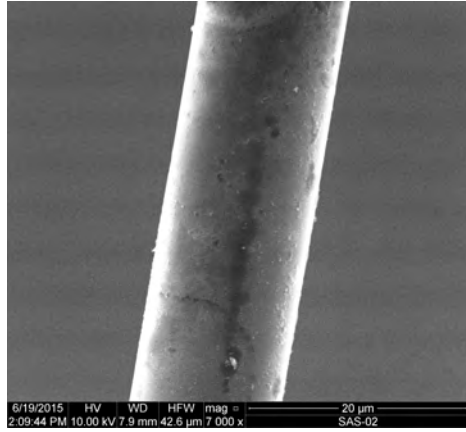
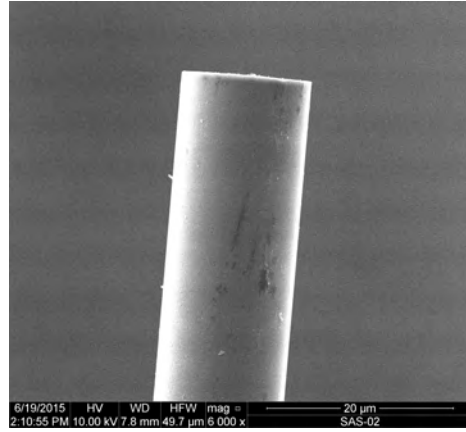
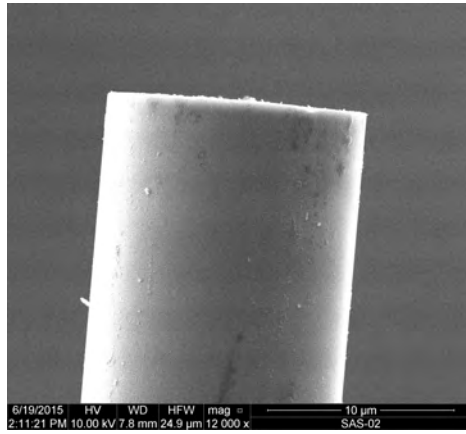
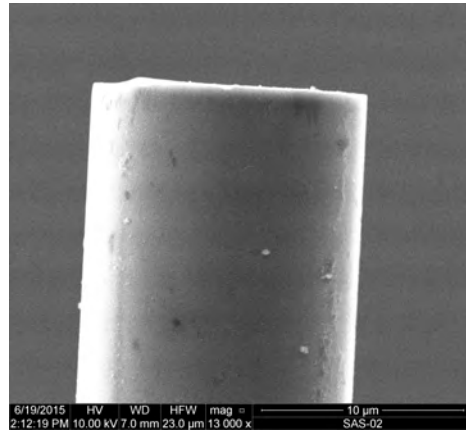
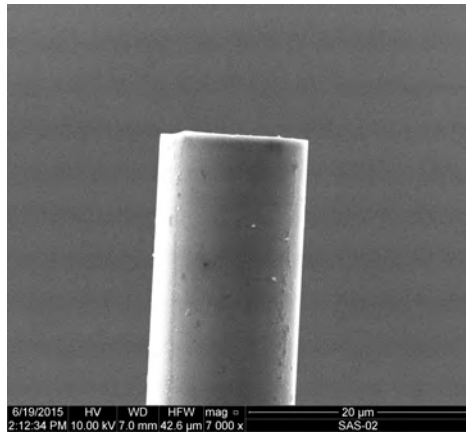
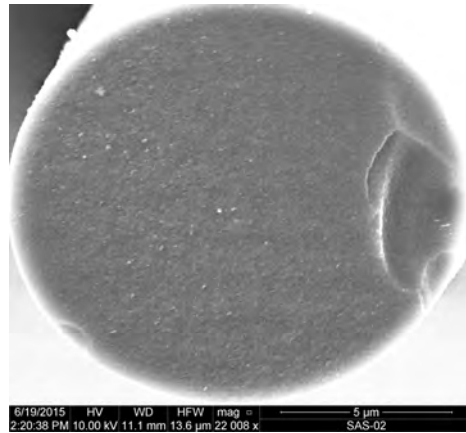
Figure B.31. Hi-Nicalon<sup>TM</sup> S fiber tow specimen A17, fracture surfaces, (800°C,  $\sigma = 980$  MPa,  $t = 17.4$  h)

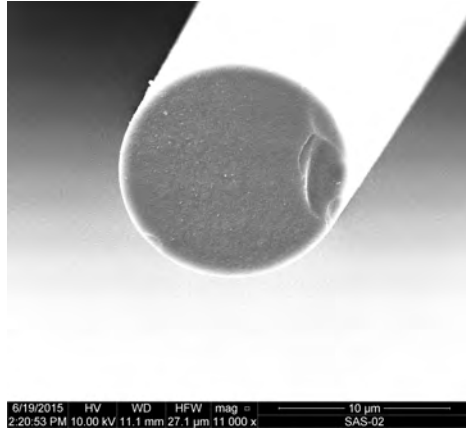
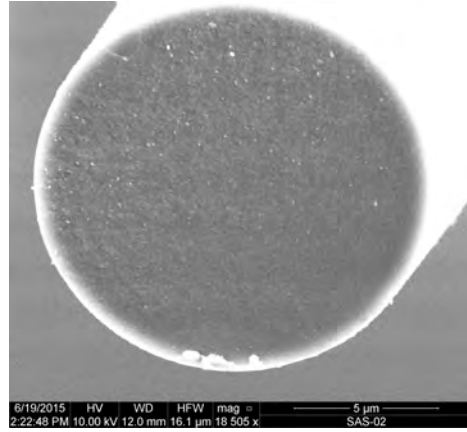
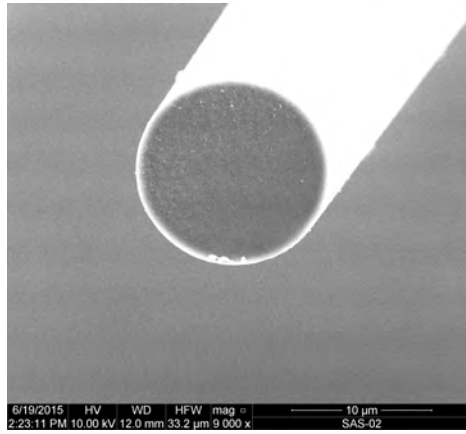
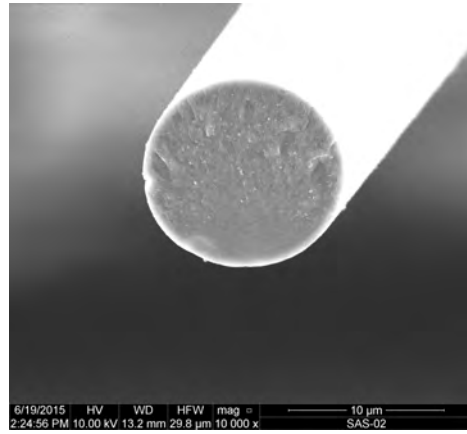
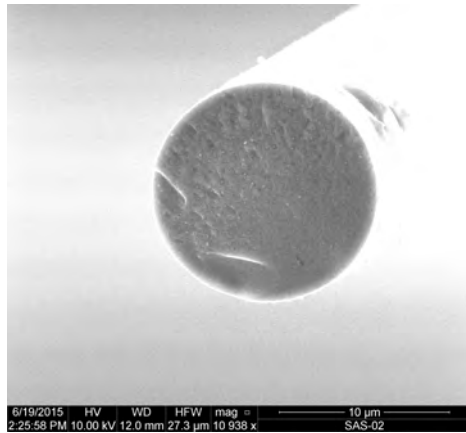
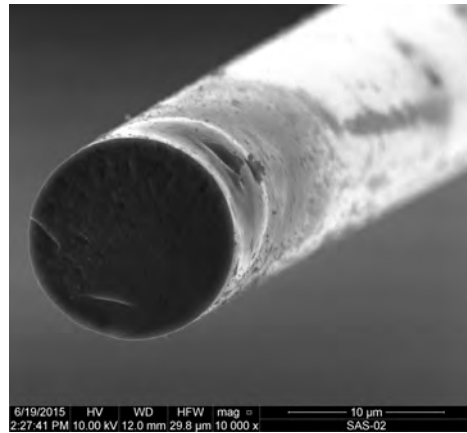
Figure B.32. Hi-Nicalon<sup>TM</sup> S fiber tow specimen A17, fracture surfaces, (800°C,  $\sigma = 980$  MPa,  $t = 17.4$  h)

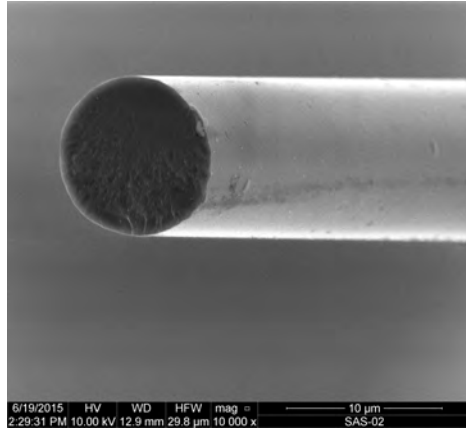
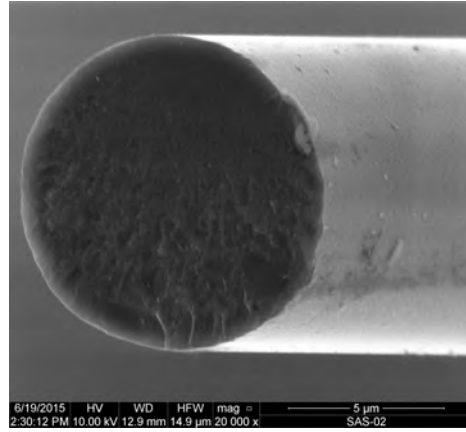
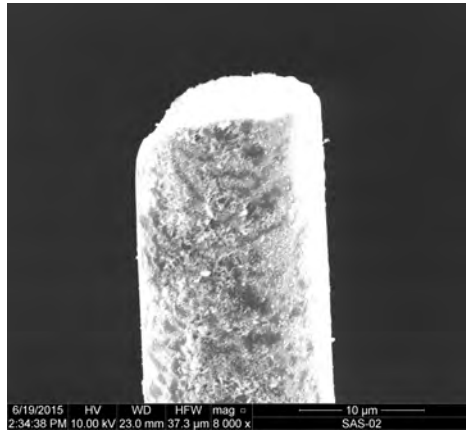
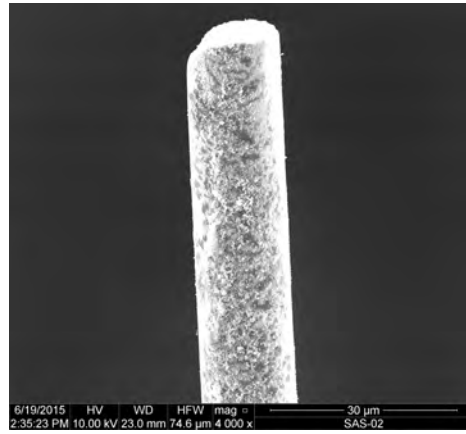
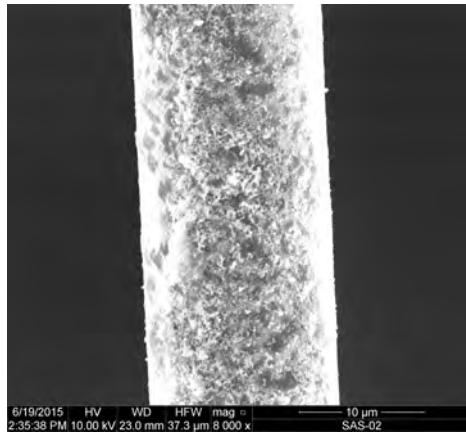
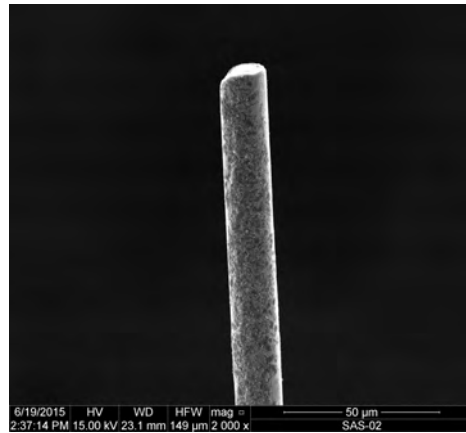
Figure B.33. Hi-Nicalon<sup>TM</sup> S fiber tow specimen A17, fracture surfaces, (800°C,  $\sigma = 980$  MPa,  $t = 17.4$  h)

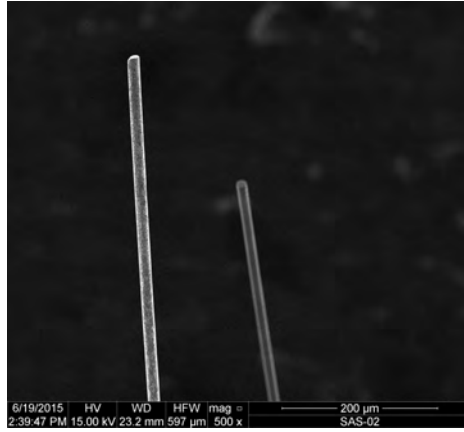
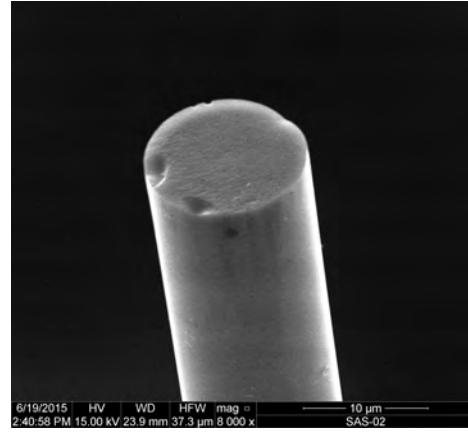
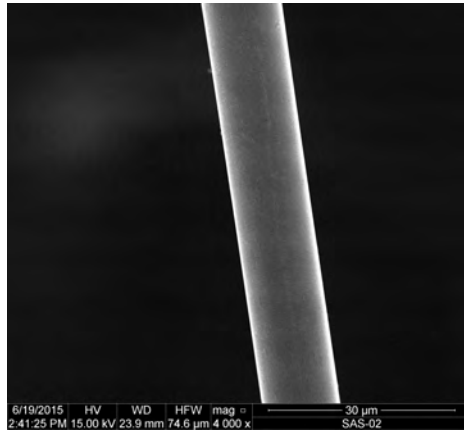
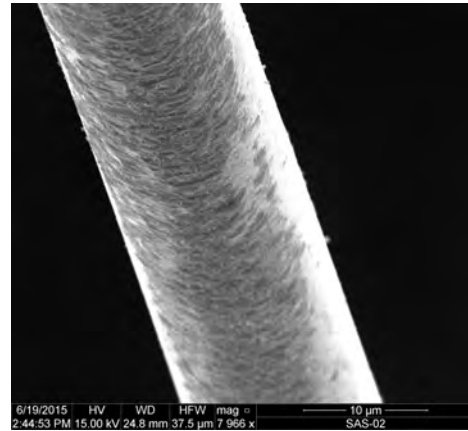
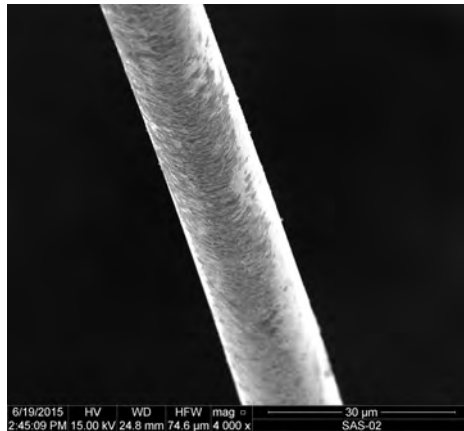
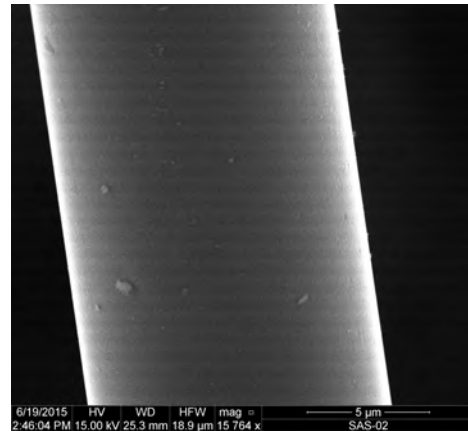
Figure B.34. Hi-Nicalon<sup>TM</sup> S fiber tow specimen A17, fracture surfaces, (800°C,  $\sigma = 980$  MPa,  $t = 17.4$  h)

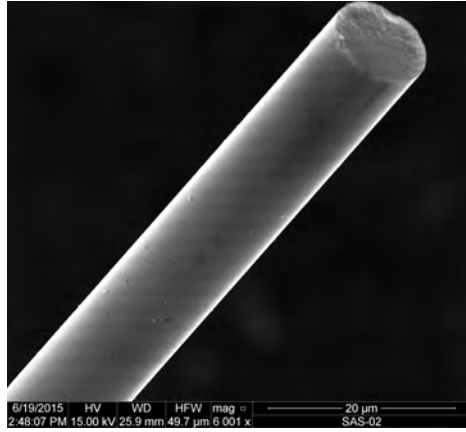
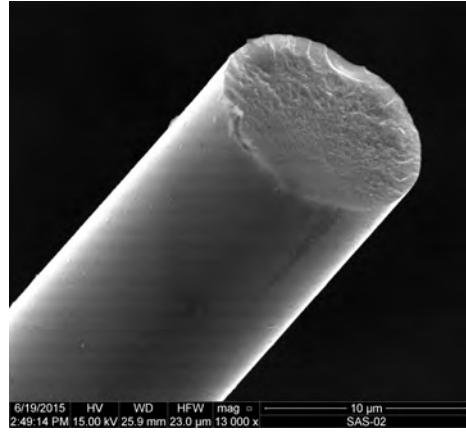
Figure B.35. Hi-Nicalon<sup>TM</sup> S fiber tow specimen A17, fracture surfaces, (800°C,  $\sigma = 980$  MPa,  $t = 17.4$  h)

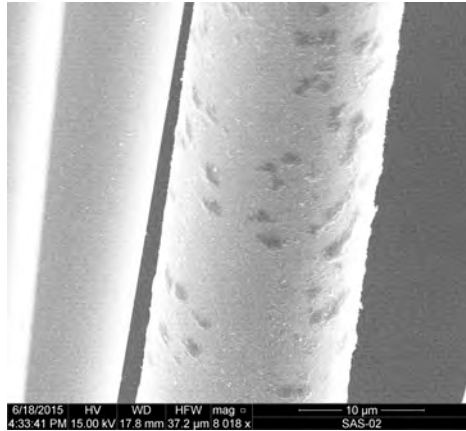
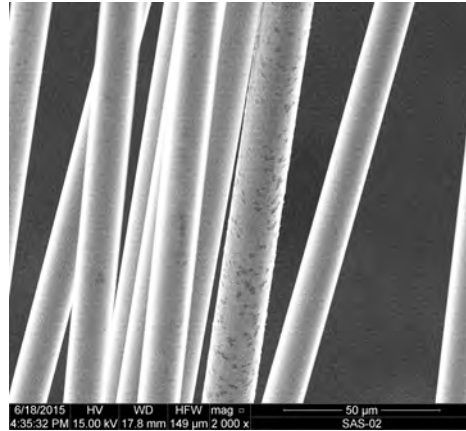
Figure B.36. Hi-Nicalon<sup>TM</sup> S fiber tow specimen A21, center section, (800°C,  $\sigma = 960$  MPa,  $t = 100$  h)

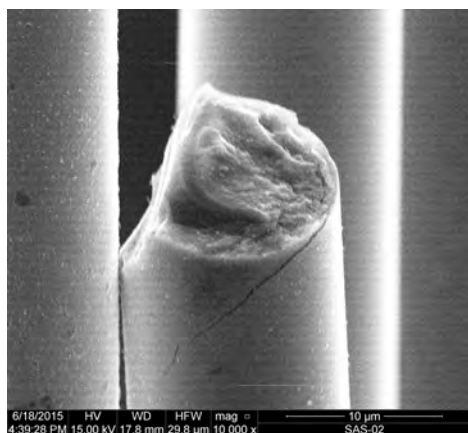
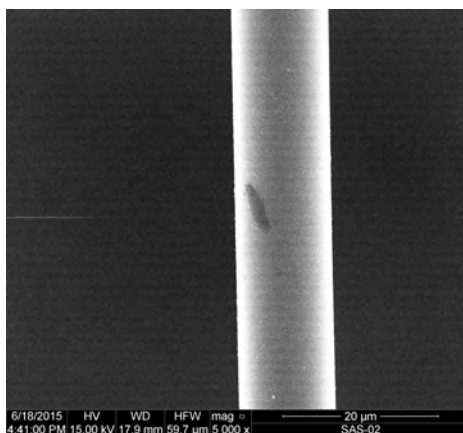
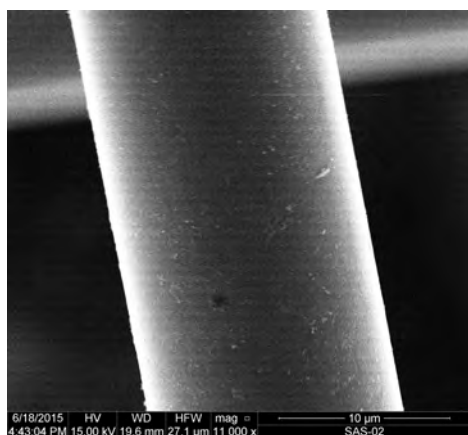
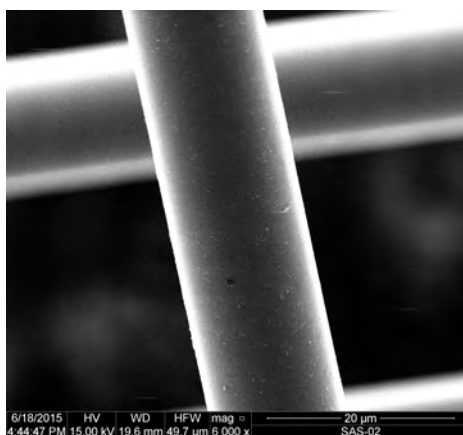
Figure B.37. Hi-Nicalon<sup>TM</sup> S fiber tow specimen A21, center section, (800°C,  $\sigma = 960$  MPa,  $t = 100$  h)

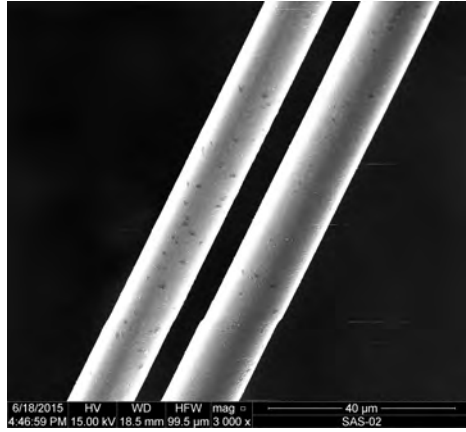
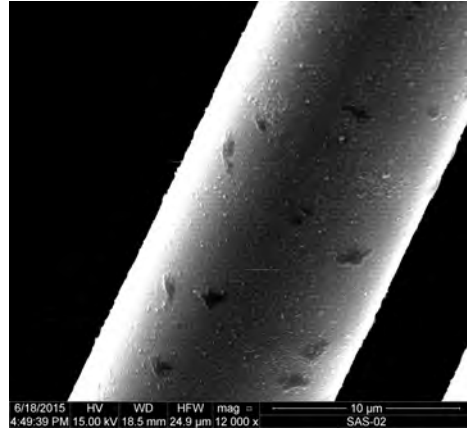
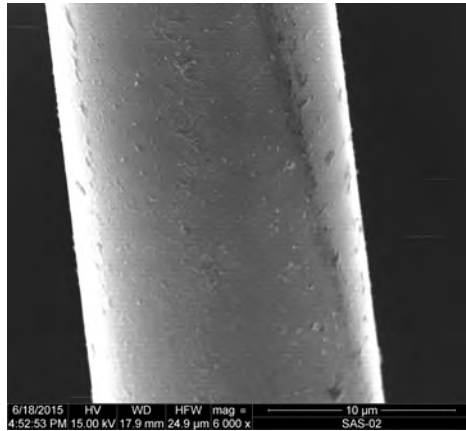
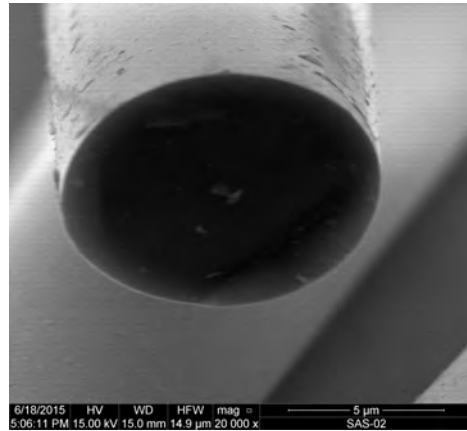
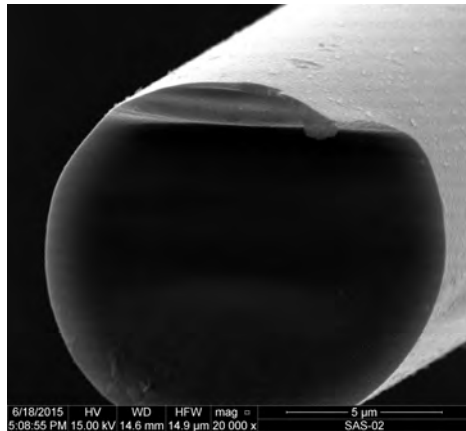
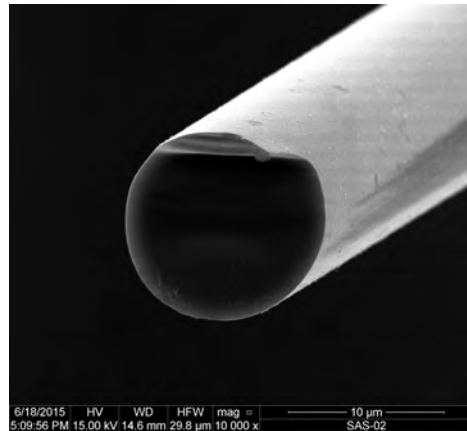
Figure B.38. Hi-Nicalon<sup>TM</sup> S fiber tow specimen A21, center section, (800°C,  $\sigma = 960$  MPa,  $t = 100$  h)

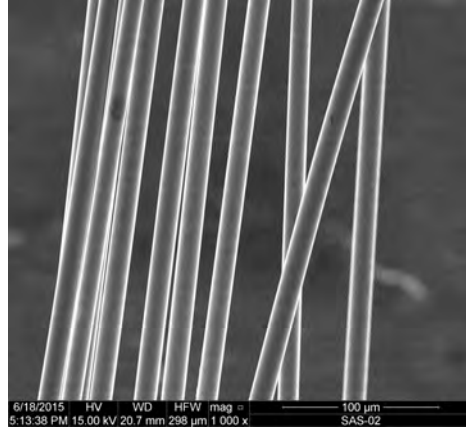
Figure B.39. Hi-Nicalon<sup>TM</sup> S fiber tow specimen A21, center section, (800°C,  $\sigma = 960$  MPa,  $t = 100$  h)

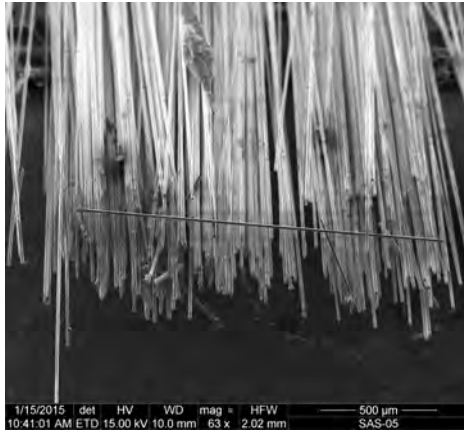
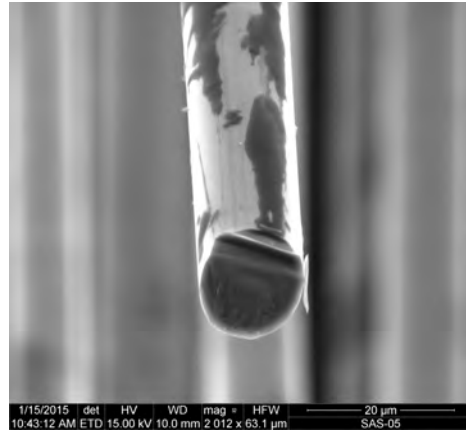
Figure B.40. Hi-Nicalon<sup>TM</sup> S fiber tow specimen SS1, lower section, (800°C,  $\sigma = 2.96$  MPa,  $t = 100$  h)

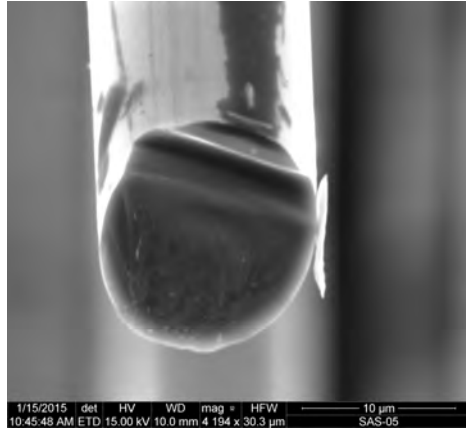
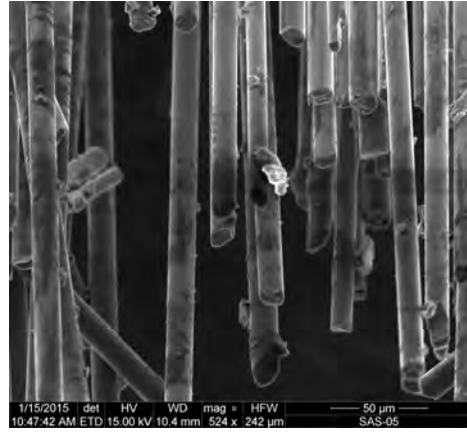
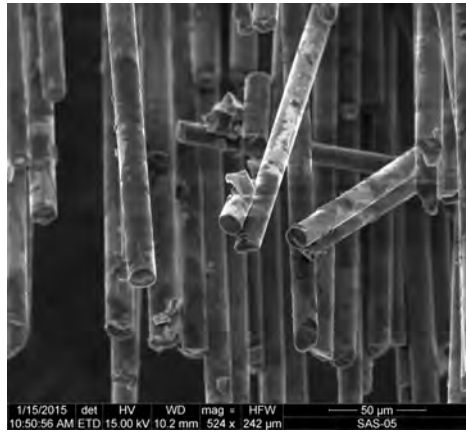
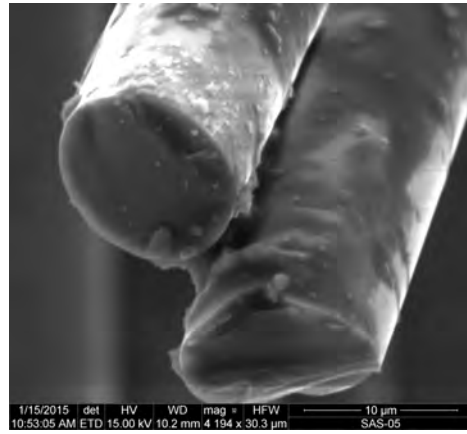
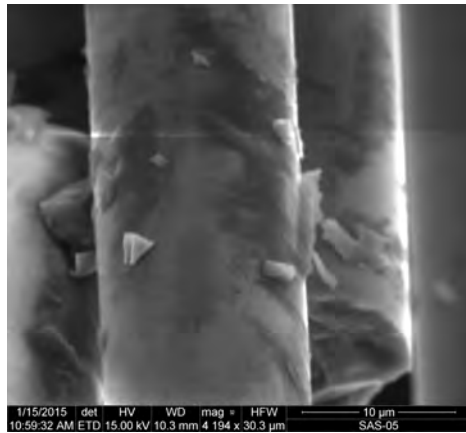
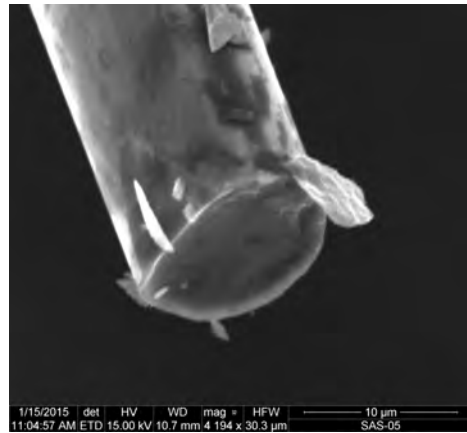
Figure B.41. Hi-Nicalon<sup>TM</sup> S fiber tow specimen SS1, lower section, (800°C,  $\sigma = 2.96$  MPa,  $t = 100$  h)

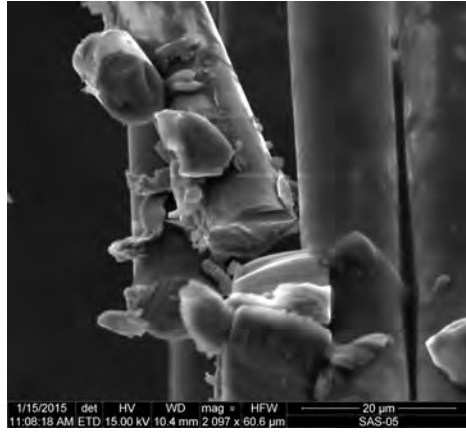
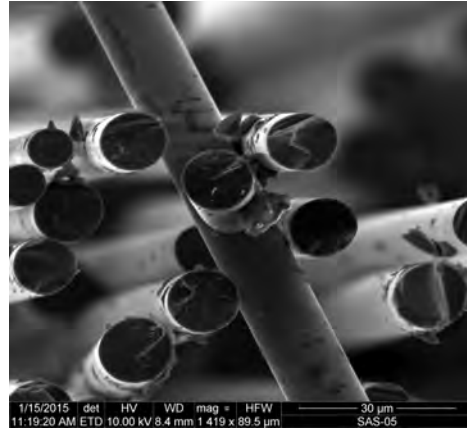
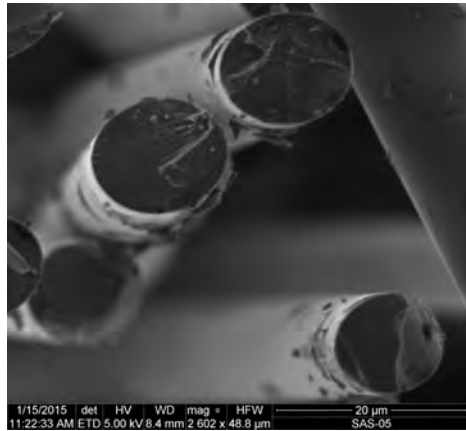
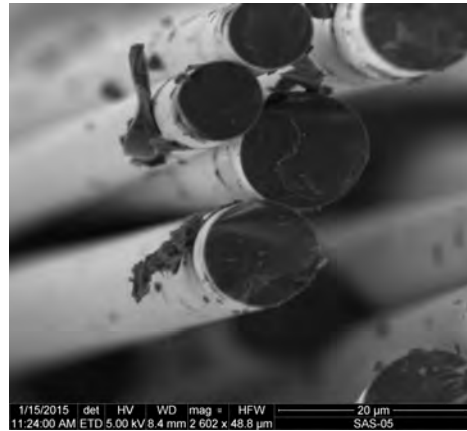
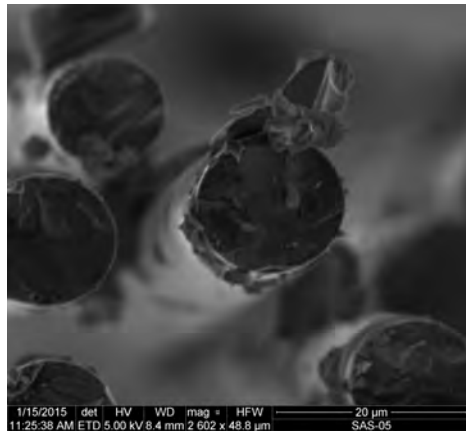
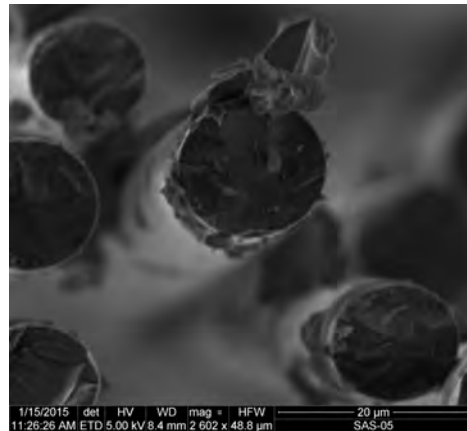
Figure B.42. Hi-Nicalon<sup>TM</sup> S fiber tow specimen SS1, lower section, (800°C,  $\sigma = 2.96$  MPa,  $t = 100$  h)

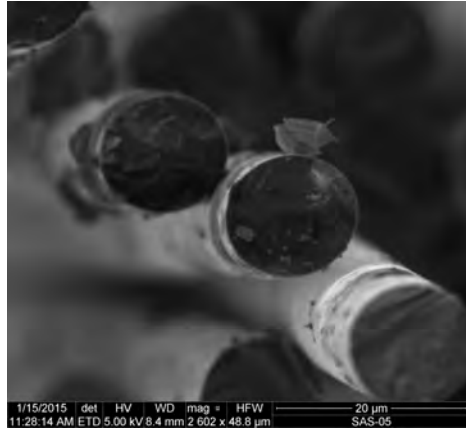
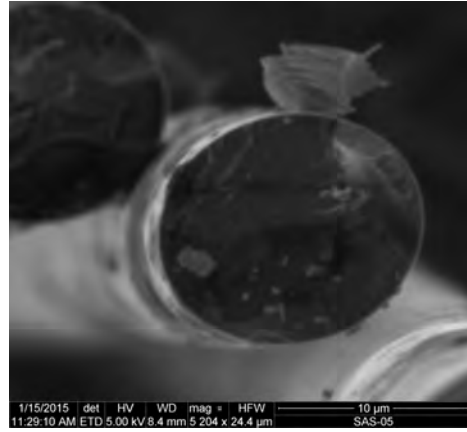
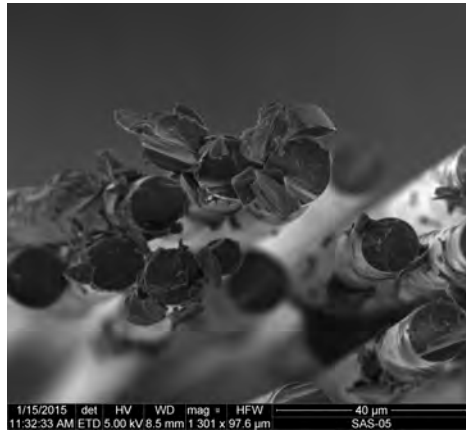
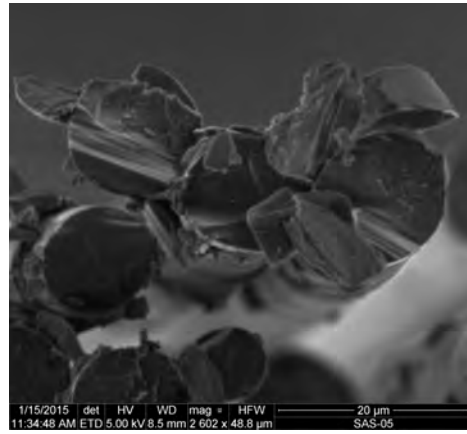
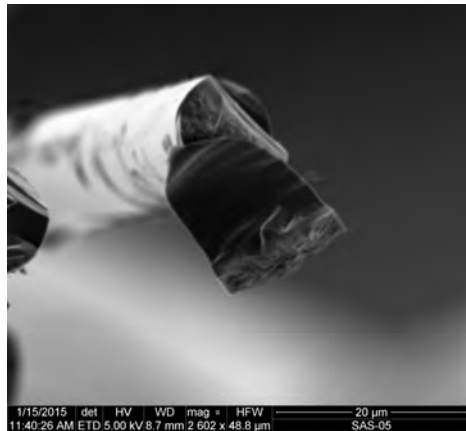
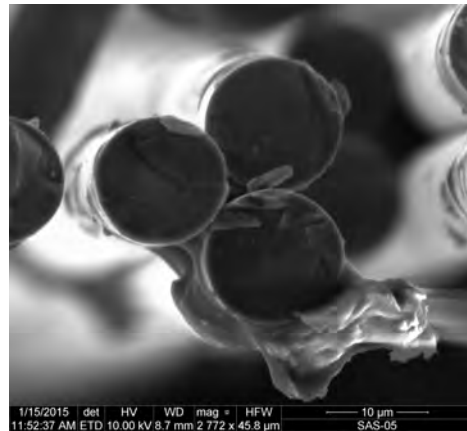
Figure B.43. Hi-Nicalon<sup>TM</sup> S fiber tow specimen SS1, lower section, (800°C,  $\sigma = 2.96$  MPa,  $t = 100$  h)

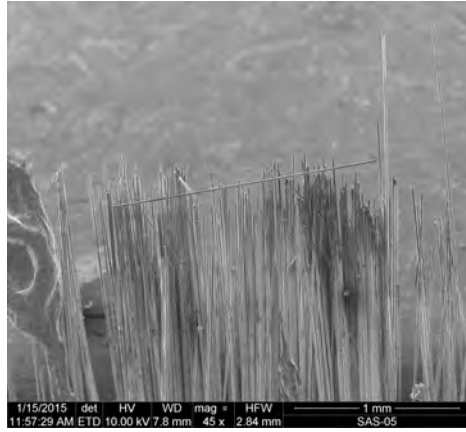
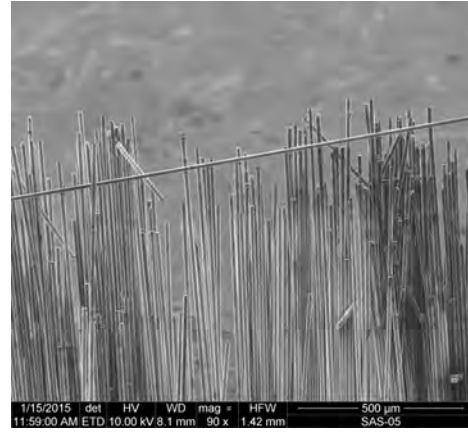
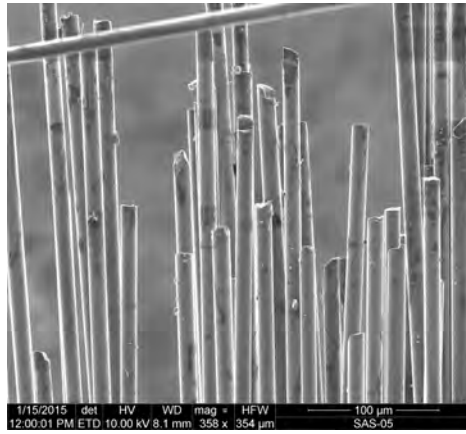
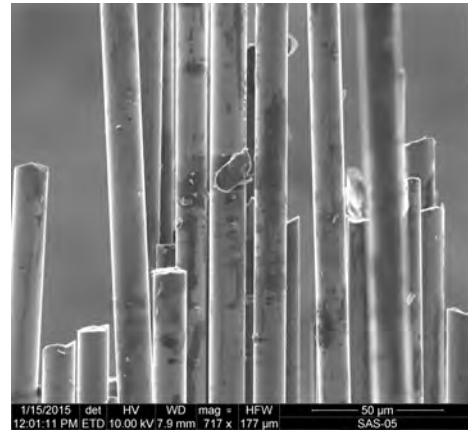
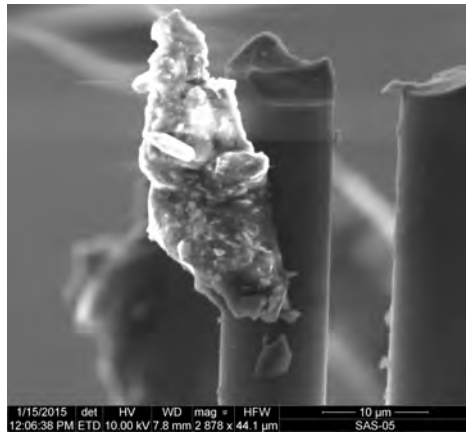
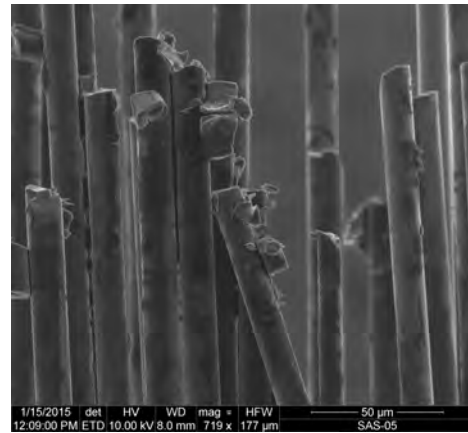
Figure B.44. Hi-Nicalon<sup>TM</sup> S fiber tow specimen SS1, lower section, (800°C,  $\sigma = 2.96$  MPa,  $t = 100$  h)

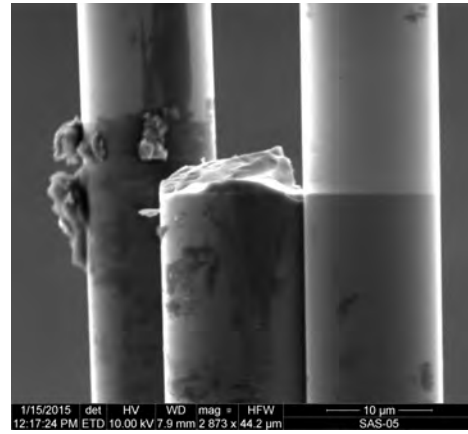
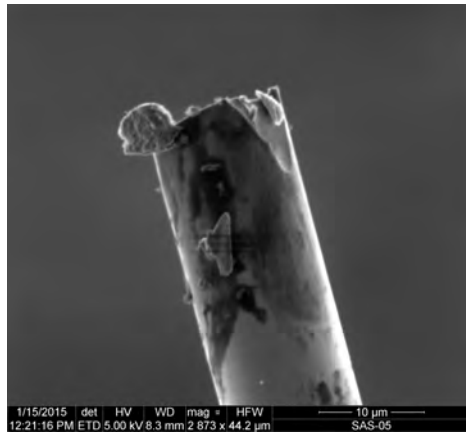
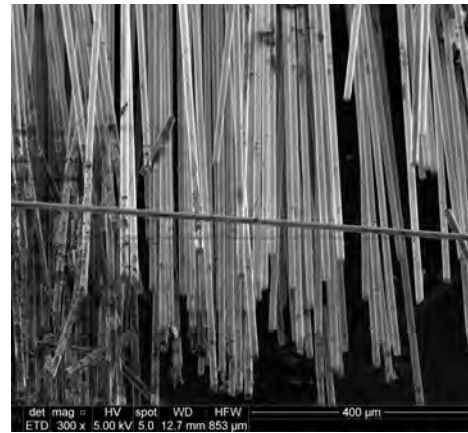
Figure B.45. Hi-Nicalon<sup>TM</sup> S fiber tow specimen SS1, lower section, (800°C,  $\sigma = 2.96$  MPa,  $t = 100$  h)

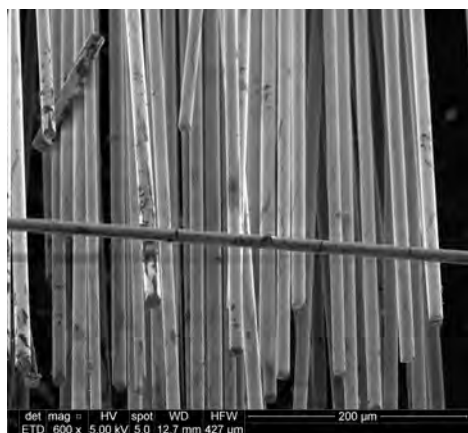
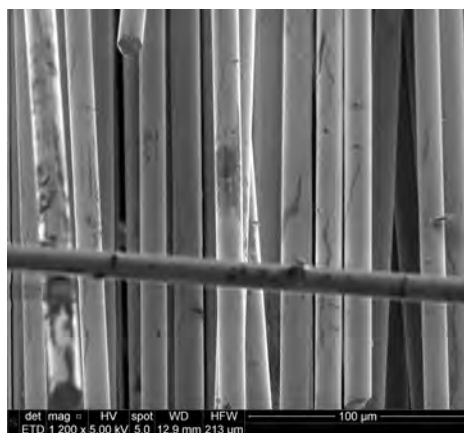
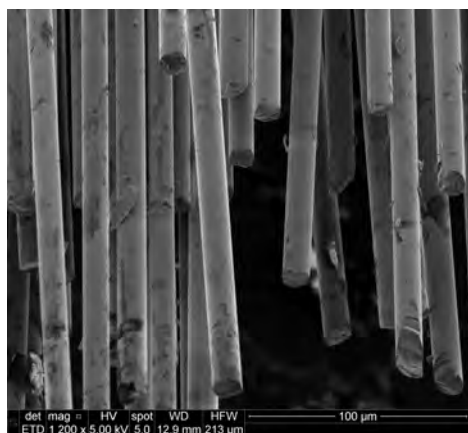
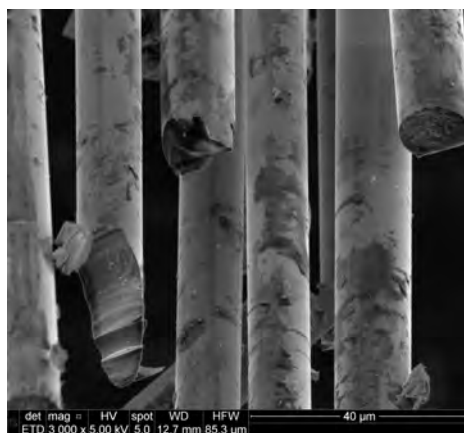
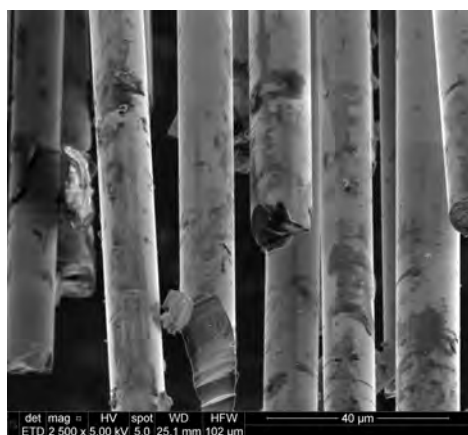
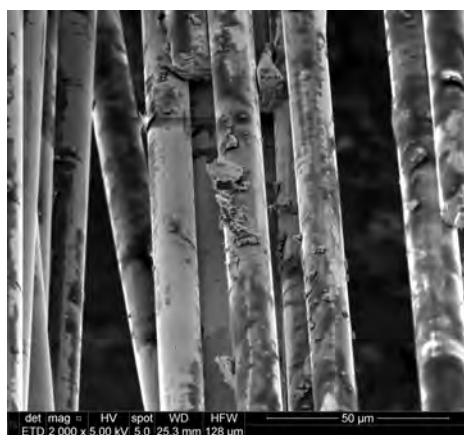
Figure B.46. Hi-Nicalon<sup>TM</sup> S fiber tow specimen SS1, lower section, (800°C,  $\sigma = 2.96$  MPa,  $t = 100$  h)

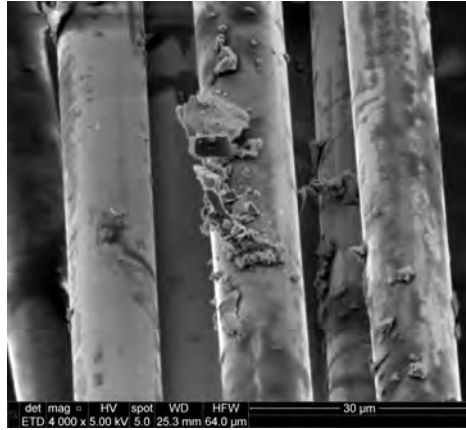
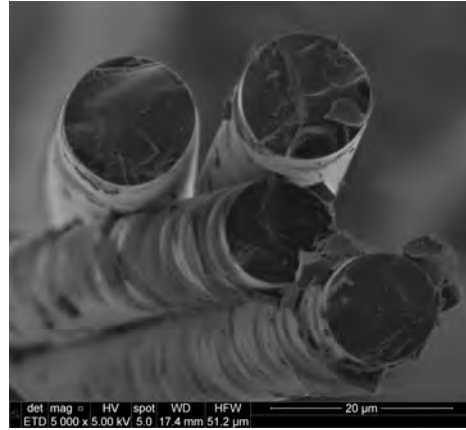
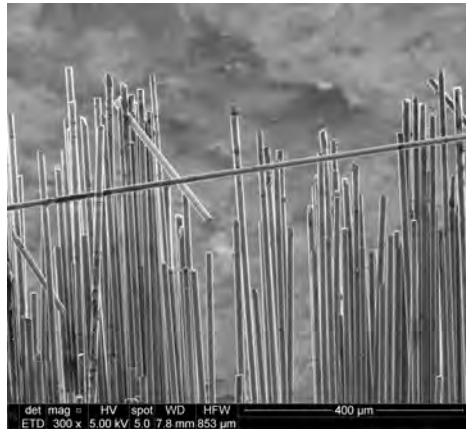
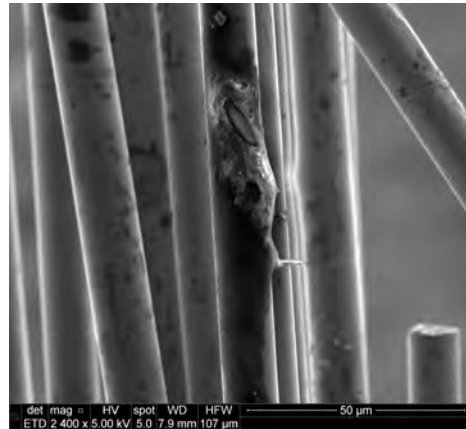
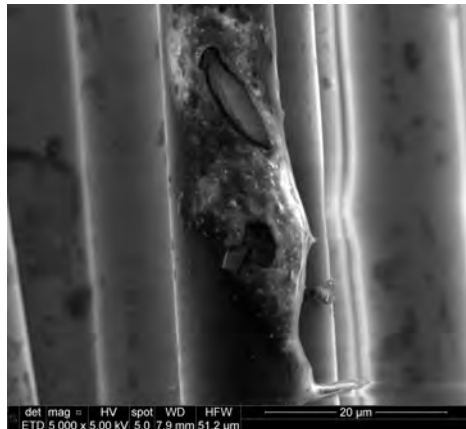
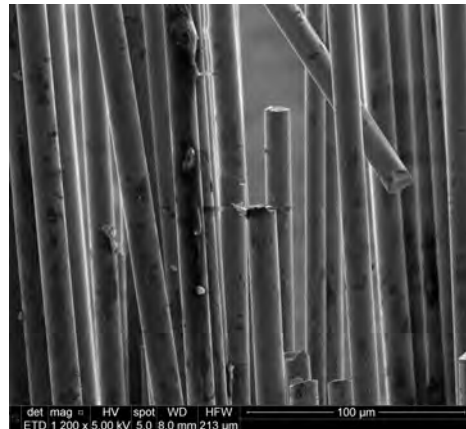
Figure B.47. Hi-Nicalon<sup>TM</sup> S fiber tow specimen SS1, lower section, (800°C,  $\sigma = 2.96$  MPa,  $t = 100$  h)

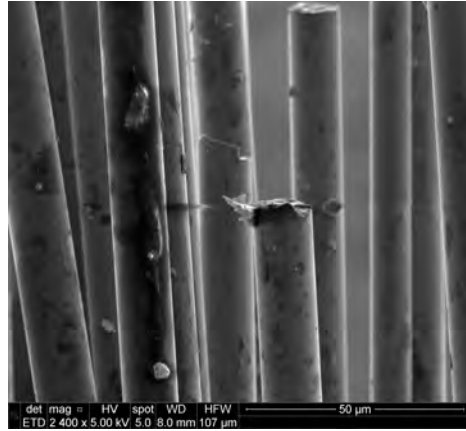
Figure B.48. Hi-Nicalon<sup>TM</sup> S fiber tow specimen SS1, lower section, (800°C,  $\sigma = 2.96$  MPa,  $t = 100$  h)

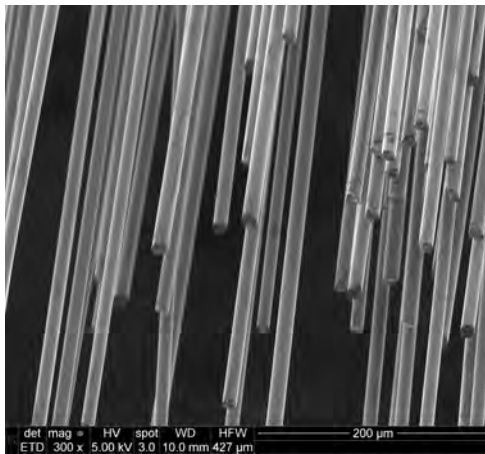
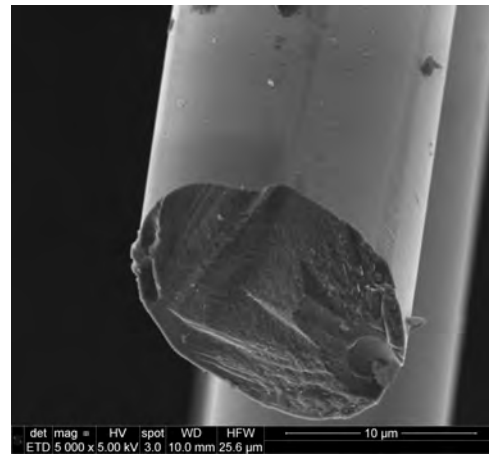
Figure B.49. Hi-Nicalon<sup>TM</sup> S fiber tow specimen SS1, center section, (800°C,  $\sigma = 2.96$  MPa,  $t = 100$  h)

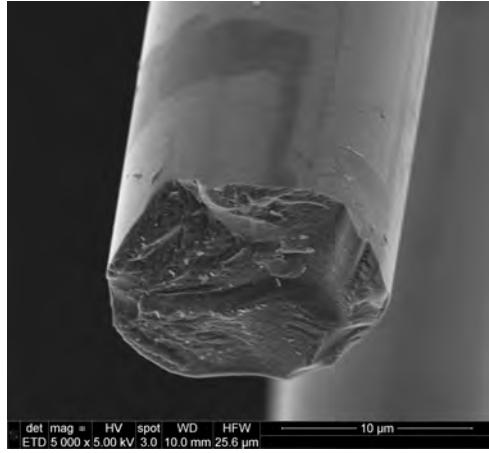
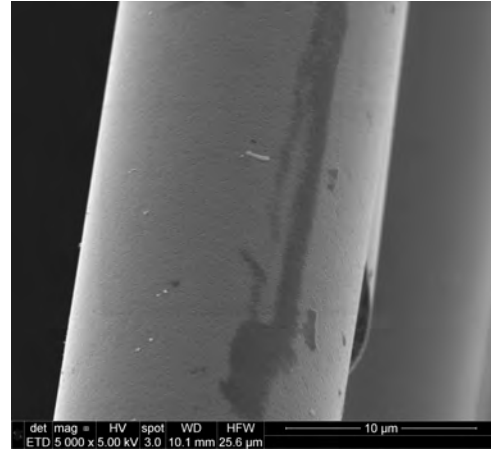
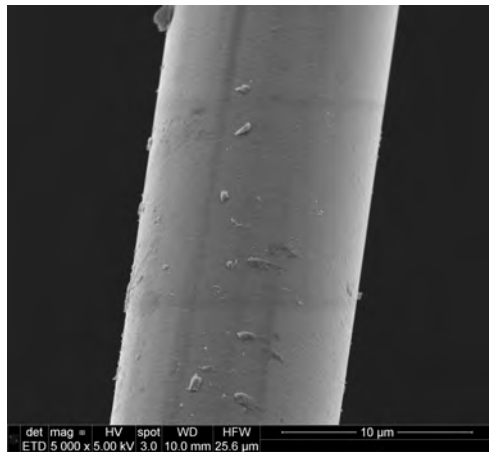
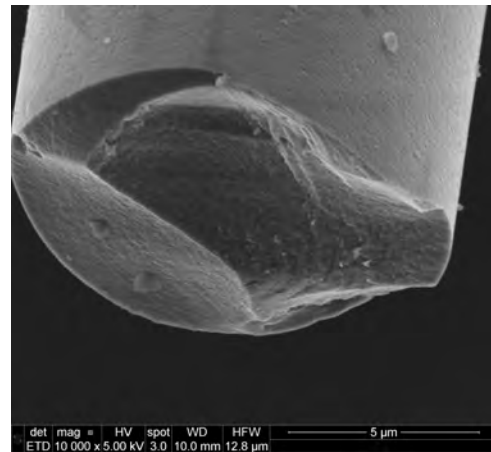
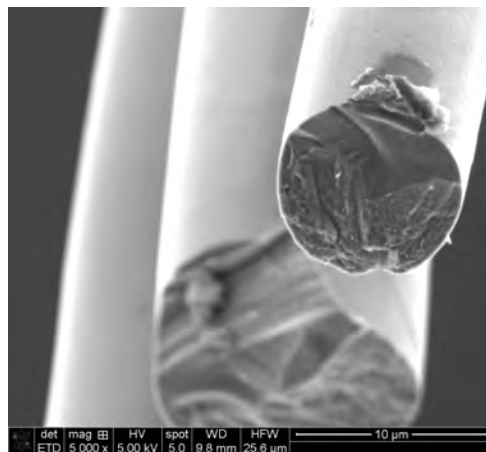
Figure B.50. Hi-Nicalon<sup>TM</sup> S fiber tow specimen SS1, center section, (800°C,  $\sigma = 2.96$  MPa,  $t = 100$  h)

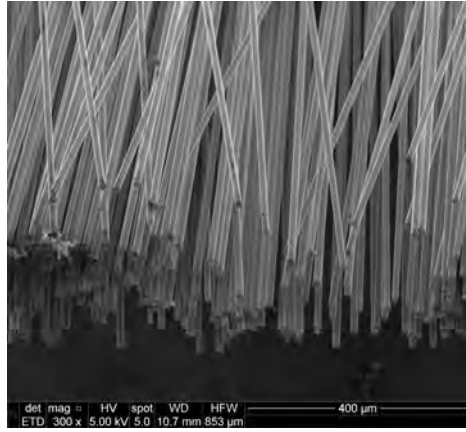
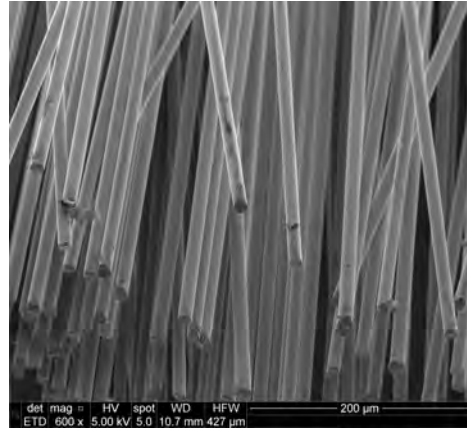
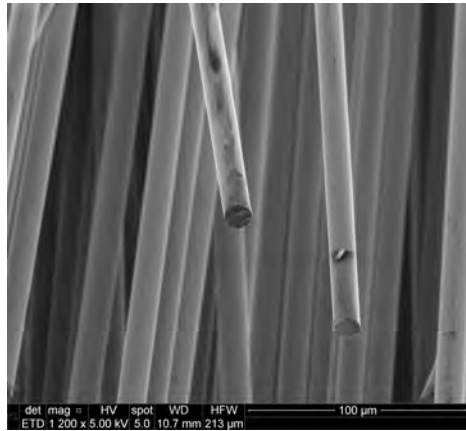
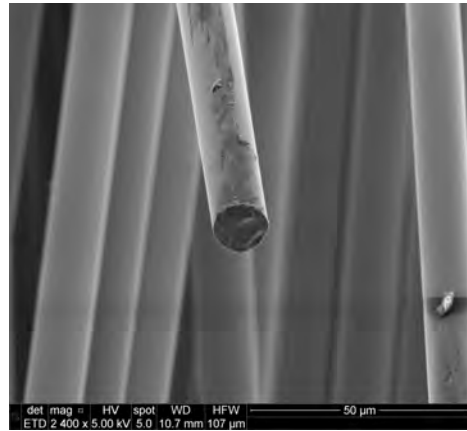
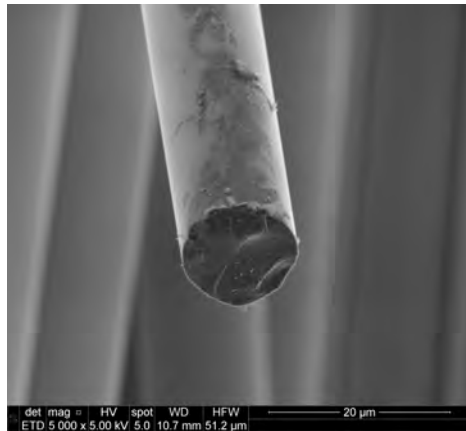
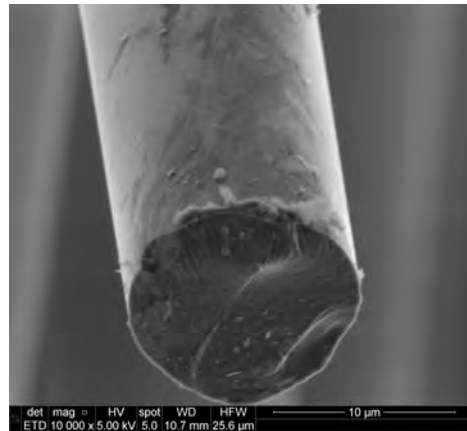
Figure B.51. Hi-Nicalon<sup>TM</sup> S fiber tow specimen SS1, upper section, (800°C,  $\sigma = 2.96$  MPa,  $t = 100$  h)

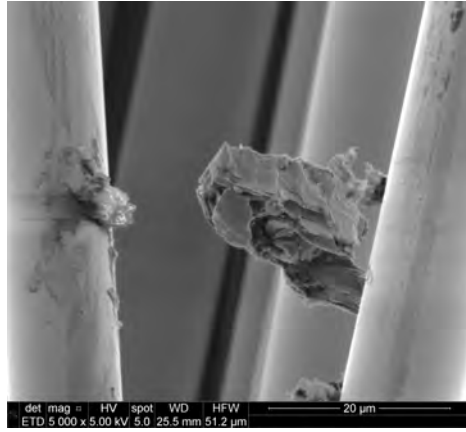
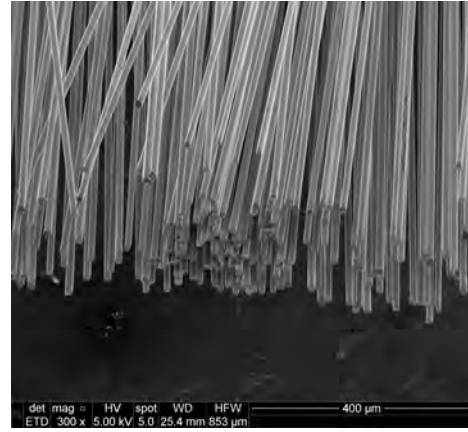
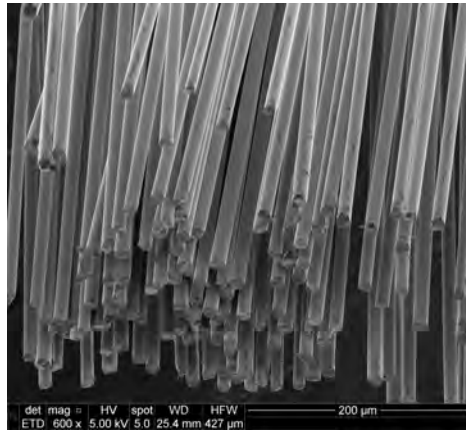
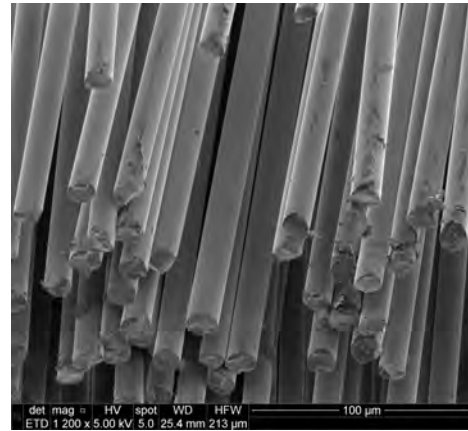
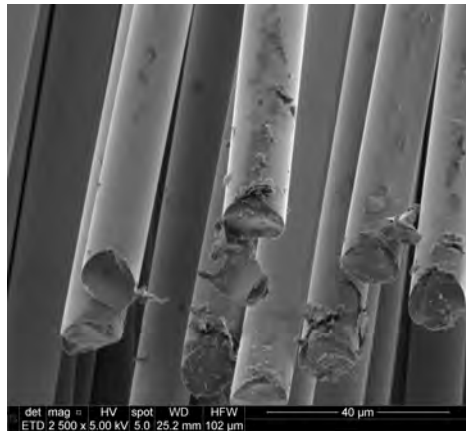
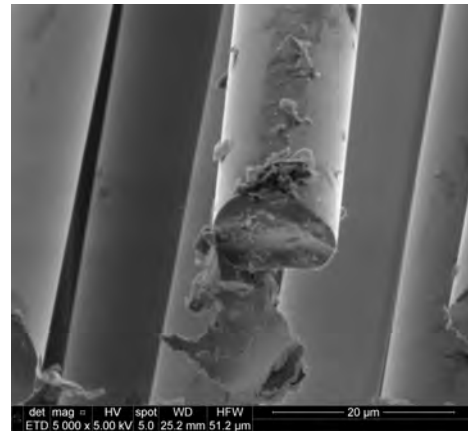
**Figure B.52.** Hi-Nicalon<sup>TM</sup> S fiber tow specimen SS1, upper section, (800°C,  $\sigma = 2.96$  MPa,  $t = 100$  h)

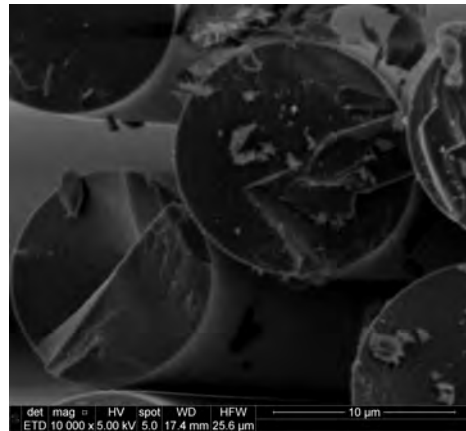
Figure B.53. Hi-Nicalon<sup>TM</sup> S fiber tow specimen SS1, upper section, (800°C,  $\sigma = 2.96$  MPa,  $t = 100$  h)

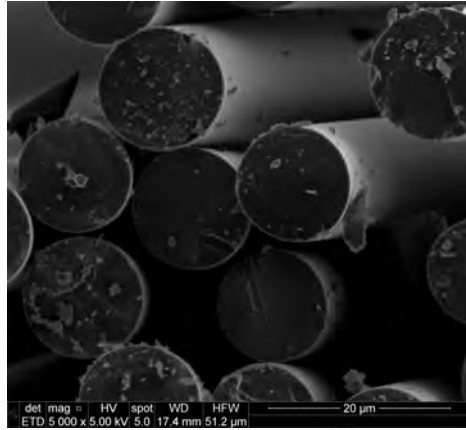
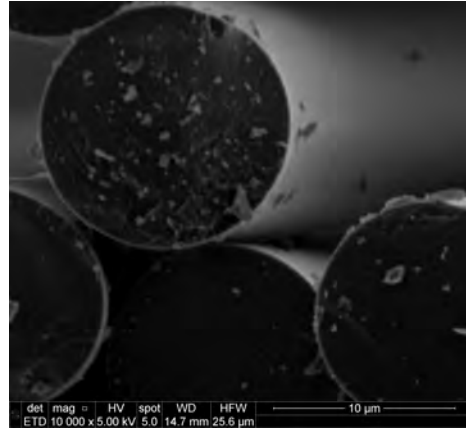
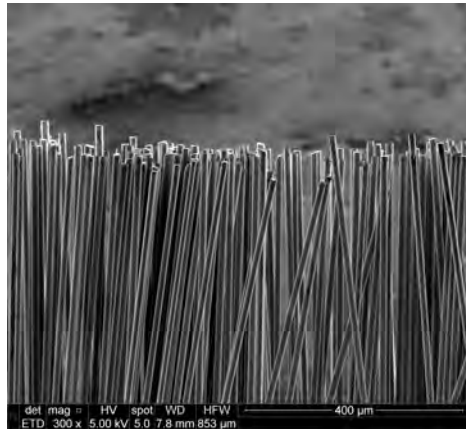
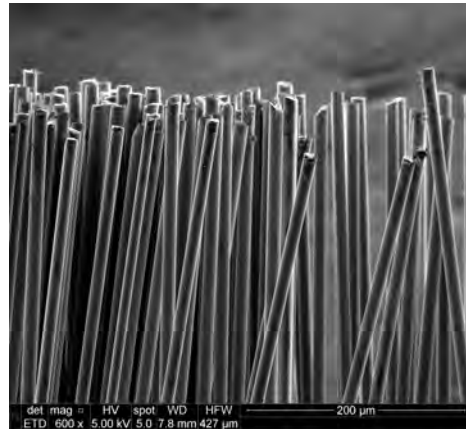
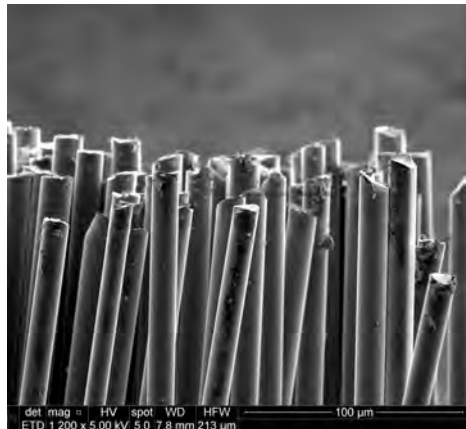
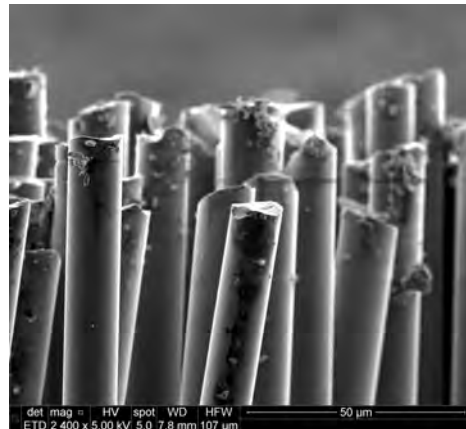
Figure B.54. Hi-Nicalon<sup>TM</sup> S fiber tow specimen SS1, upper section, (800°C,  $\sigma = 2.96$  MPa,  $t = 100$  h)
