**CREEP OF HI-NICALON<sup>TM</sup> S CERAMIC  
FIBER TOWS AT 800°C IN AIR AND IN  
SILICIC ACID-SATURATED STEAM**

DISSERTATION

AFIT-ENY-DS-15-S-067

***AIR FORCE INSTITUTE OF TECHNOLOGY***

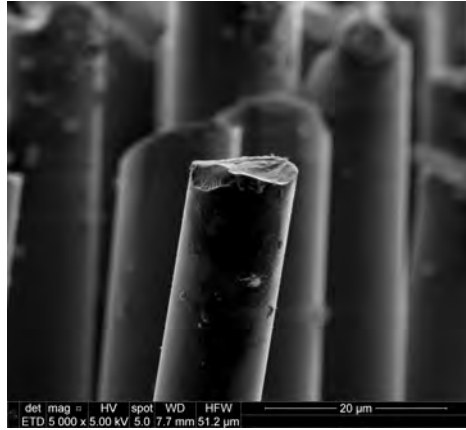
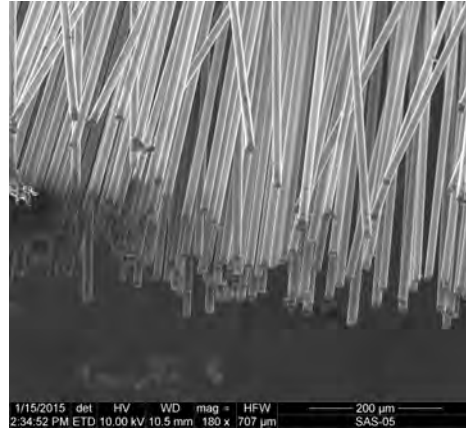
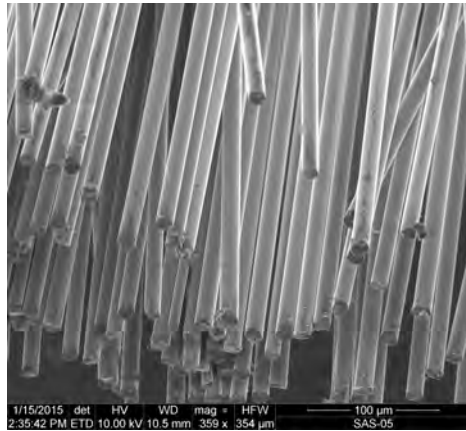
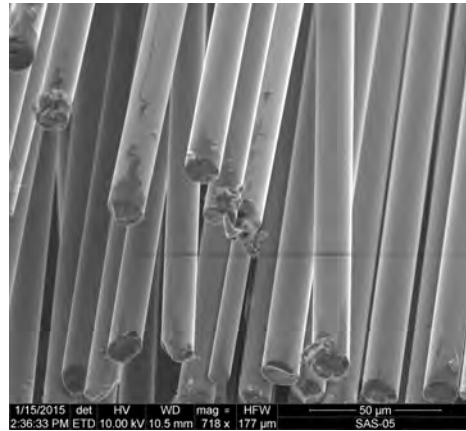
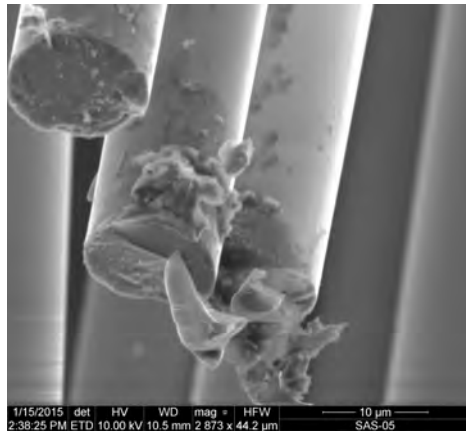
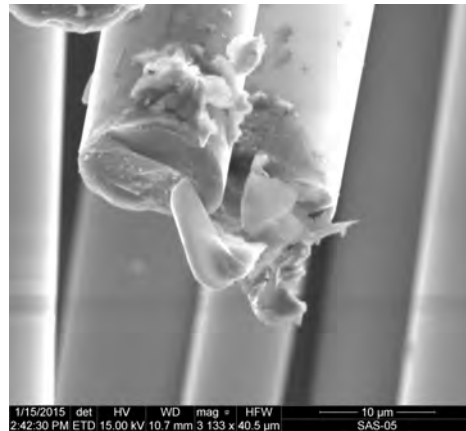
**Figure B.55.** Hi-Nicalon<sup>TM</sup> S fiber tow specimen SS1, upper section, (800°C,  $\sigma = 2.96$  MPa,  $t = 100$  h)

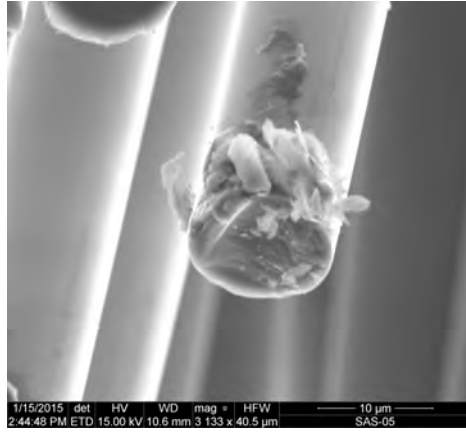
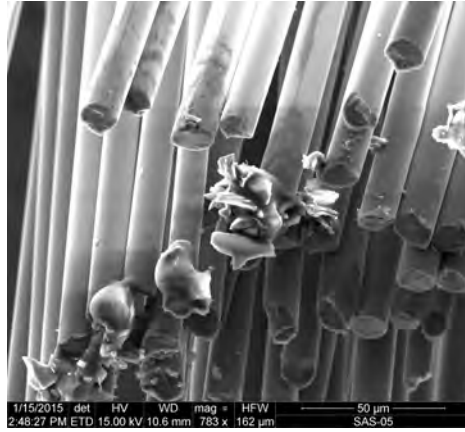
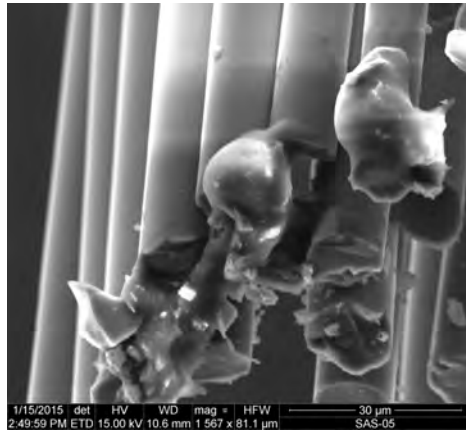
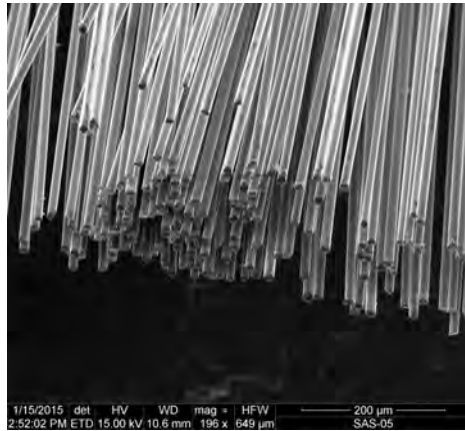
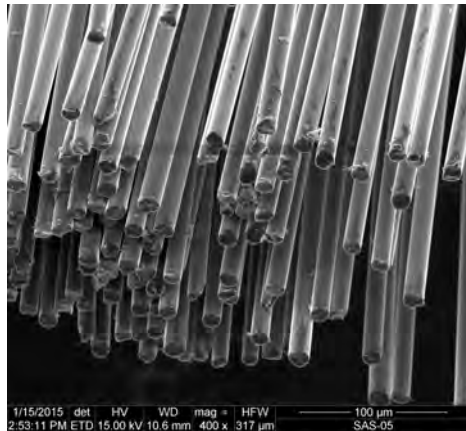
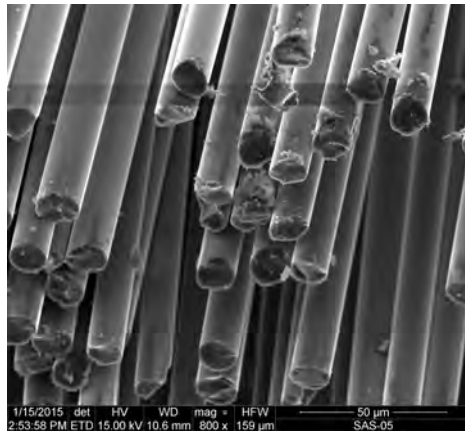
Figure B.56. Hi-Nicalon<sup>TM</sup> S fiber tow specimen SS1, upper section, (800°C,  $\sigma = 2.96$  MPa,  $t = 100$  h)

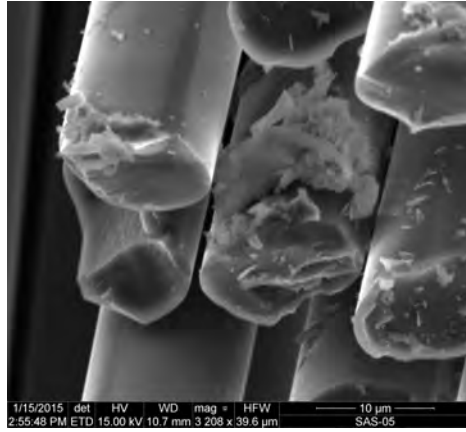
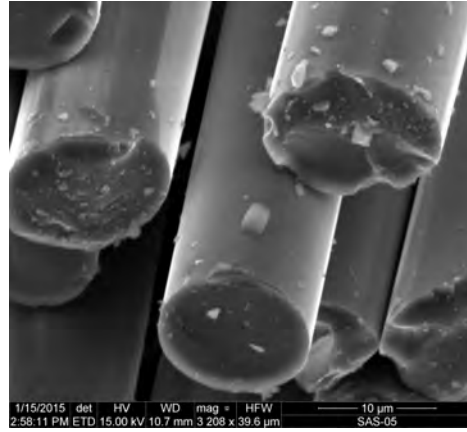
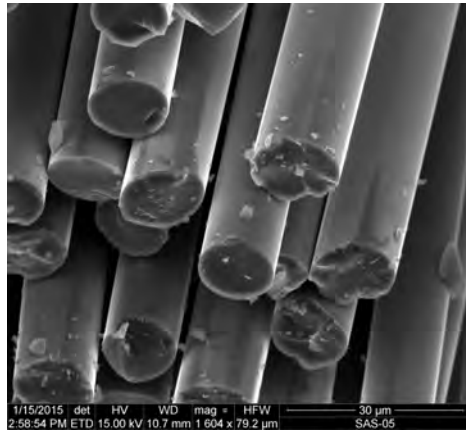
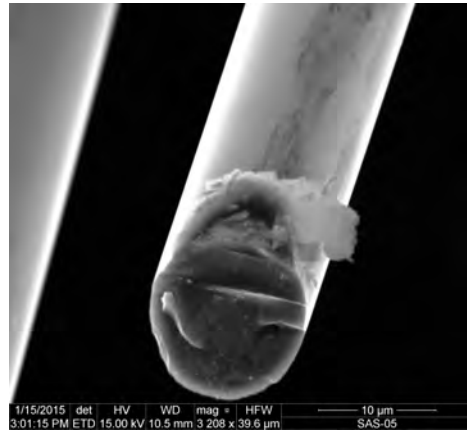
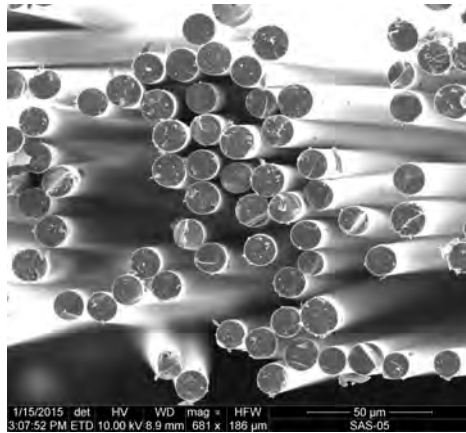
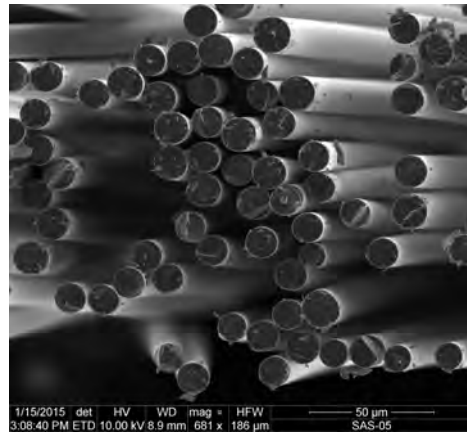
Figure B.57. Hi-Nicalon<sup>TM</sup> S fiber tow specimen SS1, upper section, (800°C,  $\sigma = 2.96$  MPa,  $t = 100$  h)

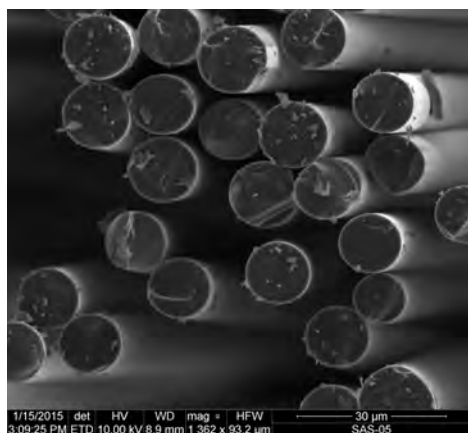
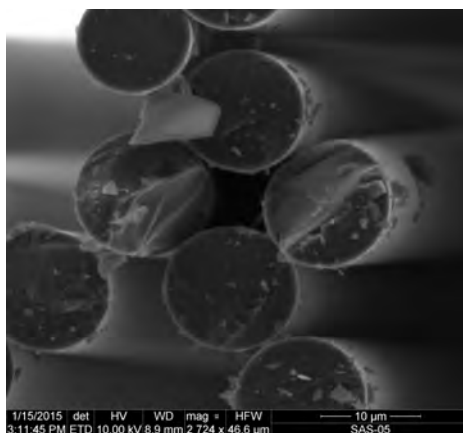
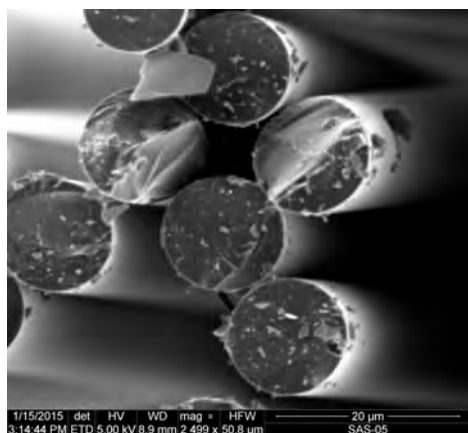
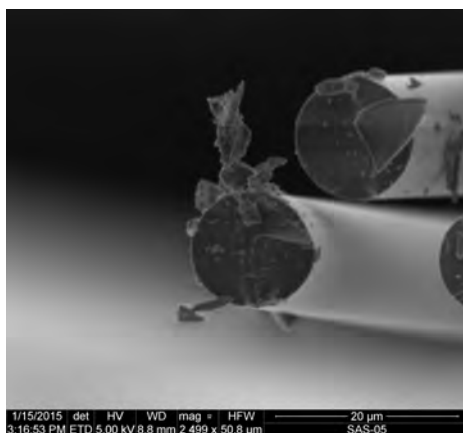
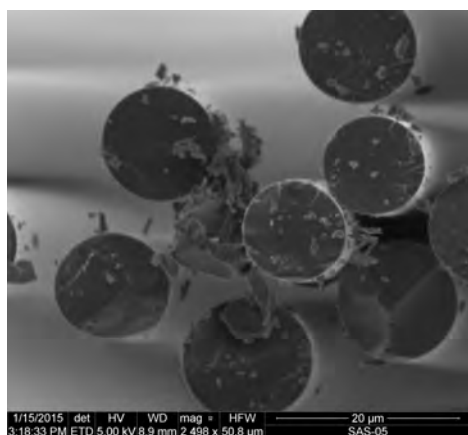
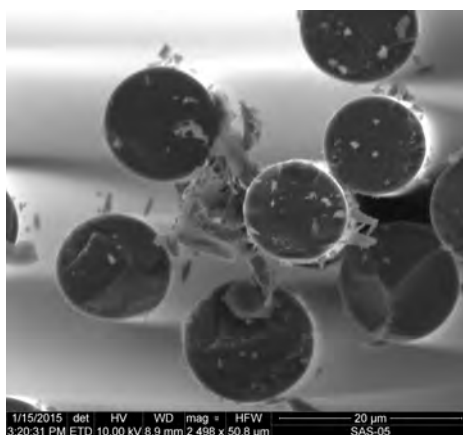
Figure B.58. Hi-Nicalon<sup>TM</sup> S fiber tow specimen SS1, upper section, (800°C,  $\sigma = 2.96$  MPa,  $t = 100$  h)

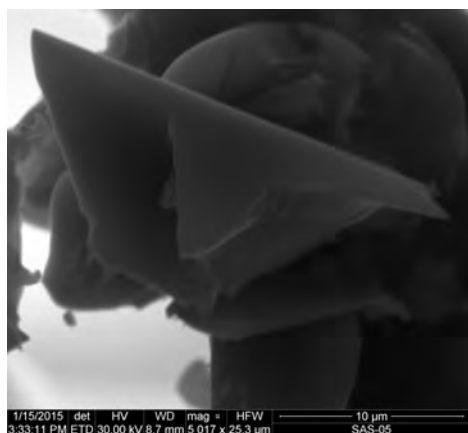
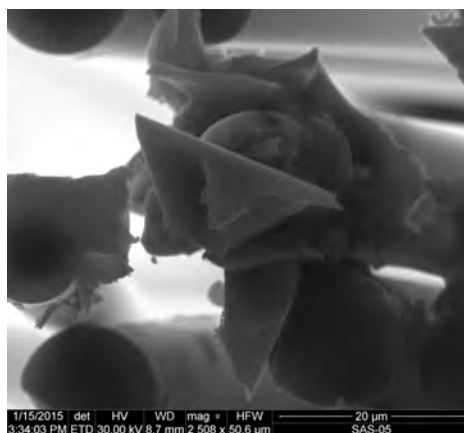
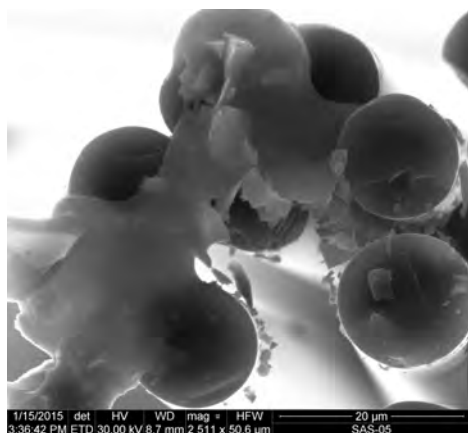
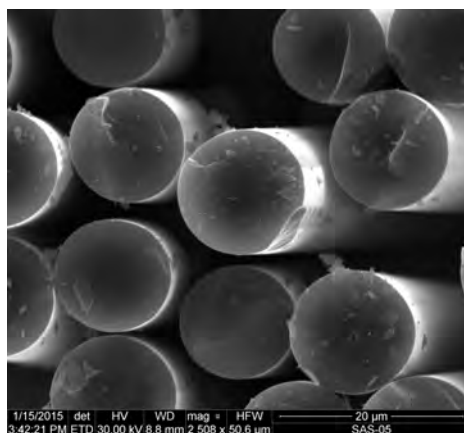
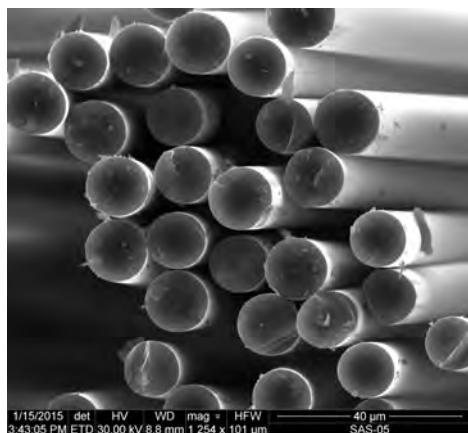
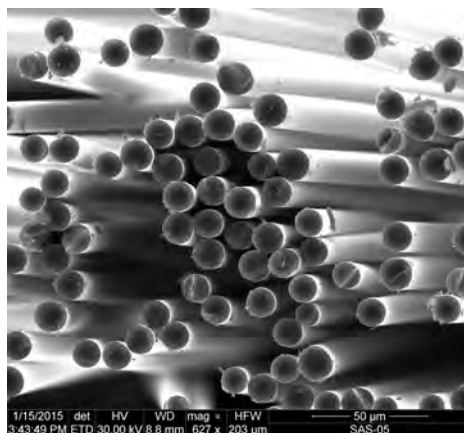
Figure B.59. Hi-Nicalon<sup>TM</sup> S fiber tow specimen SS1, upper section, (800°C,  $\sigma = 2.96$  MPa,  $t = 100$  h)

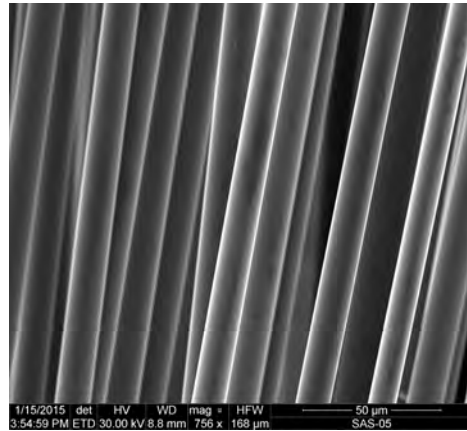
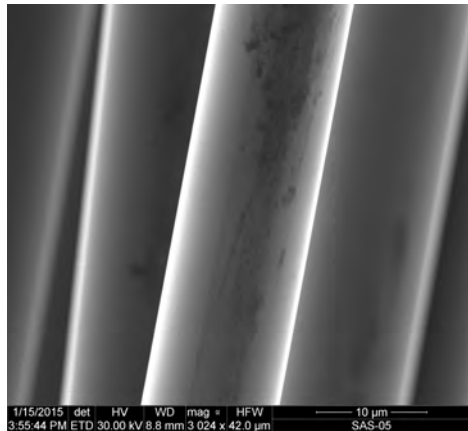
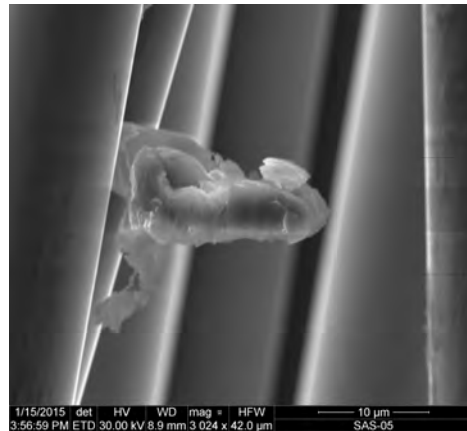
Figure B.60. Hi-Nicalon<sup>TM</sup> S fiber tow specimen SS1, upper section, (800°C,  $\sigma = 2.96$  MPa,  $t = 100$  h)

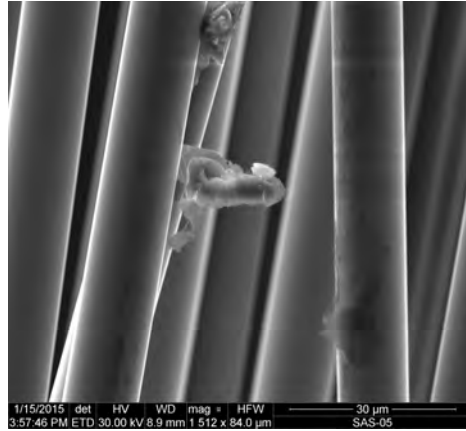
Figure B.61. Hi-Nicalon<sup>TM</sup> S fiber tow specimen SS1, upper section, (800°C,  $\sigma = 2.96$  MPa,  $t = 100$  h)

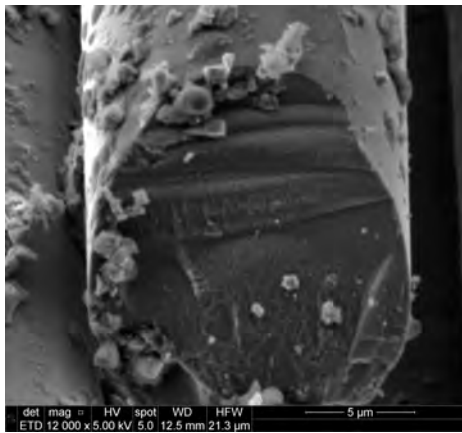
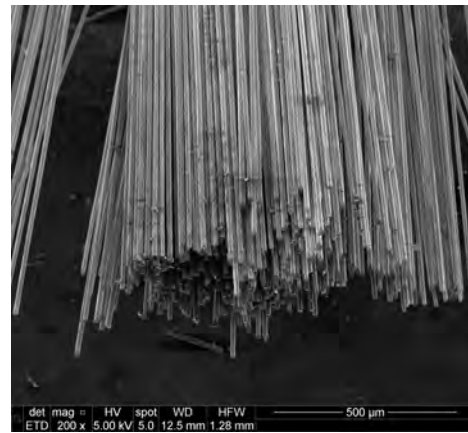
Figure B.62. Hi-Nicalon<sup>TM</sup> S fiber tow specimen SS2, lower section, (800°C,  $\sigma = 154$  MPa,  $t = 100$  h)

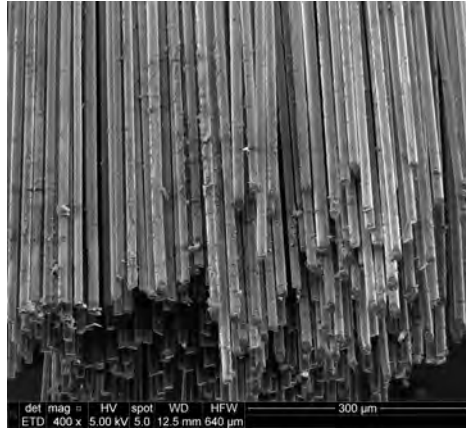
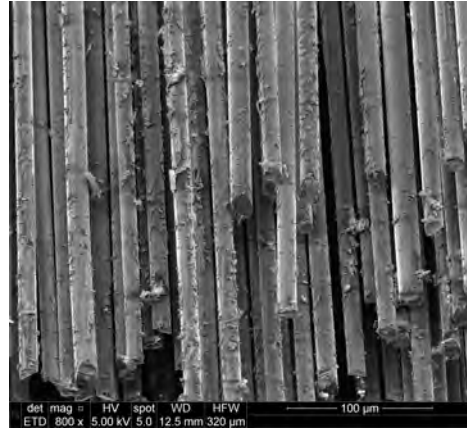
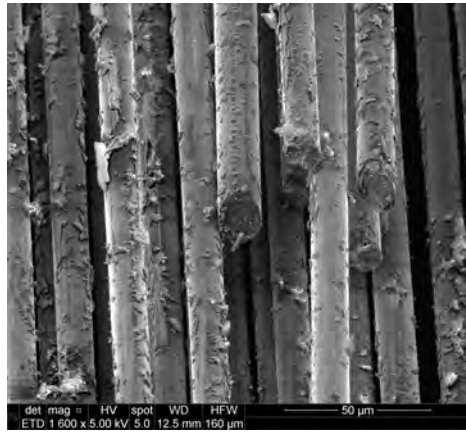
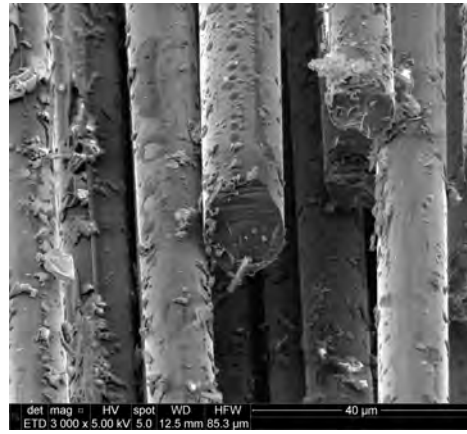
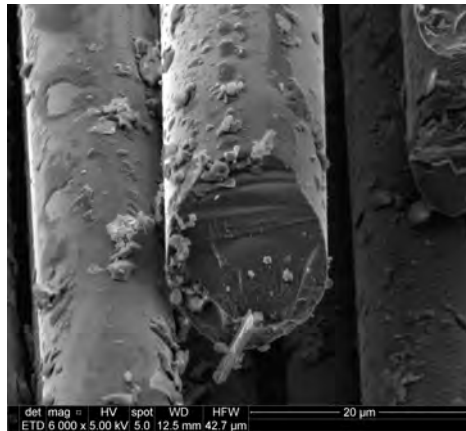
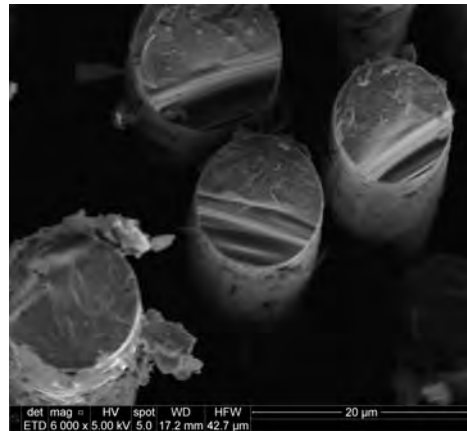
Figure B.63. Hi-Nicalon<sup>TM</sup> S fiber tow specimen SS2, lower section, (800°C,  $\sigma = 154$  MPa,  $t = 100$  h)

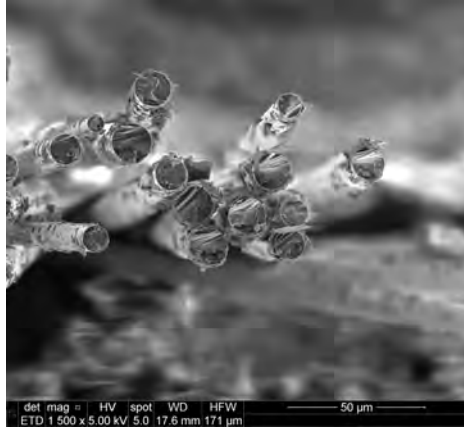
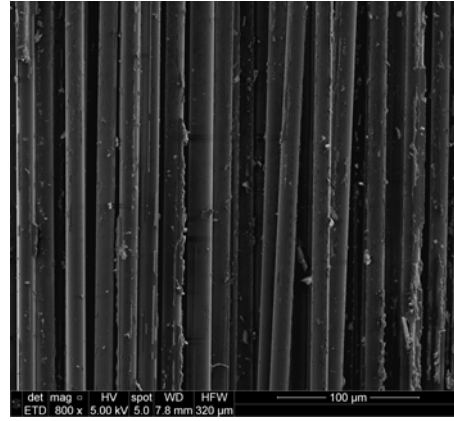
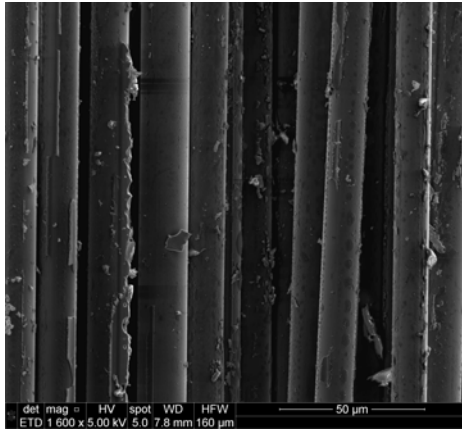
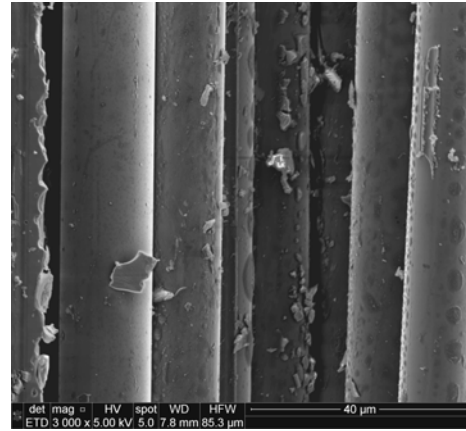
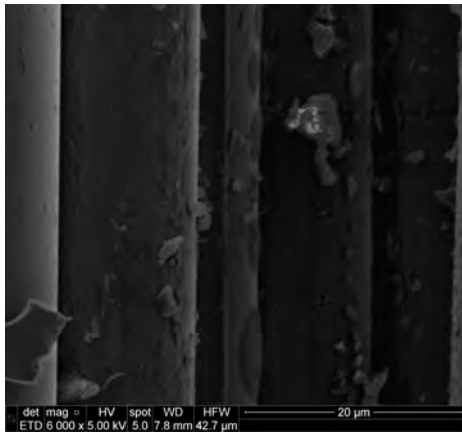
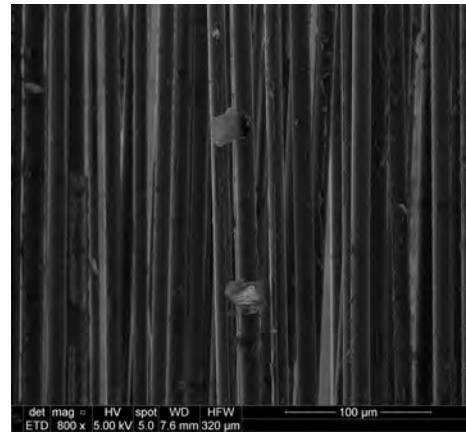
Figure B.64. Hi-Nicalon<sup>TM</sup> S fiber tow specimen SS2, lower section, (800°C,  $\sigma = 154$  MPa,  $t = 100$  h)

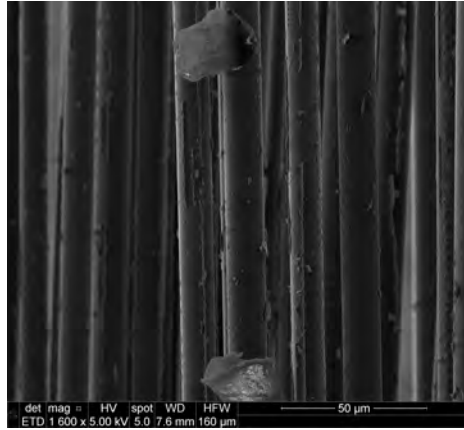
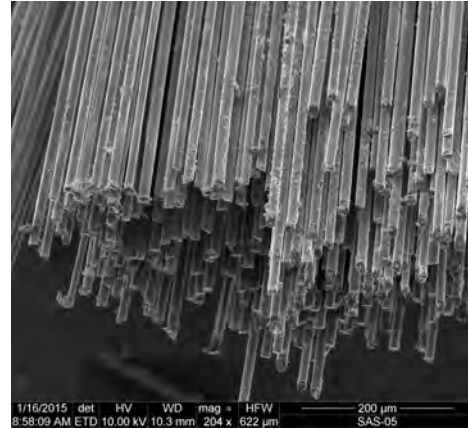
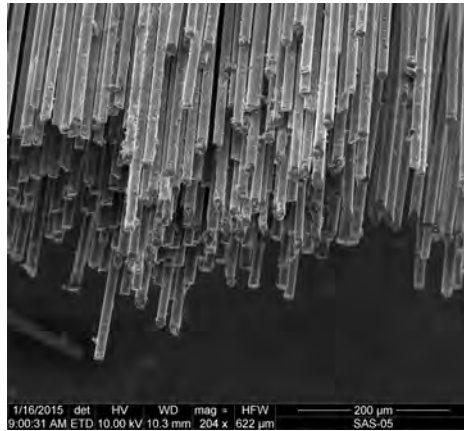
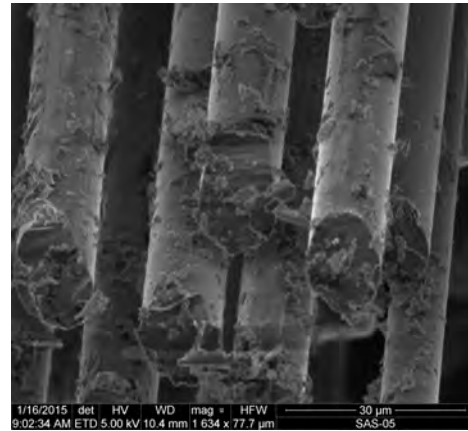
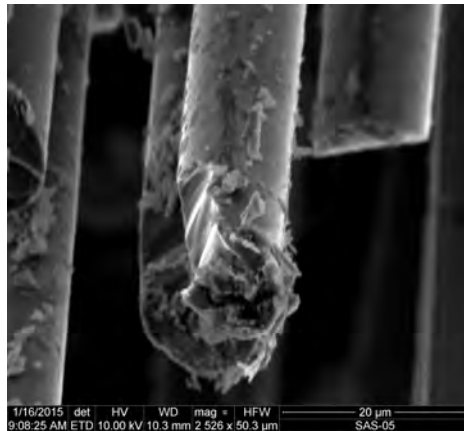
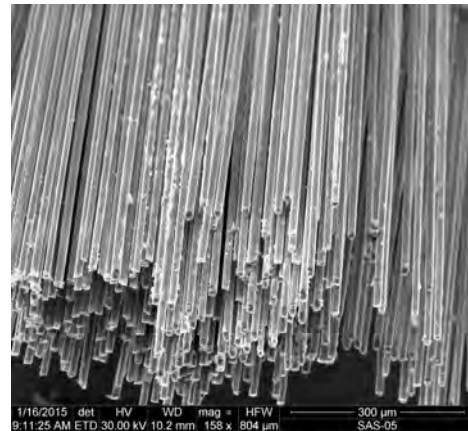
Figure B.65. Hi-Nicalon<sup>TM</sup> S fiber tow specimen SS2, lower section, (800°C,  $\sigma = 154$  MPa,  $t = 100$  h)

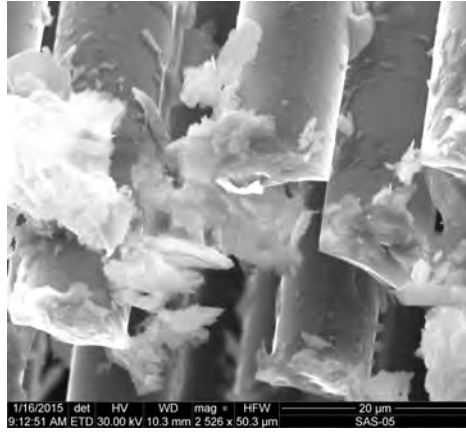
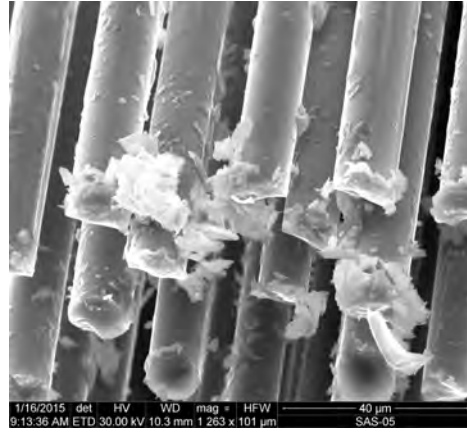
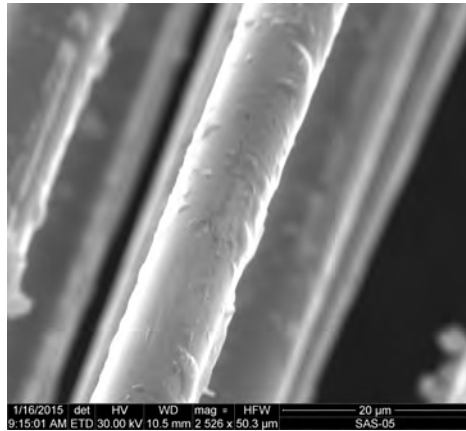
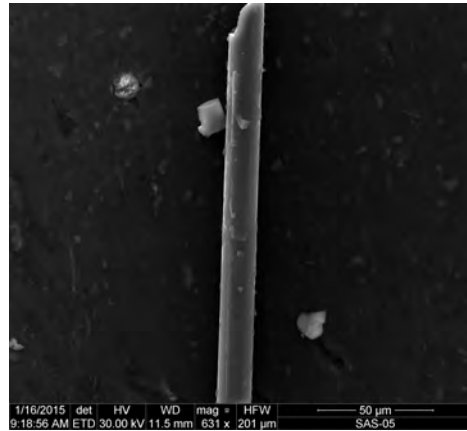
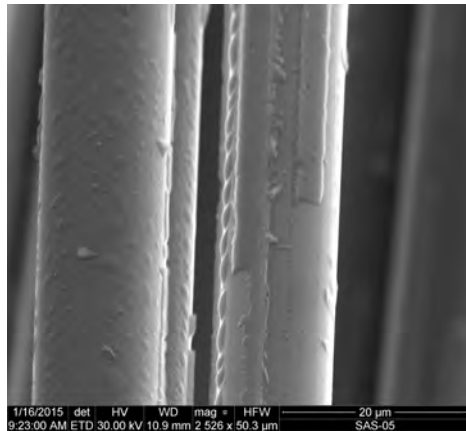
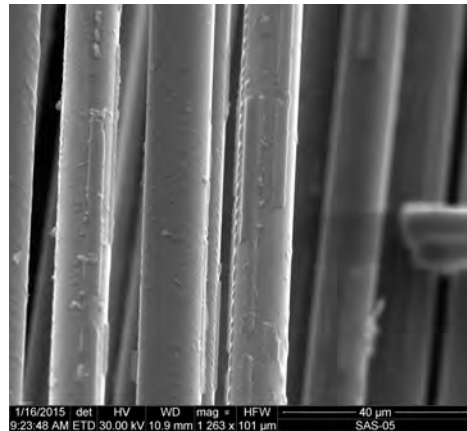
Figure B.66. Hi-Nicalon<sup>TM</sup> S fiber tow specimen SS2, lower section, (800°C,  $\sigma = 154$  MPa,  $t = 100$  h)

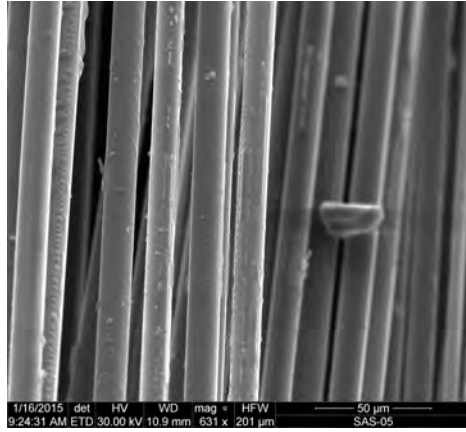
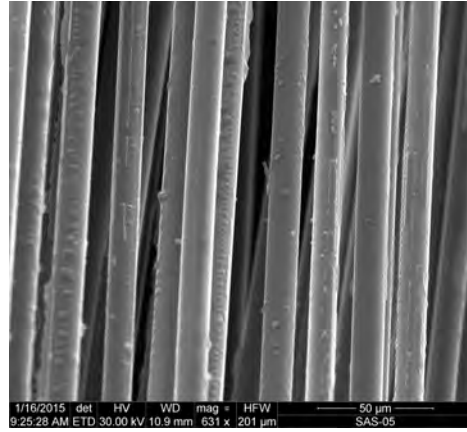
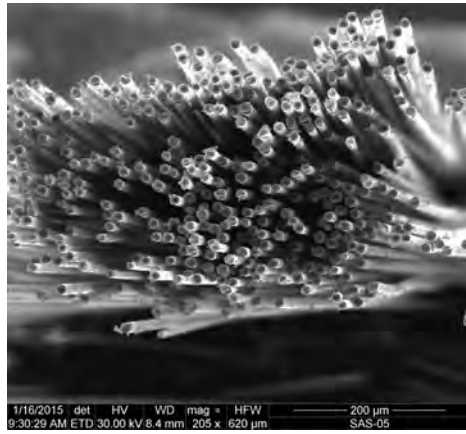
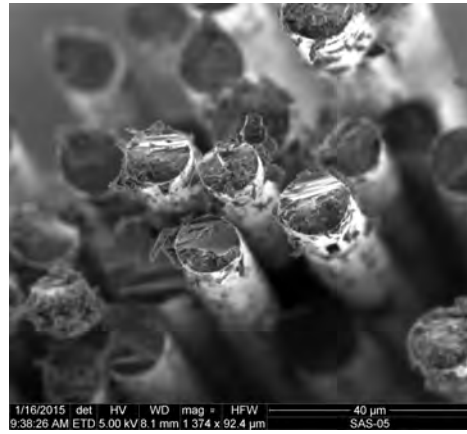
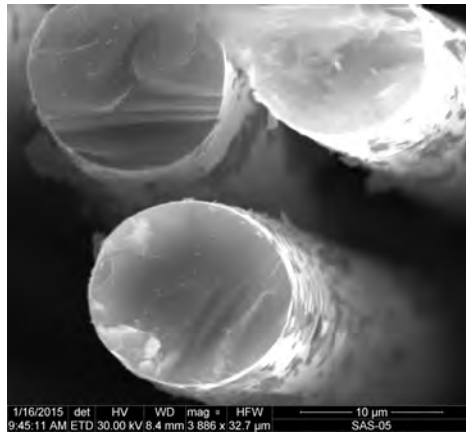
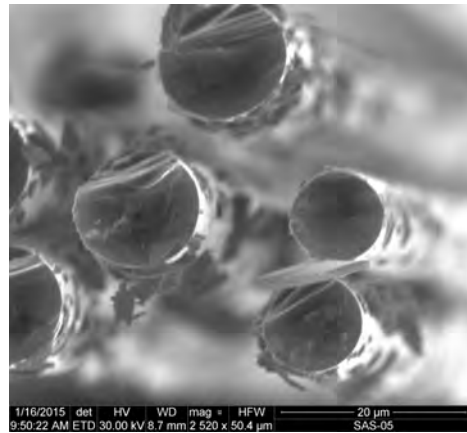
Figure B.67. Hi-Nicalon<sup>TM</sup> S fiber tow specimen SS2, lower section, (800°C,  $\sigma = 154$  MPa,  $t = 100$  h)

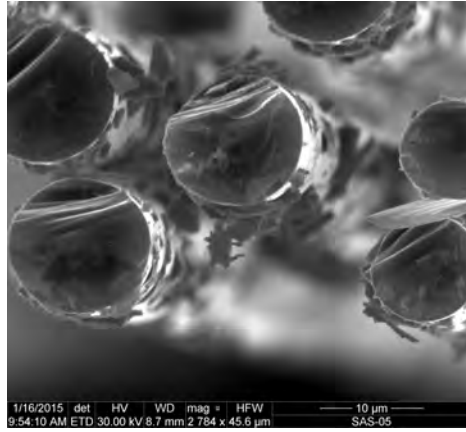
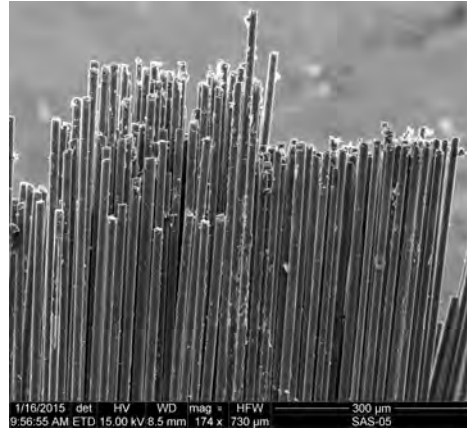
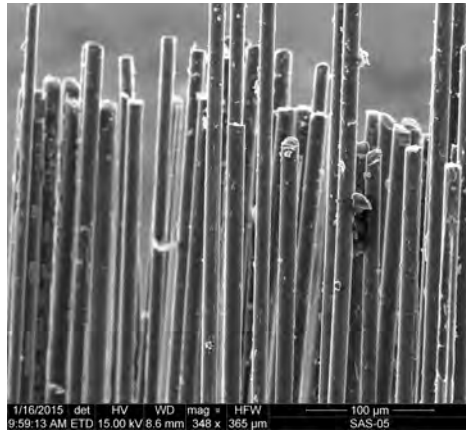
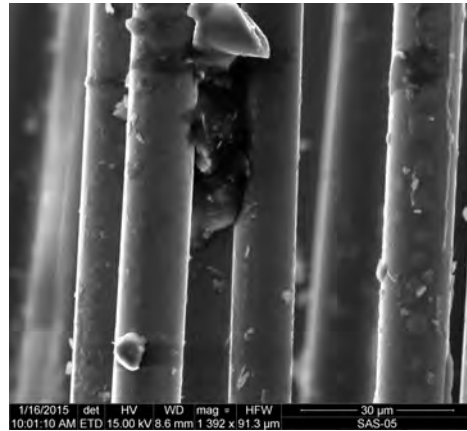
Figure B.68. Hi-Nicalon<sup>TM</sup> S fiber tow specimen SS2, lower section, (800°C,  $\sigma = 154$  MPa,  $t = 100$  h)

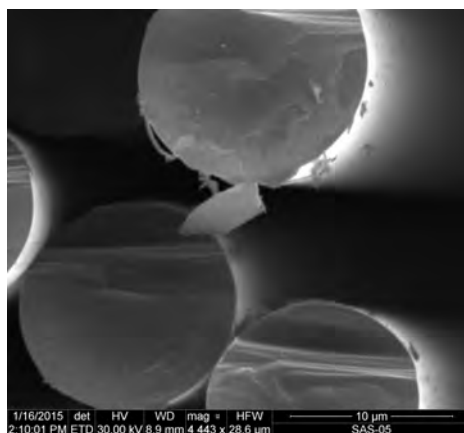
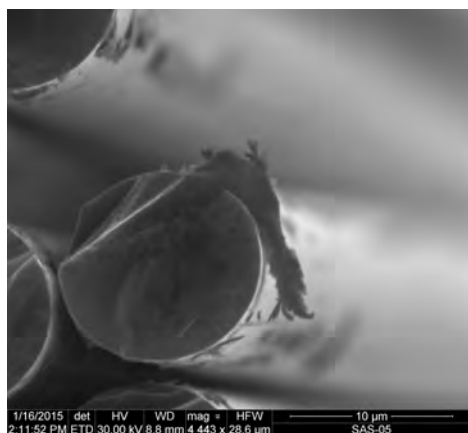
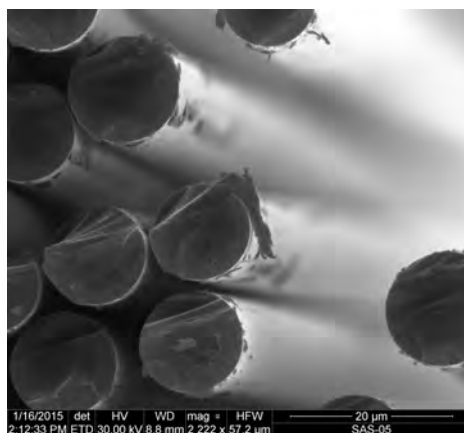
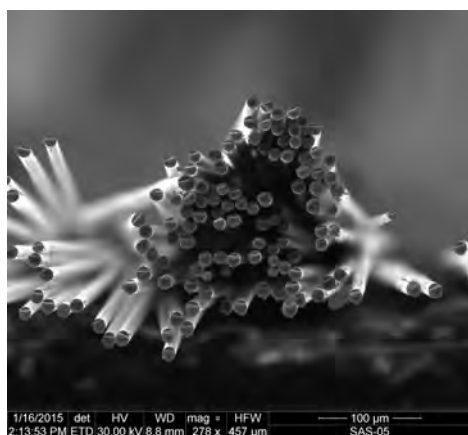
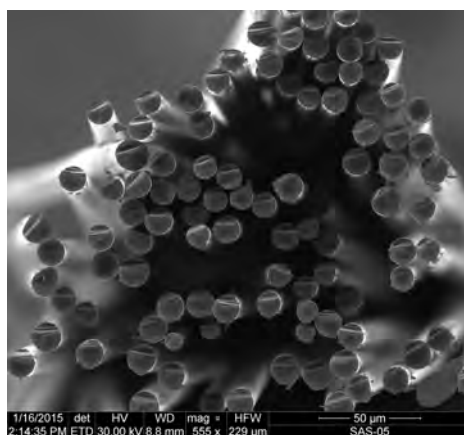
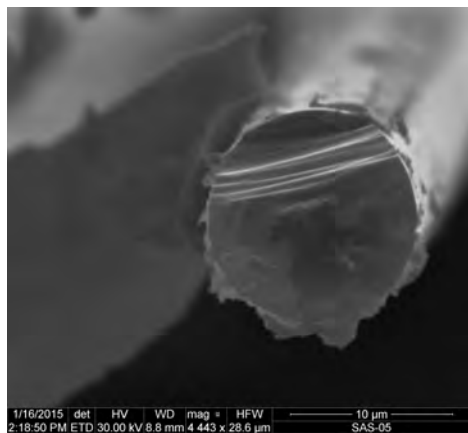
Figure B.77. Hi-Nicalon<sup>TM</sup> S fiber tow specimen SS2, upper section, (800°C,  $\sigma = 154$  MPa,  $t = 100$  h)

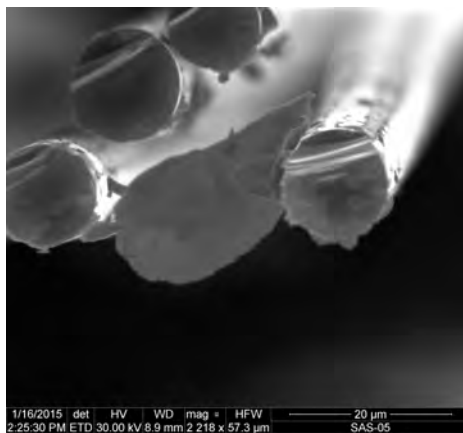
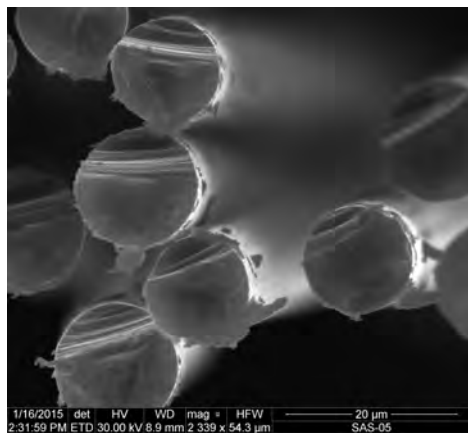
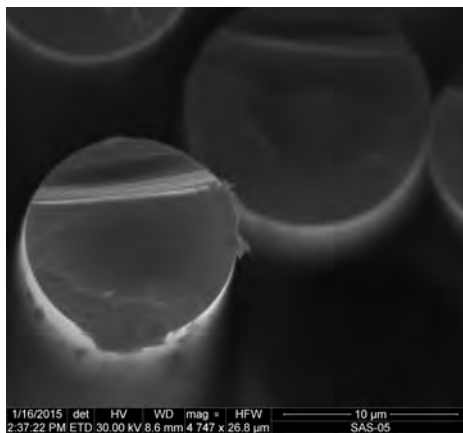
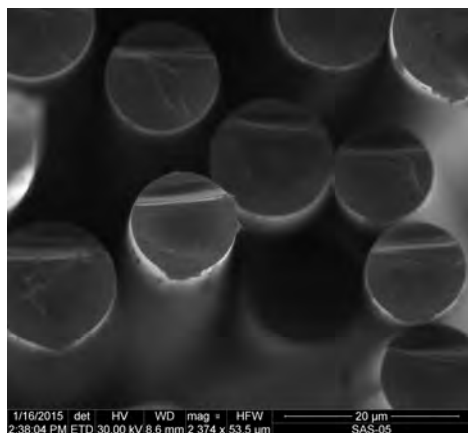
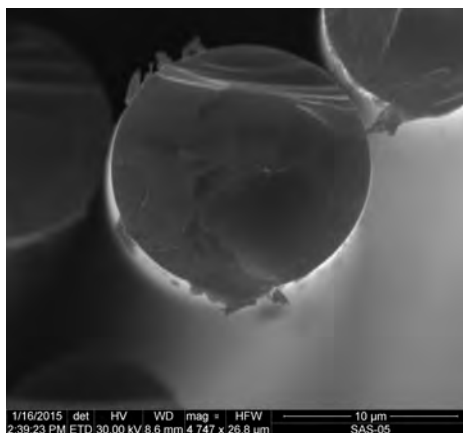
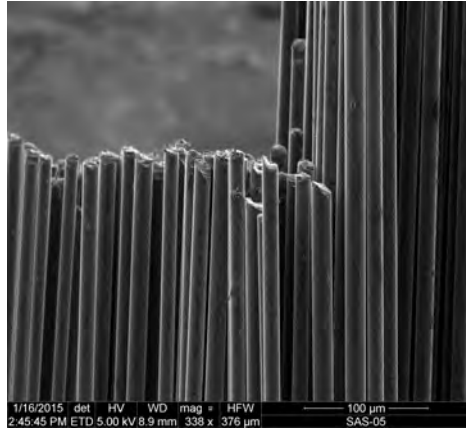
Figure B.78. Hi-Nicalon<sup>TM</sup> S fiber tow specimen SS2, upper section, (800°C,  $\sigma = 154$  MPa,  $t = 100$  h)

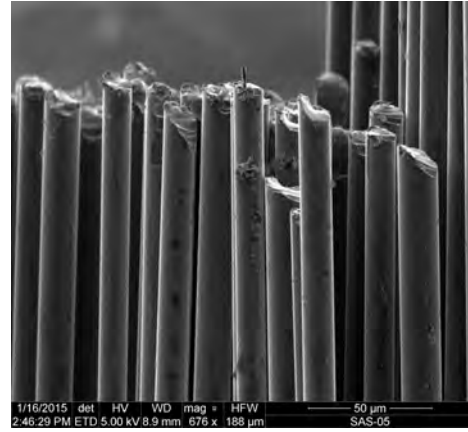
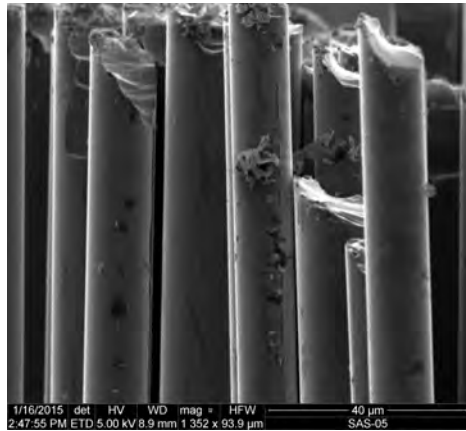
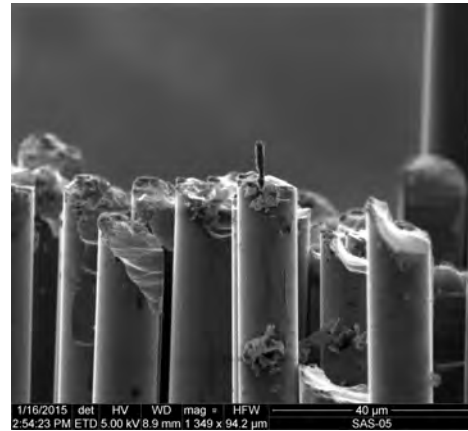
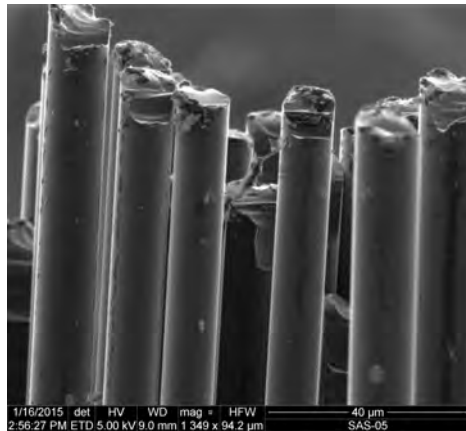
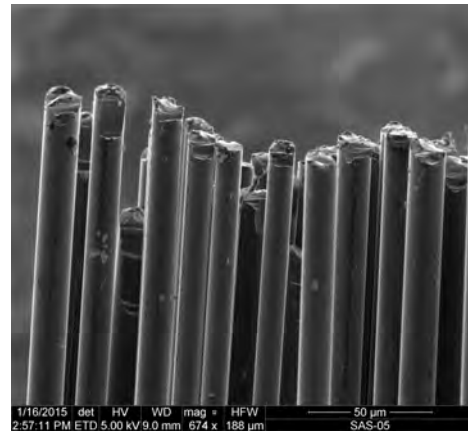
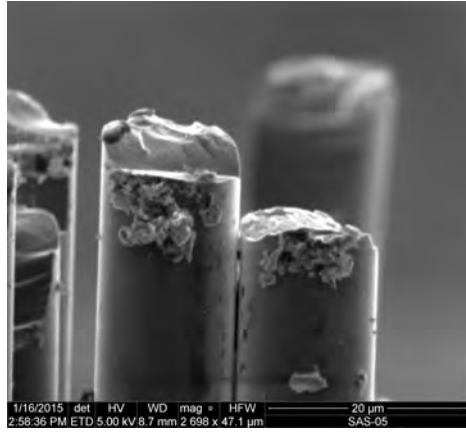
Figure B.79. Hi-Nicalon<sup>TM</sup> S fiber tow specimen SS2, upper section, (800°C,  $\sigma = 154$  MPa,  $t = 100$  h)

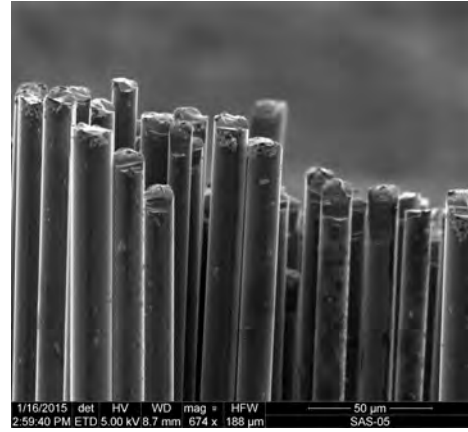
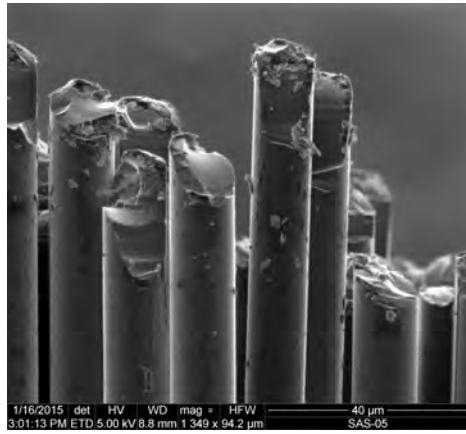
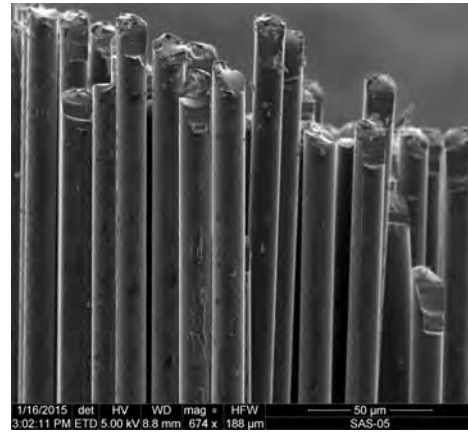
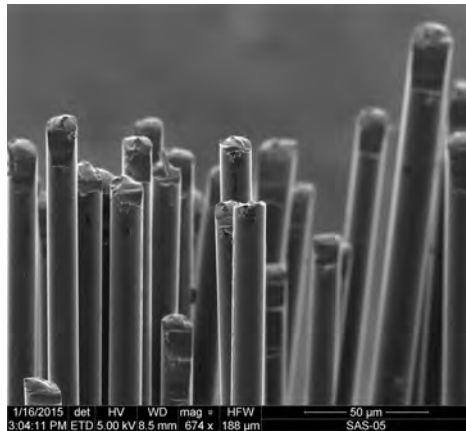
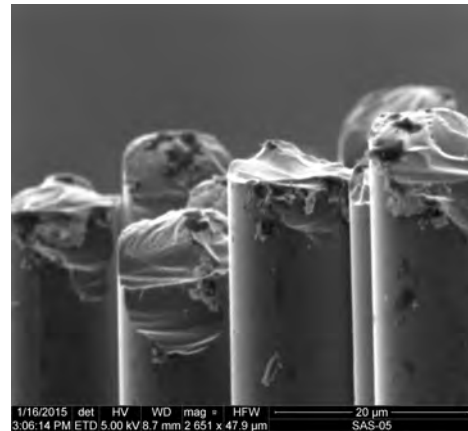
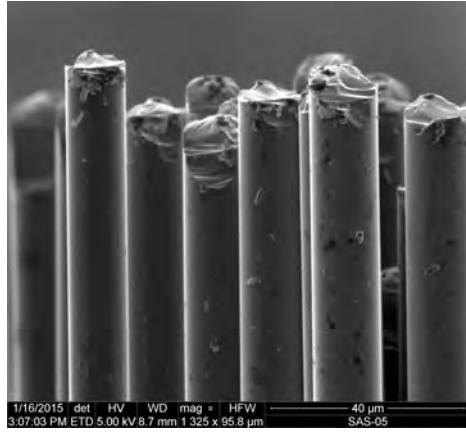
Figure B.80. Hi-Nicalon<sup>TM</sup> S fiber tow specimen SS2, upper section, (800°C,  $\sigma = 154$  MPa,  $t = 100$  h)

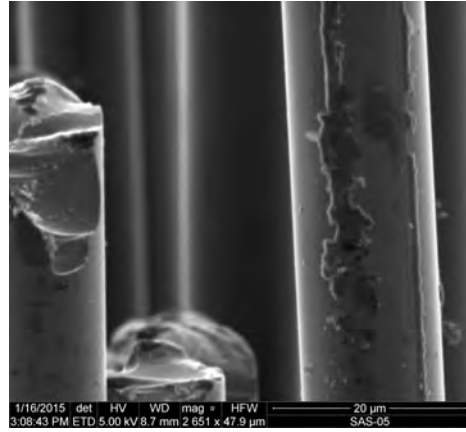
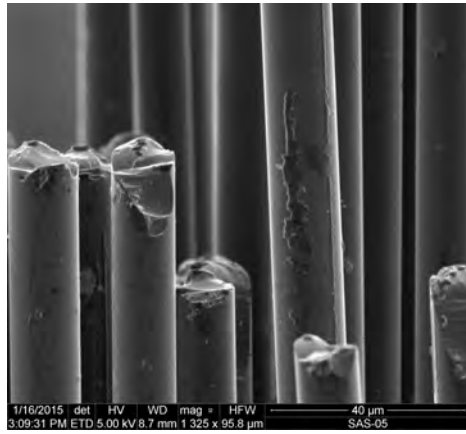
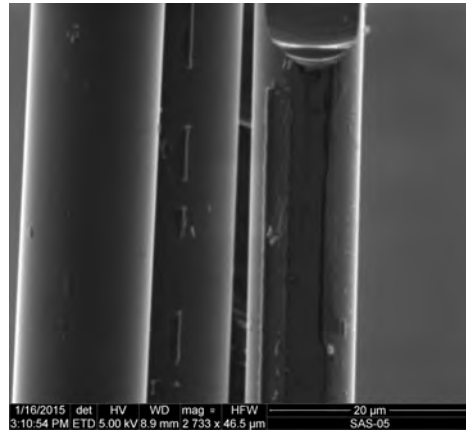
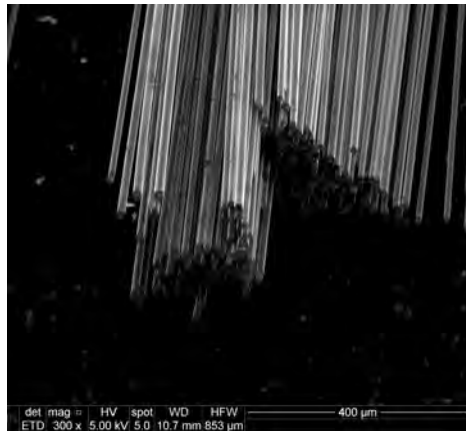
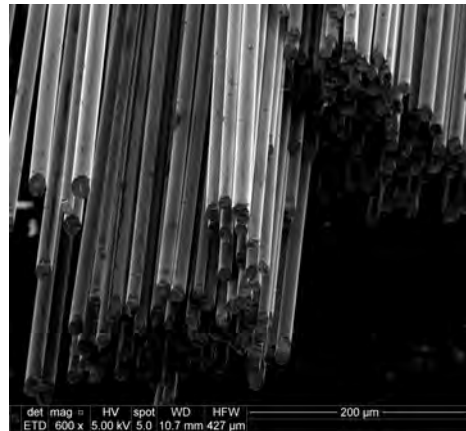
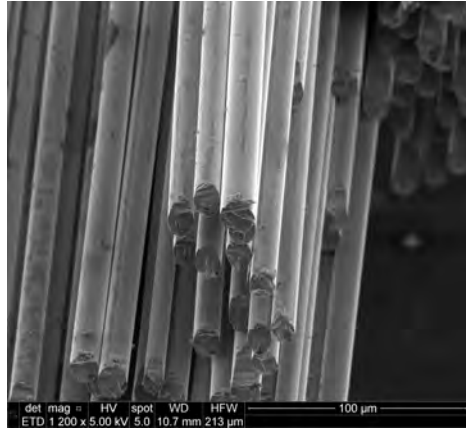
Figure B.81. Hi-Nicalon<sup>TM</sup> S fiber tow specimen SS2, upper section, (800°C,  $\sigma = 154$  MPa,  $t = 100$  h)

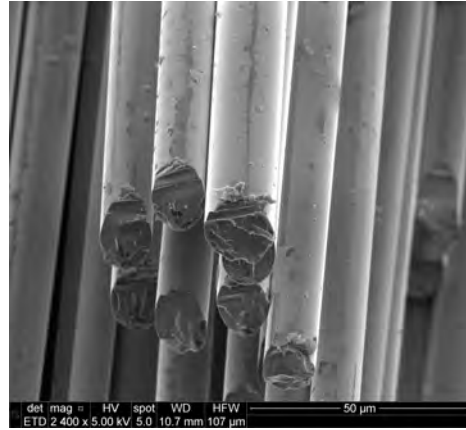
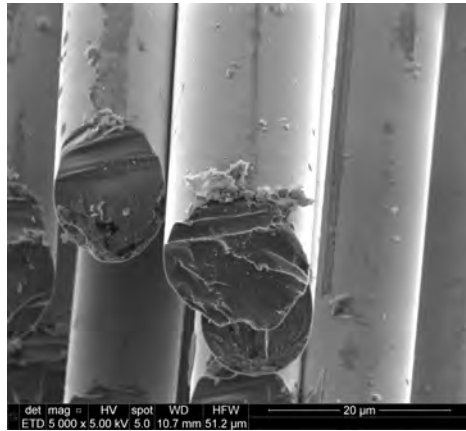
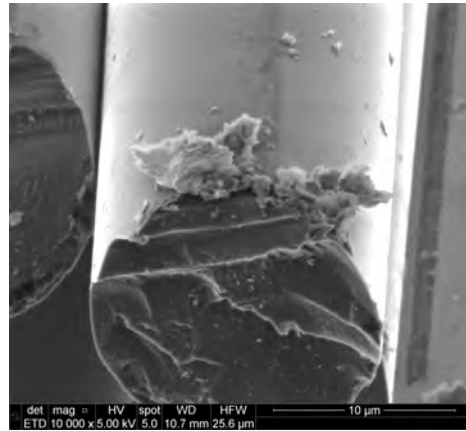
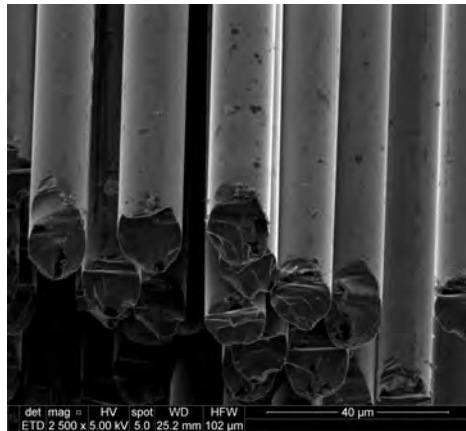
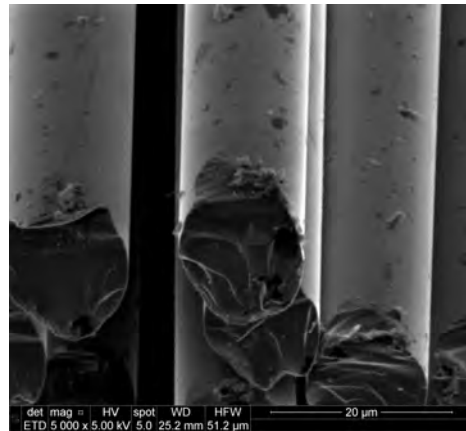
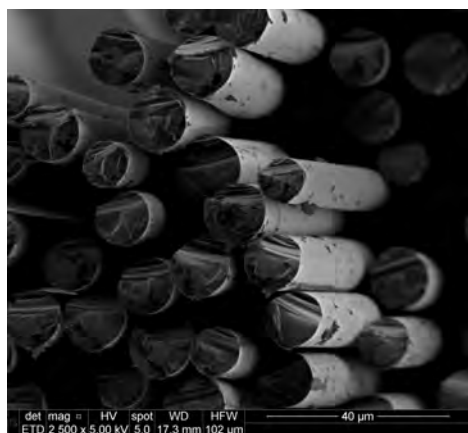
Figure B.82. Hi-Nicalon<sup>TM</sup> S fiber tow specimen SS2, upper section, (800°C,  $\sigma = 154$  MPa,  $t = 100$  h)

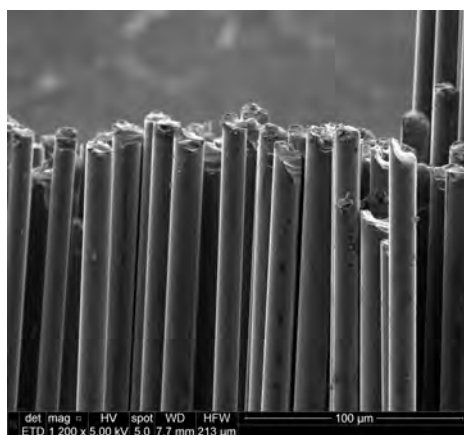
(f)

Figure B.83. Hi-Nicalon<sup>TM</sup> S fiber tow specimen SS2, upper section, (800°C,  $\sigma = 154$  MPa,  $t = 100$  h)

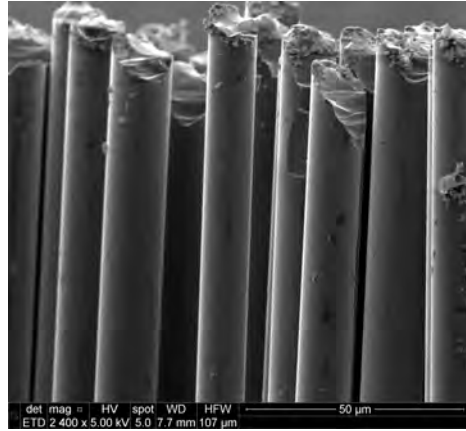
(a)

Figure B.84. Hi-Nicalon<sup>TM</sup> S fiber tow specimen SS2, upper section, (800°C,  $\sigma = 154$  MPa,  $t = 100$  h)

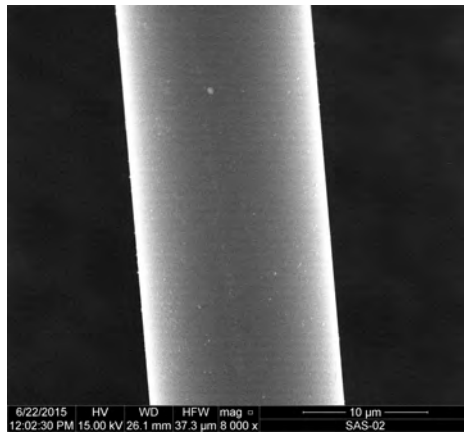
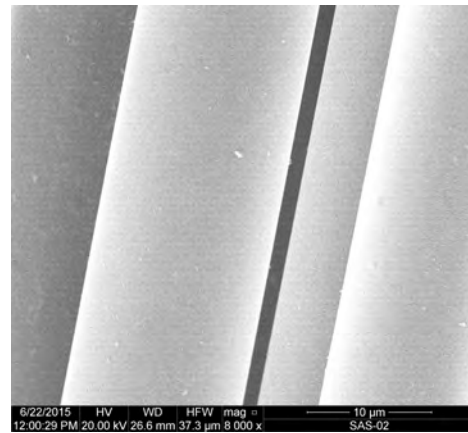
Figure B.85. Hi-Nicalon<sup>TM</sup> S fiber tow specimen SS9, center section, (800°C,  $\sigma = 400$  MPa,  $t = 100$  h)
