**CREEP OF HI-NICALON<sup>TM</sup> S CERAMIC  
FIBER TOWS AT 800°C IN AIR AND IN  
SILICIC ACID-SATURATED STEAM**

DISSERTATION

AFIT-ENY-DS-15-S-067

***AIR FORCE INSTITUTE OF TECHNOLOGY***

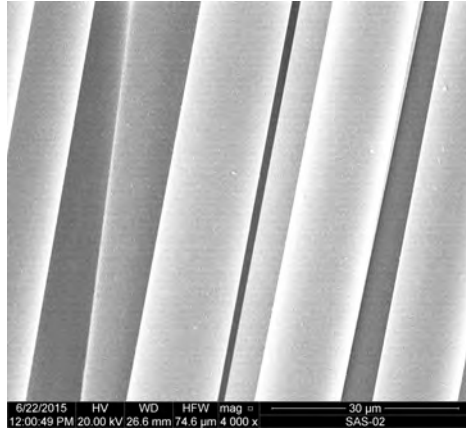
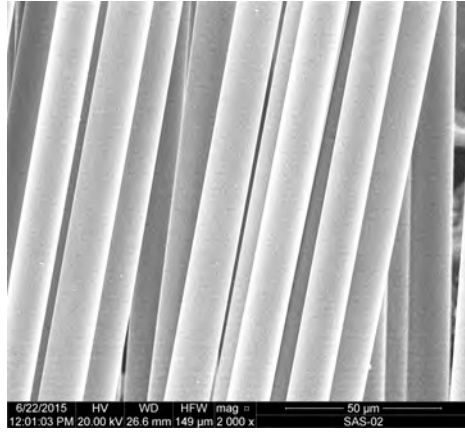
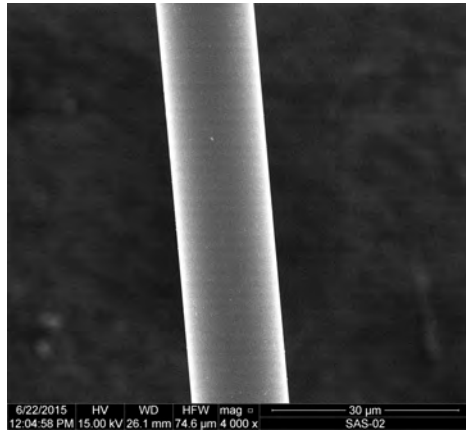
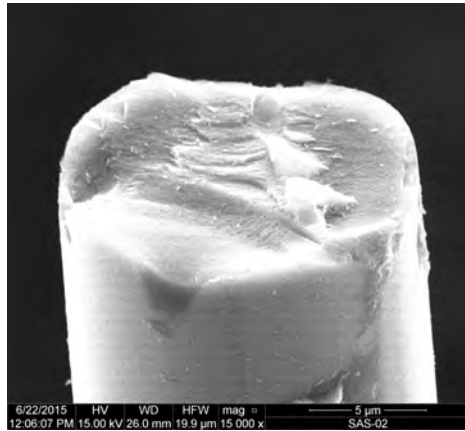
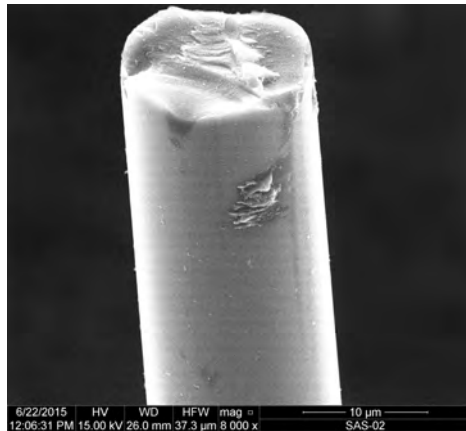
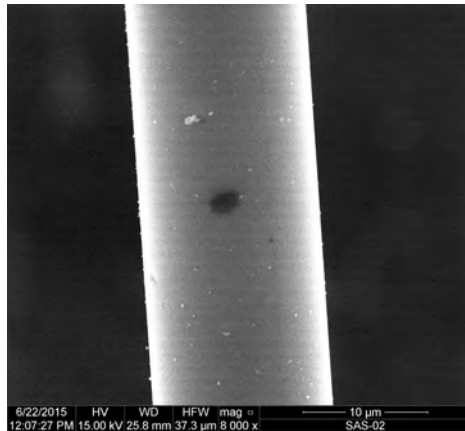
Figure B.86. Hi-Nicalon<sup>TM</sup> S fiber tow specimen SS9, center section, (800°C,  $\sigma = 400$  MPa,  $t = 100$  h)

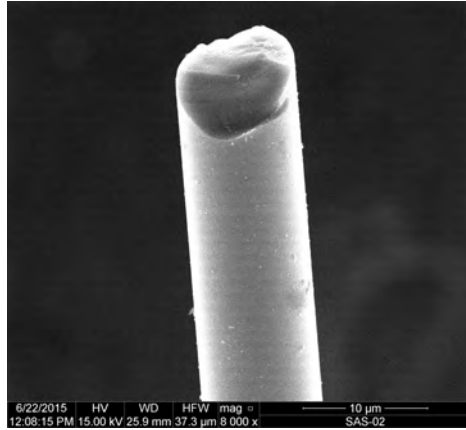
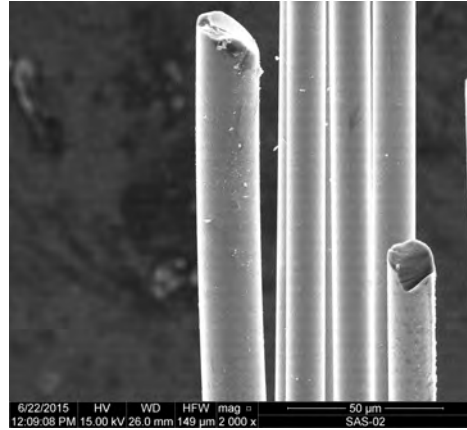
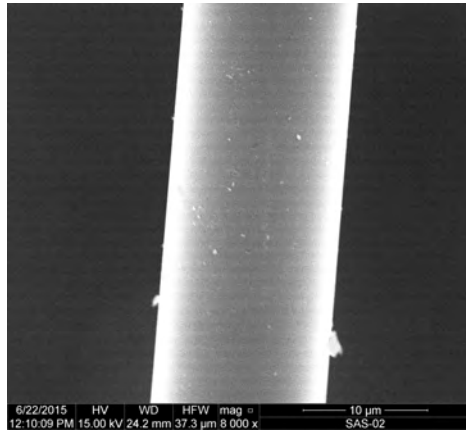
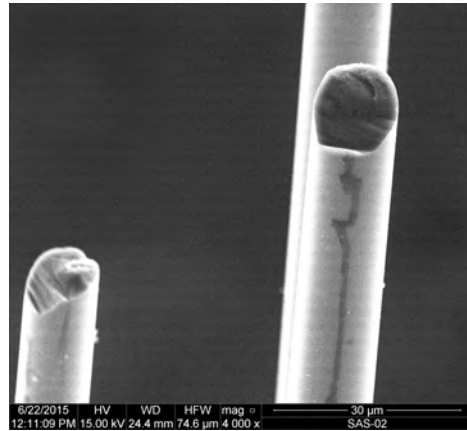
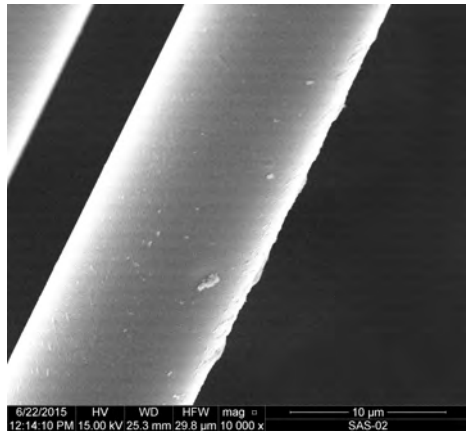
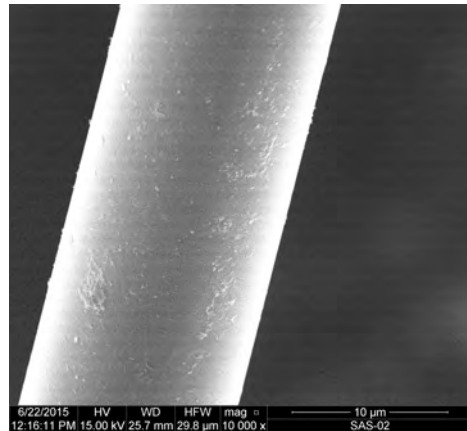
Figure B.87. Hi-Nicalon<sup>TM</sup> S fiber tow specimen SS9, center section, (800°C,  $\sigma = 400$  MPa,  $t = 100$  h)

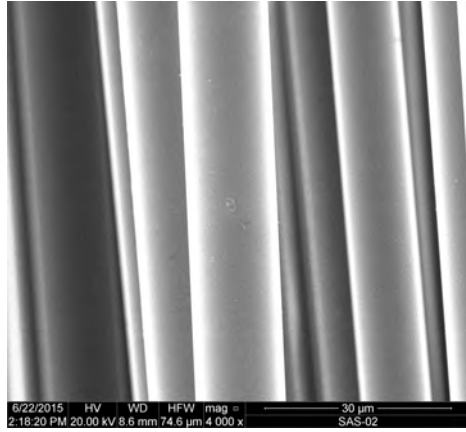
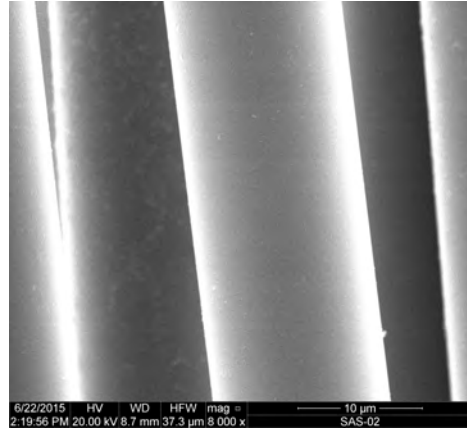
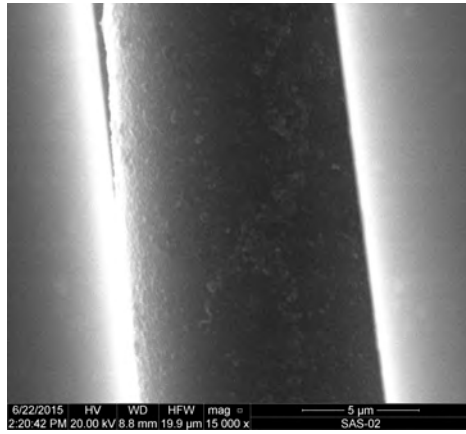
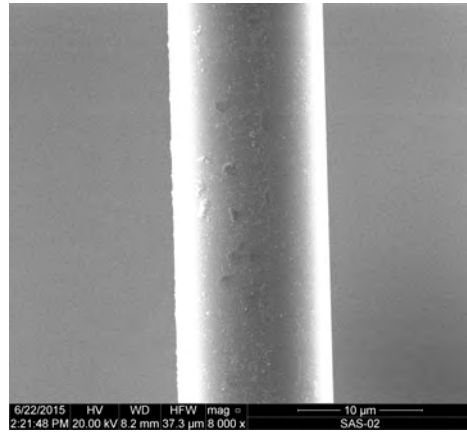
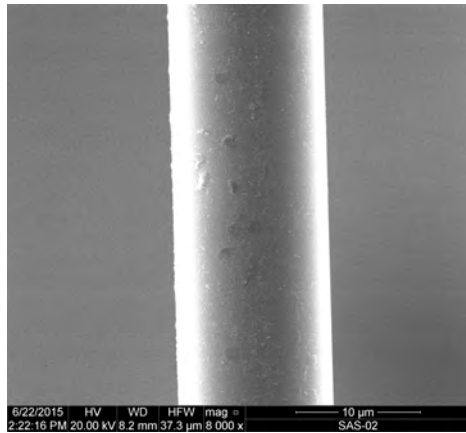
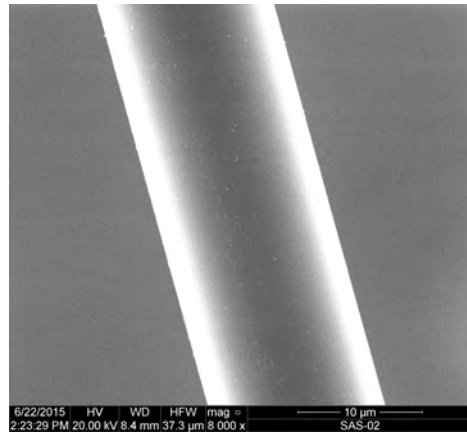
Figure B.88. Hi-Nicalon<sup>TM</sup> S fiber tow specimen SS11, center section, (800°C,  $\sigma = 425$  MPa,  $t = 100$  h)

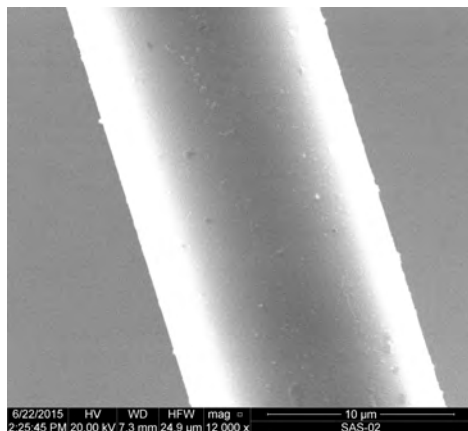
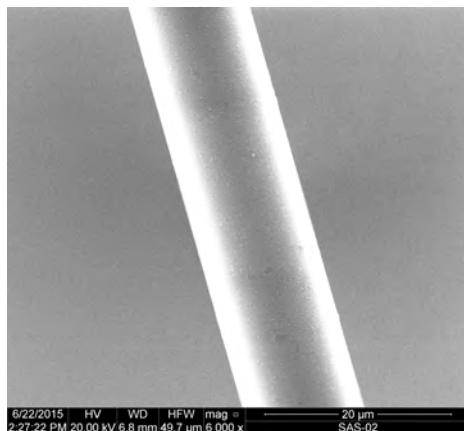
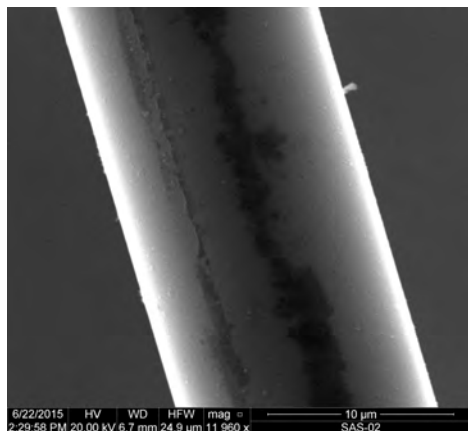
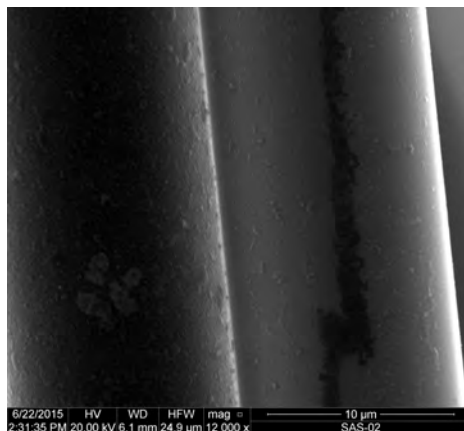
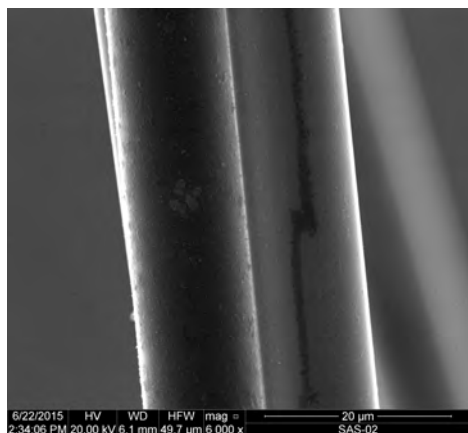
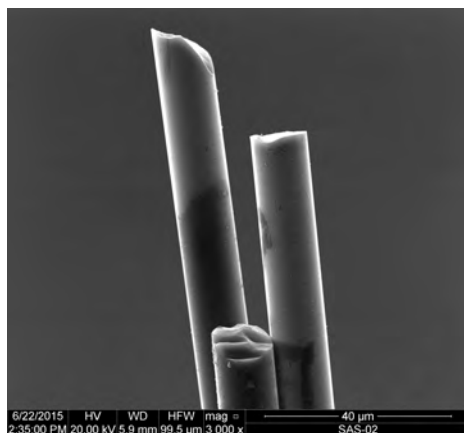
Figure B.89. Hi-Nicalon<sup>TM</sup> S fiber tow specimen SS11, center section, (800°C,  $\sigma = 425$  MPa,  $t = 100$  h)

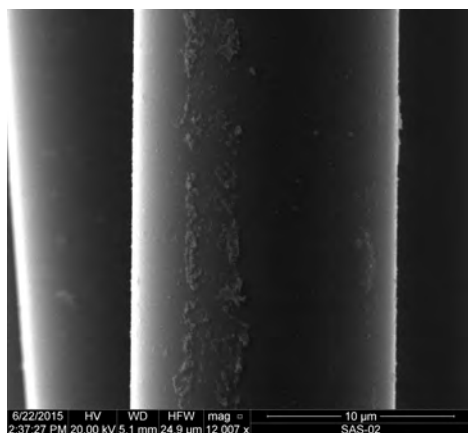
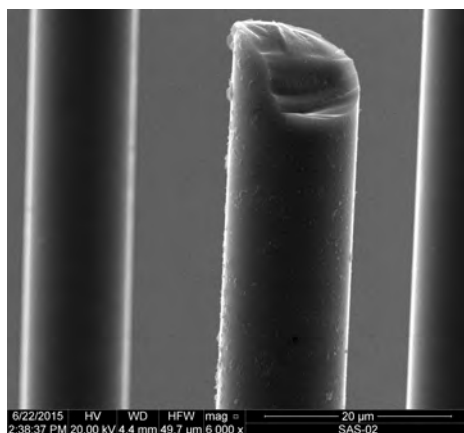
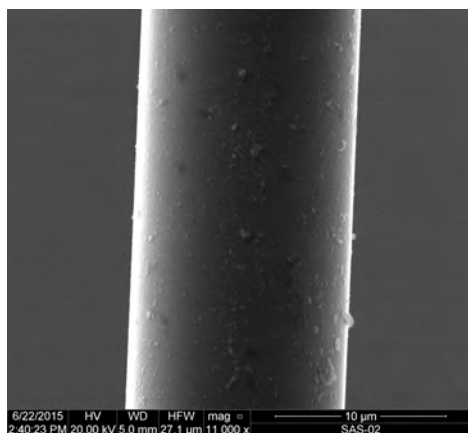
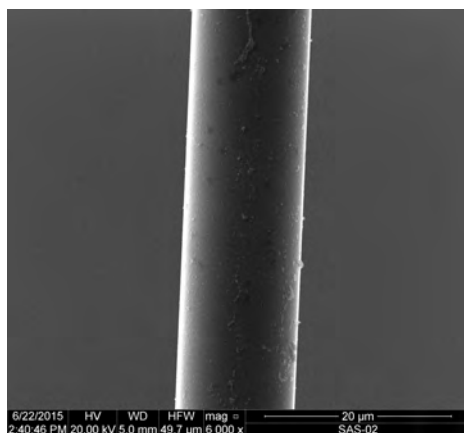
Figure B.90. Hi-Nicalon<sup>TM</sup> S fiber tow specimen SS11, center section, (800°C,  $\sigma = 425$  MPa,  $t = 100$  h)

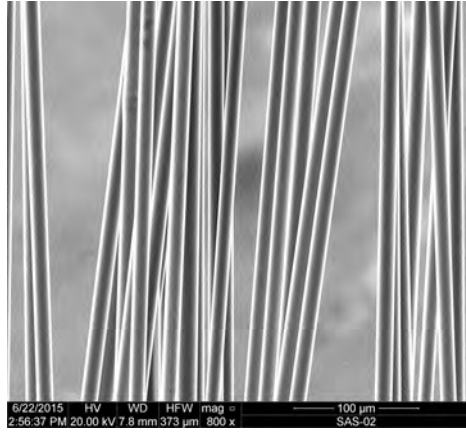
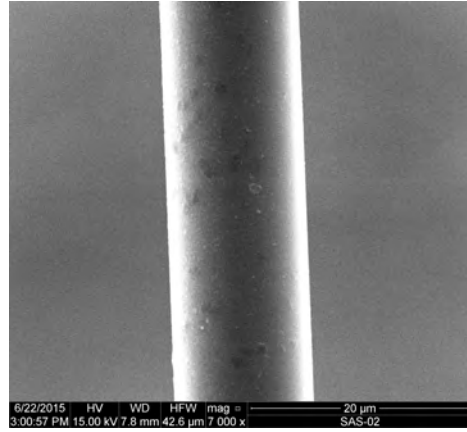
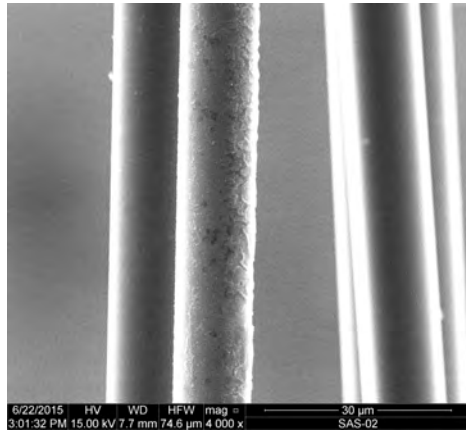
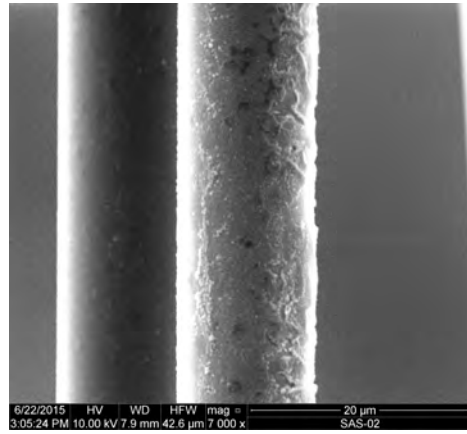
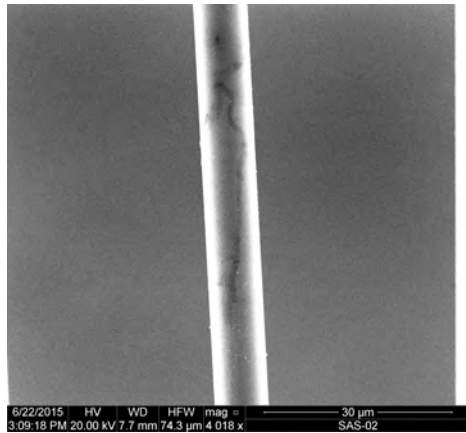
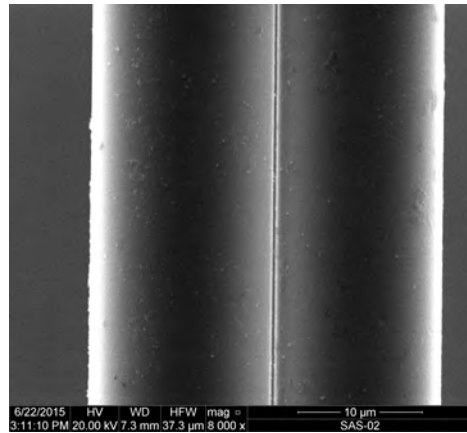
Figure B.91. Hi-Nicalon<sup>TM</sup> S fiber tow specimen SS12, center section, (800°C,  $\sigma = 450$  MPa,  $t = 100$  h)

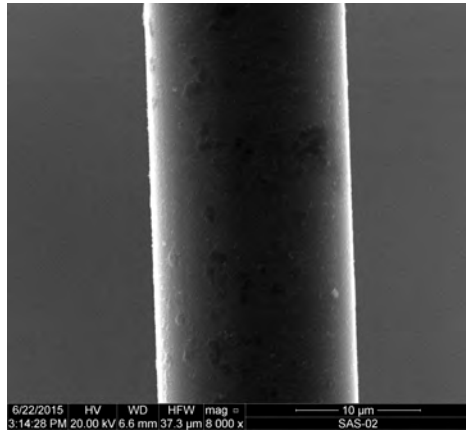
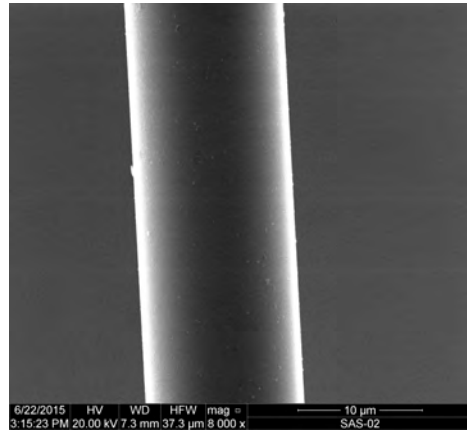
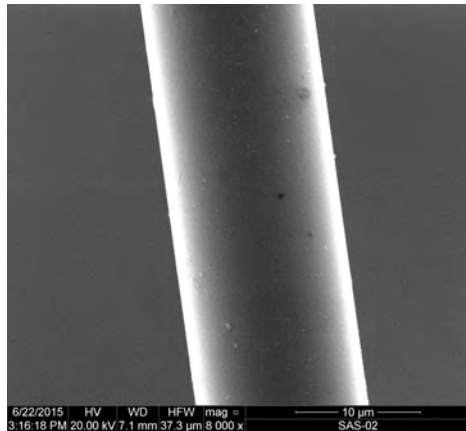
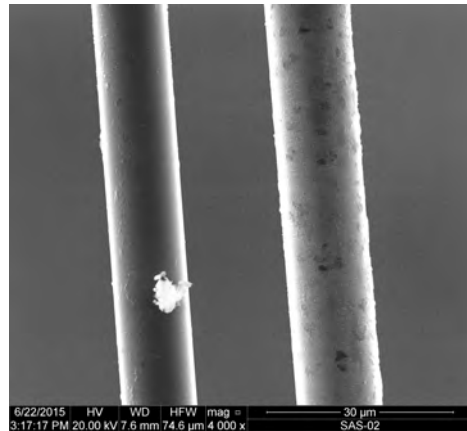
Figure B.92. Hi-Nicalon<sup>TM</sup> S fiber tow specimen SS12, center section, (800°C,  $\sigma = 450$  MPa,  $t = 100$  h)

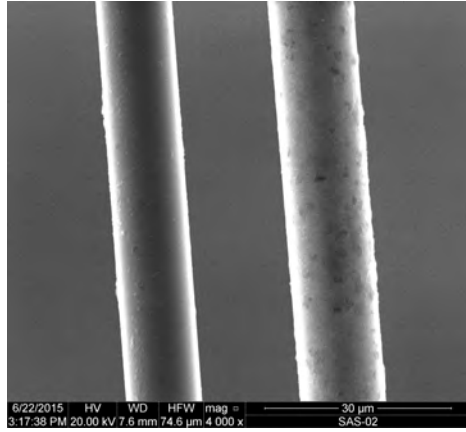
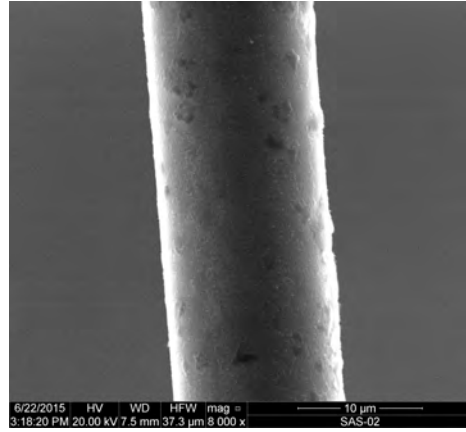
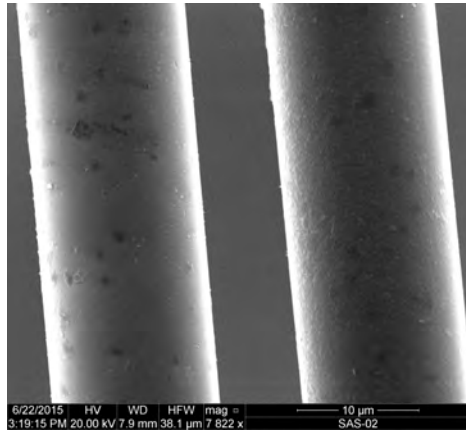
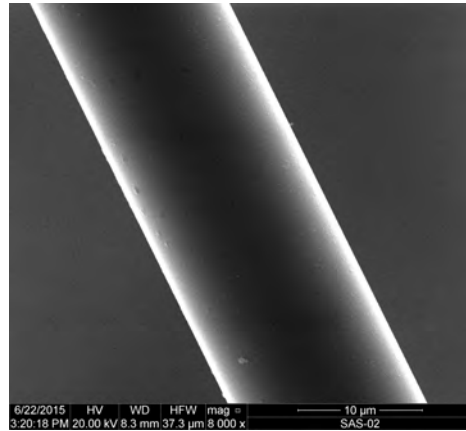
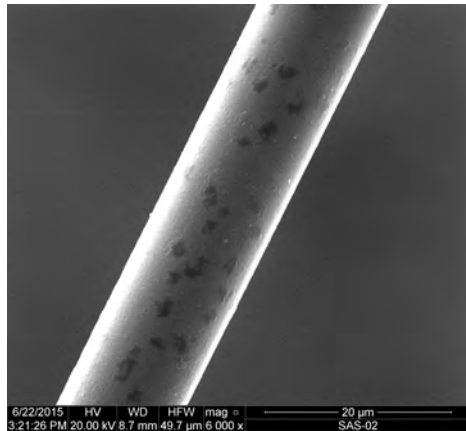
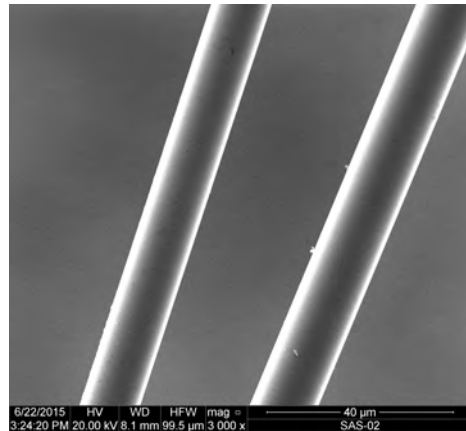
Figure B.93. Hi-Nicalon<sup>TM</sup> S fiber tow specimen SS12, center section, (800°C,  $\sigma = 450$  MPa,  $t = 100$  h)

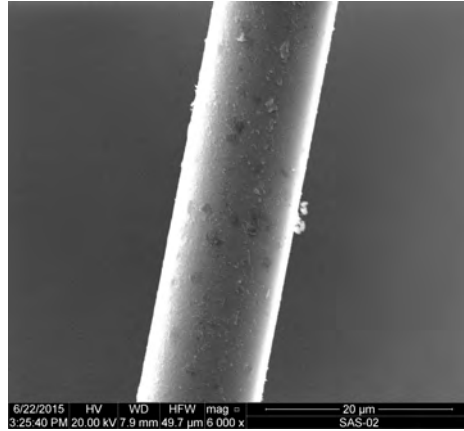
Figure B.94. Hi-Nicalon<sup>TM</sup> S fiber tow specimen SS12, center section, (800°C,  $\sigma = 450$  MPa,  $t = 100$  h)

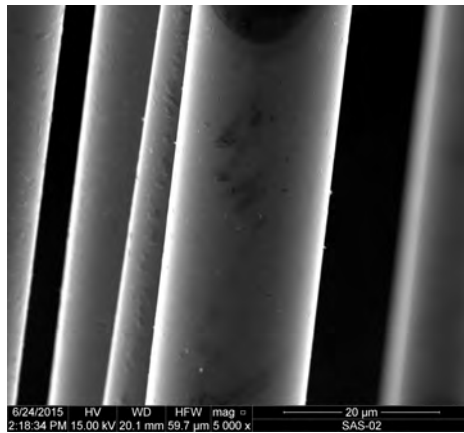
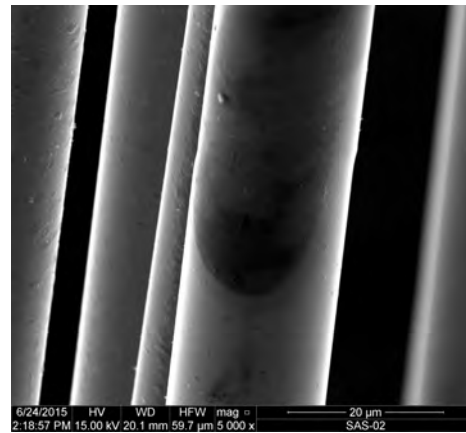
Figure B.95. Hi-Nicalon<sup>TM</sup> S fiber tow specimen SS13, center section, (800°C,  $\sigma = 538$  MPa,  $t = 76.8$  h, prematurely terminated due to power outage)

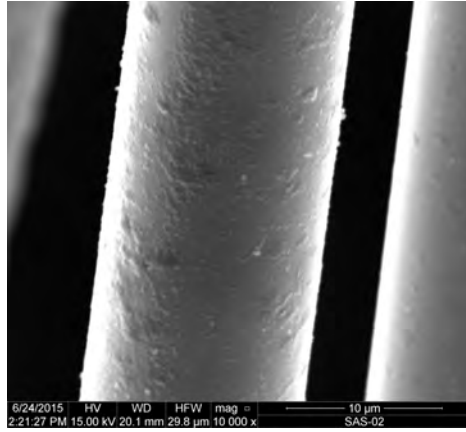
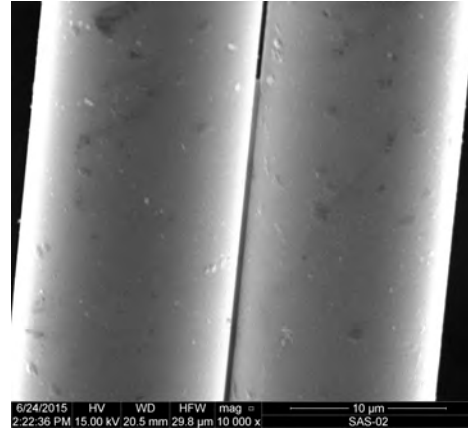
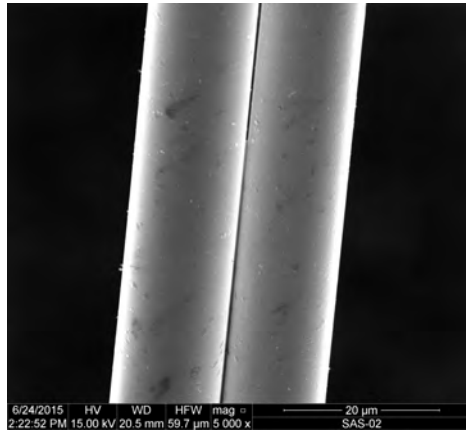
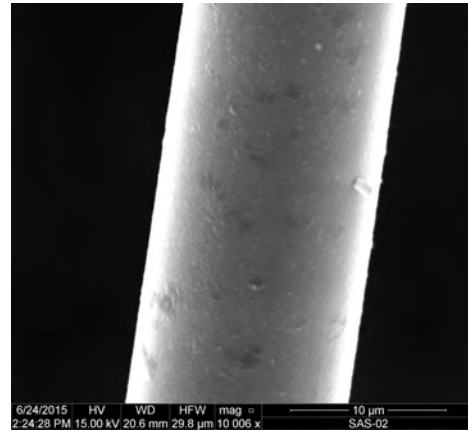
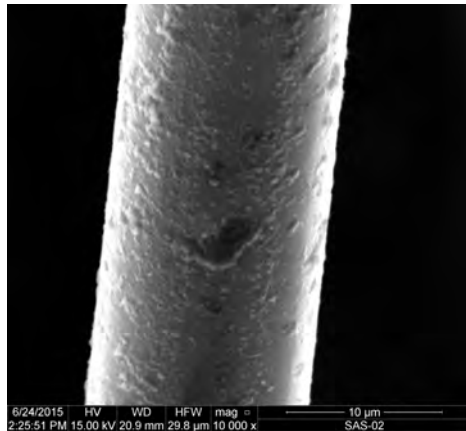
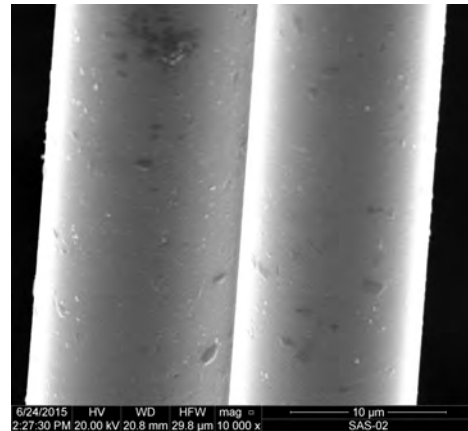
Figure B.96. Hi-Nicalon<sup>TM</sup> S fiber tow specimen SS13, center section, (800°C,  $\sigma = 538$  MPa,  $t = 76.8$  h, prematurely terminated due to power outage)

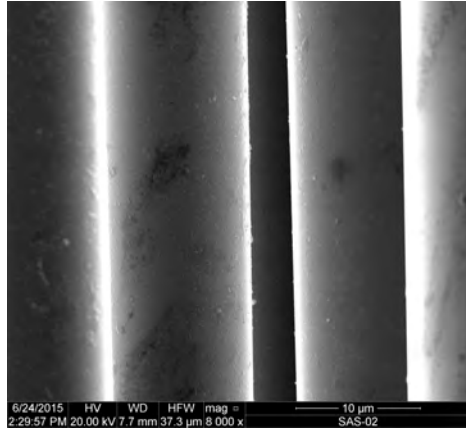
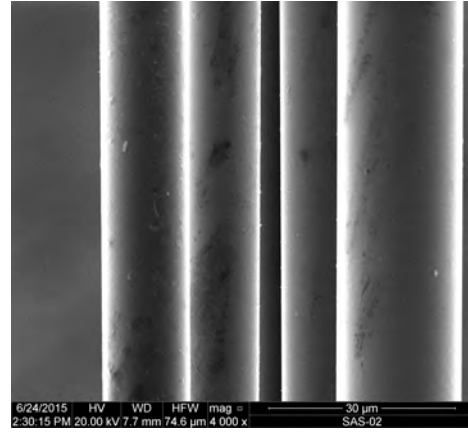
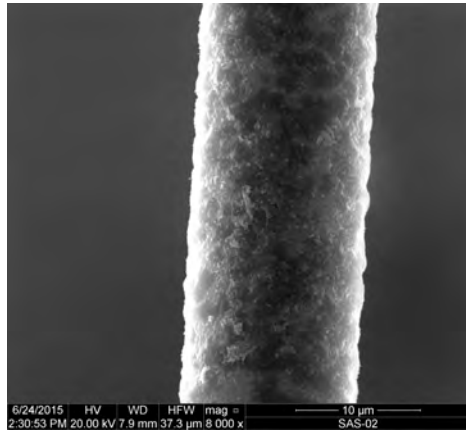
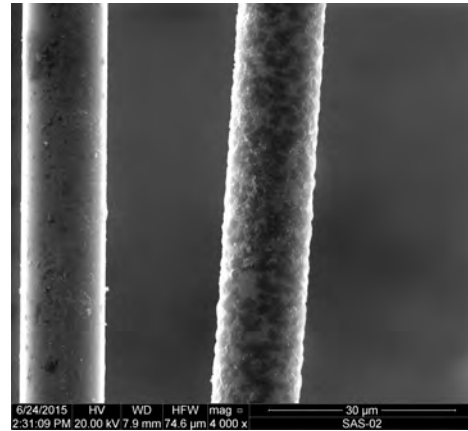
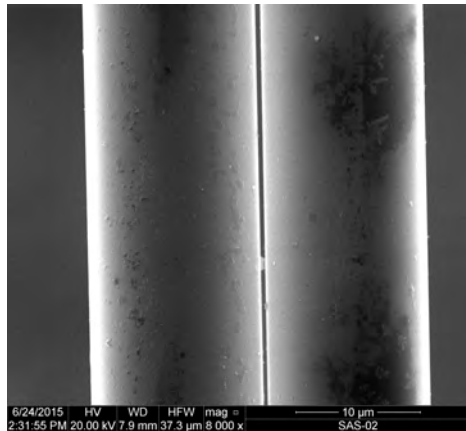
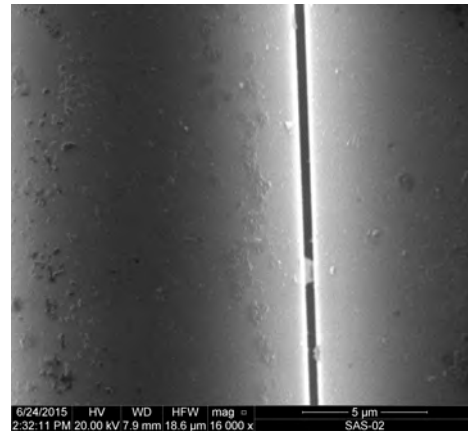
Figure B.97. Hi-Nicalon<sup>TM</sup> S fiber tow specimen SS13, center section, (800°C,  $\sigma = 538$  MPa,  $t = 76.8$  h, prematurely terminated due to power outage)

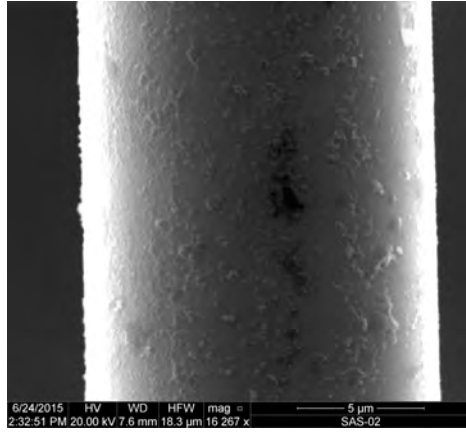
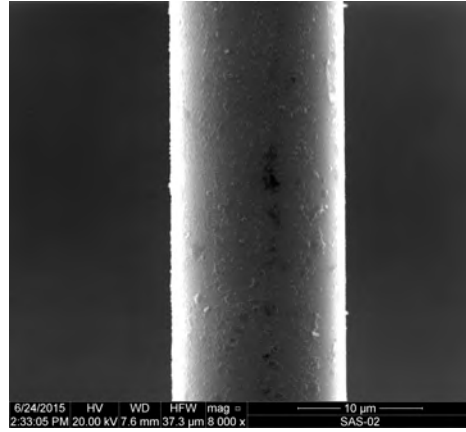
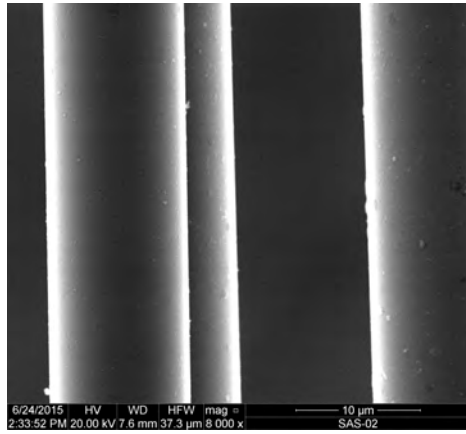
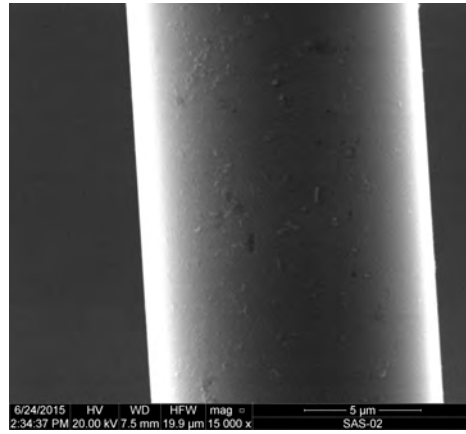
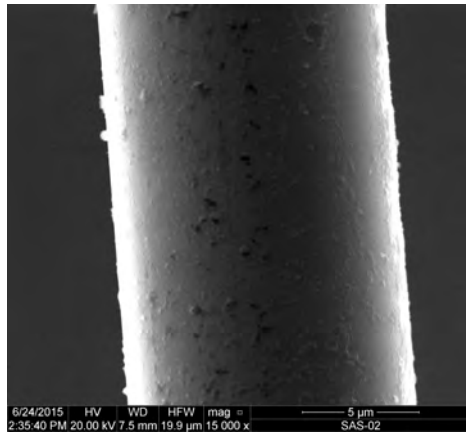
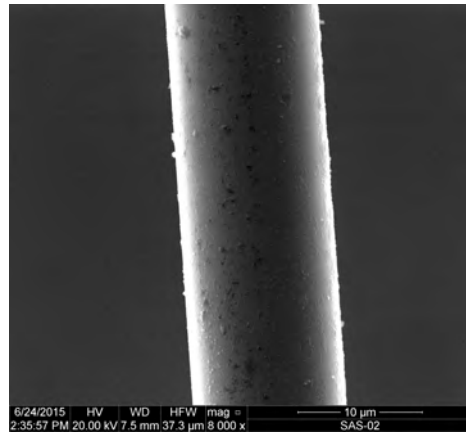
Figure B.98. Hi-Nicalon<sup>TM</sup> S fiber tow specimen SS13, center section, (800°C,  $\sigma = 538$  MPa,  $t = 76.8$  h, prematurely terminated due to power outage)

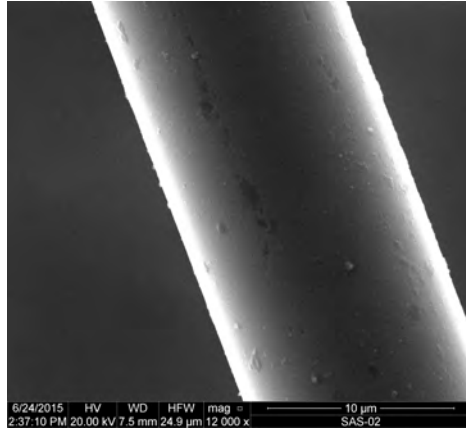
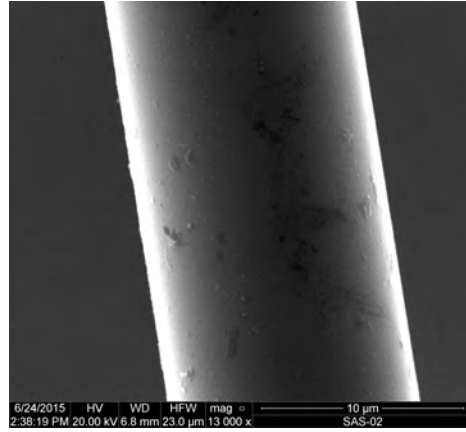
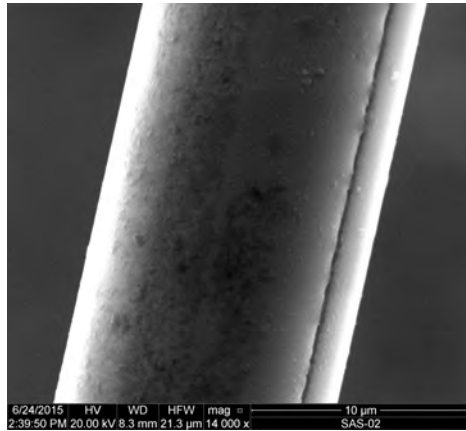
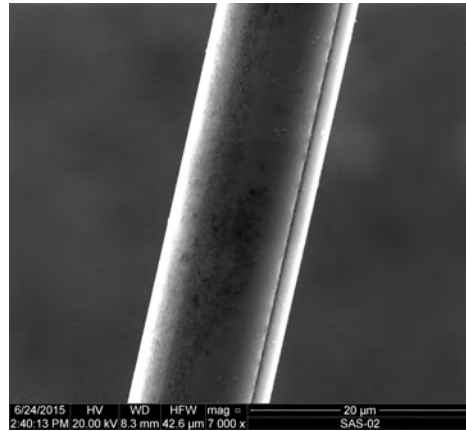
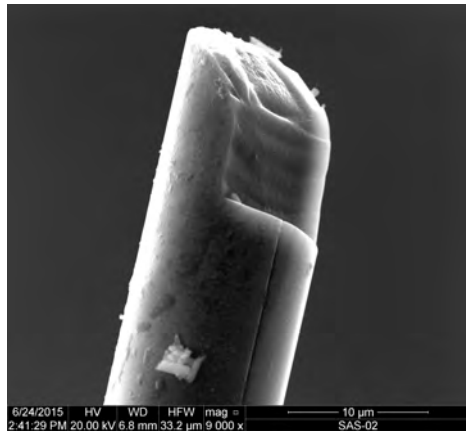
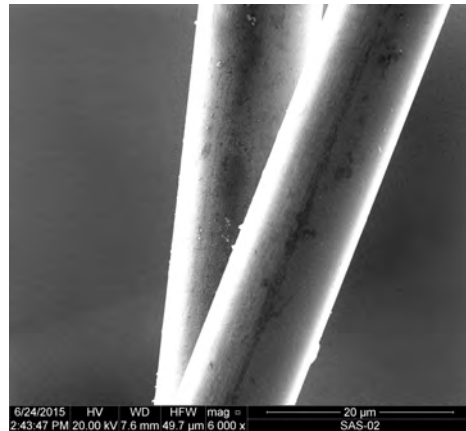
Figure B.99. Hi-Nicalon<sup>TM</sup> S fiber tow specimen SS13, center section, (800°C,  $\sigma = 538$  MPa,  $t = 76.8$  h, prematurely terminated due to power outage)

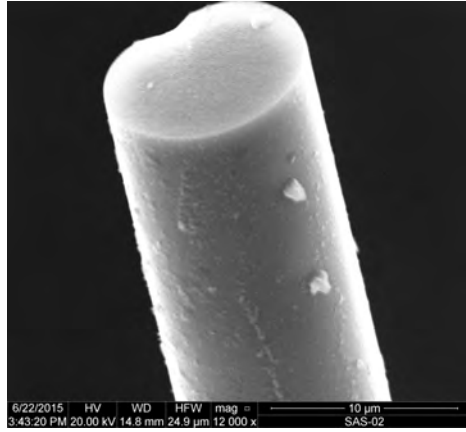
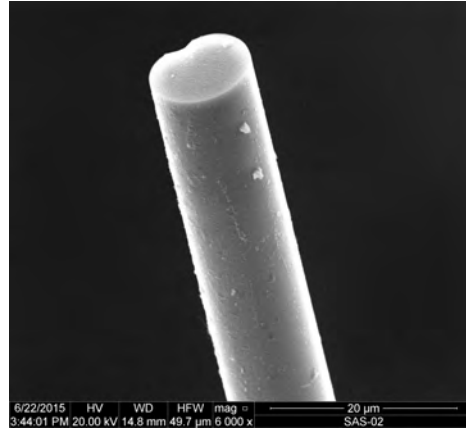
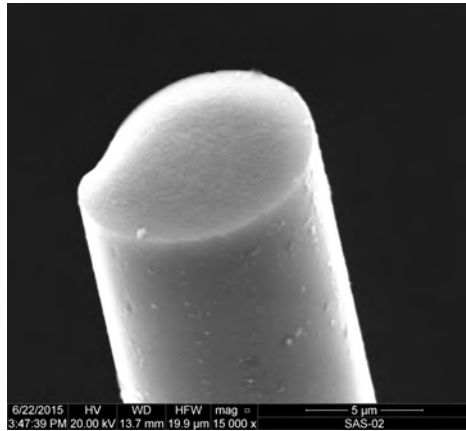
Figure B.100. Hi-Nicalon<sup>TM</sup> S fiber tow specimen SS13, fracture surface, (800°C,  $\sigma = 538$  MPa,  $t = 76.8$  h, prematurely terminated due to power outage)

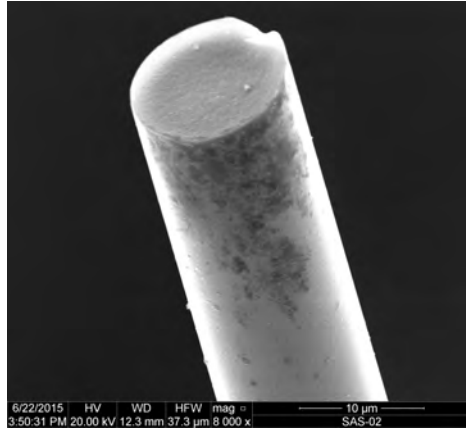
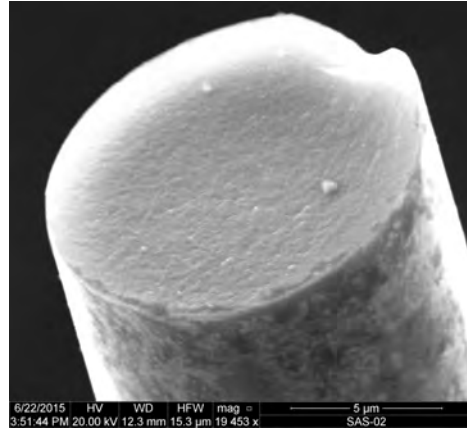
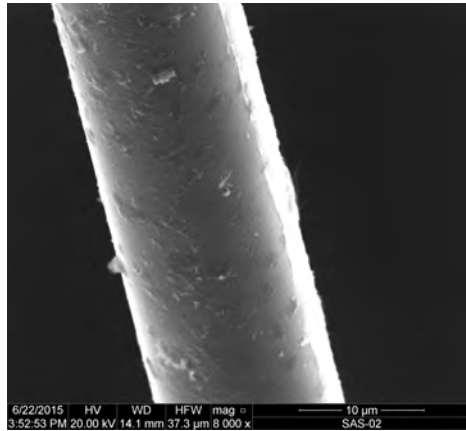
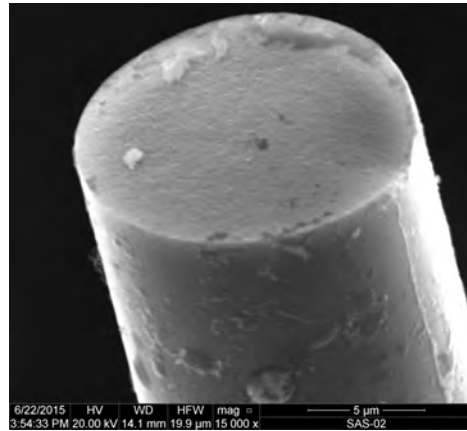
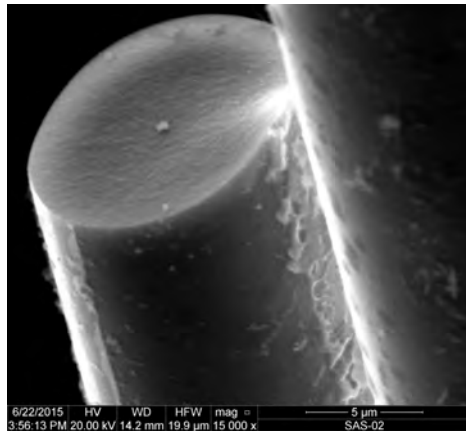
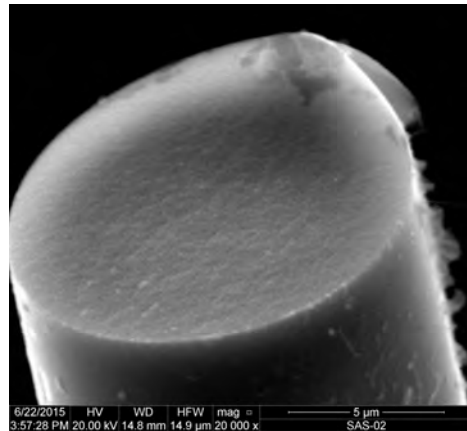
Figure B.101. Hi-Nicalon<sup>TM</sup> S fiber tow specimen SS13, fracture surface, (800°C,  $\sigma = 538$  MPa,  $t = 76.8$  h, prematurely terminated due to power outage)

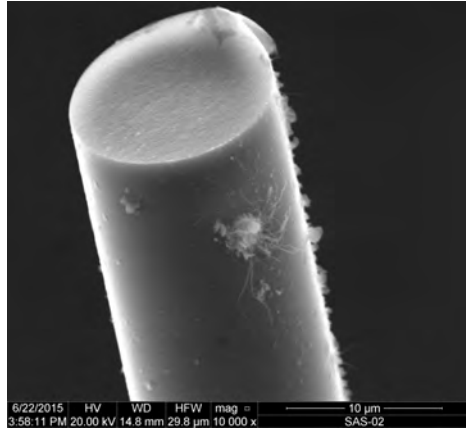
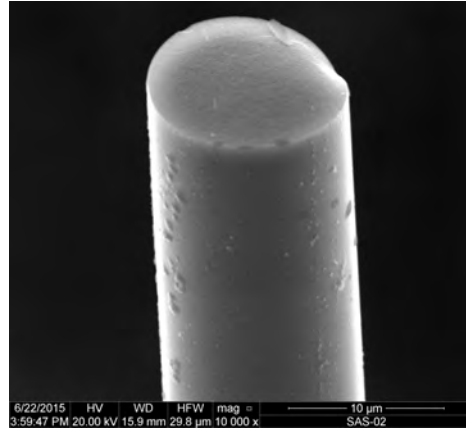
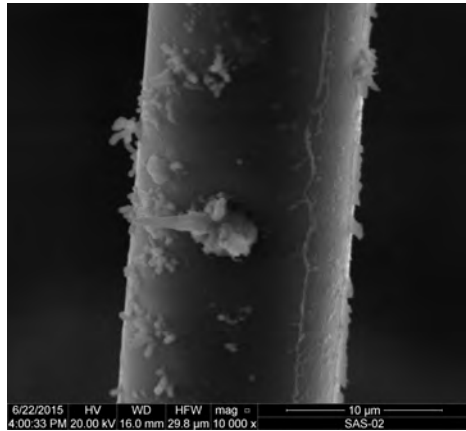
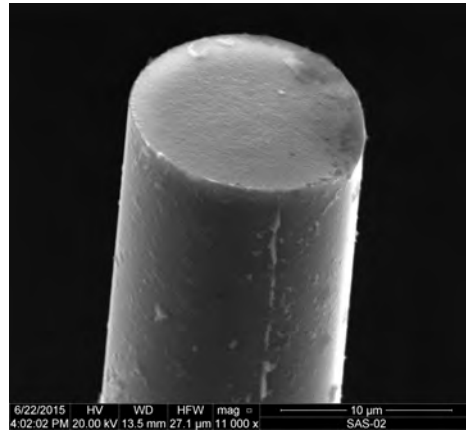
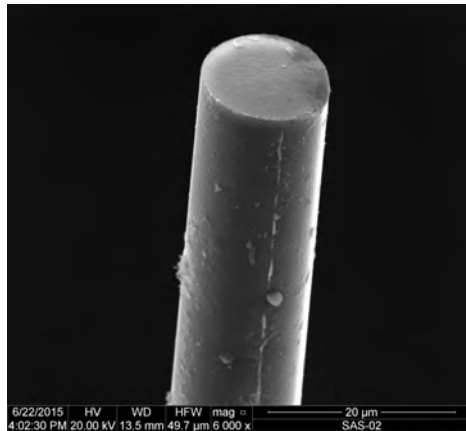
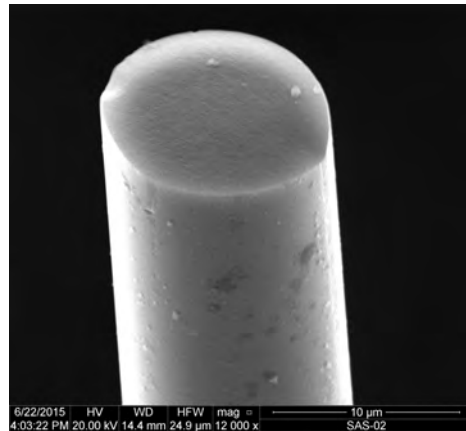
Figure B.102. Hi-Nicalon<sup>TM</sup> S fiber tow specimen SS13, fracture surface, (800°C,  $\sigma = 538$  MPa,  $t = 76.8$  h, prematurely terminated due to power outage)

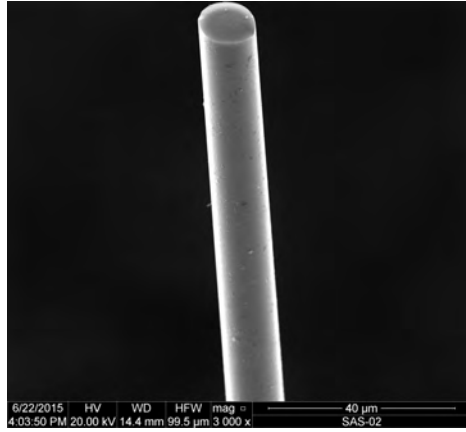
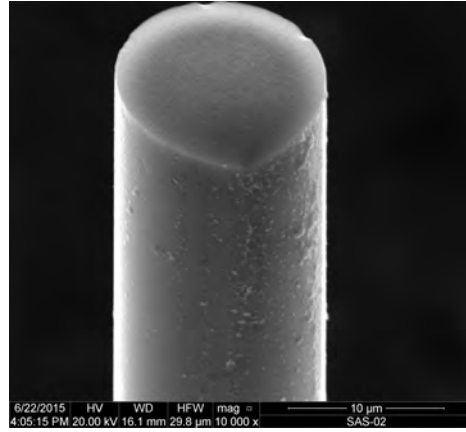
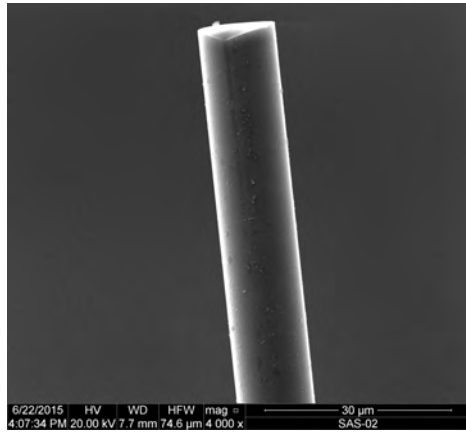
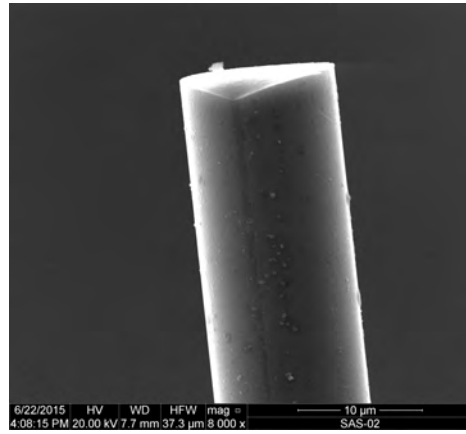
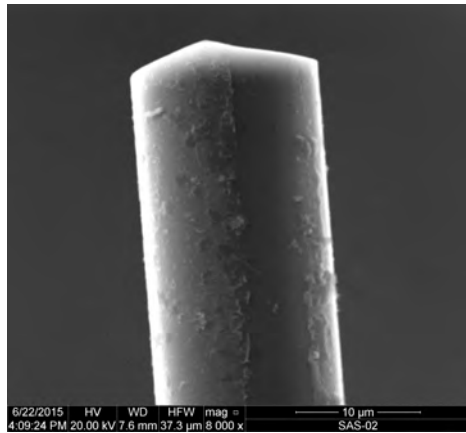
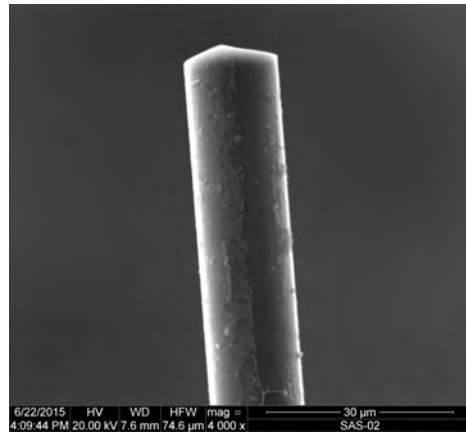
Figure B.103. Hi-Nicalon<sup>TM</sup> S fiber tow specimen SS13, fracture surface, (800°C,  $\sigma = 538$  MPa,  $t = 76.8$  h, prematurely terminated due to power outage)

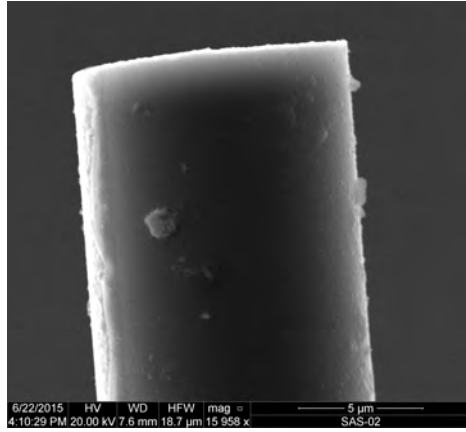
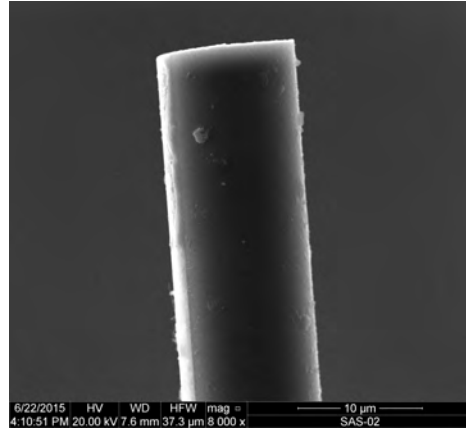
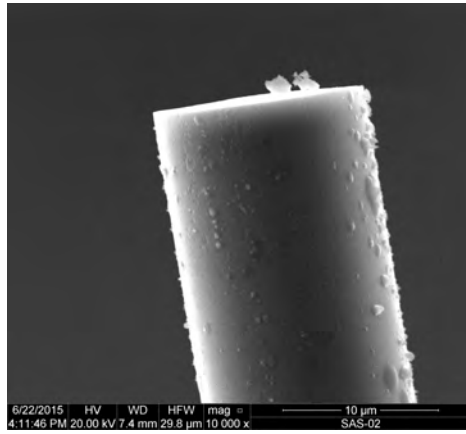
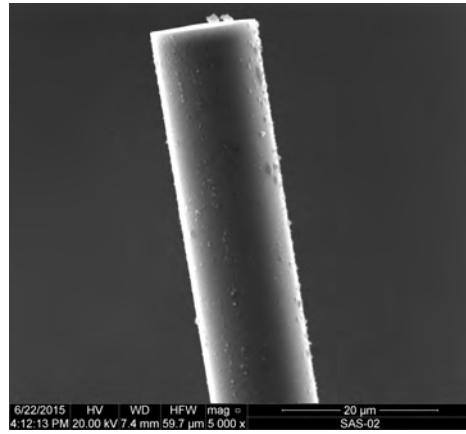
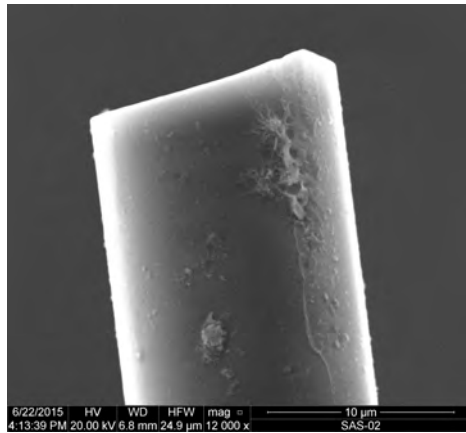
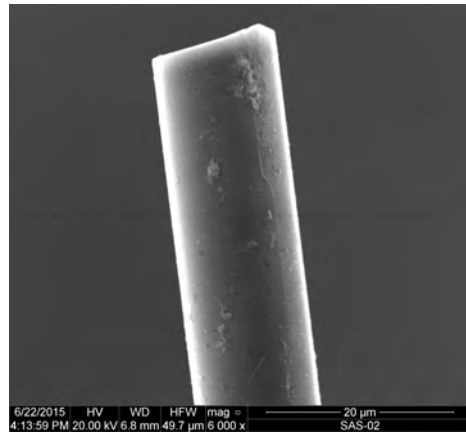
Figure B.104. Hi-Nicalon<sup>TM</sup> S fiber tow specimen SS13, fracture surface, (800°C,  $\sigma = 538$  MPa,  $t = 76.8$  h, prematurely terminated due to power outage)

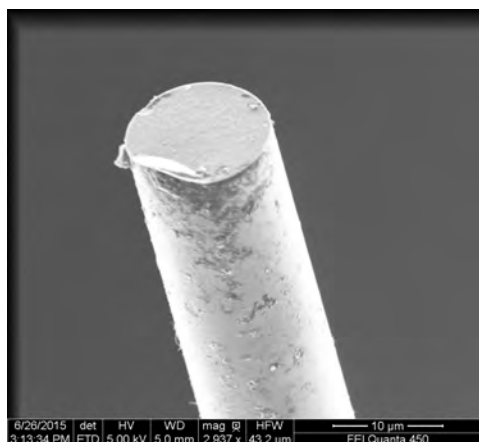
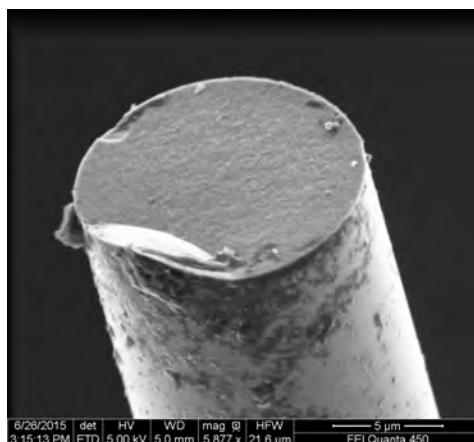
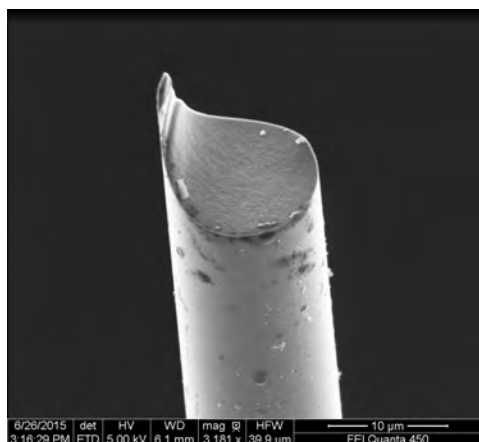
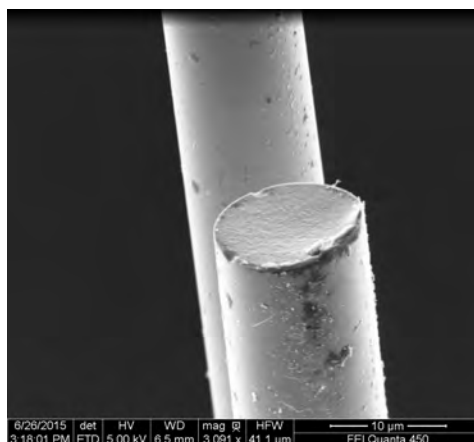
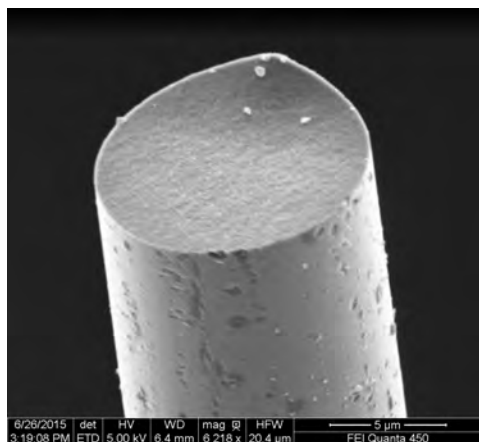
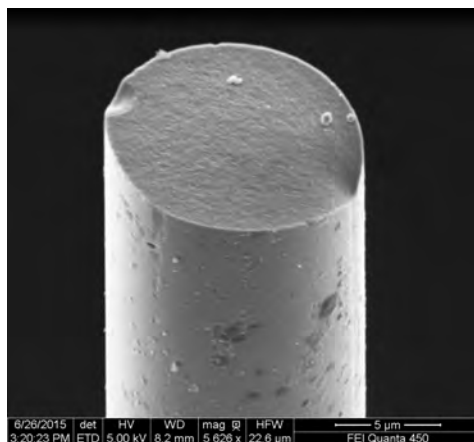
Figure B.105. Hi-Nicalon<sup>TM</sup> S fiber tow specimen SS13, fracture surface, (800°C,  $\sigma = 538$  MPa,  $t = 76.8$  h, prematurely terminated due to power outage)

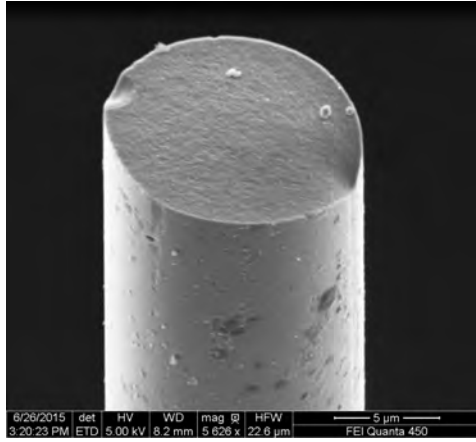
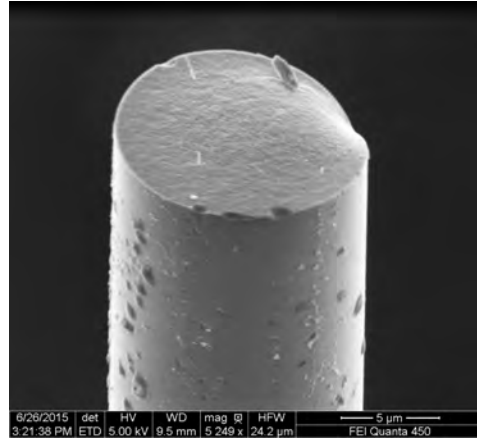
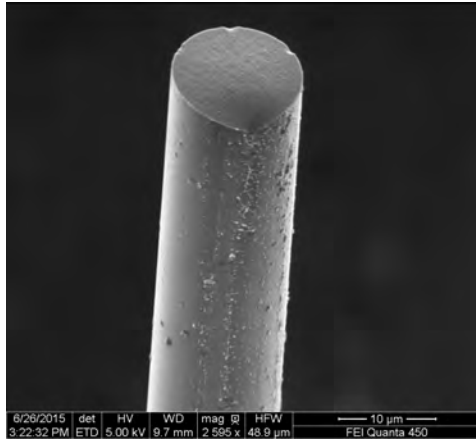
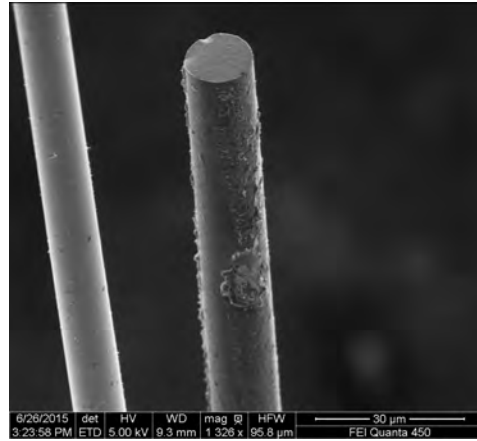
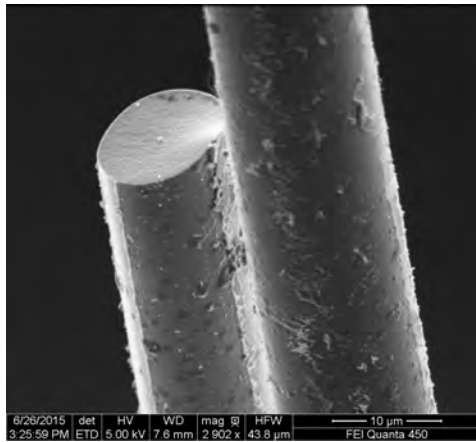
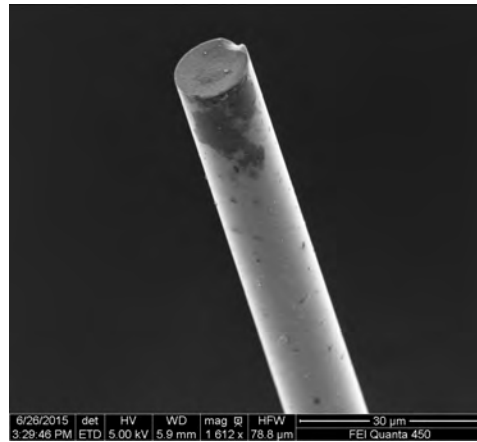
Figure B.106. Hi-Nicalon<sup>TM</sup> S fiber tow specimen SS13, fracture surface, (800°C,  $\sigma = 538$  MPa,  $t = 76.8$  h, prematurely terminated due to power outage)
