**CREEP OF HI-NICALON<sup>TM</sup> S CERAMIC  
FIBER TOWS AT 800°C IN AIR AND IN  
SILICIC ACID-SATURATED STEAM**

DISSERTATION

AFIT-ENY-DS-15-S-067

***AIR FORCE INSTITUTE OF TECHNOLOGY***

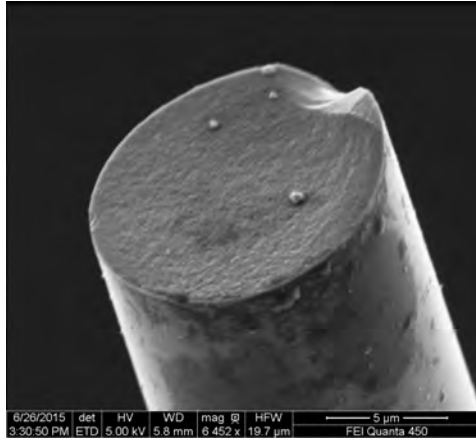
Figure B.107. Hi-Nicalon<sup>TM</sup> S fiber tow specimen SS13, fracture surface, (800°C,  $\sigma = 538$  MPa,  $t = 76.8$  h, prematurely terminated due to power outage)
