**US Army Corps  
of Engineers®**  
Engineer Research and  
Development Center

# **Full-Scale Instrumented Evaluations of Multiple Airfield Matting Systems on Soft Soil to Characterize Permanent Deformation**

June 2016

Final report

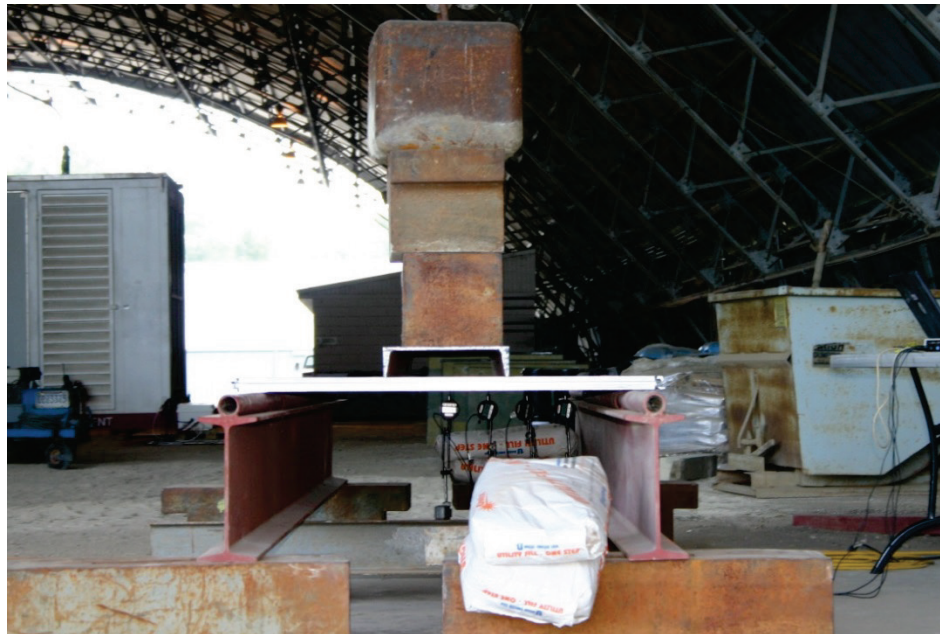
Figure 3. Simply supported beam test setup used for determining  $E_c^{NJ(2)}$ .

equal to the one measured as shown in Figure 3. A corresponding flexural rigidity was then chosen from the results of the model. Using the measured properties of the mat systems, the maximum deviatoric stress in the subgrade below the mats was determined using the ERDC layered elastic analysis computer program, WINJULEA. The maximum deviatoric stress was then related to known mat performance (i.e., passes to failure) to develop the performance criteria for the design methodology. Full-scale instrumented test section data for the AM2 and M19 matting systems and mats tested by Anderton and Gartrell (2005) were included in the Gonzalez and Rushing (2010) data set.

Berney et al. (2006) used load-deflection data from the setup shown in Figure 3 to determine the unit section modulus of different mats using an FEA program called STUBBS. Mats were modeled as simply supported plane strain beams that were assumed to be 1-in. thick. A Poisson's ratio

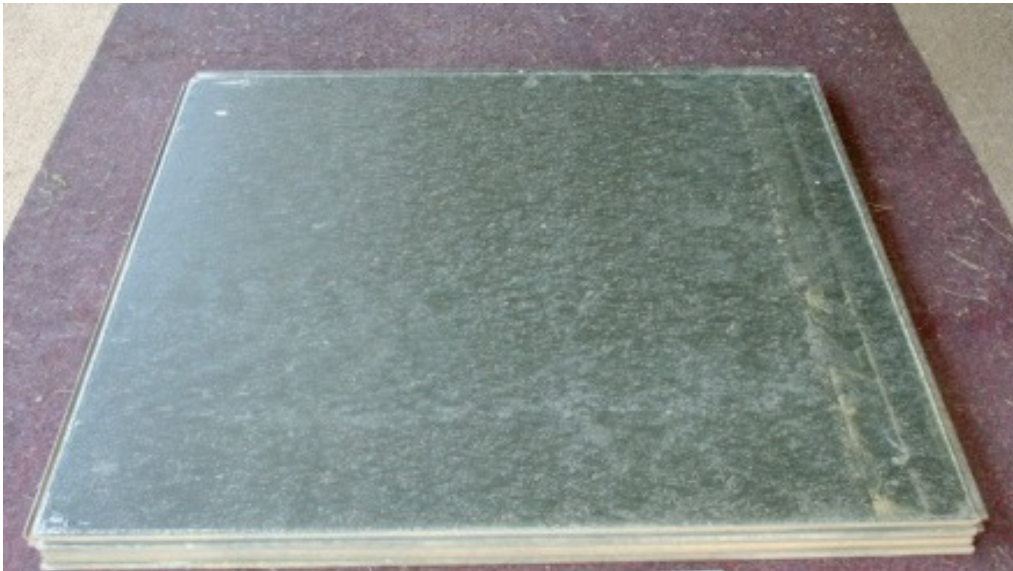
Figure 6. M19 mat panel.

M19 aluminum matting has panels nearly square that consist of a honeycomb core made of 0.125-in. hexagonal cells of aluminum foil. The core is bonded top and bottom to rolled-aluminum sheets by an epoxy adhesive. The edge connectors are welded to the top and bottom sheets and bonded with a potting compound to the core. Panels are joined along two edges by a hinge-type male/female connection. The other two edges consist of overlap/underlap end connectors that are secured by an aluminum locking

bar, much like AM2. The panels are coated with a non-skid material to increase surface friction. M19 mat used for testing was purchased from war reserve material stockpiles, so the history of the purchased mat was unknown. However, the mat was visually inspected and seemed to be in good structural condition. There were no cracked welds, nor was there any deformation. A photograph of an M19 aluminum mat panel is shown in Figure 6.

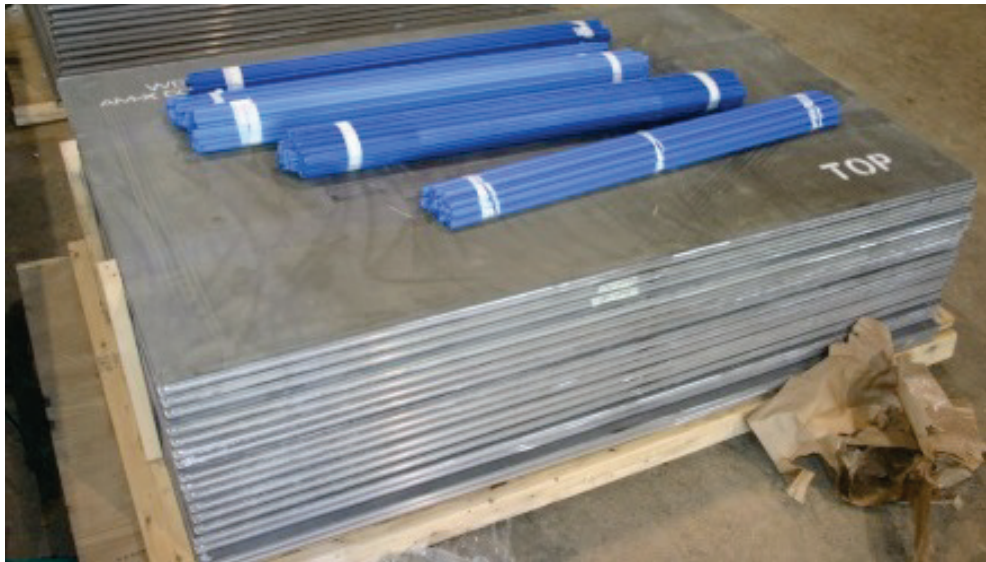
Figure 7. Carbon Fiber Composite mat panels.

The Carbon Fiber Composite mat system panels are composed of carbon fiber top and bottom skins and a foam-filled carbon fiber core. The core is constructed with vertical carbon fiber stiffeners spanning perpendicular to each other. Panels are connected on each edge by aluminum extrusions that are designed to accept an H-shaped nylon locking bar. The top and bottom skins of the individual panels are bonded by an epoxy adhesive to the aluminum extrusions. The nylon locking bars are designed to fit individually along longitudinal joints and stagger along continuous transverse joints so the system could be constructed in a brickwork configuration. The panels are coated with a non-skid material to increase the surface friction. A photograph of a stack of Carbon Fiber Composite mat panels is shown Figure 7.

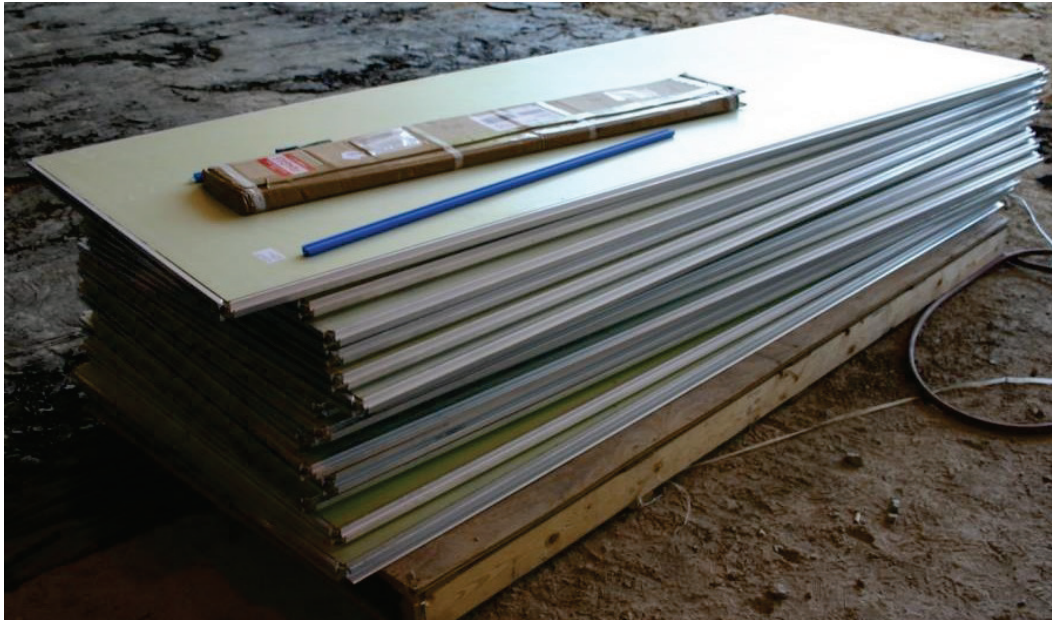
Figure 8. Aluminum Honeycomb Composite mat panels.

The Aluminum Honeycomb Composite mat system panels have an aluminum honeycomb core made of 0.125-in. hexagonal cells of aluminum foil. The mat was made to resemble M19 in its honeycomb structure. The core is bonded to top and bottom skins by an epoxy adhesive. The top and bottom skins are composed of a carbon fiber sheet sandwiched between two aluminum sheets. The mat is framed with welded aluminum connector rails. The connection along the long dimension of the mat is a hinge-type male/female system similar to that of AM2. The short ends are connected by H-shaped nylon locking bars similar to the Carbon Fiber Composite mat system. A photograph of an Aluminum Honeycomb Composite mat panels' stack is shown in Figure 8.

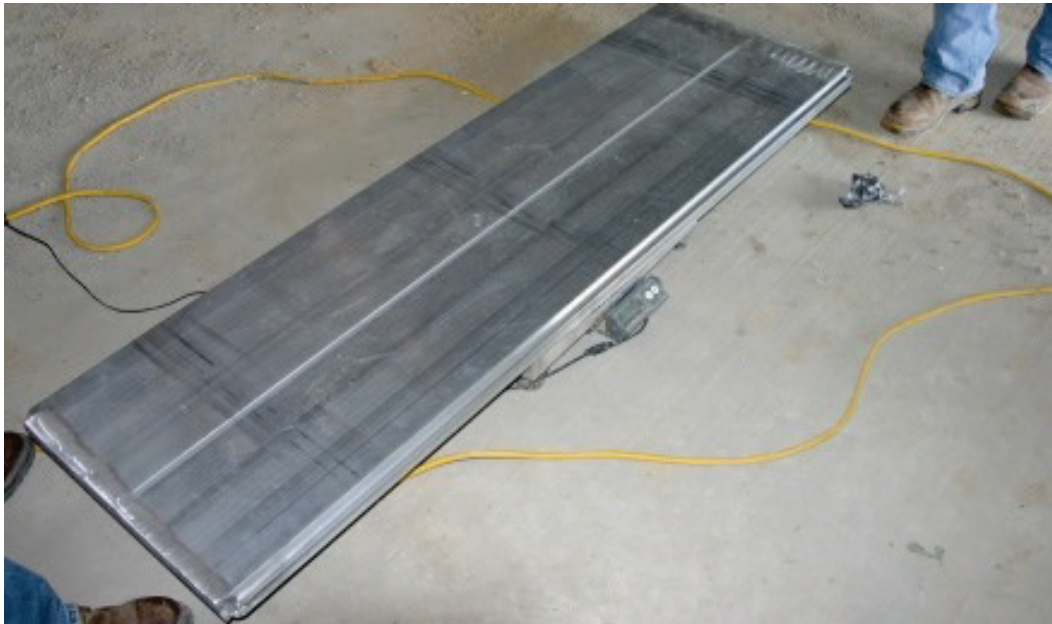
Figure 10. Aluminum Truss mat panel.

The Aluminum Truss system is a second generation prototype. Mat panels are made from two aluminum extrusions with isosceles triangle cross sections that are friction stir welded together. The connectors along the short ends of each panel are hand welded to the extrusions to create a single panel. Panels are connected on the short end by a double-arrow-shaped locking key inserted into connector slots in the welded end

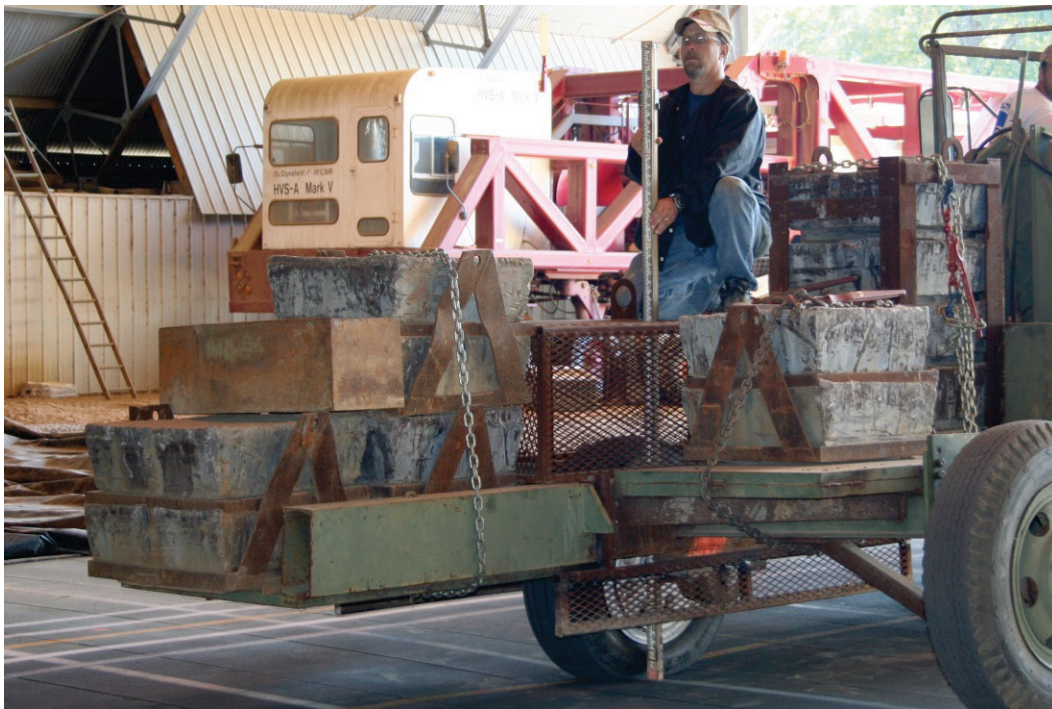
Figure 38. Rod and level measurement next to load cart tire corresponding to  $\delta_{s-1}$  measurement.

One method attempted was taking rod and level readings at certain locations on the unloaded mat surface and then parking the load cart test tire at the same locations and taking rod and level measurements immediately adjacent to the tire (Figure 38). An example of these locations on the Carbon Fiber Composite mat test section is shown in Figure 37. The difference between the unloaded and loaded measurements was the “elastic deflection” of the mat and subgrade as the test wheel moved over the mat surface. The sum of the average  $\delta_m$  on the mat surface and the average elastic deflection was used to approximate  $\delta_s$  and is given the term  $\delta_{s-1}$ . An example of these calculations is shown in Chapter 5. However, the amount of deformation of each individual element (i.e., mat and subgrade) could not be determined with this procedure, since the magnitude of subgrade elasticity was unknown. Therefore, another mechanism was used in addition to this method.

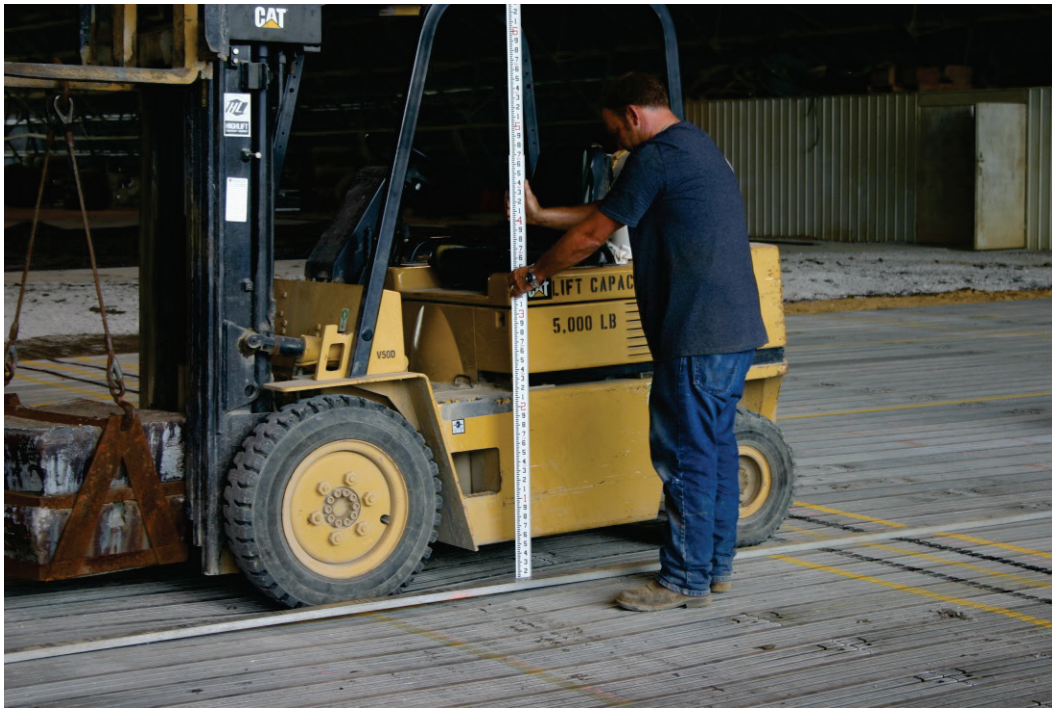
Figure 39. Loaded deflection procedure used to determine  $\delta_{s-2}$ .

An attempt was made to monitor  $\delta_s$  by adding a 6-kip load next to each cross section location with a forklift carrying 4 kips of lead blocks. The forklift was parked adjacent to each cross section, with the front axle located at the centerline (Figure 39). The purpose was to deform the mat panels just enough to contact the subgrade surface without causing elastic deformation of the subgrade. Survey data were then collected at 1-ft intervals along each cross section. This method was designated the “loaded deflection” procedure, according to Rushing and Howard (2015), and the data collected at each cross section were averaged and used to approximate the term  $\delta_{s-2}$ . An example of  $\delta_{s-2}$  determination is shown in Chapter 5.

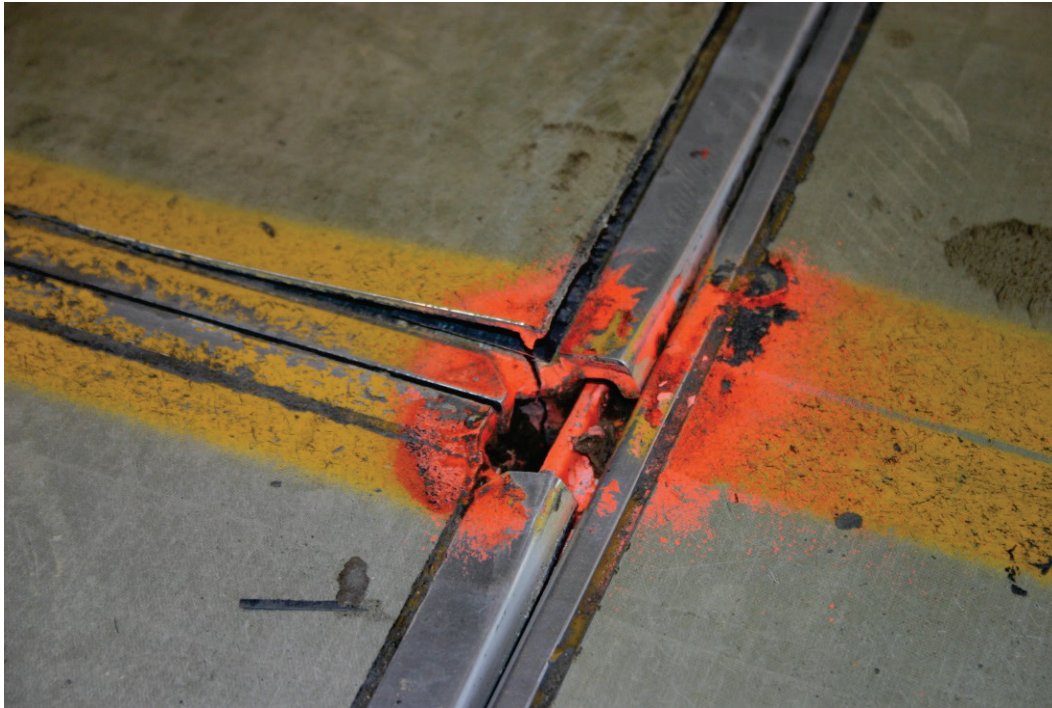
Figure 49. Skin delamination in Aluminum Honeycomb Composite panel.
