# **NAVAL POSTGRADUATE SCHOOL**

## **THESIS**

**CHARACTERIZATION OF ALUMINUM-MAGNESIUM  
ALLOY REVERSE SENSITIZED VIA HEAT TREATMENT**

Kevin D. Gamble

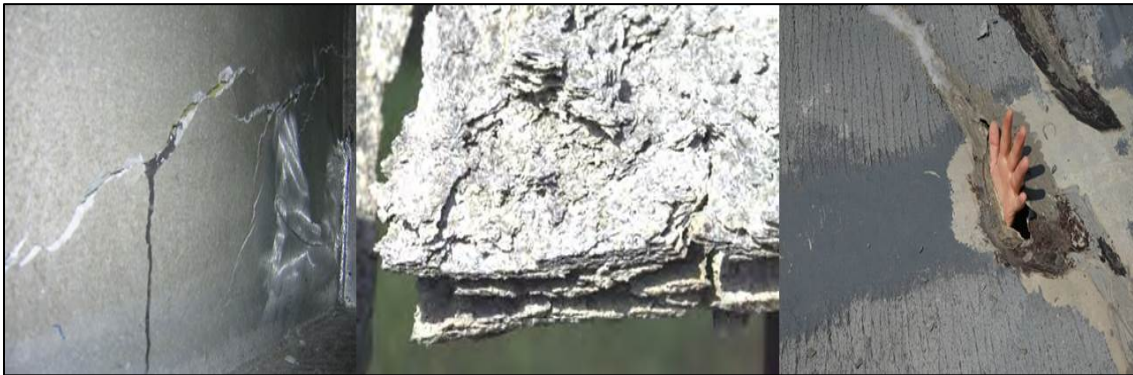
Al-Mg alloys become susceptible, however, if they become "sensitized." Once sensitized, all three elements are present for SCC of the Al-Mg alloys to occur. Over time, the material may crack and/or exfoliate. SCC in Al-Mg alloys is intergranular in nature [7]. The term intergranular stress corrosion cracking (IGSCC) is often used when discussing SCC in aluminum alloys. Shown in Figure 4, from left to right, are the effects of cracking, exfoliation, and formation of a significant-sized hole.

Figure 4. Stress Corrosion Cracking, Exfoliation, and Hole Formation, Respectively, due to Sensitization. Source: [4].

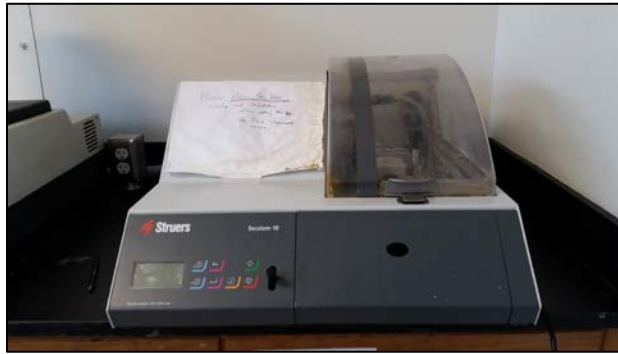
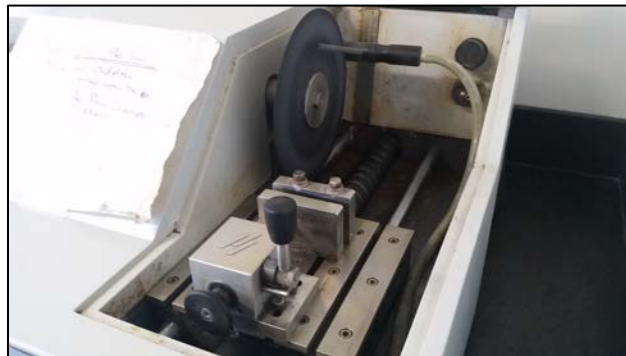
Samples were cut into smaller sections using a band saw and were further cut into rectangles measuring approximately 20 mm x 6 mm using a water-cooled Struers Secotom-10 saw, with an abrasive cutting wheel. The machine's aluminum cutting settings were 3000 RPM wheel speed and 1.0 mm/second feed speed. Two specimens were cut from each plate, in the longitudinal and transverse directions.

Figure 15. Struers Secotom-10 Saw, Front View

Figure 16. Struers Secotom-10 Saw, Inside View

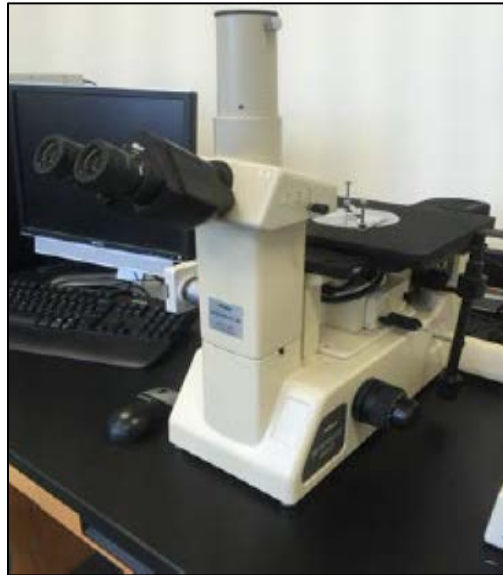
A Nikon Epiphot 200 optical microscope was used for imaging, shown in Figure 20. The microscope is capable of magnifications of x25, x100, x200, x500, and x1000. It was used to determine rolling direction of the specimens so test specimens could be prepared according to the applicable ASTM specifications.

Figure 20. Nikon Epiphot 200 Optical Microscope

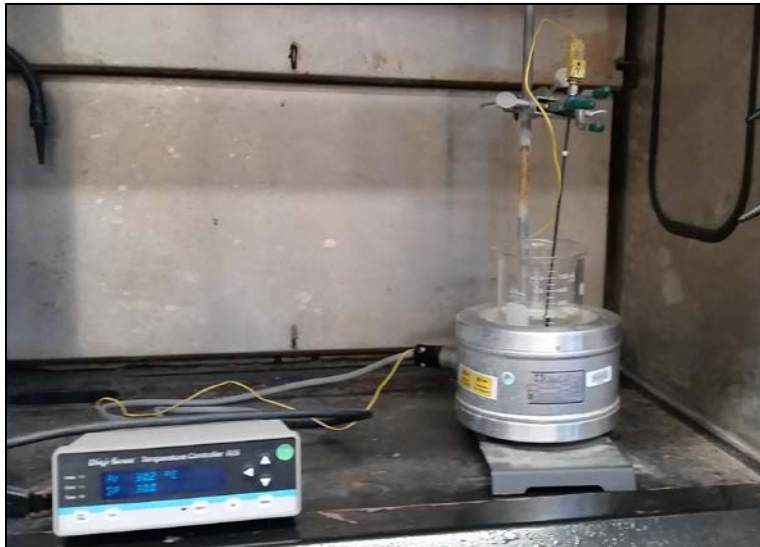
NAMLTL was conducted to quantitatively determine the degree of sensitization of all specimens, which is correlated to the degree of intergranular corrosion susceptibility. Test specimens were contained in a beaker filled with

The  $\beta$ -phase precipitate is anodic to the surrounding Al-Mg solution. It is preferentially corroded by the nitric acid, resulting in a loss of mass or the grain boundary precipitate. Using the test apparatus shown in Figure 21, test specimens were immersed in nitric acid for 24 hours, with temperature maintained at 30°C (86°F). Specimens were weighed and the total surface area determined before and after the test. The resulting loss in mass indicates the degree of sensitization. According to ASTM G67 a mass loss greater than 25 mg/cm<sup>2</sup> is susceptible to intergranular corrosion, which can lead to stress corrosion cracking [14].

Figure 22. NAMLT Apparatus
