# **FINAL REPORT**

## **Demonstrate a Low Biochemical Oxygen Demand Aircraft Deicing Fluid**

**ESTCP Project WP-200905**

**March 2013**

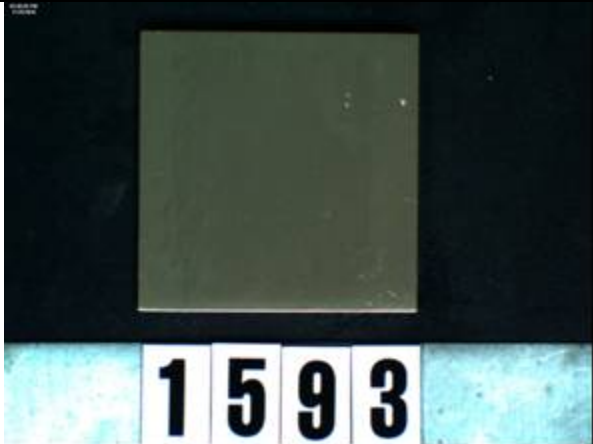
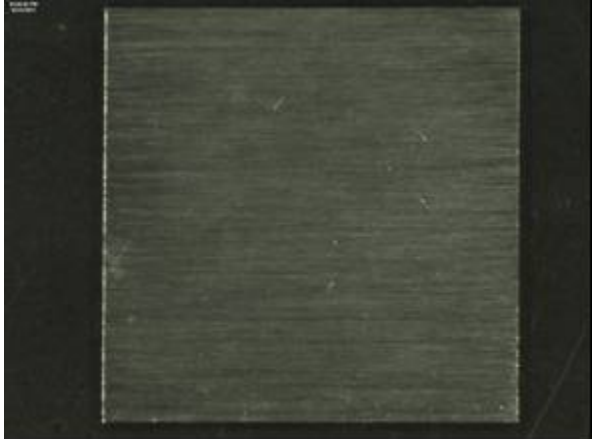
**Table 5. Alternate Immersion Photos – After Exposure**

| Substrate Material | Photo |
|---|---|
| 4140 Steel | |
| 7075-T6 Bare Aluminum Alloy | |
| AZ91E-T6 Cast Magnesium Alloy | |

| C99300 Aluminum-Bronze Alloy | |
| Titanium 6Al-4V | |

Test results from Type I Octaflo deicer from a previous testing effort was reviewed and compared to this data. The PG deicer also had little to no effect on these metallic substrate materials.

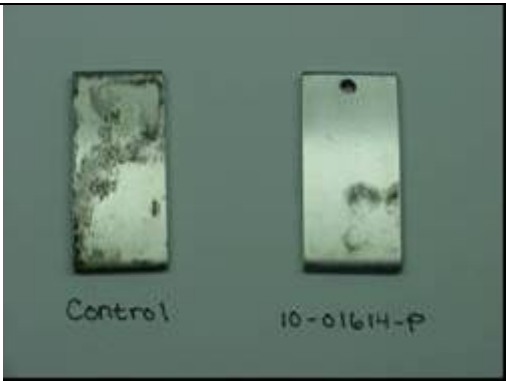
**Figure 1. Photos of Metallic Materials after 168-hour Immersion**

The EcoFlo deicer appeared to have minimal effect on the various metallic materials. All materials exhibited less than 0.5% change in weight when exposed to the deicing solution.

| 4140 Steel | | 7075-T6 Aluminum (Bare) | |
| AZ91E-T6 Cast Magnesium Alloy | | C99300 Aluminum-Bronze Alloy | |

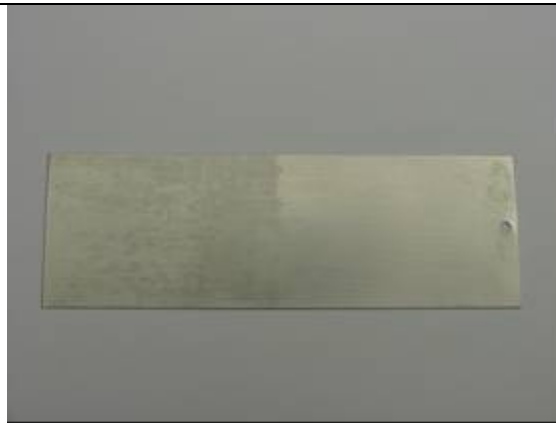
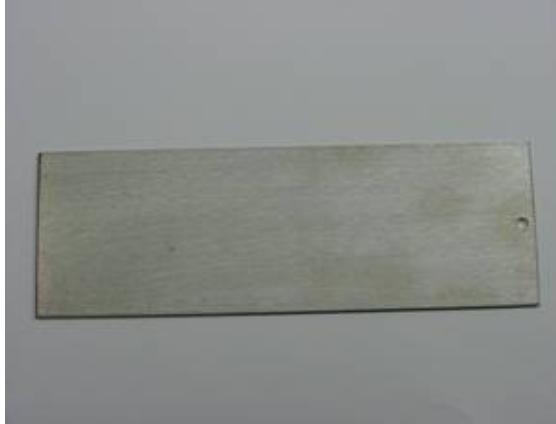
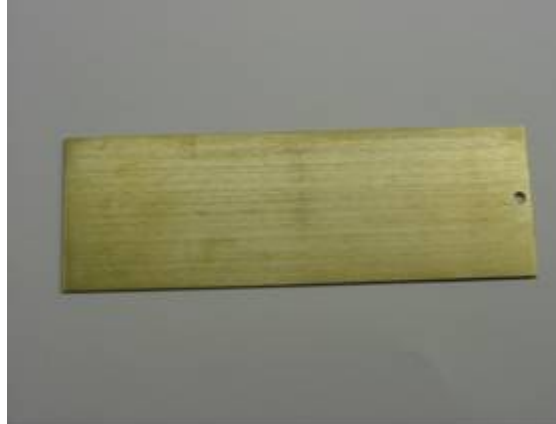
**Figure 2. Photos of Effects of Painted Surfaces Panels after Test**

All substrates received a PASS rating when exposed to the deicing solution indicating no effects of the deicer on the metallic material. From the photos in Figure 2, minimal staining can be noted on the lower portions of the panels, which was the area exposed to the deicer. However, nothing beyond staining was noted for this exposure, so results are considered passing.

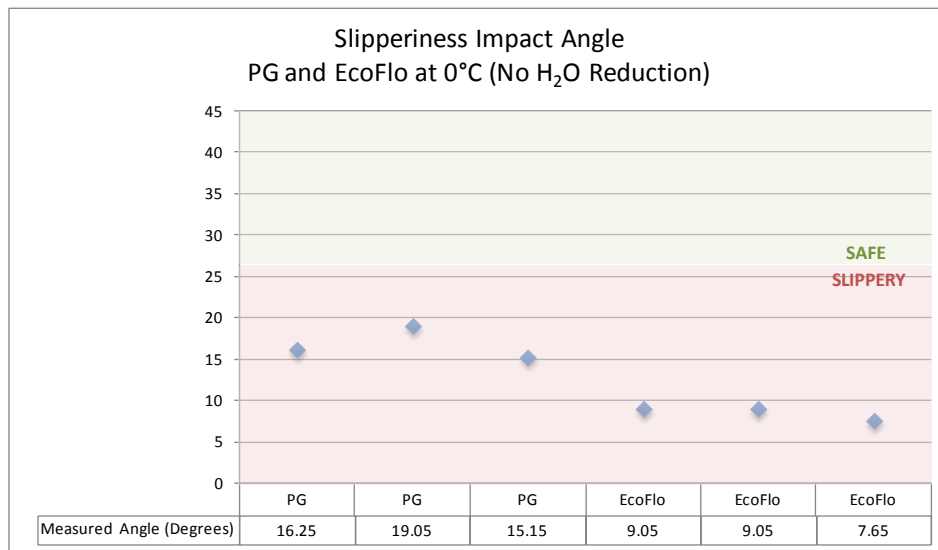
**Slip Measurements at 0°C, with No H<sub>2</sub>O Reduction Prior to Test**

Time limitations prevented gathering a significant number of repetitions for each set of conditions but the measurements are still fairly consistent. At 0°C, with the fluid at either the selected operational, in-truck concentration (65%vol fluid in water) or at the reduced water concentration, the impact angle at which a slip occurred for EcoFlo was measurably lower than the angle for PG (i.e., the EcoFlo test panel was more slippery than the PG fluid test panel) (Figures 6 and 7).

With no water reduction from the fluid before application and wind tunnel operation, the average of the three measurements resulting from the PG was 16.8° (or an estimated stride length of 19.7 in.) while EcoFlo resulted in an average of 8.6° (estimated stride length of 10.2 in.). The EcoFlo treated surface would require a smaller stride for prevention of sliding than the PG, but both fluids are definitely unsafe for normal walking.

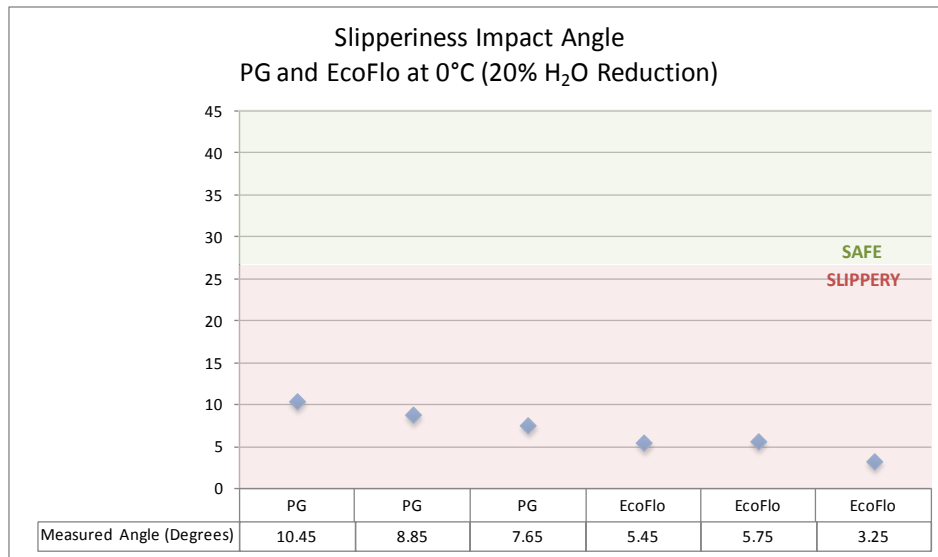
**Slip Measurements at 0°C, with 20% H<sub>2</sub>O Reduction Prior to Test**

When the fluids were more concentrated by allowing 20% of the water to evaporate prior to application, the slipperiness increased. For PG, the resulting average angle where slip first occurred was 9.0° (estimated stride length of 10.6 in.) while for EcoFlo the average angle was 4.8° (estimated stride length of 5.7 in.). So any residue resulting from EcoFlo was still slightly more slippery than that from PG. (Note that, as an approximate baseline, a test panel with no fluid used for VIT calibration runs at 0°C resulted in slip at just over 31° or an estimated stride length of over 35 in).

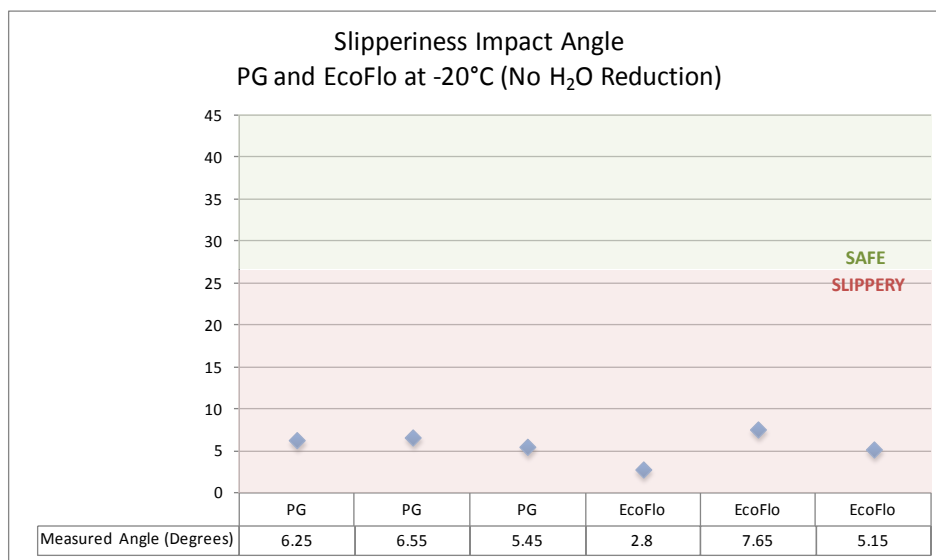
**Slip Measurements at -20°C, with No H<sub>2</sub>O Reduction Prior to Test**

After operating the wind tunnel at -20°C, both fluids left the aluminum test panel much more slippery than the 0°C test runs and well beyond what would be considered safe (Figures 8 and 9).

With no water reduction, the average of the three PG measurements was 5.5° (or an estimated stride length of 6.5 in.) while EcoFlo resulted in an average of 5.2° (estimated stride length of 6.1 in.). In this case, the difference between the two fluids is likely negligible compared to the tolerance limitations of the measurement methodology and given the limited number of repetitions. Both fluids result in a highly slippery and clearly unsafe walking surface.

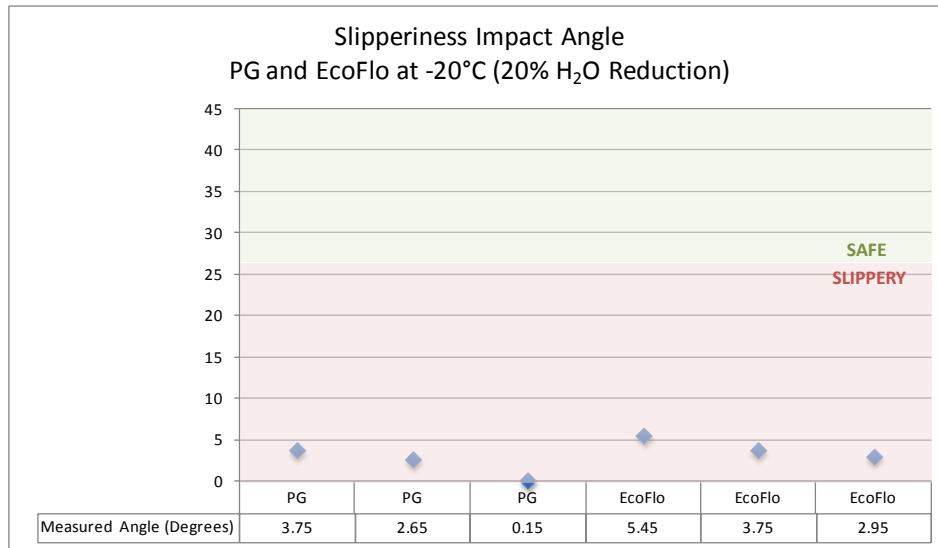
**Slip Measurements at -20°C, with 20% H<sub>2</sub>O Reduction Prior to Test**

When concentrated by removing 20% of the water content, the slipperiness again increased. In this case, the PG fluid resulted in the lower slip angle, 0.2° (estimated stride length of 0.2 in.) in comparison to 3.0° (estimated stride length 3.5 in.) for EcoFlo. Again, the difference between the two fluids is likely negligible compared to the tolerance limitations of the evaluation, but it's clear that both fluids result in a highly slippery surface. (In this case, at -20°C, test panels with no fluid used for VIT calibration runs resulted in slip at slightly smaller angles than the 0°C runs: 25 – 29° or an estimated stride length of about 30 in.).
