# NAVAL POSTGRADUATE SCHOOL

## THESIS

**A META-ANALYSIS OF CORROSION STUDIES FOR  
MARITIME PATROL AND RECONNAISSANCE  
AIRCRAFT (MPRA)**

September 2016

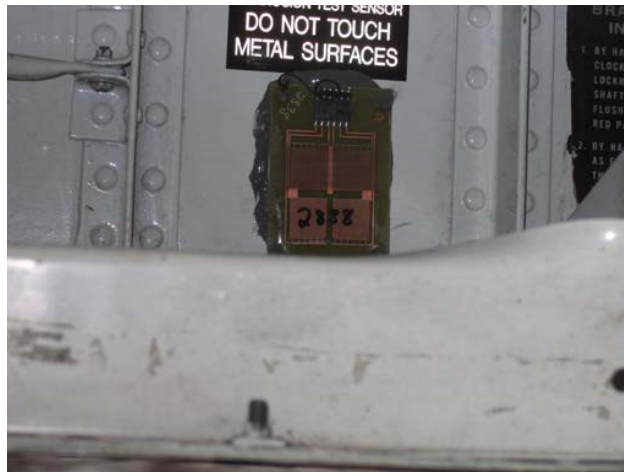
Figure 3. Sensor Located in NG. Source: Abbott, Columbus, and Beals (2009, 4).

Corrosion sensors were attached in 10 locations on each aircraft. This attachment was required because corrosion exposure and build up vary along the outer mold line of the aircraft. Thus, each corrosion sensor provides a recorded corrosion severity plotted as an out values, which are important to observing corrosion severity levels over time. Figures 3, 4, and 5 are photographs of the sensor installations at three different locations. Seven of the 10 locations were considered a must to evaluate as they are very susceptible to corrosion build up. The landing gear wheel wells were the most susceptible to moisture and exposure to corrosive contaminants.

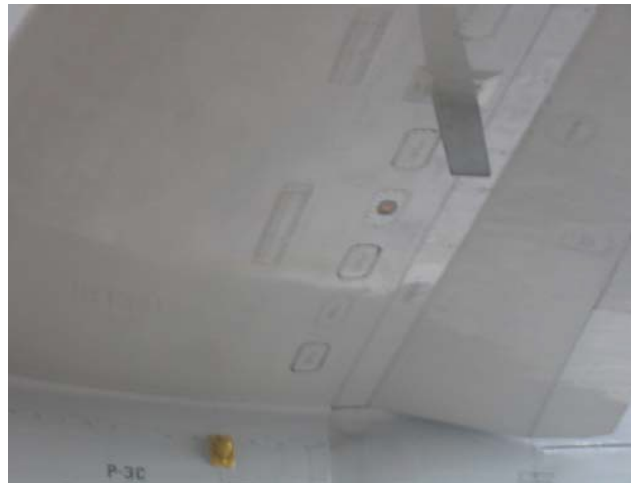
Figure 5. Sensor on Access Panel in Lower Surface of Left Horizontal.  
Source: Abbott, Columbus, and Beals (2009, 5).

Additional sensors were mounted on external surfaces of the P-3 aircraft. All sensors functioned properly and there was no loss of sensors or data on any of the aircraft.
