**TECHNICAL REPORT**  
**TR-NAVFAC-EXWC-EV-1704**  
**DECEMBER 2016**

**Innovative Acoustic Sensor Technologies for Leak Detection  
in Challenging Pipe Types (Cost and Performance Report)**

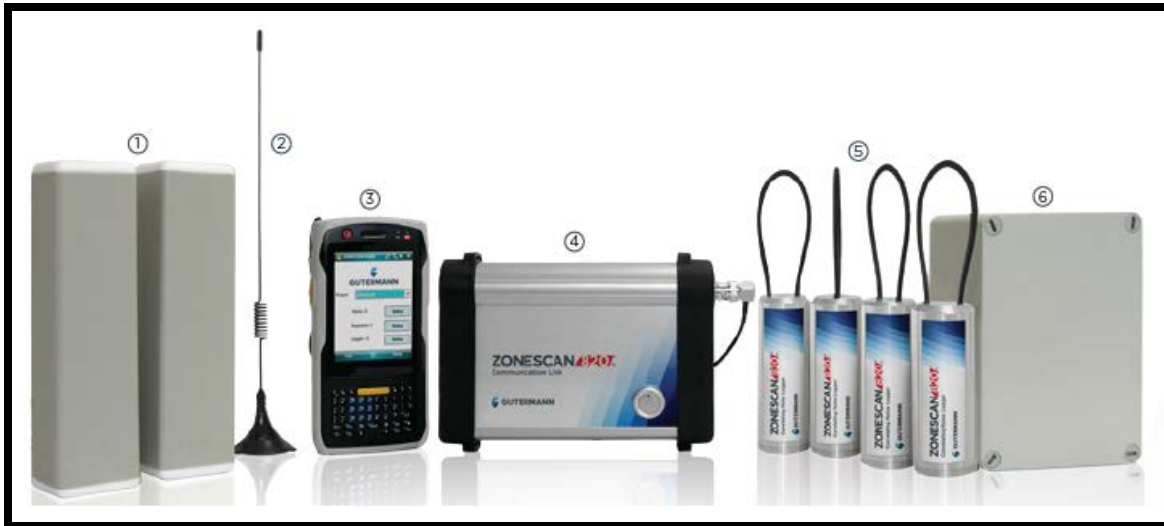
The ZoneScan Alpha acoustic logger sensor system for continuous monitoring is shown in Figure 2-2. Table 2-2 summarizes the primary components, along with their respective function. System components include: (1) radio repeater modules to send data to a centralized computer processing system; (2) extended antenna (optional to transmit data over longer distances); (3) personal data assistant (PDA) for system setup; (4) communication link for system setup; (5) ZoneScan acoustic sensors; and (6) ZoneScan Alpha Com Link. The system also relies on data management, processing and display capabilities provided by a personal computer system

operated by the user and Gutermann's centralized server that provides data processing capability. The sensors are permanently or temporarily installed on valves or fire hydrants at targeted areas of the potable water distribution system. The sensors are easily attached via a magnet on the bottom of each sensor. The sensors can be connected via radio transmission or they can be integrated into an existing AMI network.

**Figure 2-2. ZoneScan Alpha System Components (Courtesy of Gutermann)**

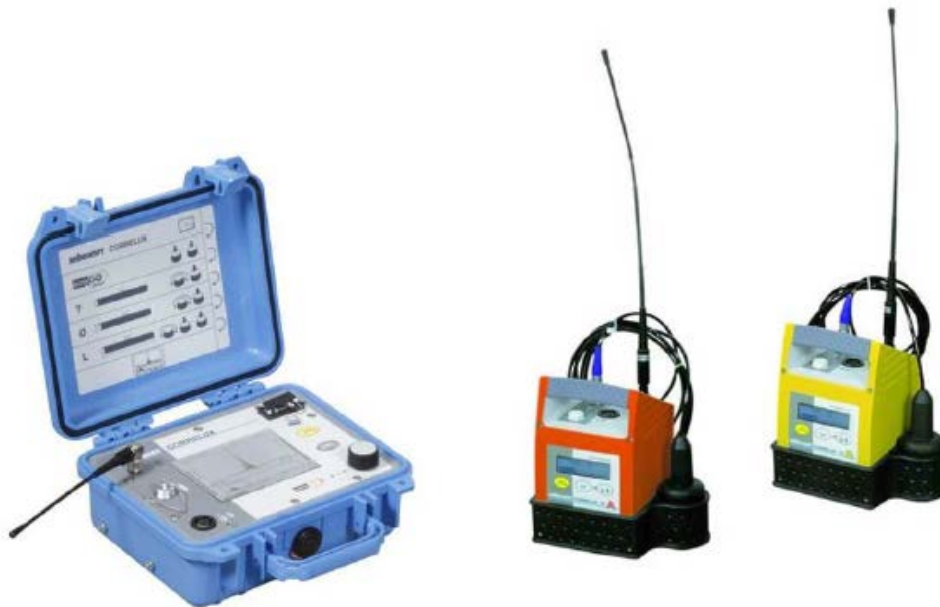
The Correlux HL6000X is a correlator system used for automatically pinpointing leaks in water pipes (see Figure 2-5). It consists of two radio transmitters that connect to piezo-ceramic accelerometers (transmitter A and B), the correlator (the user interface device), correlation software, and headphones. The correlator device can be connected to a personal computer for software updates, downloading data, and to printout results. The correlator device has enough memory to record data for up to 10 segments. It is powered by a battery with an operational life of 12 hours. Each radio transmitter is powered by an internal battery with an operational life of 15 hours. All devices can also be externally powered using a 12-volt direct current car adapter or 110-volt alternating current power supply.

**Figure 2-5. Correlux HL6000X System (Courtesy of Vivax-Metrotech)**

The correlator system works by placing the two accelerometers (sensors) at either end of a pipe section (on valves, exposed pipe sections, or hydrants as the local conditions dictates). Table 2-6 shows the recommended sensor spacing based upon pipe type. The sensor spacing must be accurately measured for input into the correlator if a leak is detected. No information was

available on a minimum detectable leak size or typical location accuracy of the Correlux system. The correlator is activated and the sensor outputs are transmitted to the correlator. Once the correlator unit receives the sensor outputs and inputs data into the correlation software for analysis, the user provides the pipe data including the pipe material, pipe diameter, and pipe length. The device then displays the correlation graph, which compares both signals and provides the distance to the leak. For each correlation, the software automatically sets filters depending on the pipe material, and the filter limits can be adjusted by the user. If a leak is detected, the correlator provides the leak location in feet away from each of the two sensors. At that point the operator uses a listening probe to validate the leak location at the calculated distance from the sensors. If no leak is detected in the correlator, a zero reading is displayed and one of the sensors can be placed to evaluate the next pipe segment in the field survey.

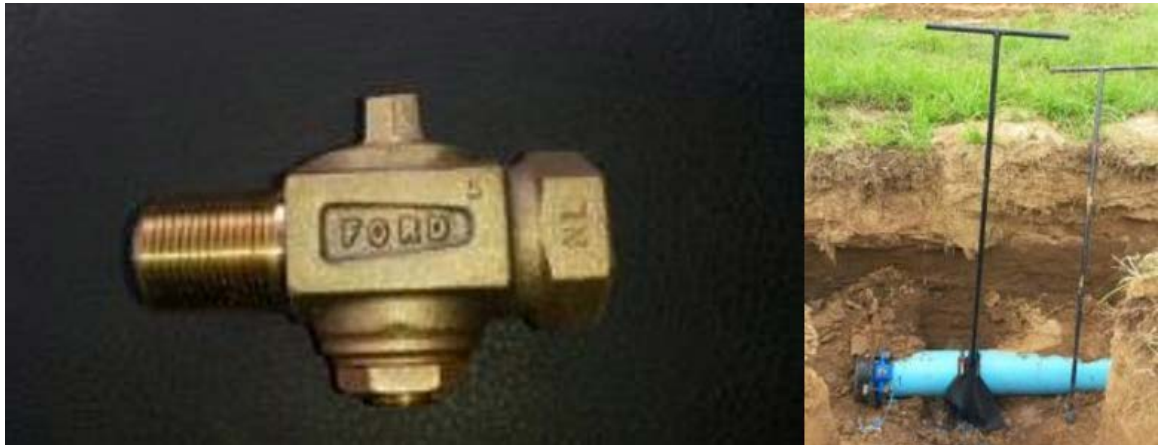
**Figure 5-2. Simulated Leak Configuration Using Corporation Valves**
