**SURFACE ROUGHNESS OF ELECTRON BEAM MELTING TI-6AL-4V  
EFFECT ON ULTRASONIC TESTING**

THESIS

Evan T. Hanks, Captain, USAF

AFIT-ENY-MS-16-M-216

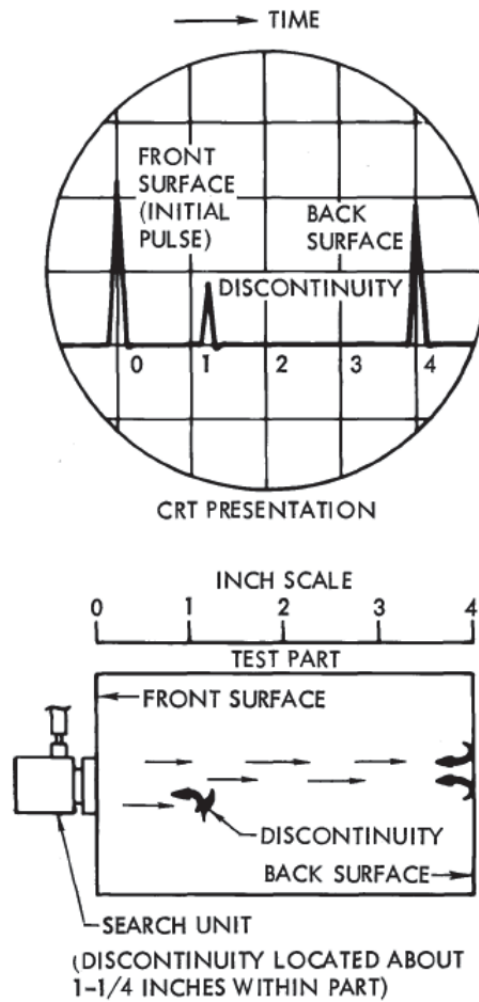
**Figure 7.** Example of A-Scan indication of imbedded flaw in sample [13]

and the final indication, denoted as (3), is the back wall of the sample. This is also represented in Figure 7 showing a discontinuity and the corresponding indication. If using a computerized controller to move the transducer over the sample, multiple A-scans are compiled into a “B-scan”. B-scans provide a cross-sectional representation of the sample. Figure 8 shows an example of a B-scan where the white horizontal line corresponds to the A-scan in Figure 6. A-scans are also electronically gated to produce a “C-scan”. C-scans are planar views of the gated region of the A-scans. Figure 9 shows a C-scan as a planar image where the amplitude of the return is shown in 256 greyscale with black as zero and white as 255. C-scans are very useful as they present a large amount of information in one image. This is described in greater detail in later sections.

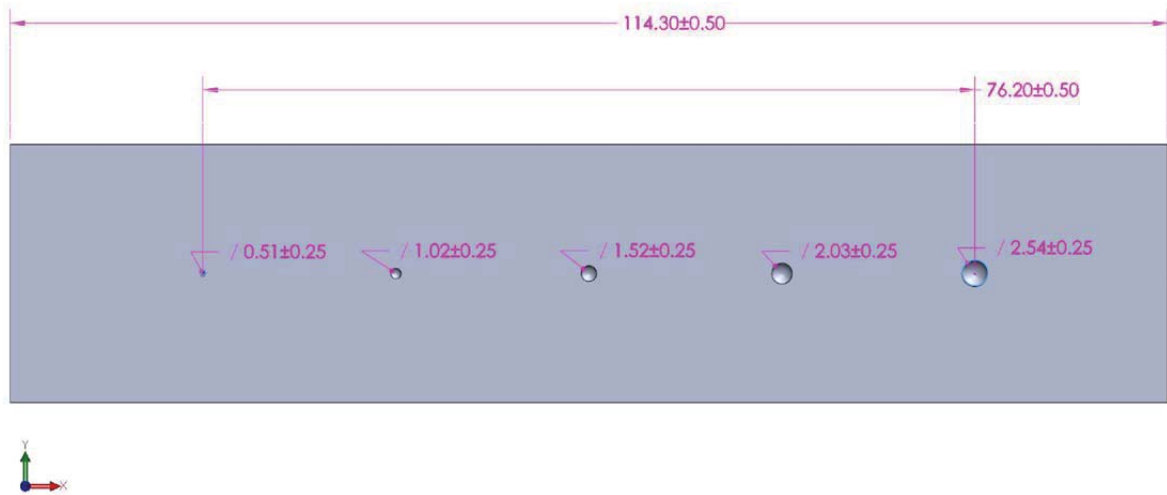
**Figure 13.** CAD design of samples to include defects with dimensions in mm

The specimens used in this testing were designed by the Structural Materials Division of the Air Force Research Laboratory (AFRL) for the purpose of testing nondestructive as well as destructive inspection techniques. The samples were designed as rectangular blocks 25.4mm wide (Y), 25.4mm tall (Z), and 114.3mm long (X) represented in Figure 12. Specimens were designed and built as sets of two exactly similar samples in each production run. Each block was designed with five embedded spherical flaws ranging in size from 0.51mm to 2.54mm in diameter as listed in Table 1. These flaws were designed on the center line of the sample with the center of the spheres evenly spaced in ascending diameter as shown in Figure 13.

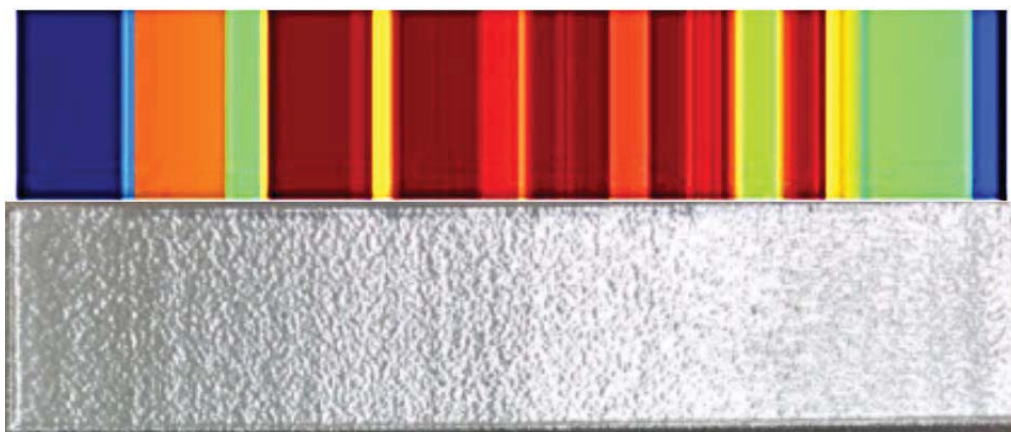
**Figure 37.** Beam current map compared to surface striations, Sample A-42 [39]
