**LEVERAGING UNMANNED AERIAL SYSTEMS TO MODERNIZE AIRFIELD  
DAMAGE ASSESSMENT**

THESIS

AFIT-ENV-MS-18-M-188

In Partial Fulfillment of the Requirements for the  
Degree of Master of Science in Engineering and Environmental management

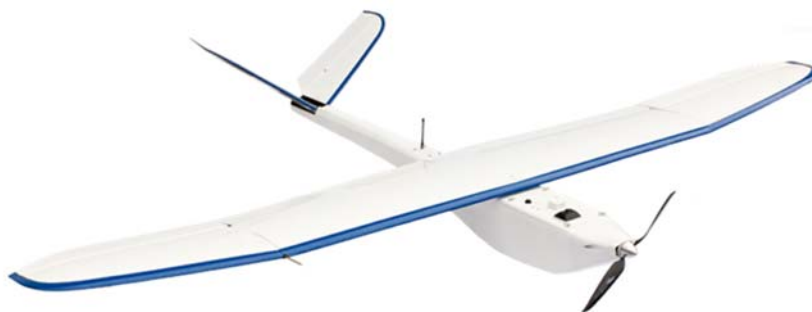
**Figure 3. Altavian F7200 Nova (www.altavian.com)**

system that could survey an airfield, identify pavement damage as well as explosive hazards, and produce a minimum operating strip solution in under 90 minutes. Initial designs resembled that of the approach fielded by Shephard and Storm (2017), who utilized the Altavian F7200 “Nova”, fixed-wing air vehicle (**Error! Reference source not found.**), the “Fusion” MP22 modular sensor package, and “Flare” mobile ground control station to conduct a series of infrastructure assessments. Shephard and Storm’s research team surveyed two airfields and one highway overpass. Combining the individual flight times and processing time, the research team generated reports for a 290-acre airfield in 120 minutes and a 30-acre airfield in 15.5 minutes (Shepherd & Storm, 2017a, 2017b) using the Pix4D™ software. In addition, using the Altavian R8700 “Galaxy” octo-rotor (**Error! Reference source not found.**) to survey a seven-acre highway overpass and generate a report in 82.5 minutes (Shepherd & Storm, 2017c). Ultimately, the AFIT research team decided upon an approach similar to the RADAS current concept; however, they also incorporated elements from previous iterations. Their air vehicles and methodology are described in Chapter III and Appendix I. Small Unmanned Aerial Systems Components

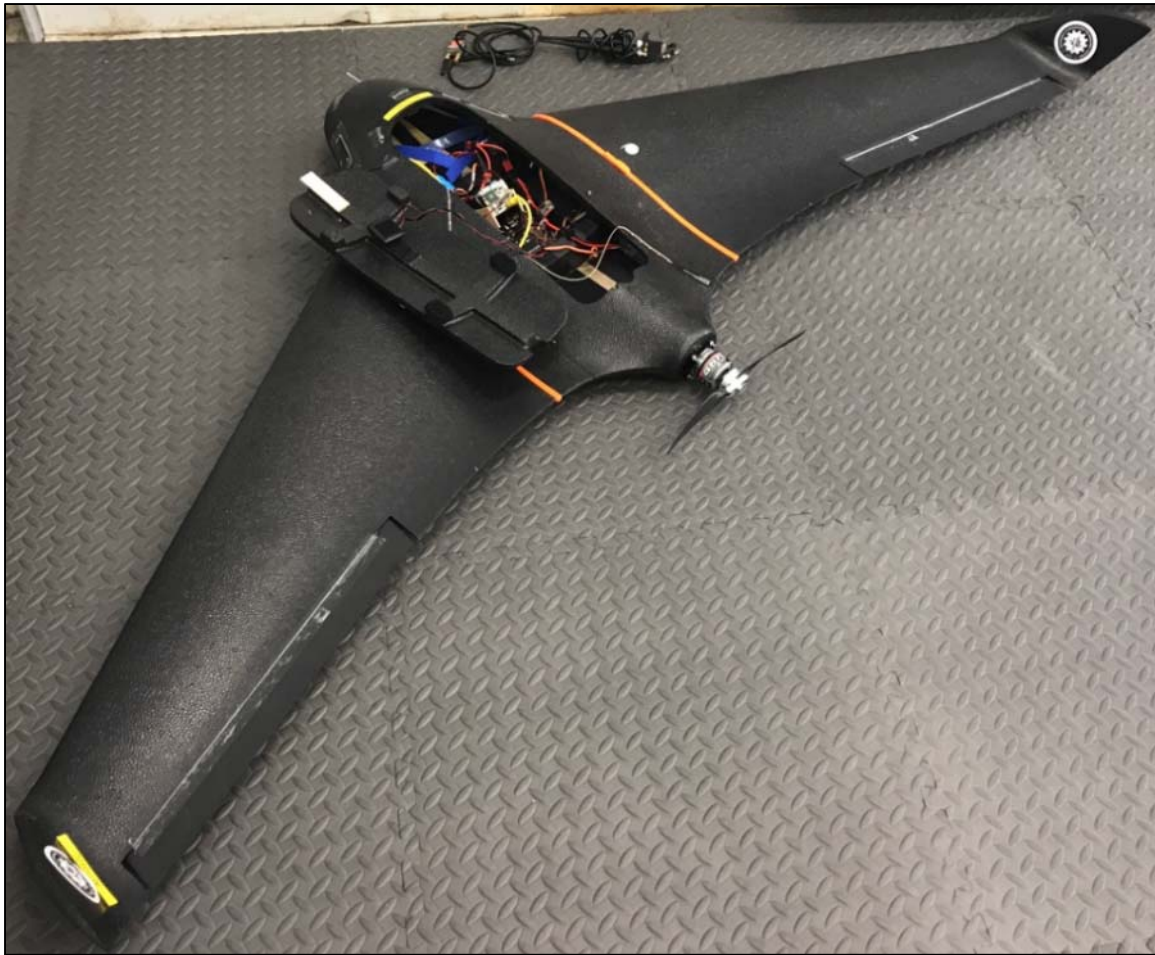
**Figure 7. Skywalker X-8, "Flying Wing"**

The Skywalker X-8, “Flying Wing” (Figure 7) is a commercial off-the-shelf

(COTS) ‘delta-wing’ shaped lifting body that is readily available through a multitude of online vendors. With a wingspan of 2.12 meters, the Skywalker employed in this thesis has been modified for greater control and in-flight stability. Structural modifications of note include stiffened wing spars, elevators, and winglets. The propulsion system consists of a Turnigy G46 brushless, outrigger electronic 670 kV motor and 13x7 foldable, pusher propeller. The sensor package is a Sony HD Block Camera that has been mounted forward facing at a 60-degree downward pointing angle (**Error! Reference source not found..**). The interior has been customized for mounting Lithium-Polymer (Li-Po) batteries, communications components, and optimizing the air vehicle’s center of gravity. Lastly, this application of the Skywalker X8 does not call for a landing gear. The research team determined that, in the post-attack condition, the airfield surface may not be conducive to rolling takeoffs or landings. Therefore, a catapult assisted takeoff (Figure 9) and “belly landing” approach was implemented. Further fixed-wing air vehicle configuration information can be found in Appendix I.

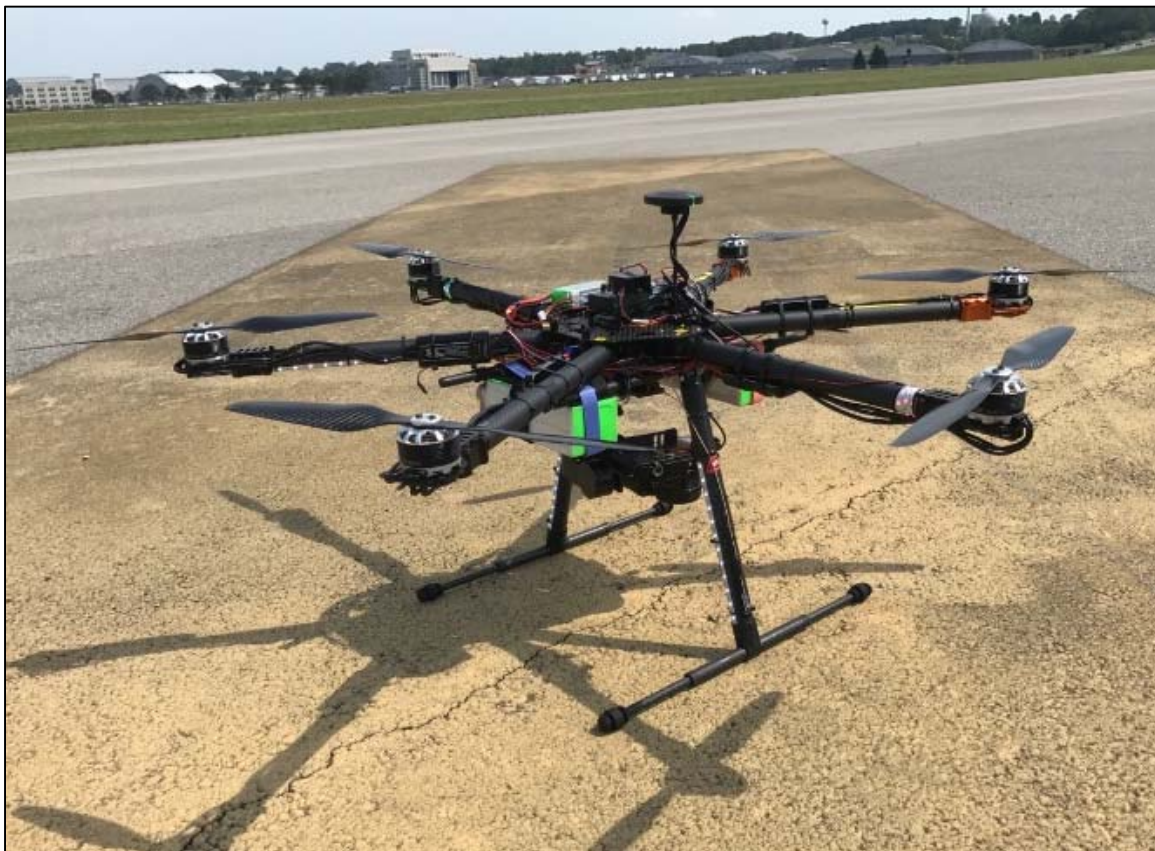
**Figure 10. Tarot Hex-rotor, Storm Pro-3 Gimbal, & Sony α6000 Camera**

served by the Pixhawk™ 2.0 autopilot, a GPS receiver, two 6S 10,000 milliamp hour Li-Po batteries wired in parallel (primary flight power source), and one 3S Li-Po battery (autopilot backup and gimbal power sources). Additional features include stiffened landing gear, directional light-emitting diodes, and a Sony α6000 camera. Further hex-rotor air vehicle configuration information can be found in Appendix I.

The objective of the Tarot T960 build was to utilize the waypoints generated by the Survey Phase to thoroughly inspect the airfield surfaces, thereby providing recovery teams with high resolution images of the objects present on the airfield operating surfaces. This

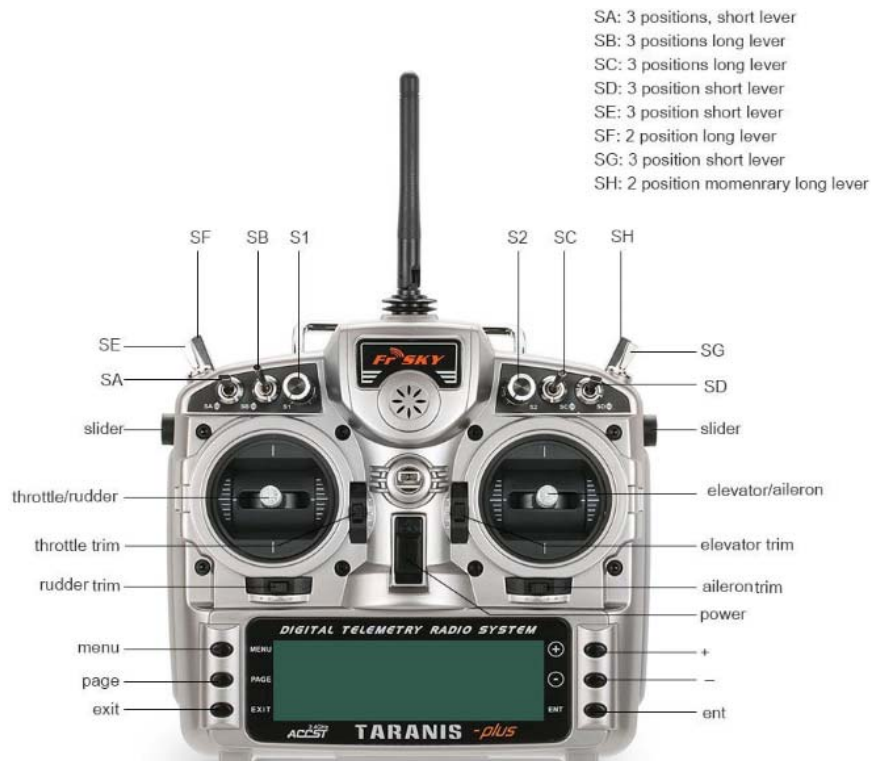
Figure 33. FrSky Taranis X9D Radio Transmitter

**FrSky Taranis Radio Controller.** The FrSky Taranis X9D™ radio (Figure 33. FrSky Taranis X9D Radio Transmitter) is a powerful controller favored by many RC SUAS enthusiasts. This transmitter operates on a 2.4 gigahertz frequency and offers up to 16 channels. Additional features include: audio speech outputs (values, alarms, mode settings, etc.), real-time flight data logging receiver signal strength indicator, and super low latency and vibration alerts. This device weighs eight pounds and is widely available in hobbyist stores as well as in online retailers.

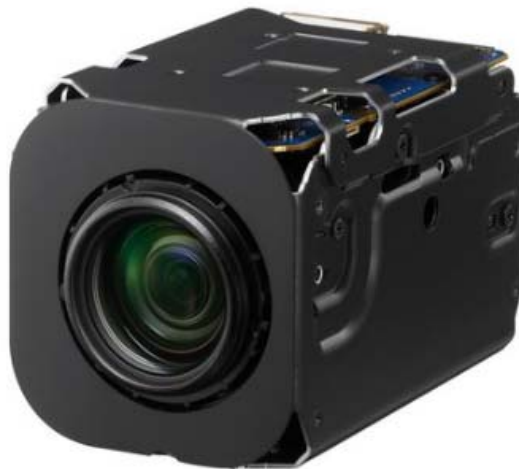
**Figure 34. Sony High Definition Color Block Camera (FCB-EV7100)**

**Sony High Definition, Color Block Camera.** The Sony FCB-EV7100 camera (shown in Figure 34 is a 1/2.8 type Exmor CMOS image sensor with full HD (1920x1080) at 60 fps and 10x optical zoom. It features a wide-dynamic range, auto Infrared Cutfilter Removal (ICR), and a compact design (Sony Corporation of America, 2017a).

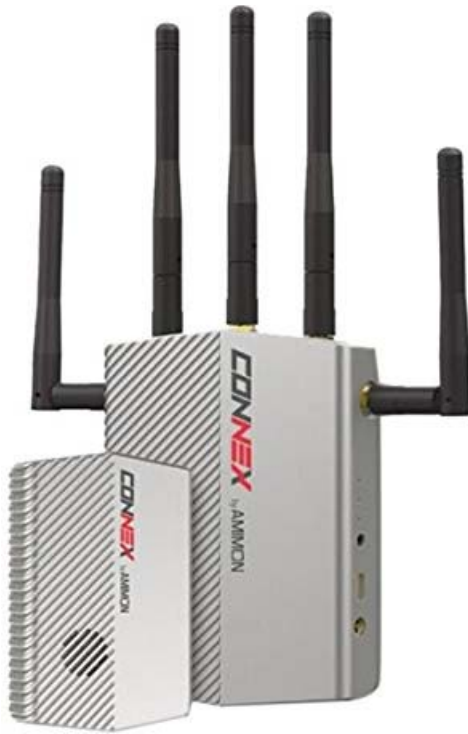
**Figure 35. Amimon CONNEX HD Wireless Video Transmitter/Receiver**

**CONNEX HD Wireless Video Receiver.** The Amimon CONNEX HD (**Figure 35**) is a 5.8-GHz, wireless video receiver/transmitter that is cable of providing live/near-zero latency, feed from an SUAS imaging platform. This receiver allows up to 1080p resolution at 60 frames per second. The basic system features a range of up to 3,300 feet (line-of-sight), can display data from telemetry modules, and supports encrypted video transmission.

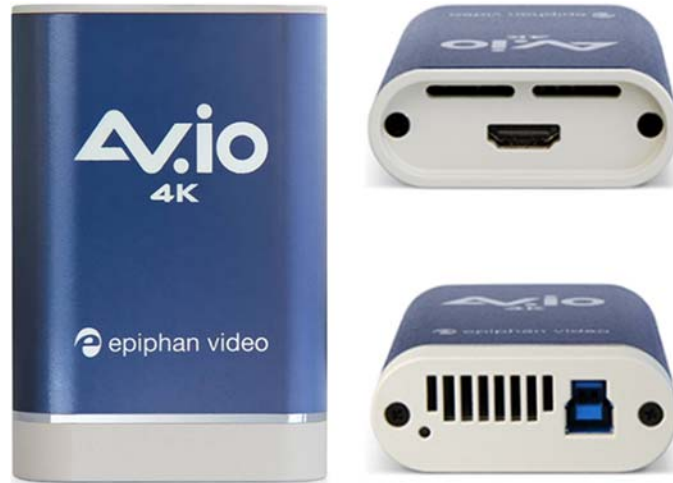
**Figure 36. Epiphan Av.io 4k Video Capture Card**

**AV.io video capture card.** The Av.io 4k video capture card (shown in Figure 36) – Epiphan Systems Inc. – is a rugged HD video and audio capture card capable of producing an image resolution of 4096x2160, with 4K UHD video streaming at 30 fps and 1080p at 60fps. In addition, this card pushes PCM audio over HDMI™ at up to 24-bit, 96kHz via two-channel stereo audio outputs, complete with automatic resampling at 48kHz and 16-bit encoding. Lastly, this device captures video and audio with, at most, one to two frames of latency, thus providing a seamless, real-time airfield survey (Epiphan Systems Inc., 2017).

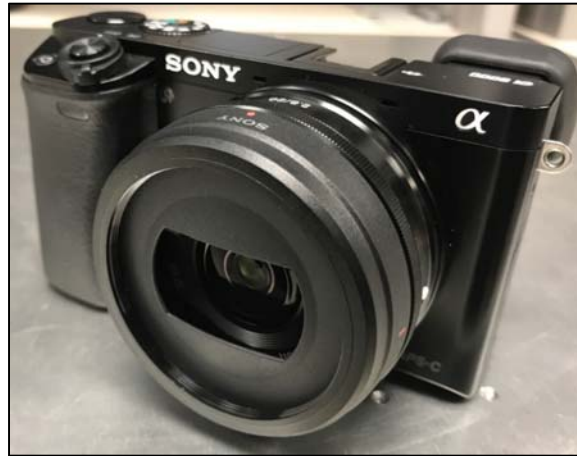
**Figure 38. Sony α6000 Digital Camera & 2.8x20mm "Pancake" Lens**

**Sony α6000 camera.** The Sony α6000 (shown in Figure 38) is a mirrorless, compact, E-mount, digital camera that boasts a 24.3-megapixel APS-C CMOS sensor and diffraction-reducing image processor. It is capable of 11 frames-per-second continuous shooting and subject-tracking as well as full HD video recording at 1080p/60p and 24p (Sony Corporation of America, 2017). The base camera has been fitted with an E 20.4 millimeter, F2.8, “pancake” lens, which has a seven-blade circular aperture for rounded defocusing and an aspherical lens that maintains high contrast and minimizes distortion and flatness of the image pane; it has a compact design, faster autofocus response, and reduced minimum focusing distances (Sony Corporation of America, 2017b).

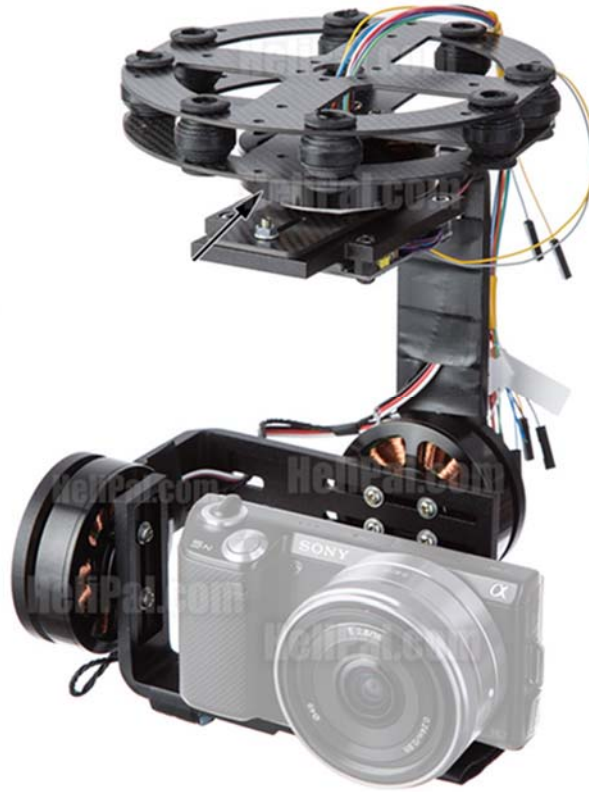
**Figure 39. Storm Pro-3, Universal Three Axis Gimbal**

**Storm Pro-3 gimbal.** The Storm Pro-3 (shown in Figure 39) is a universal, three-axis, brushless gimbal that is mounted on the underside of the Tarot T960 frame. It provides 360 degrees of continuous pan axis movement and a self-contained Inertial Measurement Unit (IMU) for stabilization; it can support any camera – including smart phones – weighing 350 – 600 grams (Helipal, 2017a). This gimbal was included such that atmospheric conditions (i.e., wind) would be mitigated during imaging operations. In addition, while not utilized in the final configuration, the Storm Pro-3 is capable of being linked to the Pixhawk 2.0 autopilot. This linkage allows for pinpoint geo-locating accuracy and enhanced image stabilization during flight.

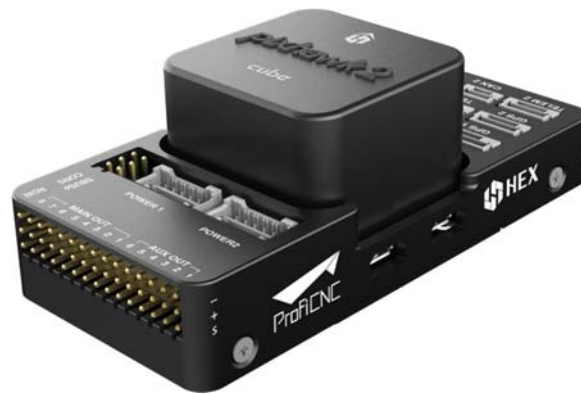
**Figure 40. Pixhawk 2.0**

**Pixhawk Autopilot.** The Pixhawk™ 2.0 (shown in Figure 40) is an autopilot developed by the Pixhawk open hardware community in 2017 (PX4 Autopilot, 2017). It features “14 pulse width modulation/servo outputs”, connectivity options for peripherals, an integrated backup system for in-flight recovery and manual override, multi-tone piezo audio indicator, and microSD card. This autopilot operates on a 32-bit STM32F427 Cortex M4 core with FPU processor, “capable of 168 MHz, 256 kB Ram, 2 MB Flash, and 32-bit failsafe co-processor” (PX4 Autopilot, 2017).

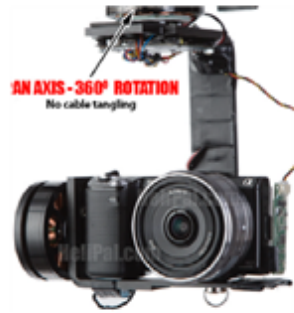
## MULTI-ROTOR STRUCTURE

AN AXIS - 360° ROTATION  
No cable tangling

TAROT T960 + DJI 15.5.5 PROPELLER (x6) + KDE 4215XF 465KV BRUSHLESS MOTOR (x6) + KDE XF-UAS 75A ESC (x6)

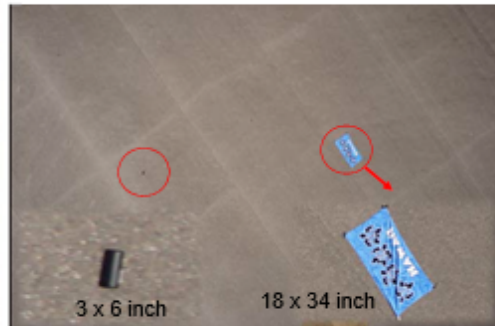
23.5 x 15.6m Image @ Alt' 20m (0.39cm/pixel)
