# FINAL REPORT

## Automated Aerosol-Sealing of Building Envelopes

ESTCP Project EW-201511

Mark Modera  
Curtis Harrington  
UC Davis Western Cooling Efficiency Center

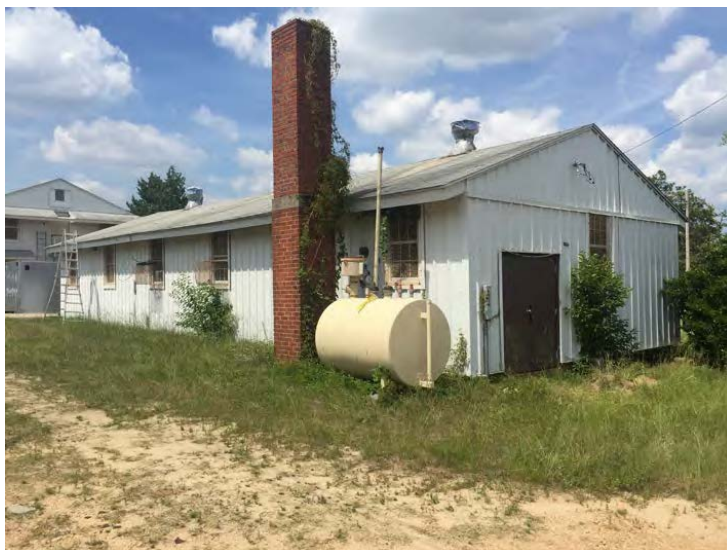
Building A5436 is a one story WWII era frame structure on a crawl space open to the outdoors, and in poor condition (Figure 7). Bathroom ceilings were collapsed and required temporary blocking during the sealing process due to the size of the hole.

**Figure 7. Building A5436 at Fort Bragg Army Base**
