TECHNICAL REPORT 3109
OCTOBER 2017

Water Quality Monitoring of Biofouling Removal from the ex-USS INDEPENDENCE (CV 62)

Water Body Number
WA-15-0040 Sinclair Inlet

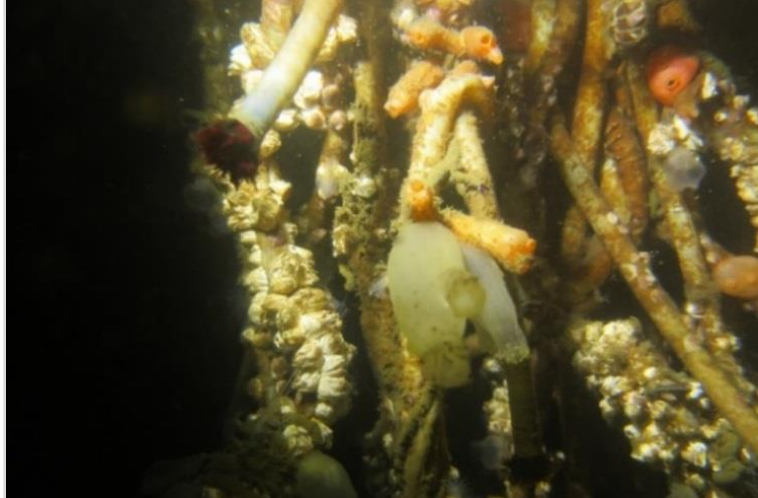
Figure 1. Example of biofouling density and diversity on the hull of the ex-INDEPENDENCE observed during pre-removal inspections.

Hull biofouling inspections were conducted by the US Navy's hull cleaning experts, NAVSEA 00C prior to in-water removal to characterize the species and mass of biological material on the hull and what specific equipment and procedures would be employed to reduce the potential transport of invasive species. On November 5, 2016, Seaward Marine Services, Inc. under contract by NAVSEA assessed and documented the amount of biofouling on the hull of the ex-INDEPENDENCE. This inspection determined the average biofouling growth to be approximately two inches (in) in thickness, however, inspection was limited to the bow of the vessel and 300 feet (ft) aft due to barges and other equipment tied up to the ex-INDEPENDENCE. In December 2016, prior to biofouling removal, SSC Pacific in collaboration with NUWC conducted in-water hull surveys and documented dense biofouling on all parts of the vessel (SSC Pacific and NUWC, 2016). In these surveys, biomass thickness was observed to vary across the hull, with areas of a few large organisms (i.e., tubeworms) interspersed with areas of densely concentrated smaller organisms (i.e., barnacles). Figure 1 shows an example of biofouling observed on the hull. Biomass wet weight ranged from $<0.1 \text{ kg/m}^2$ to 2.0 kg/m^2 in stratified random samples. Biomass across the entire wetted hull surface was estimated to be 54,010 kg (geometric mean of total wet weight) comprised of water (76%) calcareous matter, i.e. shells (18%) and organic matter (6%) or 3,146 kg (SSC Pacific and NUWC, 2016).

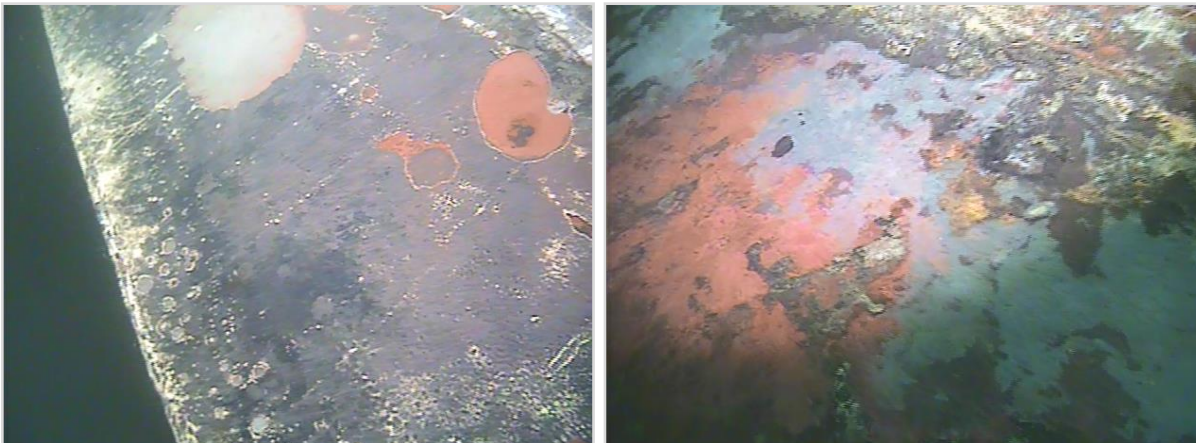
Figure 2. Top edge of port bilge keel showing paint (left) and top of port bilge keel showing paint and areas of bare hull (right).

Biofouling removal was conducted by Seaward Marine Inc., under contract to the Navy, from 6 to 27 January 2017. Biofouling removal was conducted using the self-propelled, diver driven SCAMP® cleaning machine in accordance with the Naval Ships' Technical Manual (NSTM) Chapter 081 (Naval Sea Systems Command, 2006). In addition, NSTM Chapter 081 provides a description of the various tools used to clean ship hulls such as diver-operated machines with rotating brushes. This equipment uses either multi-brushes or single-brushes fitted with different brush types depending on the type of machine and fouling conditions present. The multi-brush machines utilize an impeller to hold the vehicle against the hull, while wheels move the large unit along the easily accessible areas of the hull. Single-brush units are held in place by both the diver and the suction force generated from the rotating brush, and are used to clean appendages and hull areas that the large multi-brush unit cannot access. For areas that are more difficult to reach, divers employ high-pressure water jets. Post-removal dive surveys showed 99% of the hull surface was free of biofouling organisms (SSC Pacific and NUWC, 2016) such as those shown in Figure 2 of the port bilge keel.

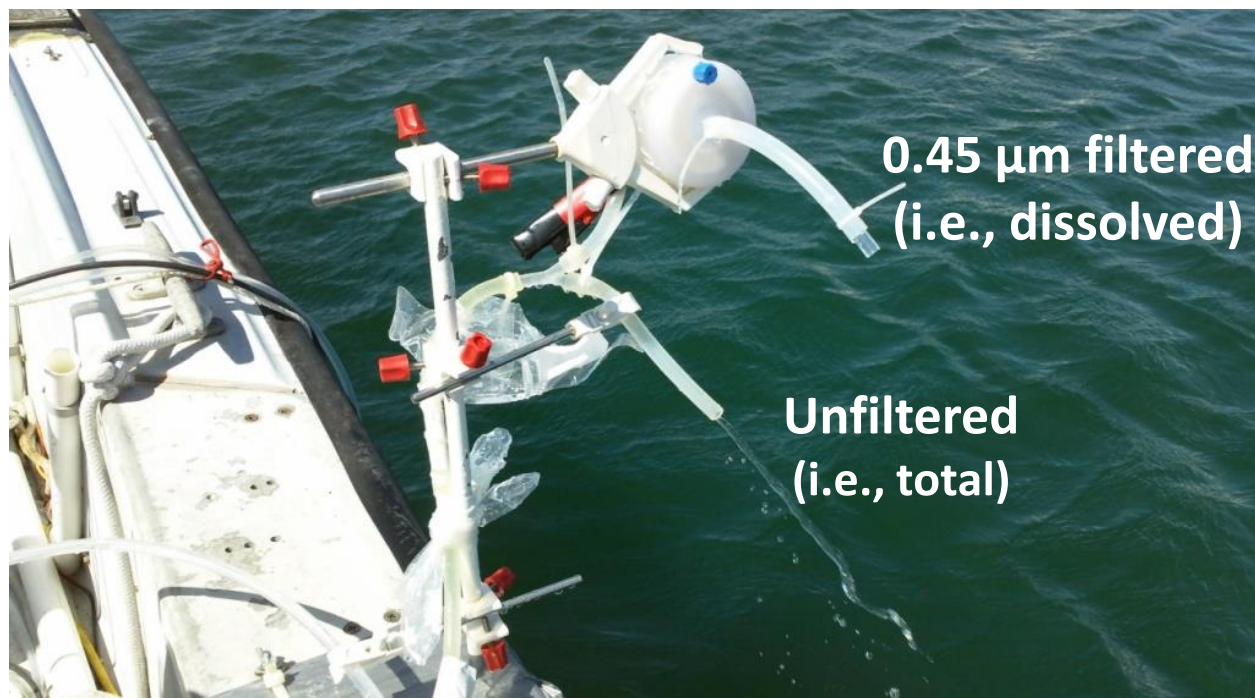
Figure 9. Peristaltic pump set up for collection of unfiltered and filtered water chemistry samples.

Water samples were collected using a peristaltic pump with Teflon® pump-head and weighted Teflon® tubing, and the option for in-line filtration with acid-cleaned high-volume polypropylene 0.45 µm Calix filter cartridges (US EPA, 1996; Figure 9). With the pump engaged and water pumping continuously through the tubing, the weighted Teflon® tubing was lowered to the desired depth (surface, mid-depth, and near-bottom) and the desired sample volume was collected in pre-cleaned sample bottles after rinsing the bottle three times with the flowing sample water. Dissolved samples were collected in a similar manner by toggling the flow through the in-line filtration cartridge (US EPA, 1996). Samples for BOD, nutrients and total metals were collected using the unfiltered option in the system. Samples for DOC and dissolved metals were collected using the filtered option in the system. All samples were labeled and a strict chain-of-custody and data log were kept for all field sampling activities.

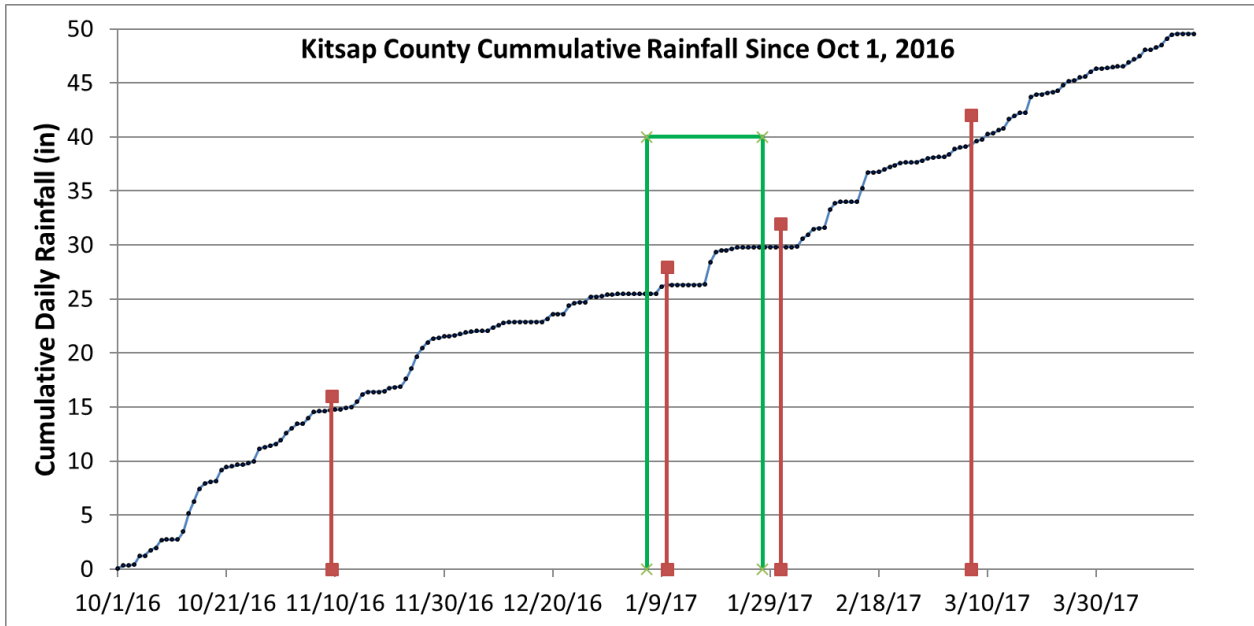
Figure 10. The average cumulative rainfall reported for rain gauges in Kitsap County from October 1, 2016 to April 17, 2017 (<https://www.cocorahs.org/ViewData/RainyDaysReport.aspx>). The water quality monitoring events (red bars) and biofouling removal period (green box) are also shown.

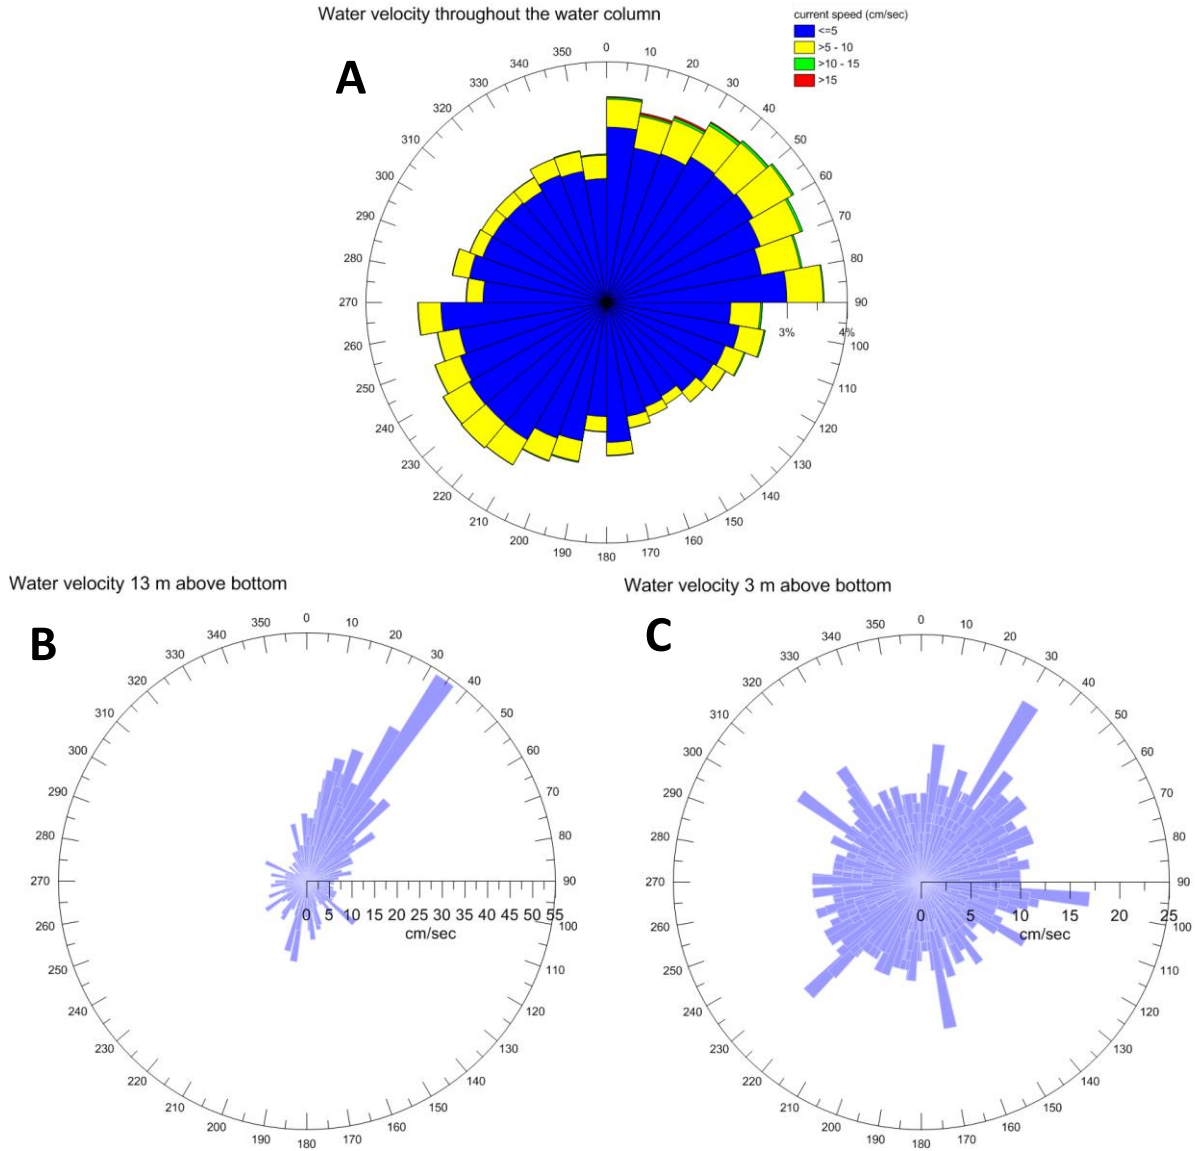
Figure 11. Current speed and direction recorded by ACDP moored near CV 62 showing the average velocities throughout the water column (A), near the surface (B, about 40 ft water depth), and near the bottom (C, about 9ft from bottom).

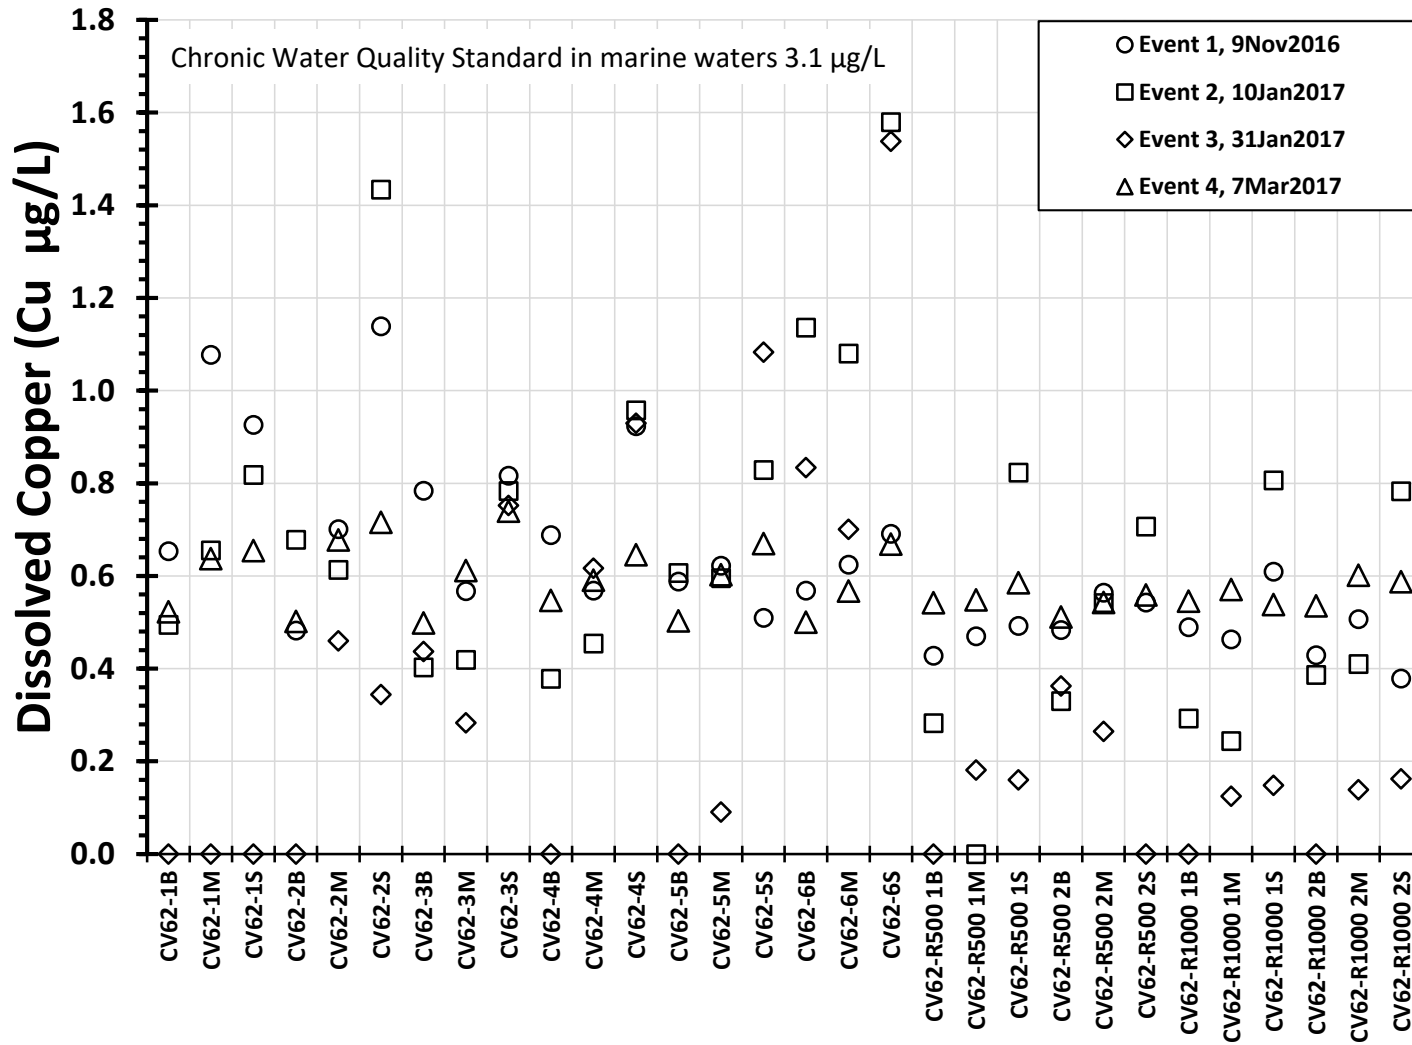
Figure 12. Dissolved copper concentration (Cu µg/L) distributions measured during the four sampling events to assess metal loading generated by biofouling-removal from the hull of the ex-INDEPENDENCE (CV 62). Non-detects (ND) are plotted as zero concentration (MDL 0.47 ± 0.20 µg/L).

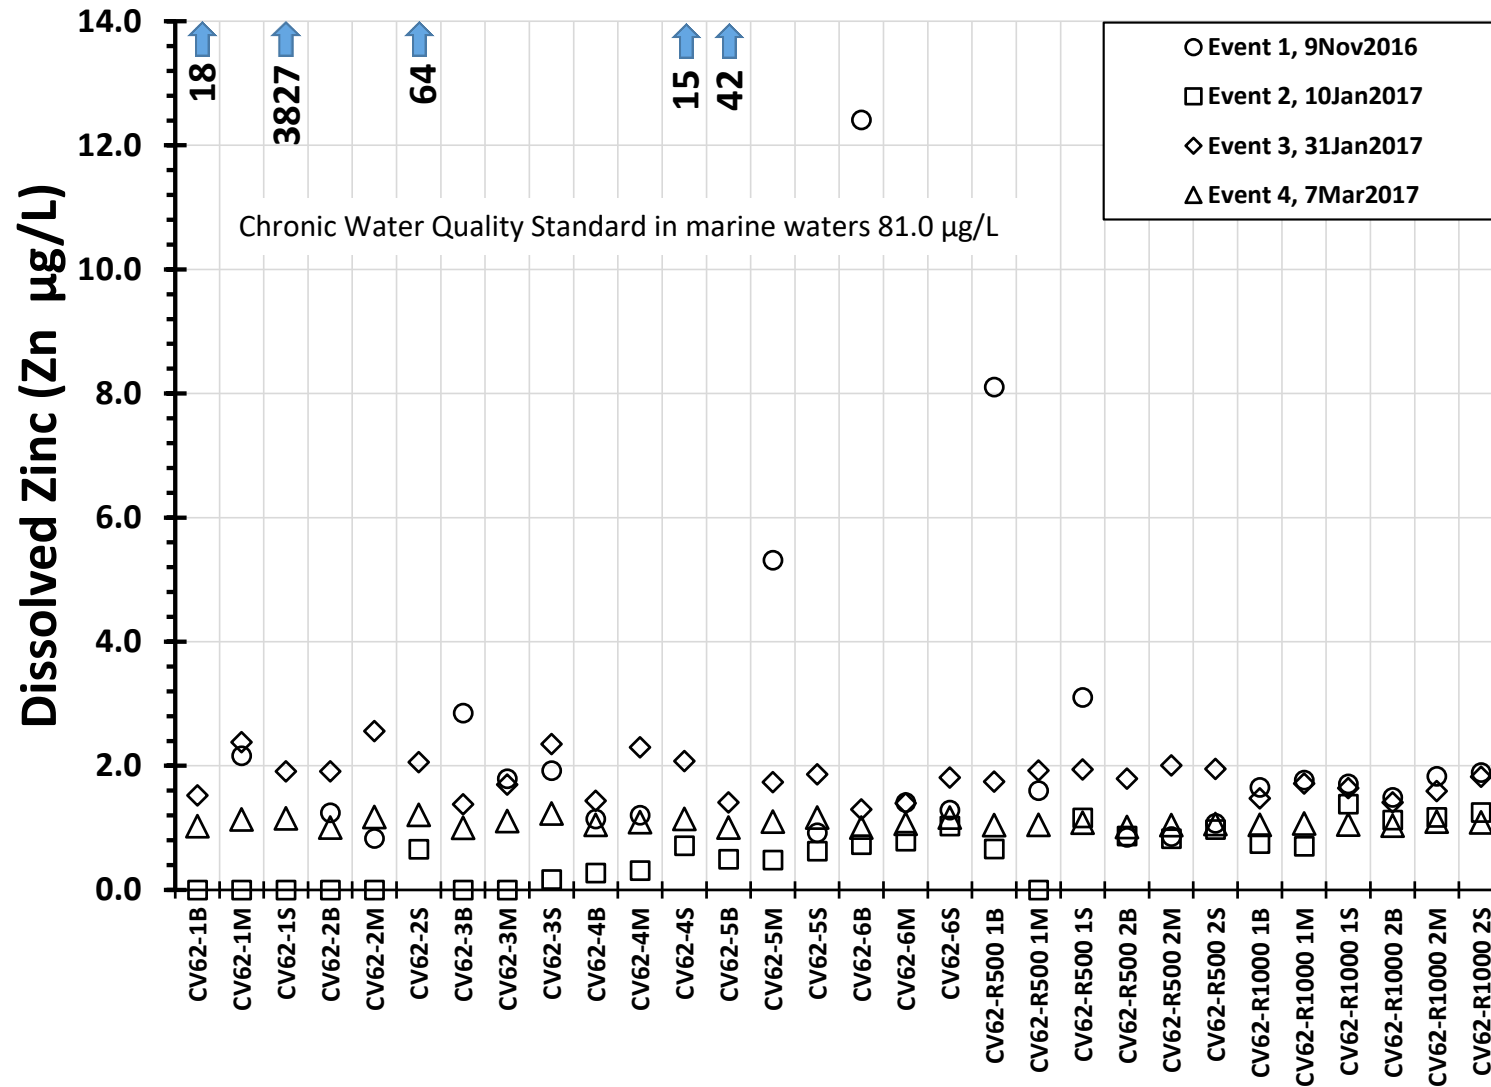
Figure 14. Dissolved zinc concentration (Zn µg/L) distributions measured during the four sampling events to assess metal loading generated by biofouling-removal from the hull of the ex-INDEPENDENCE (CV 62). Numerical data and arrows are shown for Event 1 where values are above 14.0 µg/L. Non-detects (ND) are shown as zero concentration (MDL 0.66± 0.28 µg/L).

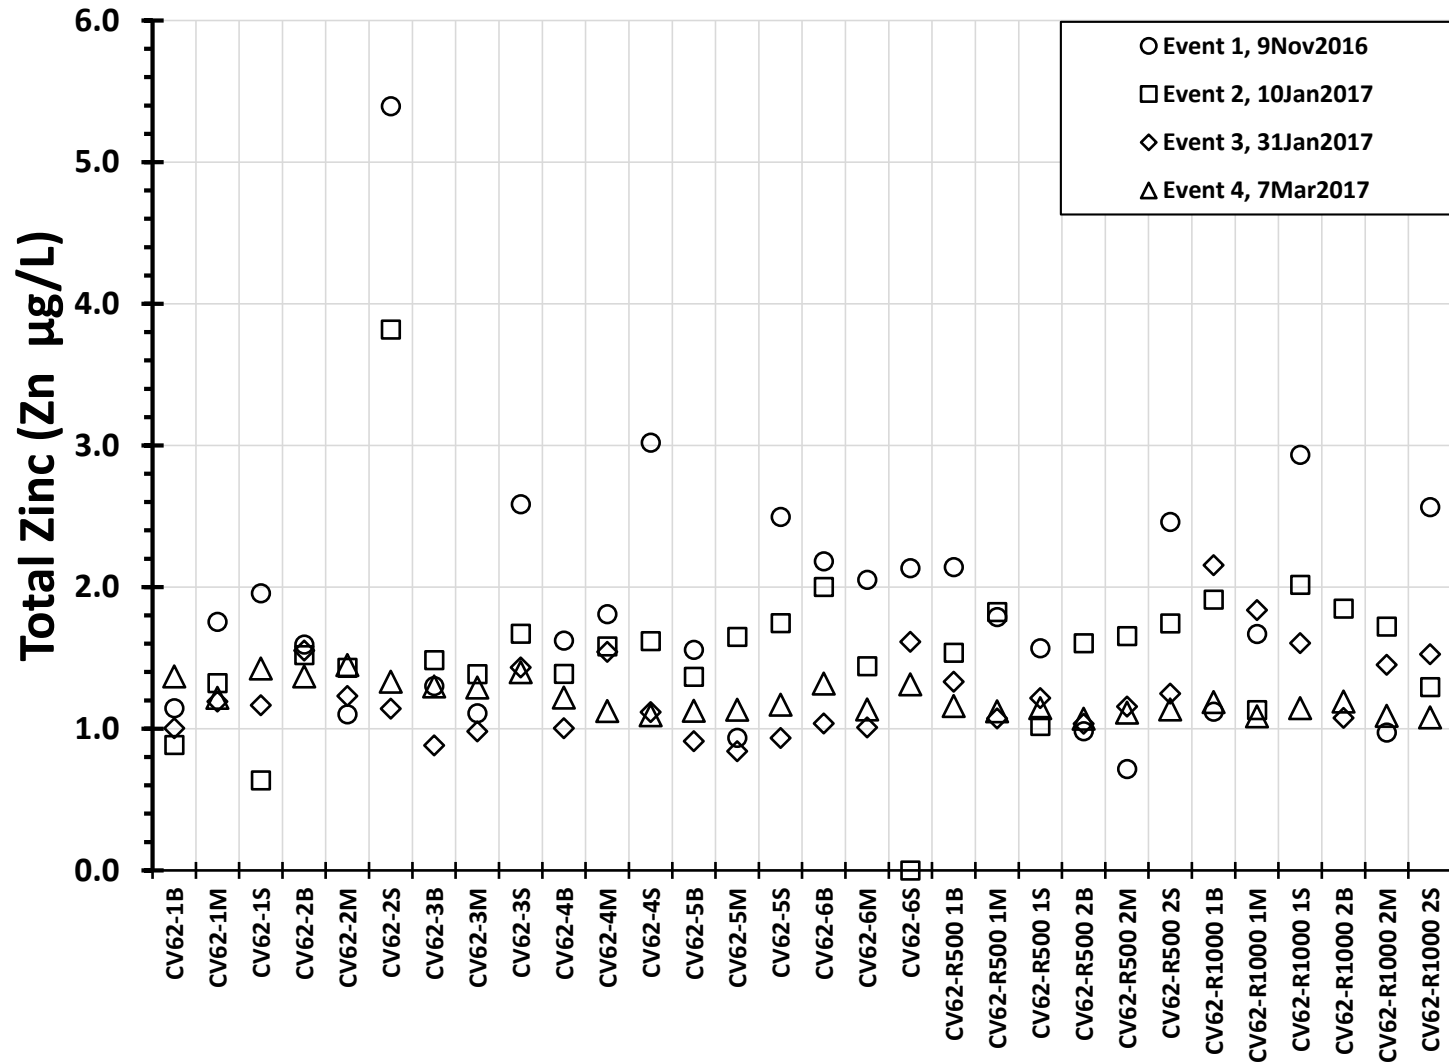
Figure 15. Total zinc concentration (Zn µg/L) distributions measured during the four sampling events to assess metal loading generated by biofouling-removal from the hull of the ex-INDEPENDENCE (CV 62).

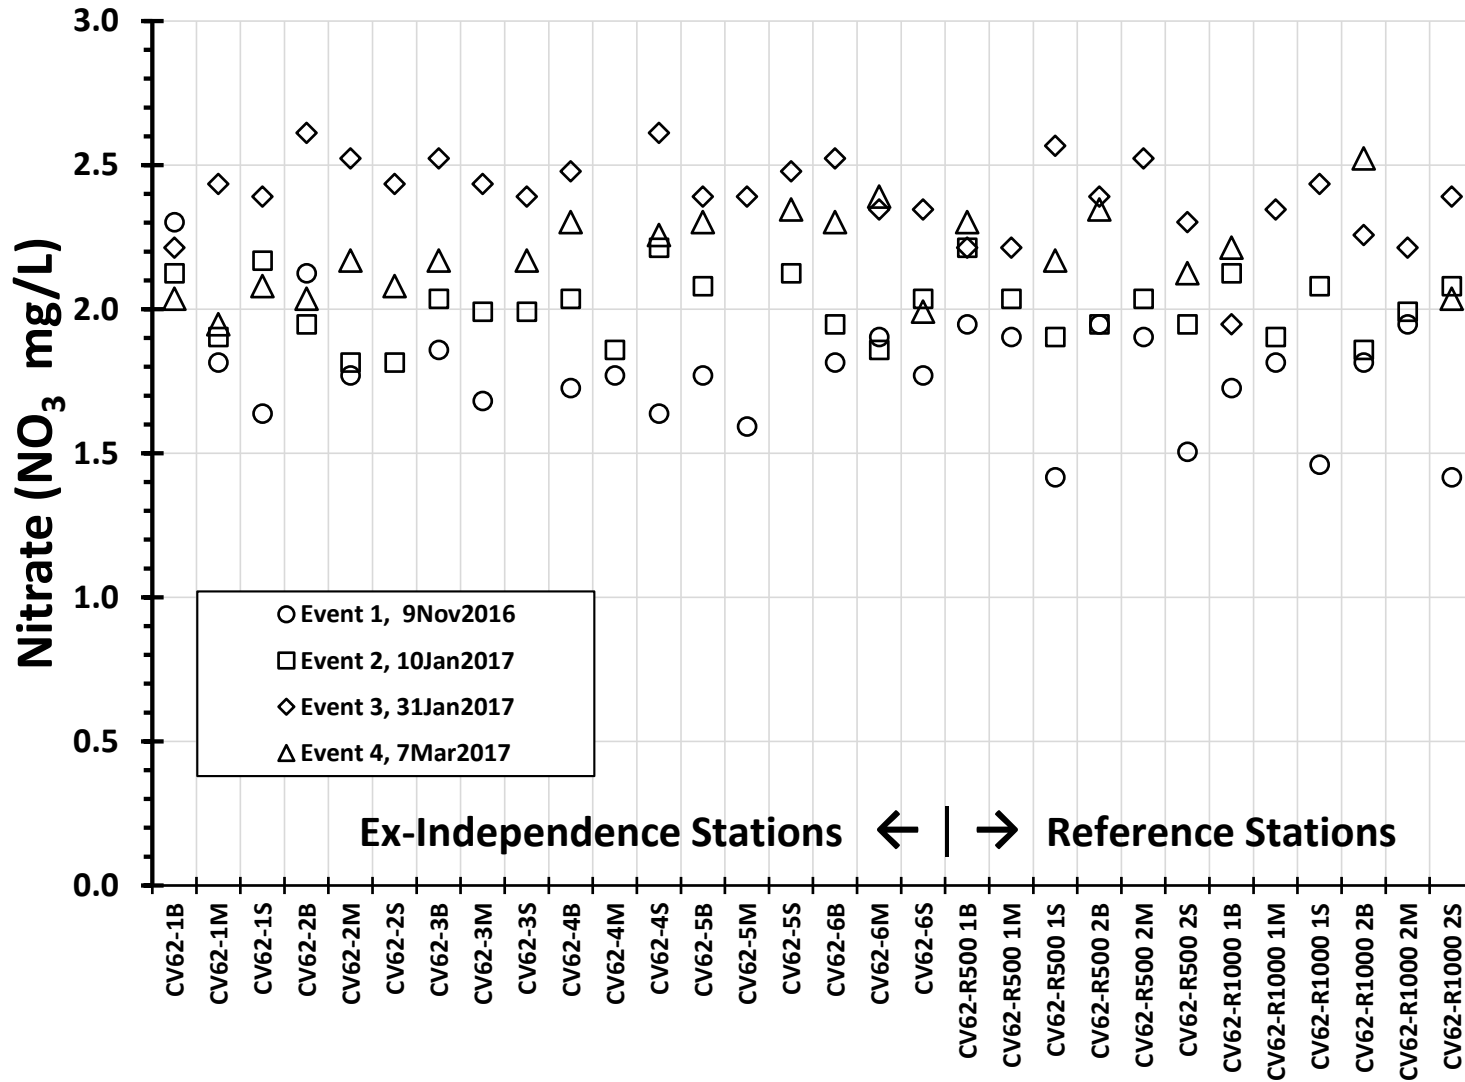
Figure 16. Nitrate (NO₃) concentration (mg/L) distributions measured during the four sampling events associated with biofouling removal from the ex-INDEPENDENCE (CV 62).

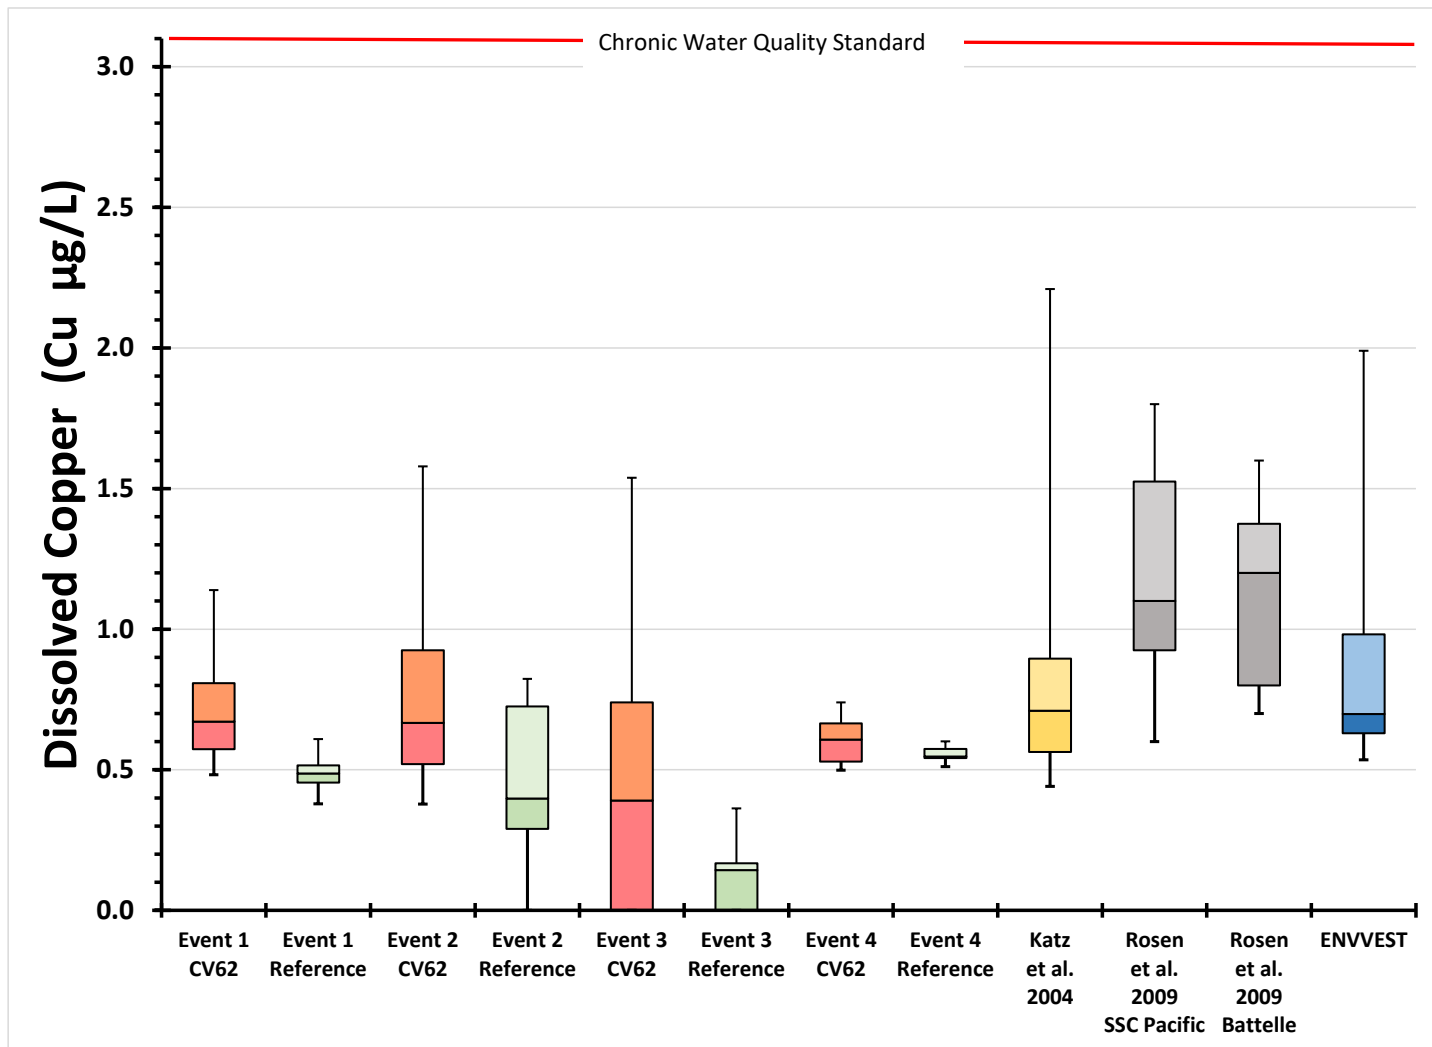
Figure 20. Comparison of the range in dissolved copper (Cu) measured ($\mu\text{g/L}$) during this study compared to Katz et al. (2004), Rosen et al. (2009), and data collected in December 2016 and March 2017 by the ENVVEST program.

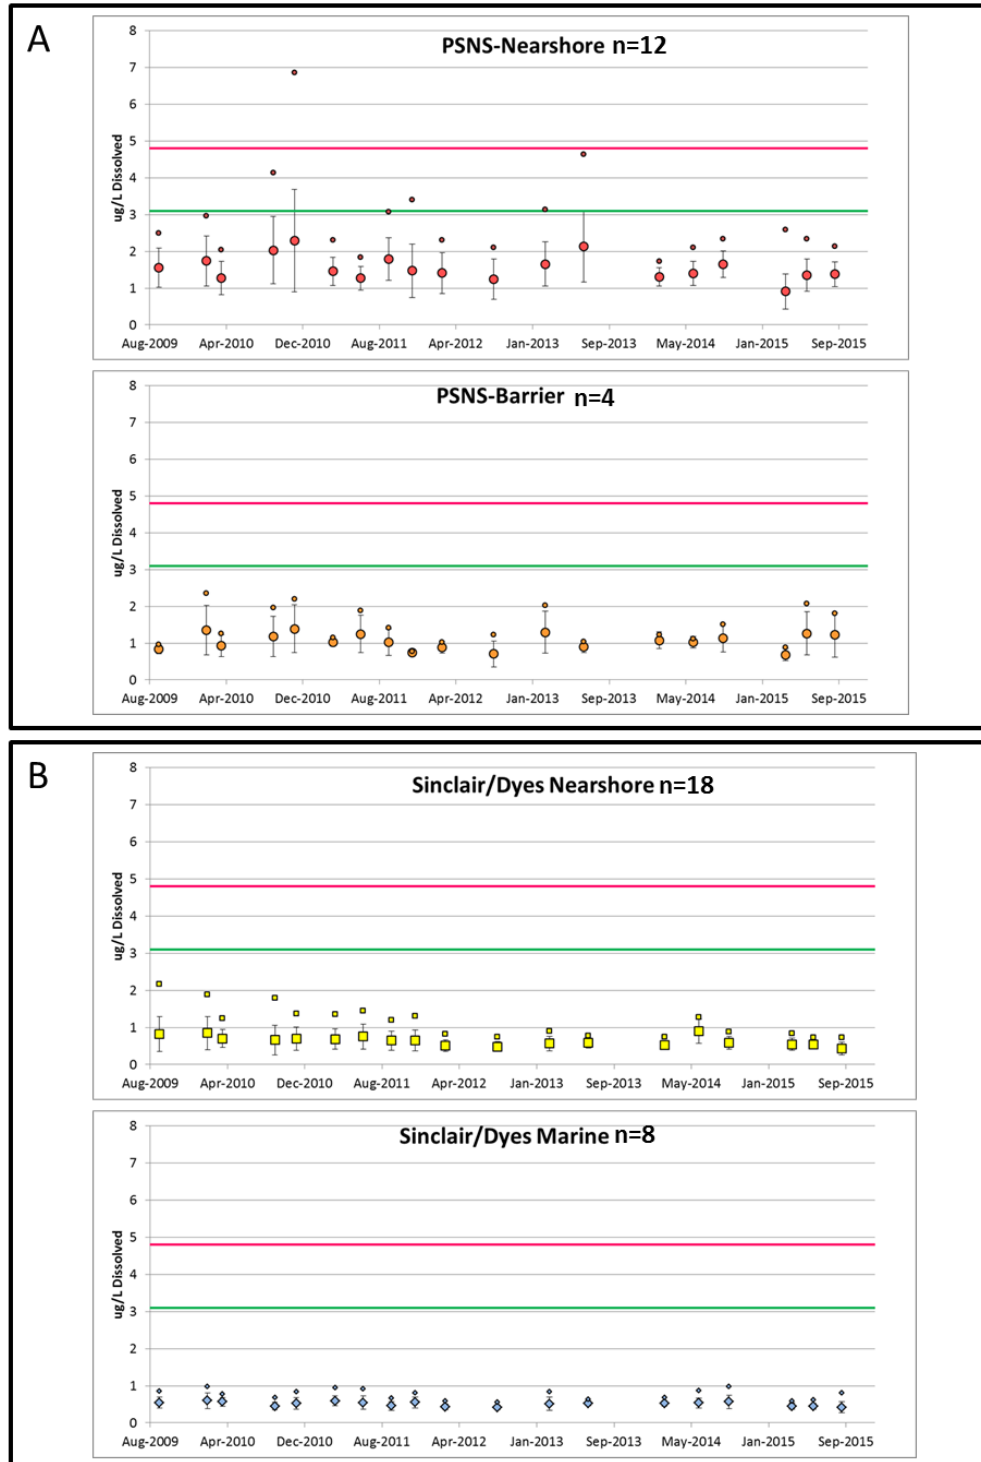
Figure 22. Dissolved Cu ($\mu\text{g/L}$) measured during ENVVEST seasonal monitoring events at locations within PSNS (A) and reference nearshore and marine stations in Sinclair and Dyes Inlets (B), from Johnston et al. (2017a). Large symbols are means with standard deviation for error bars, smaller points are maximum for sampling event, the green and red horizontal lines are the water quality CCC and CMC for Cu, respectively.

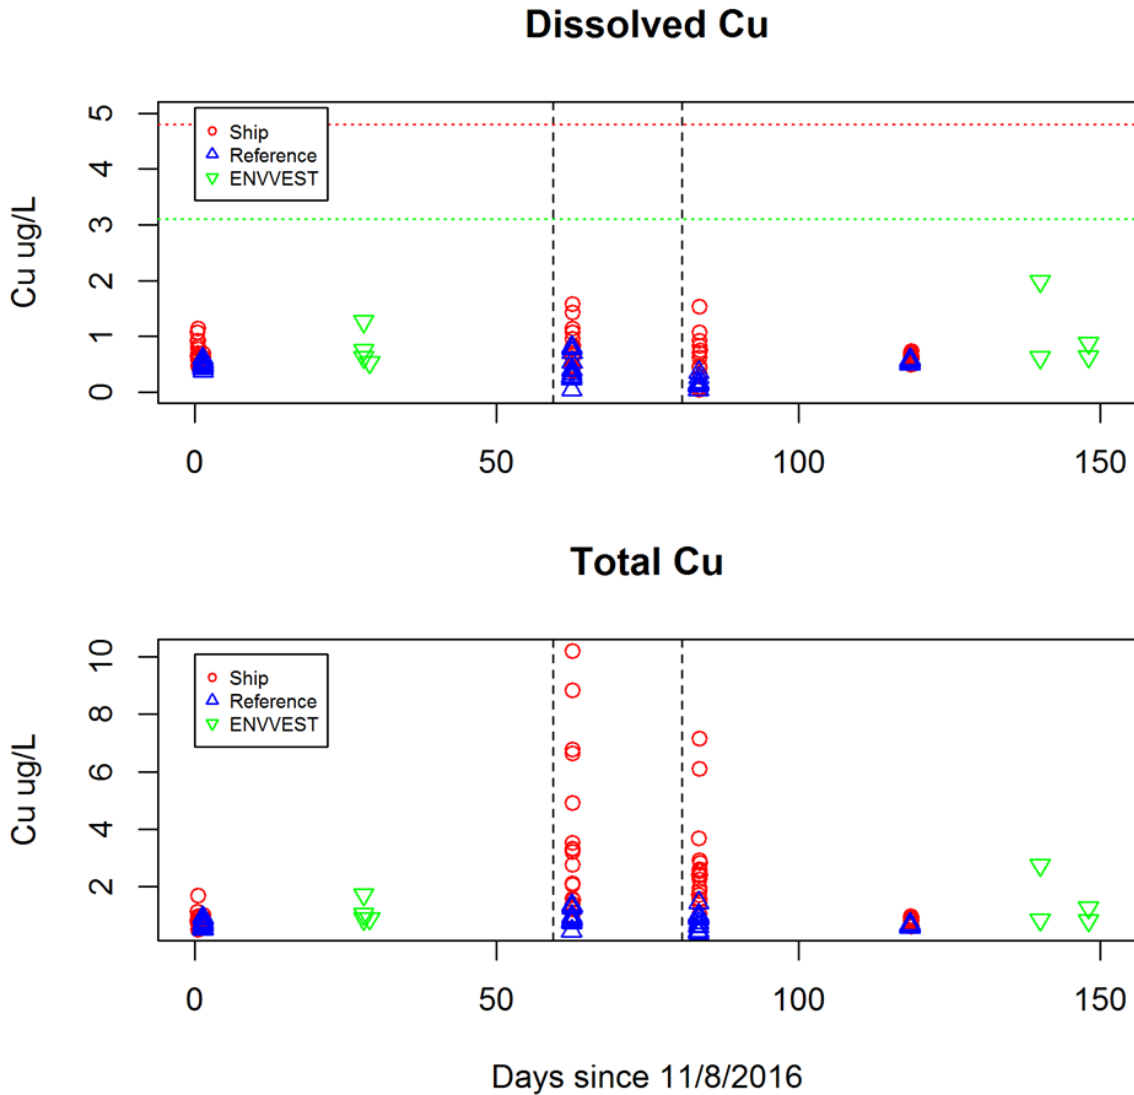
Figure 24. Results for dissolved and total copper ($\mu\text{g/L}$) measured at Ship (red circles), Reference (blue triangle) and ENVVEST (green triangles) sampling sites during the study. The upper panel shows chronic (green dotted line) and acute (red dotted line) water quality standards and the vertical dashed lines denote the beginning and end of biofouling removal. See Figure 21 for sampling locations.

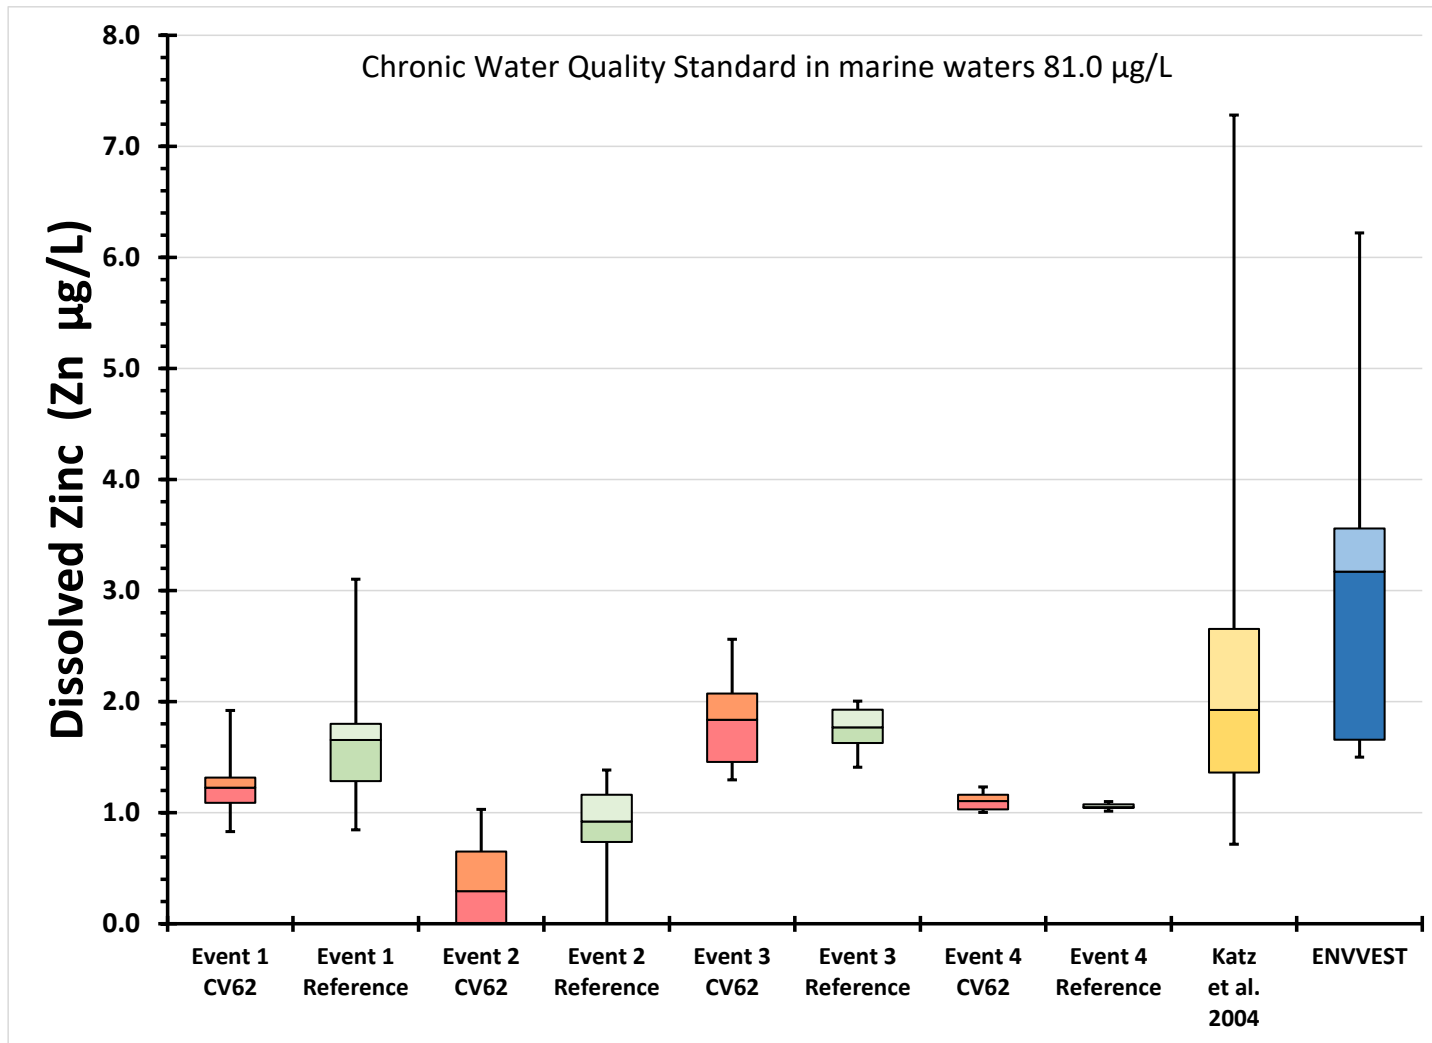
Figure 25. Comparison of the range of dissolved zinc (Zn) measured ($\mu\text{g/L}$) in this effort to those from Katz et al. (2004), and data collected in December 2016 and March 2017 by the ENNVEST program. Dissolved Zn data considered contaminated from Event 1 was omitted for this figure.

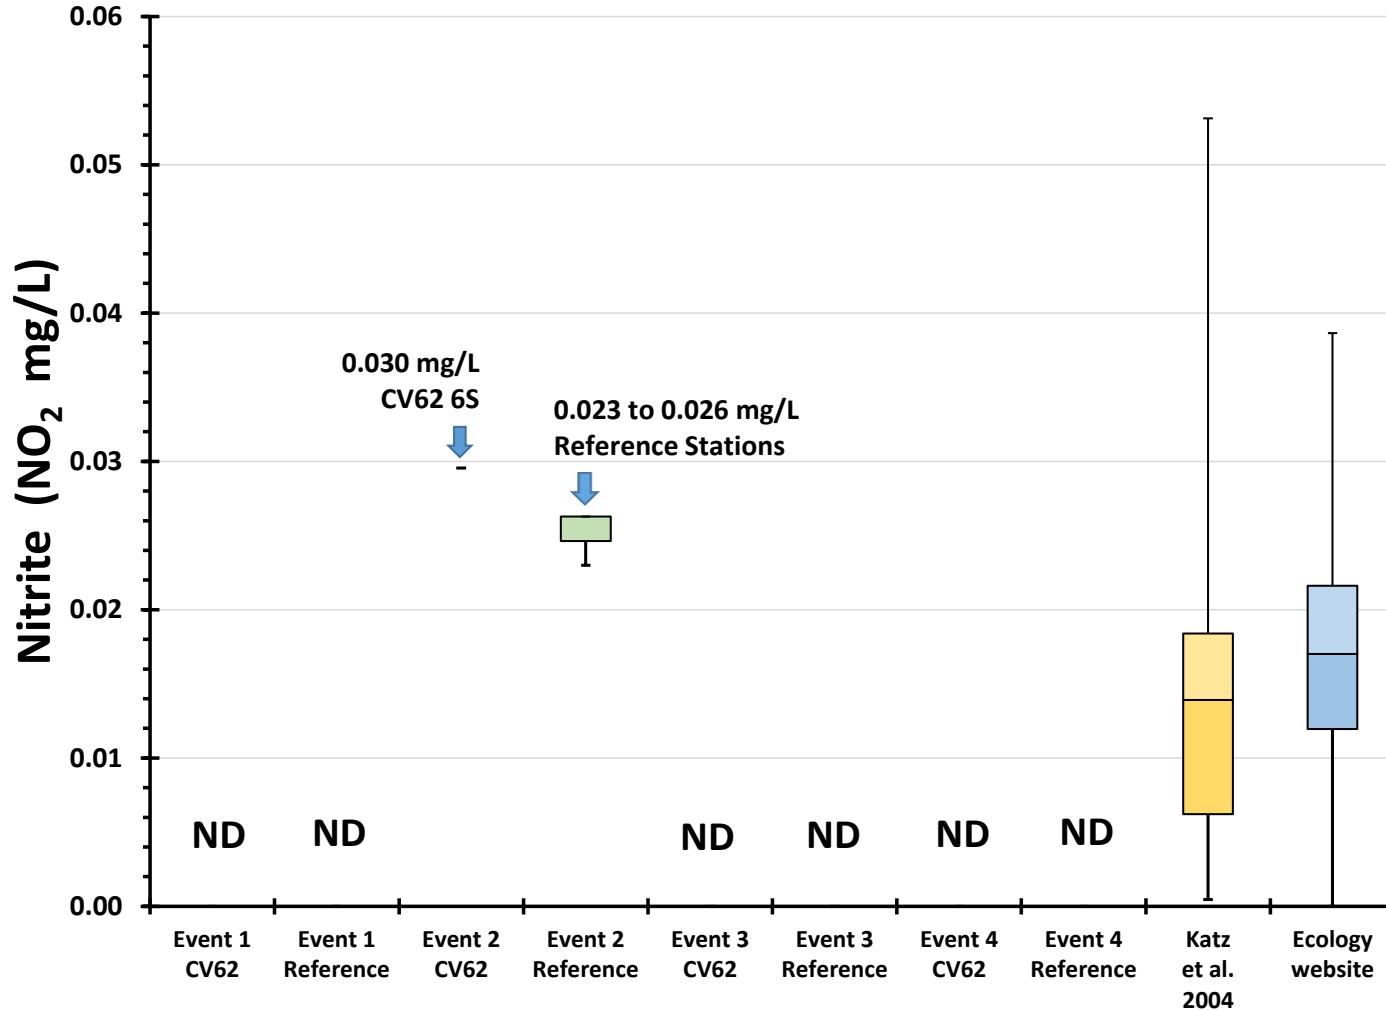
Figure 28. Comparison of the range in nitrite (NO₂) measured (mg/L) in this effort to those from Katz et al. (2004) and data reported for one station in Sinclair Inlet (SIN001_0) monitored by the State of Washington Department of Ecology (<https://fortress.wa.gov/ecy/eap/marinewg/mwdataset.asp?staID=129>, accessed 15 May 2017). (Ecology, 2017a) ND is non-detect.

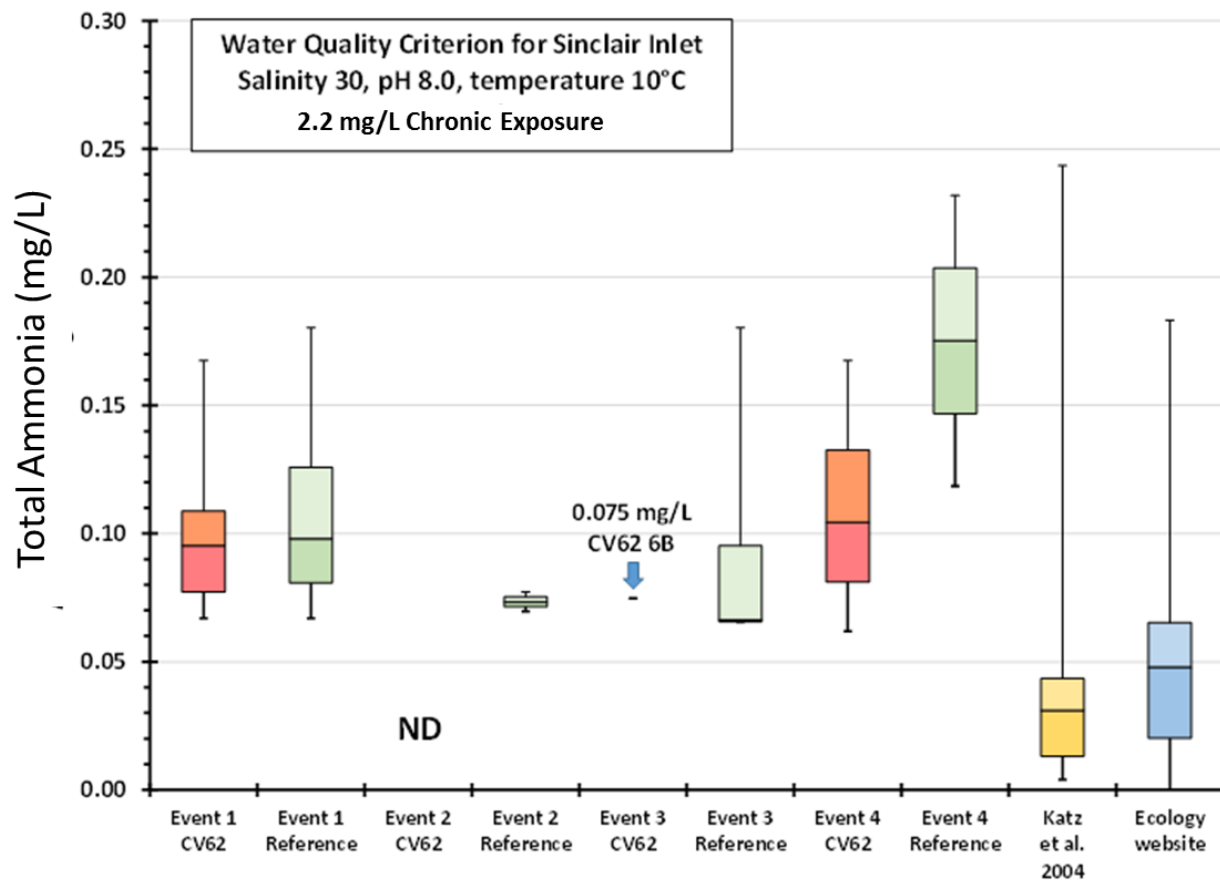
Figure 29. Comparison of the range in total ammonia measured (mg/L) in this effort to those from Katz et al. (2004) and data reported for one station in Sinclair Inlet (SIN001_0) monitored by the State of Washington Department of Ecology (<https://fortress.wa.gov/ecy/eap/marinewq/mwdataset.asp?stalD=129>, accessed 15 May 2017). ND is non-detect.

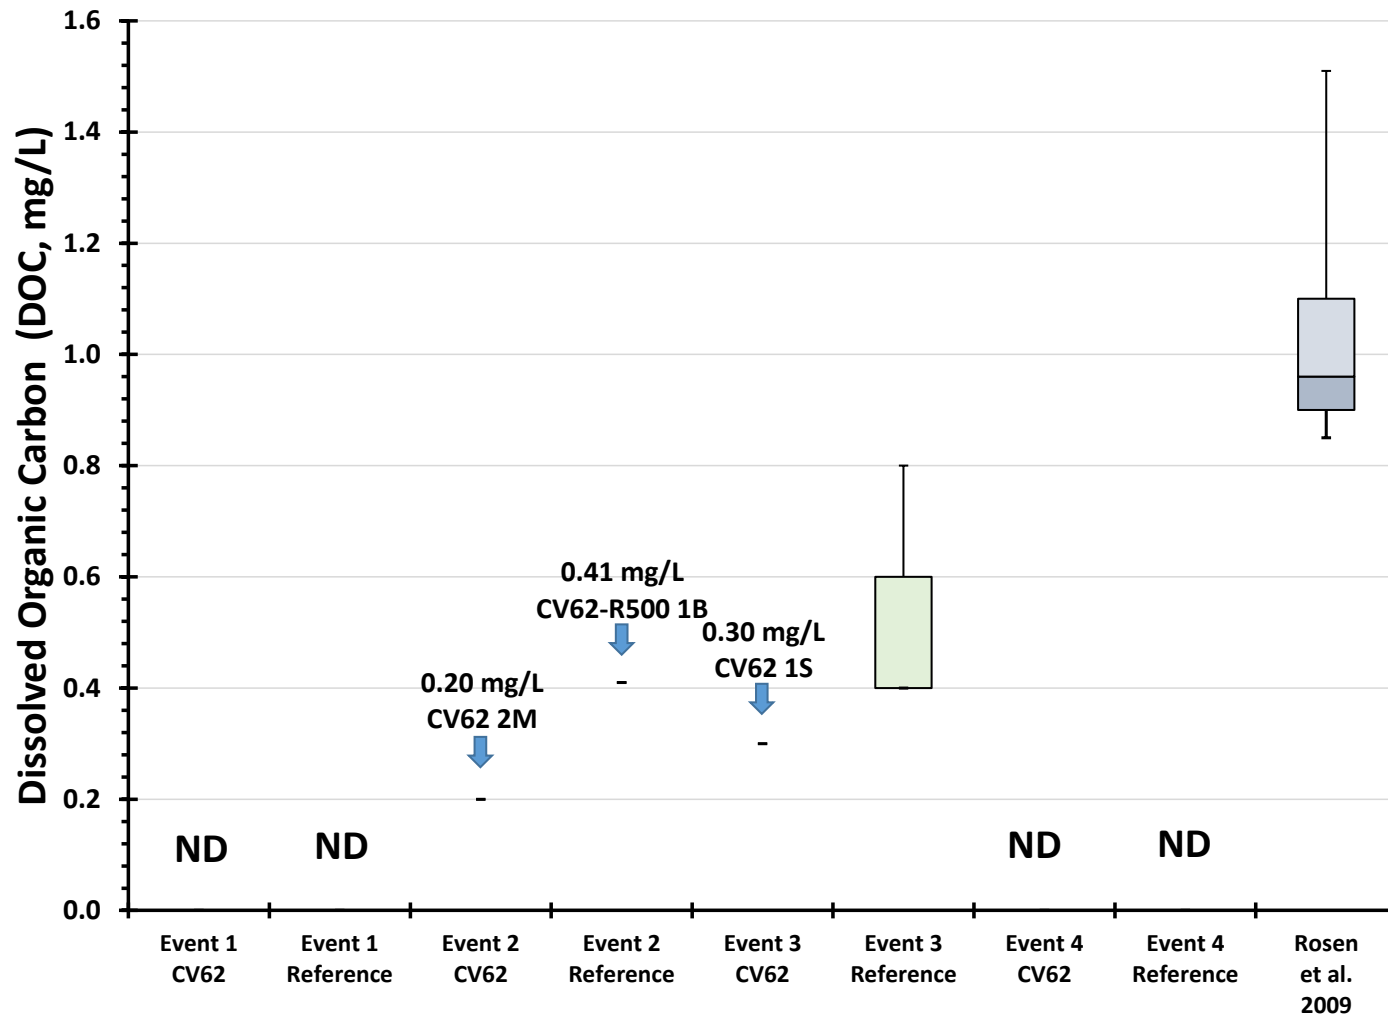
Figure 30. Comparison of the range in dissolved organic carbon (DOC) measured (mg/L) in this effort to those from Rosen et al. (2009) measured in winter. ND is non-detect (MDL 0.2 mg/L)
