TECHNICAL REPORT 3109
OCTOBER 2017

Water Quality Monitoring of Biofouling Removal from the ex-USS INDEPENDENCE (CV 62)

Water Body Number
WA-15-0040 Sinclair Inlet

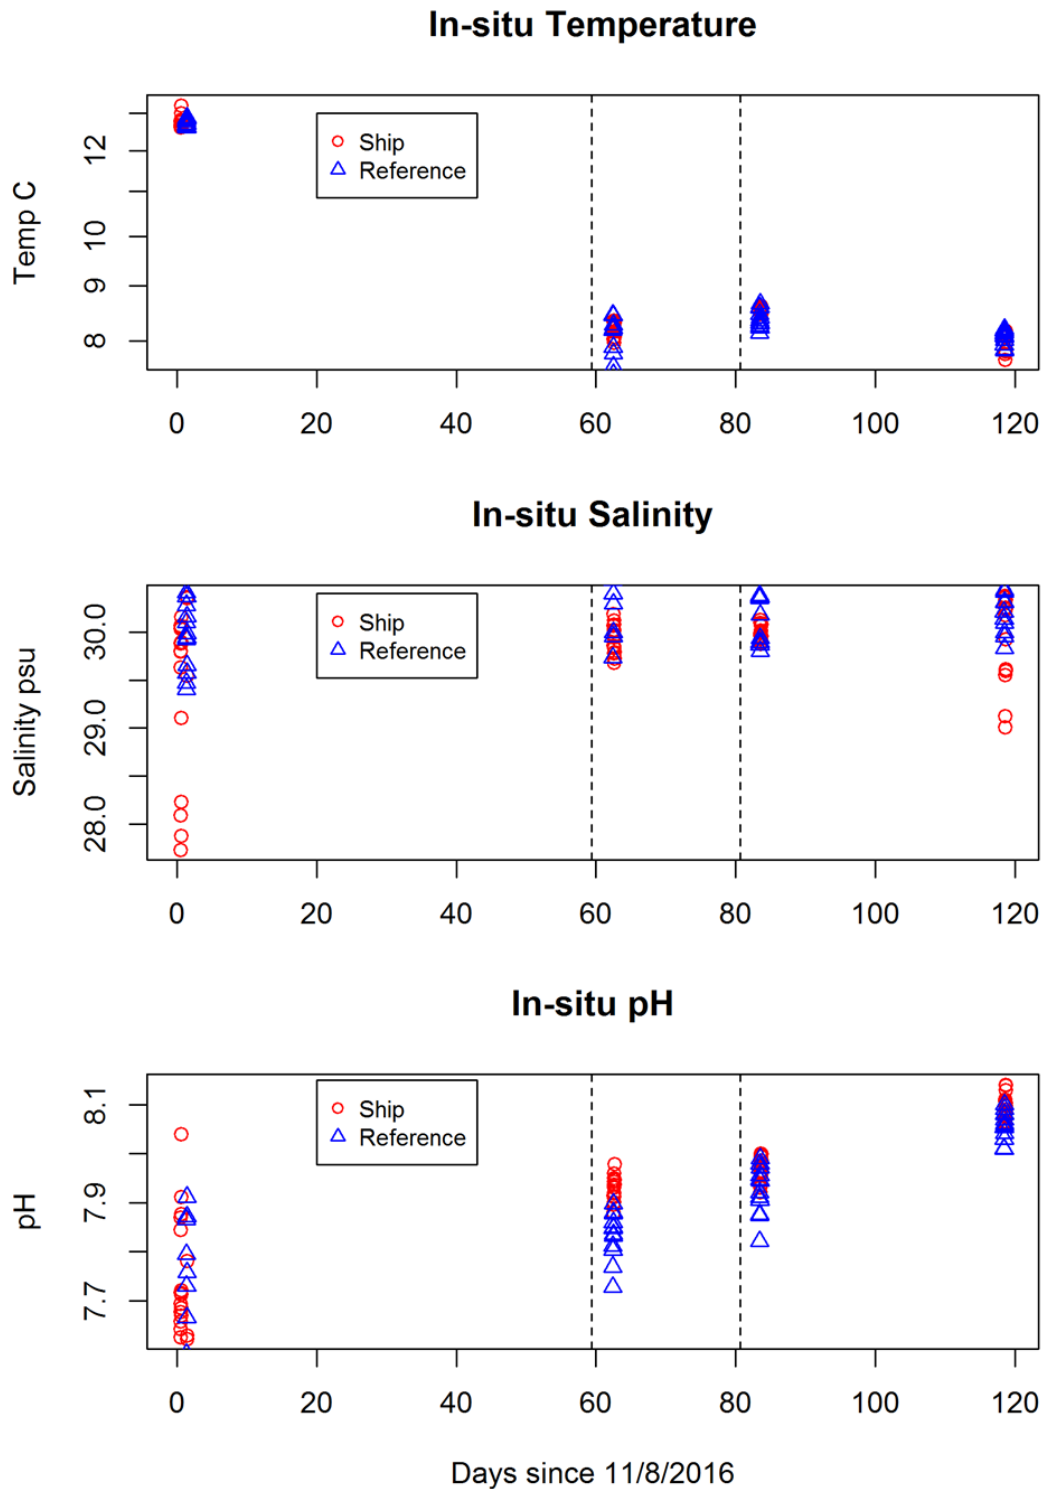
Figure C-1. Results for in-situ temperature ($^{\circ}\text{C}$), in-situ salinity (psu), and in-situ pH measured at Ship and Reference sites during the study. The vertical dashed lines denote the beginning and end of biofouling removal.

There was a sharp decrease in water temperature between Event 1 and subsequent events from the onset of winter (Appendix C: Table C-1, Figure C-1, and Figure C-7). The significant reduction in water temperature has effects on the results of the study. With the onset of winter, the decrease in temperature and reduction in sunlight cause plankton growth to be diminished; microbial growth and metabolism are essentially shutdown; and the decrease in water temperatures increases the solubility of dissolved oxygen. Winter storm-related wind and rain increase the already substantial tidal mixing, and the water column is more likely to be stratified by fresh water plumes from storm runoff and increased stream flow from the watershed than from temperature which occurs in the warmer months.

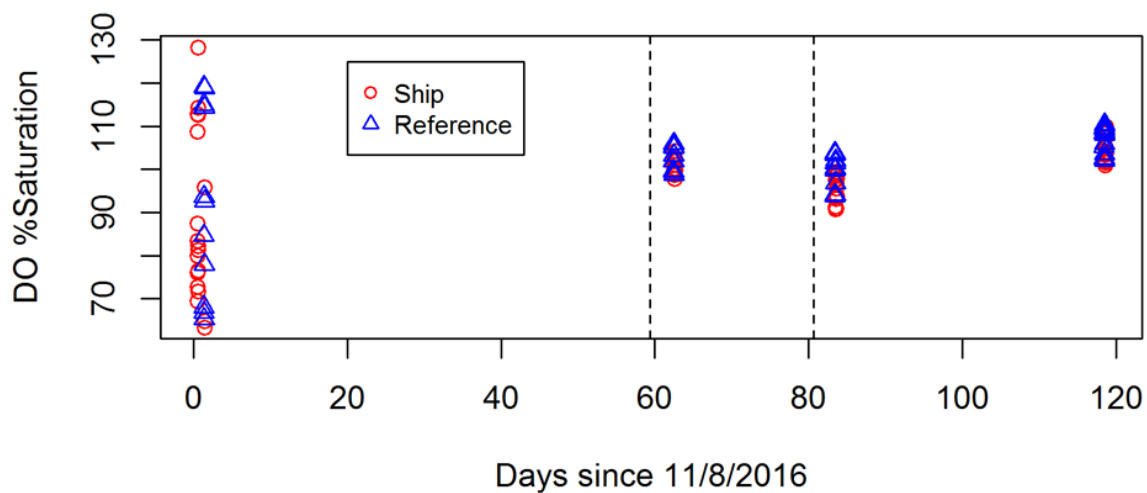
Figure C-2. Results for in-situ dissolved oxygen (mg/L) and in-situ percent dissolved oxygen saturation measured at Ship and Reference sites during the study. The vertical dashed lines denote the beginning and end of biofouling removal.

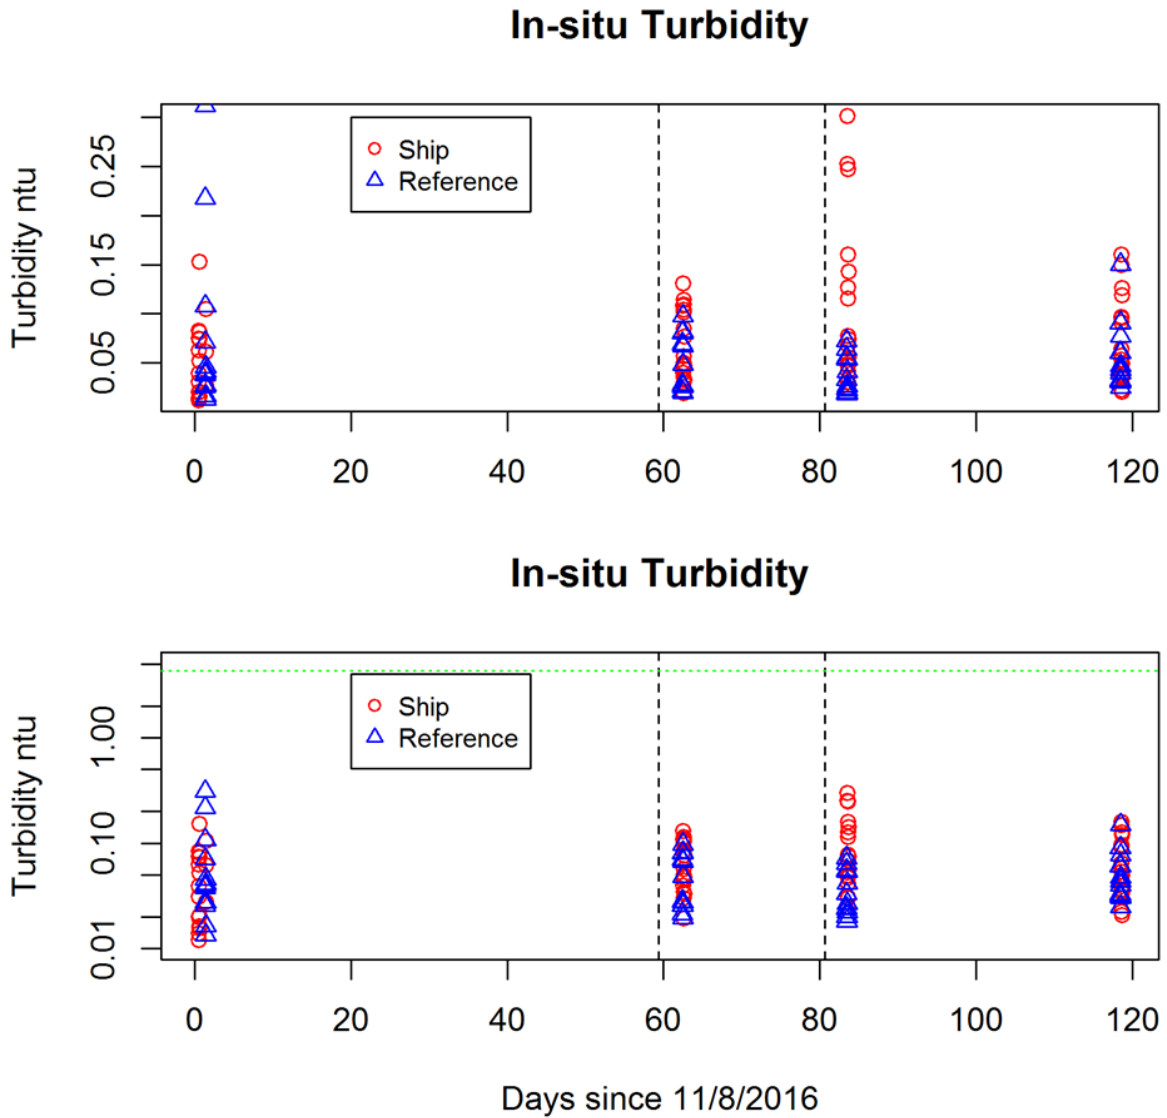
Figure C-3. Results for in-situ turbidity (NTU, log scale) measured at Ship and Reference sites during the study, with the lower panel showing the data scaled to show the regulatory threshold of 5 NTU above background (green dotted line). The vertical dashed lines denote the beginning and end of biofouling removal.

Very slight and short term differences in turbidity were measured during the study by both the in-situ (Appendix C: Table C-1, Figure C-3, Figure C-10) and the discrete turbidity sensors (Appendix C: Table C-1, Figure C-4, Figure C-11). Turbidity levels did not exceed WQS for any measurements during the study. Secchi disk depth observations also corroborate the low turbidity measurements obtained by field sensors (Appendix C: Figure C-4).

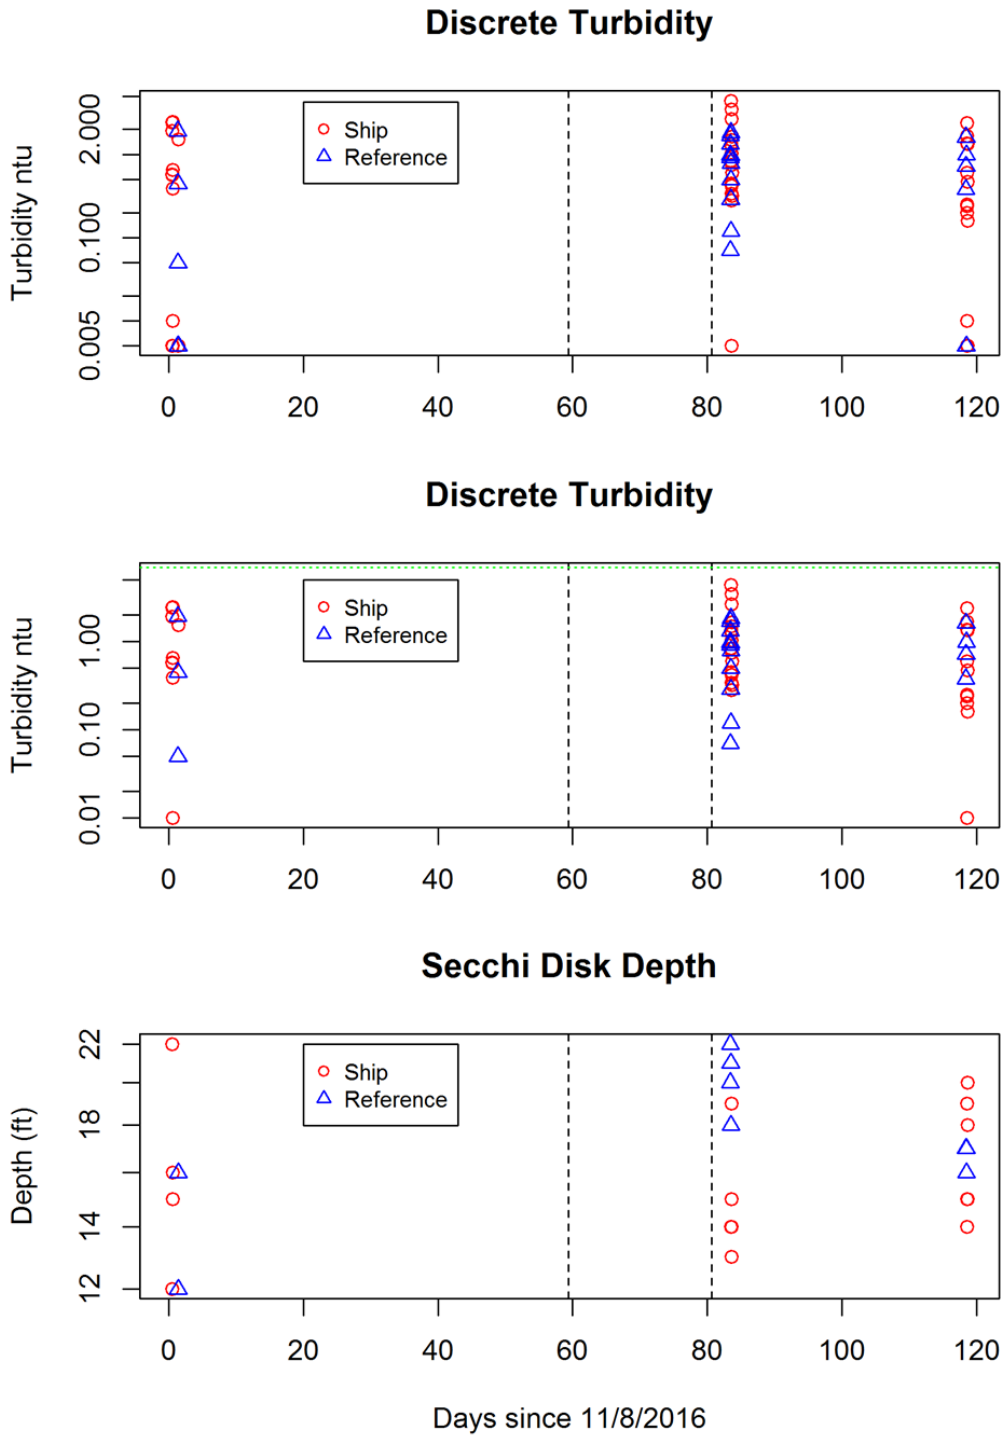
Figure C-4. Results for discrete turbidity (NTU, log scale) and Secchi disk depth (ft) measured at Ship and Reference sites during the study. The middle panel shows the data scaled to the regulatory threshold of 5 NTU above background (green dotted line). The vertical dashed lines denote the beginning and end of biofouling removal.

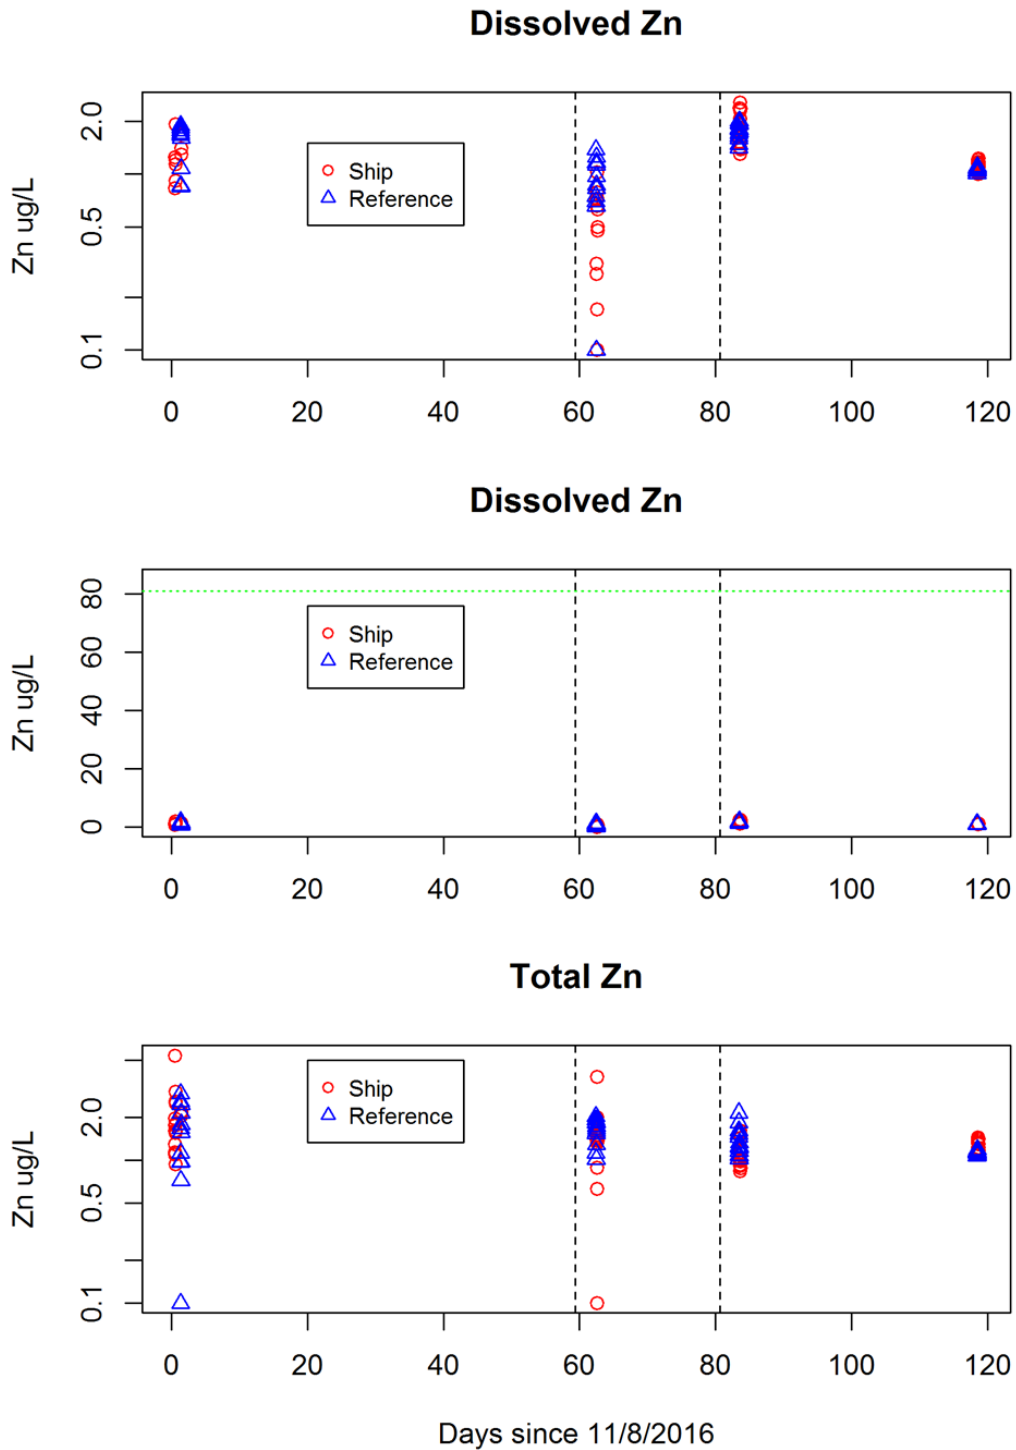
Figure C-6. Results for dissolved zinc ($\mu\text{g/L}$) measured at Ship and Reference sites during the study. The data are scaled to show chronic water quality standard (green dotted line) and the vertical dashed lines denote the beginning and end of biofouling removal.

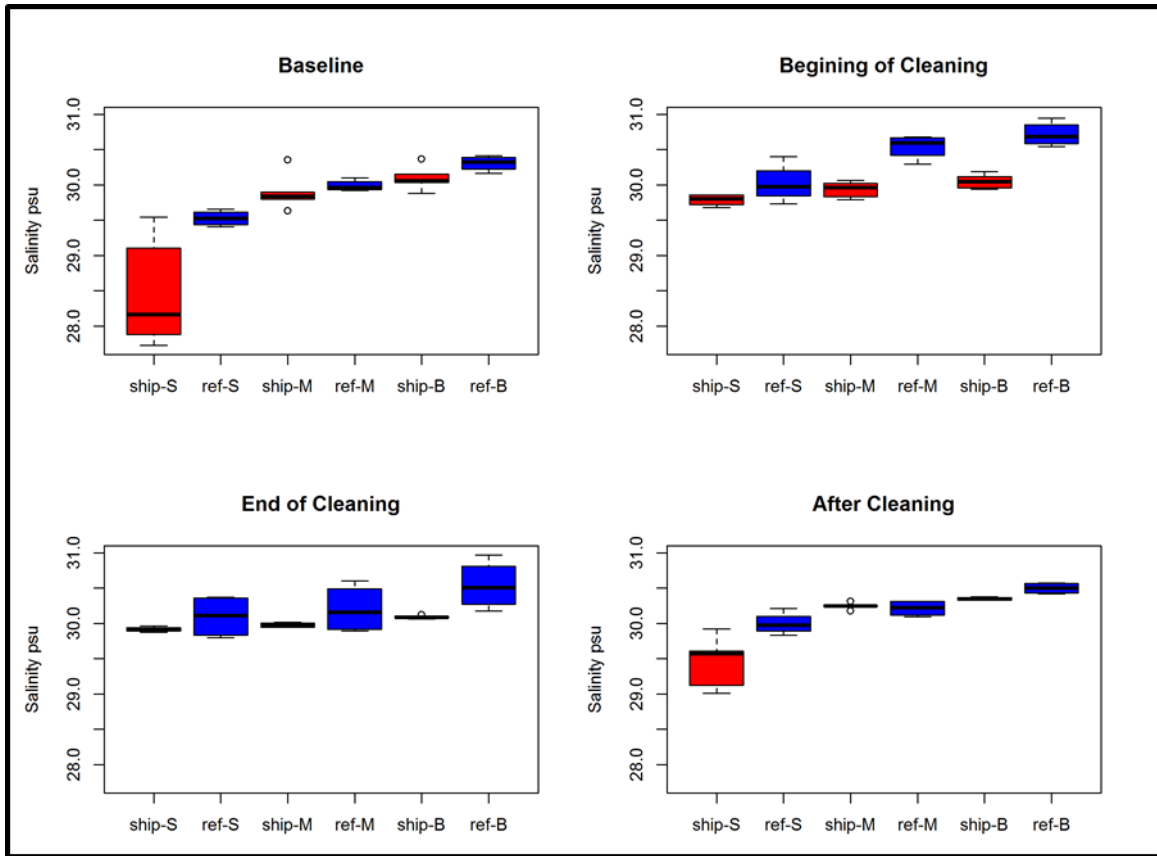
Figure C-9. Box and whisker plots for in-situ salinity (psu) by sampling event, type and strata scaled at same scale for all events.
