# FINAL REPORT

## Full-Scale Fixed-Bed Biological Perchlorate Destruction Demonstration

Construction of a Fixed-Bed Bioreactor Wellhead Treatment System

ESTCP Project ER-201169

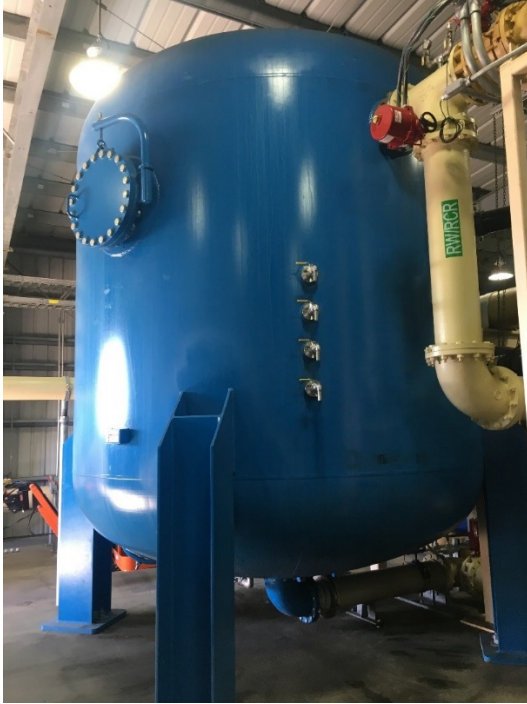
Figure 4 Completed Bioreactor

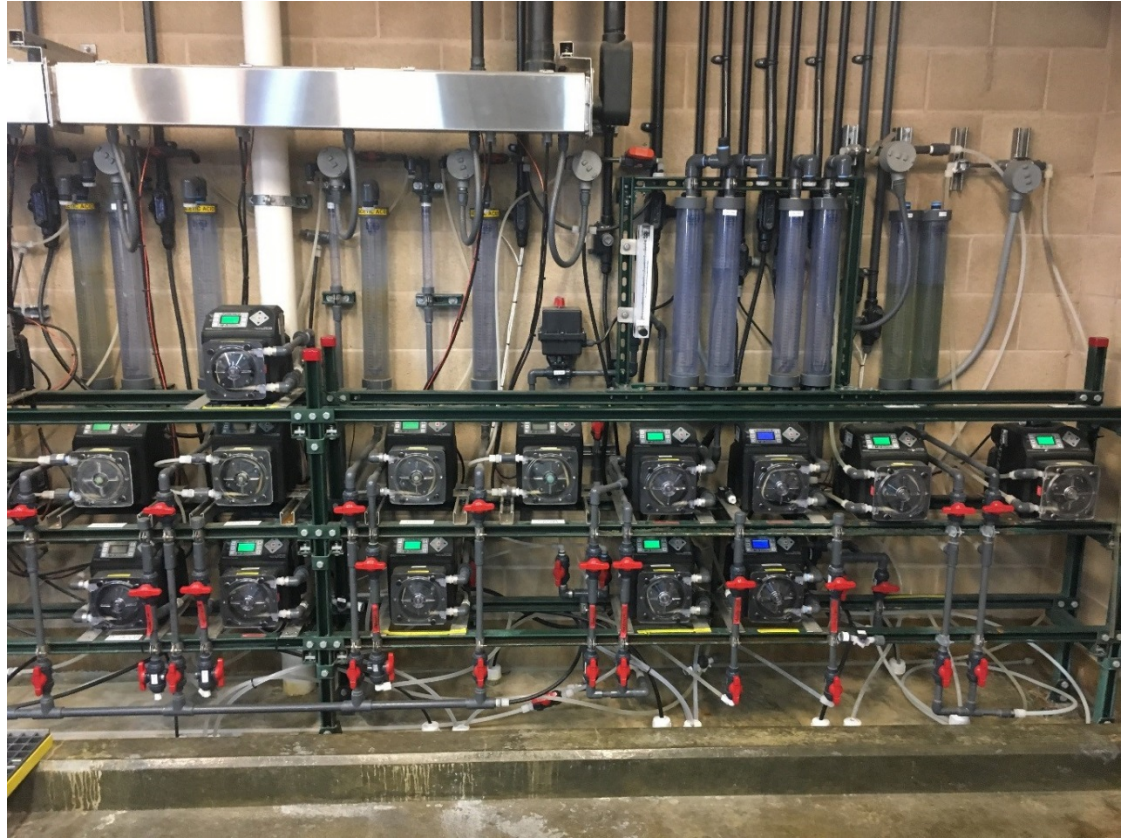
The FXB bioreactor feed water is amended with electron donor (acetic acid) and nutrient (phosphoric acid), and the FXB bioreactor effluent (i.e., FXB biofilter feed) is re-oxygenated using peroxide, and dosed with coagulant to enhance turbidity removal. The system was designed such that typical raw water concentrations of perchlorate and nitrate are 66  $\mu\text{g/L}$  and 3.5 mg/L as N (respectively) and are to be reduced to target effluent concentrations of  $\leq 0.5 \mu\text{g/L}$  and  $\leq 0.5 \text{ mg/L}$  as N. Hydrogen peroxide is used to dechlorinate distribution water prior to backwashing. Coagulant is also dosed during the backwash recovery process to improve settling. Sodium hypochlorite is dosed downstream of the biofilter to provide residual disinfection prior to distribution. A photo of the chemical feed pumps is provided in Figure 5.

Figure 5 Chemical Feed Pumps

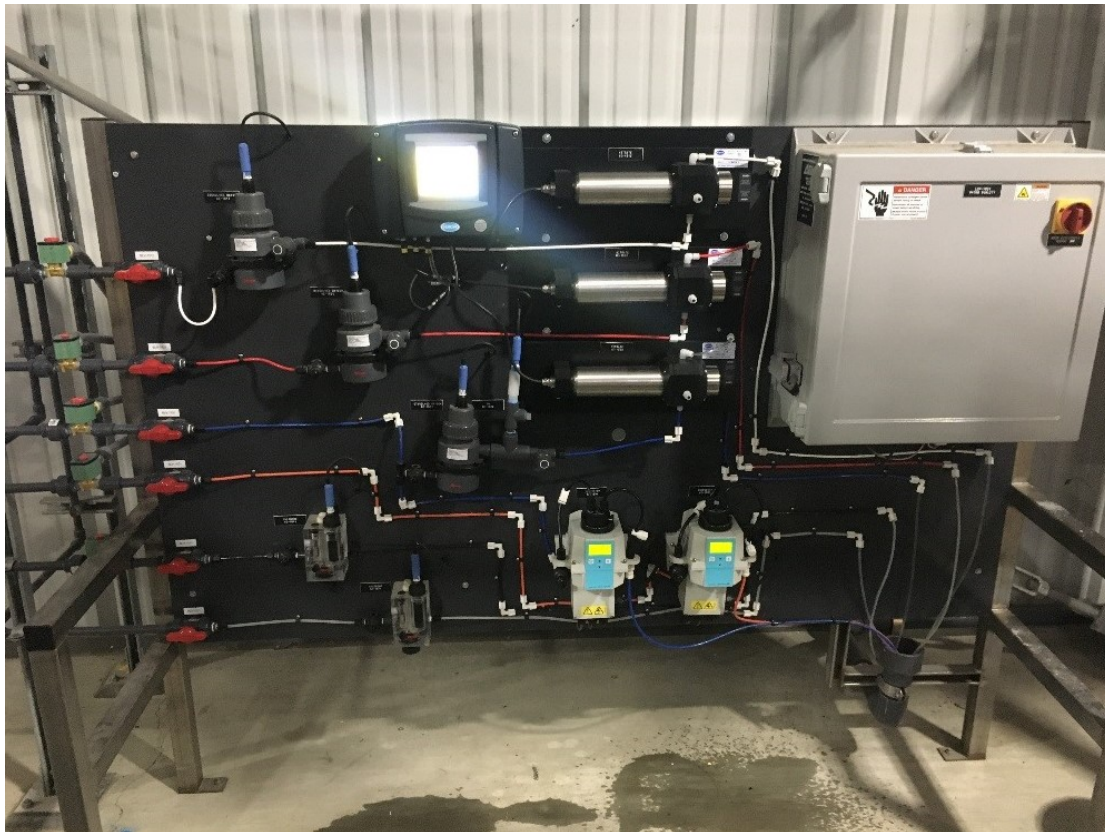
A single sample panel houses all water quality monitoring instruments included in the package system, with the exception of a remote analyzer to be used for monitoring of CT pipe effluent (Figure 12).

Figure 12 Water Quality Monitoring Instruments

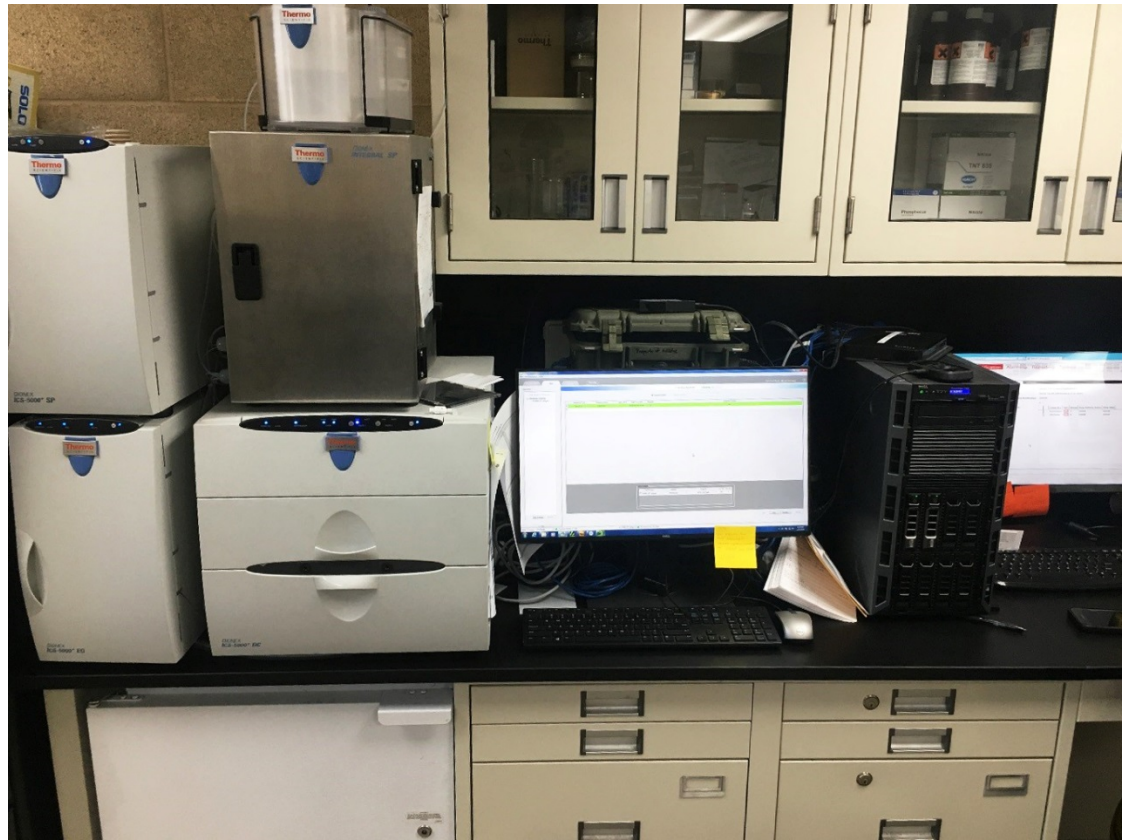
The FXB system equipped with an in-line ion chromatograph (IC), which samples for perchlorate in the biofilter effluent approximately every 30 minutes and exports data to the FXB system

programmable logic controller (Figure 13). High perchlorate alarms ( $\geq 2.9$  ppb) triggered at the PLC based on IC data trigger an immediate shutdown of the FXB system.

Figure 13 Ion Chromatograph

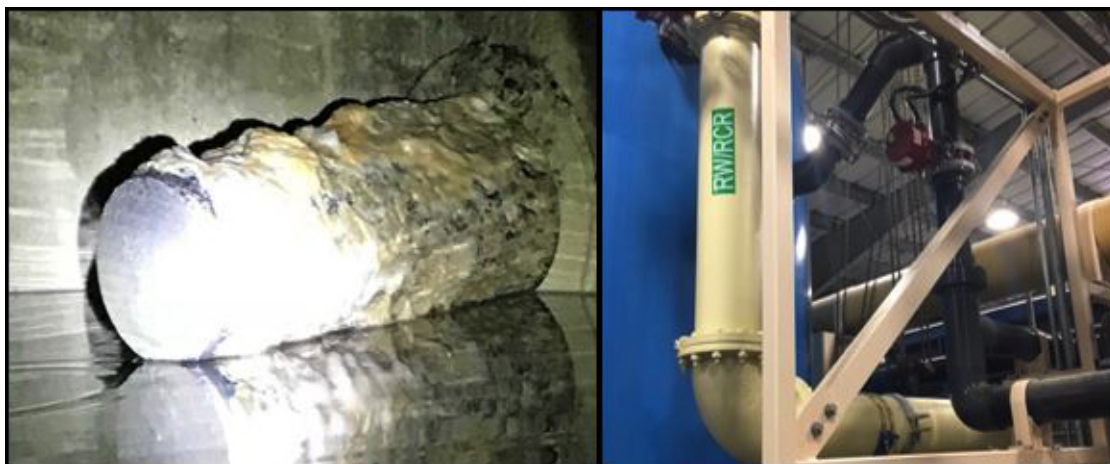
The treatment vessel draindown connections were designed with a screen insert that served as a nucleation surface for biomass growth which negatively impacted backwash performance

(Figure 12; left). In March 2018, the vessel draindown connects were modified to eliminate the biofouling issue. The screen insert was removed and replaced with 45° upturn elbows to prevent media washout during a backwash (Figure 20; right).

Figure 20 Vessel Draindown Modifications

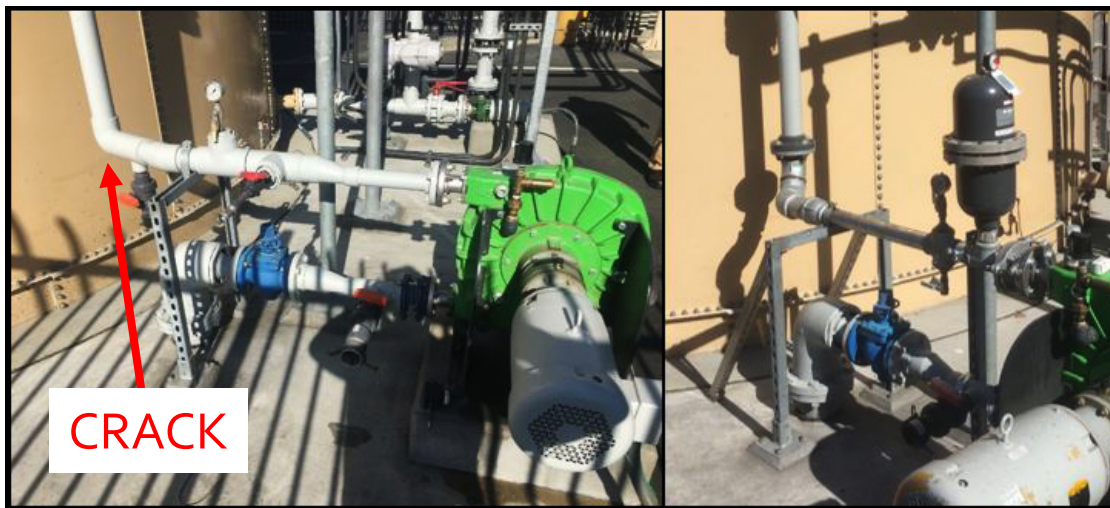
Vibration of the peristaltic sludge pump caused shaking in the connecting pipe which led to a crack (Figure 21; left). To address this, bellow joints and kickers were installed on both the suction and discharge of the pump and the discharge piping was rebuilt with galvanized steel incorporating 2, 45° elbows (Figure 21; right). Furthermore, a 2" flex coupling and pulsation dampener were installed on the discharging piping. The changes abated the shaking even when the peristaltic sludge pump was operating at 100 percent speed.

Figure 21 Sludge Pump Modifications
