Fatigue of two oxide/oxide ceramic matrix  
composites at 1200°C in air and in steam. Effect  
of diamond-drilled effusion holes.

THESIS

Anthony Robert Cabri, 2d Lt, USAF  
AFIT-ENY-MS-21-M-291

**AIR FORCE INSTITUTE OF TECHNOLOGY**

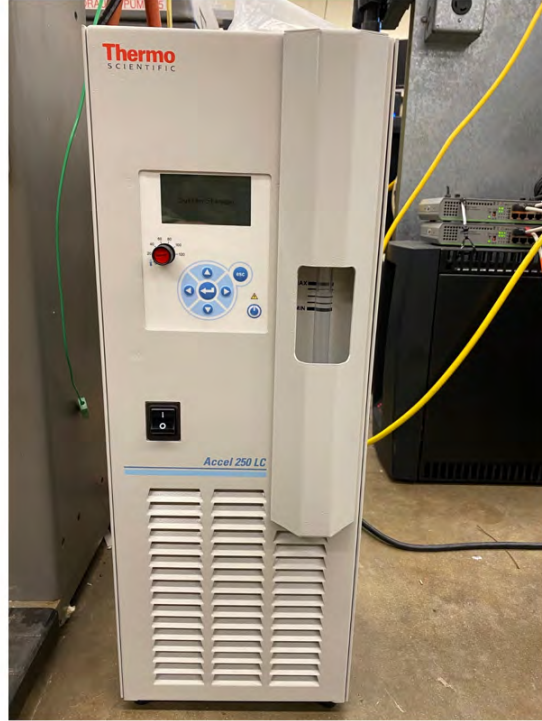
**Figure 12. Thermo Scientific Accel 250 LC, Chiller used to regulate grip temperature**

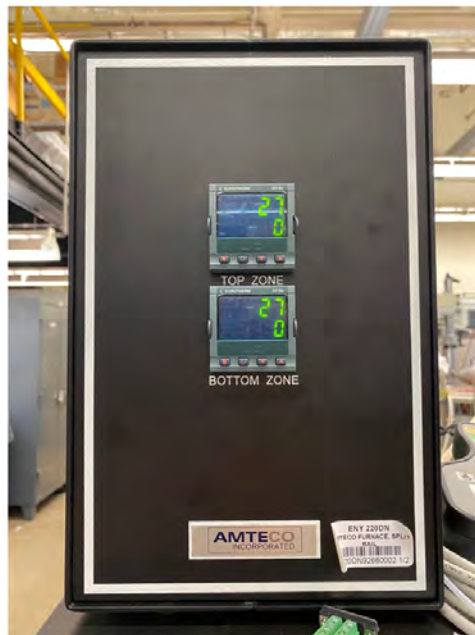
Figure 14. AMTECO Two-Zone temperature controller

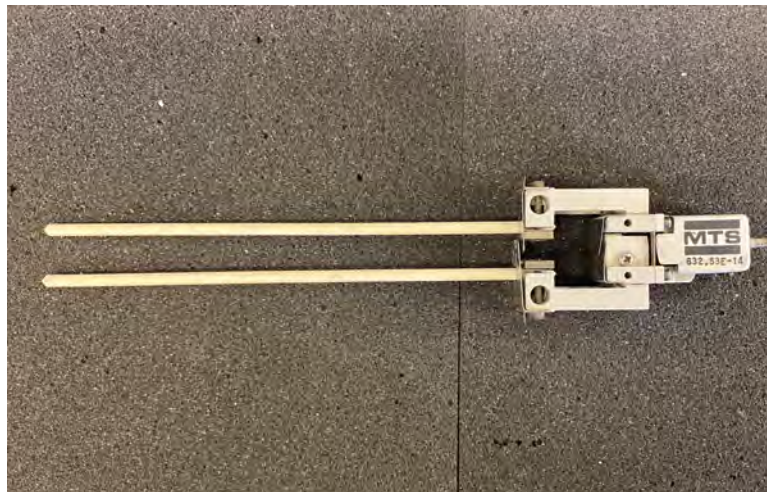
Figure 17. Low-contact force high-temperature MTS extensometer used to measure strain

An MTS low-contact force high-temperature extensometer Model 632.53E-14 (Figure 17) was used to measure strain in all tests.

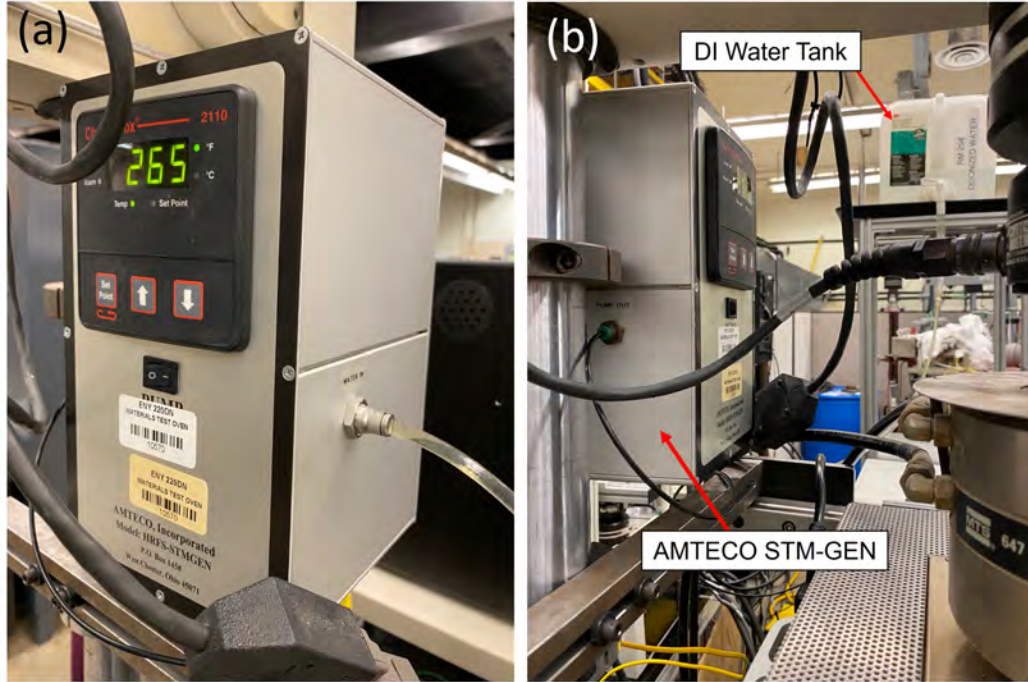
**Figure 18. (a) AMTECO HRFS-STMGEN, Steam Generator/Pump, with Chromalox 2110 Temperature Controller, (b) Steam Generator with DI Water Holding Tank and feed tube**

For testing in steam, an AMTECO HRFS-STMGEN steam generator with a Chromalox 2110 temperature controller and deionized water were used to generate steam delivered to the susceptor via the feeding tube. Figure 18 shows the AMTECO steam generator.

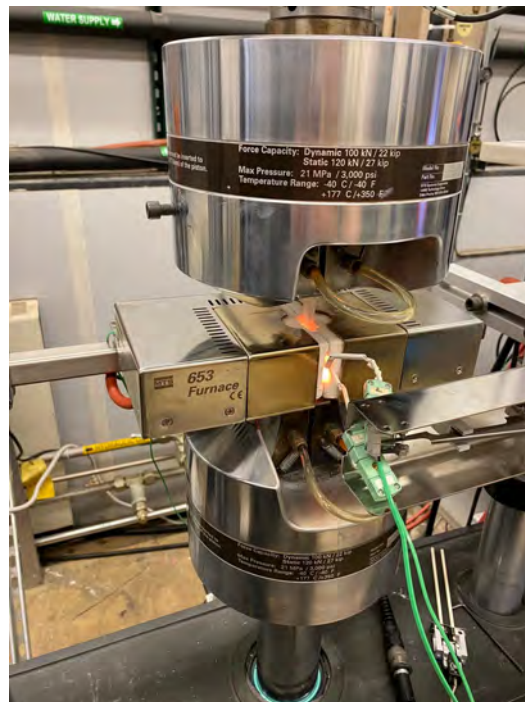
Figure 20. MTS 653 Furnace

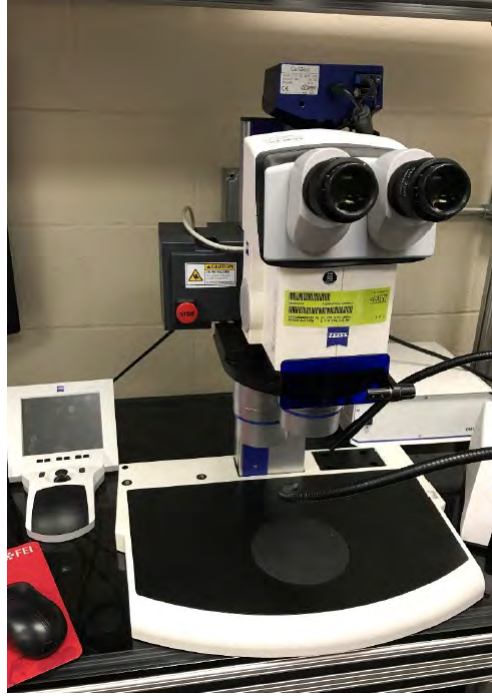
Figure 21. ZEISS Optical Microscope

All tested specimens were examined with the ZEISS SteREO Discovery.V12 optical microscope (Figure 21) equipped with an AxioCamHRc digital camera and Axio-Vision (Version 4.8) software.

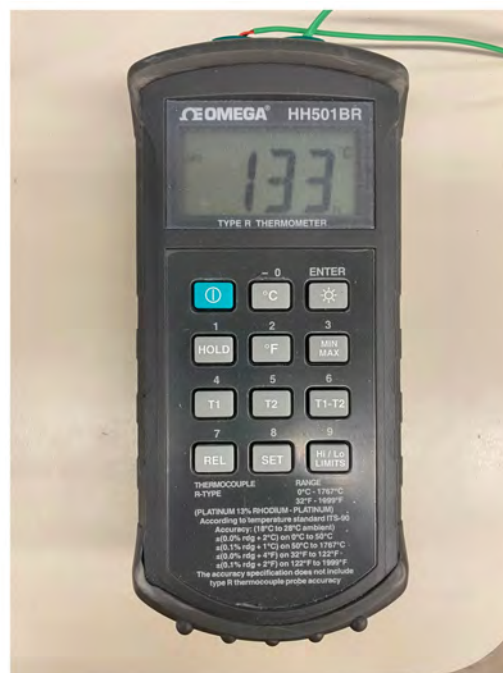
Figure 29. Omega HH501BR Thermometer used in AMTECO furnace temperature calibration

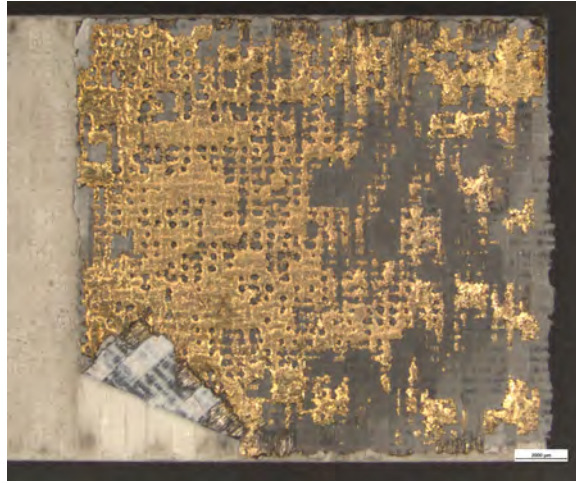
**Figure 45. Top section of brazed joint**

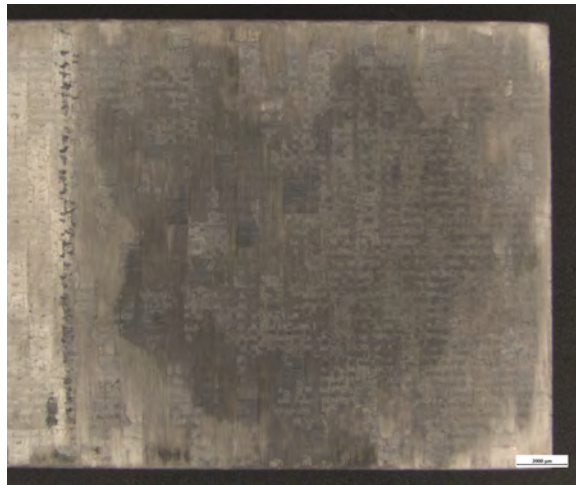
**Figure 46. Bottom section of brazed joint**

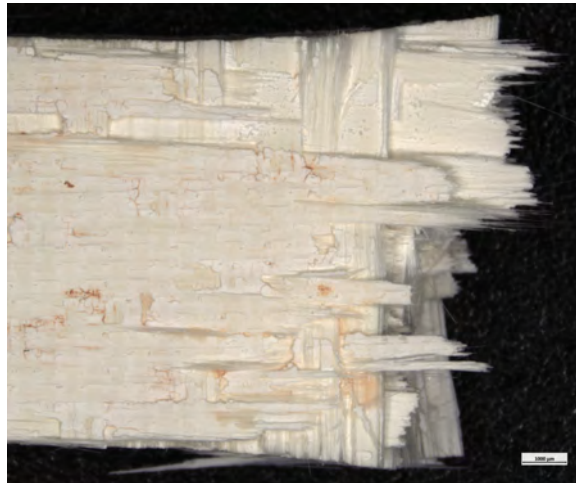
Figure 62. Optical micrograph of a N720/AM specimen fracture surface tested in tension-tension fatigue at 1200°C in air.  $\sigma_{\max} = 130$  MPa,  $N_f > 100,000$
