REPORT NO. RL3-57

Test on Model GP-3 Transmitting Equipment

Manufactured by Westinghouse Electric and Manufacturing Company

Report on  
Test on Model GP-3 Transmitting Equipment

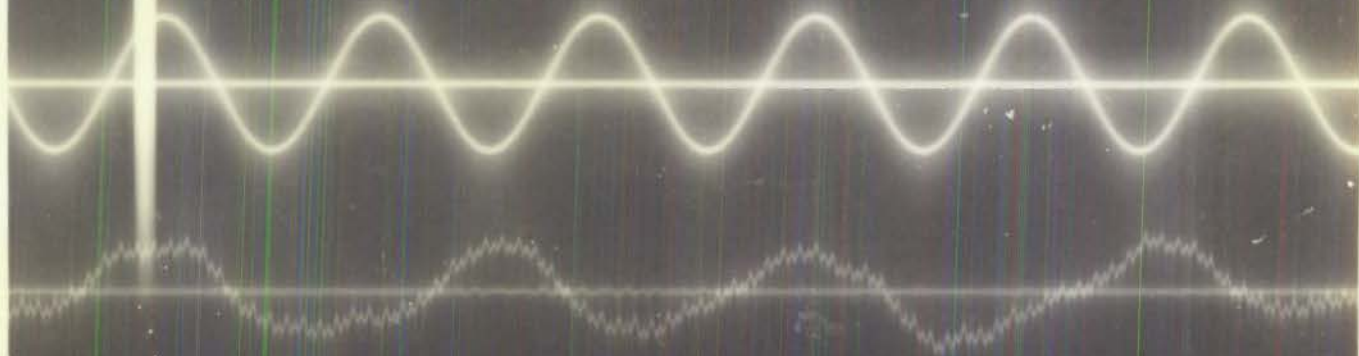
FILM 4A

LOW VOLTAGE RECTIFIER  
FULL POWER CW RECTIFIER RIPPLE

$$\frac{0.2 \text{ CM.} \times \frac{1}{2} \times 2.5 \text{ VOLTS/CM.}}{490} \times 100 = 0.05\%$$

- 3-36. Ripple measurements were made from oscillographic records. These records are shown on Plates 9 to 11. Calculating the ripple percentage it is found that the low voltage rectifier has very little ripple while the high voltage rectifier has only 0.18% ripple which is well within the specified 1%.

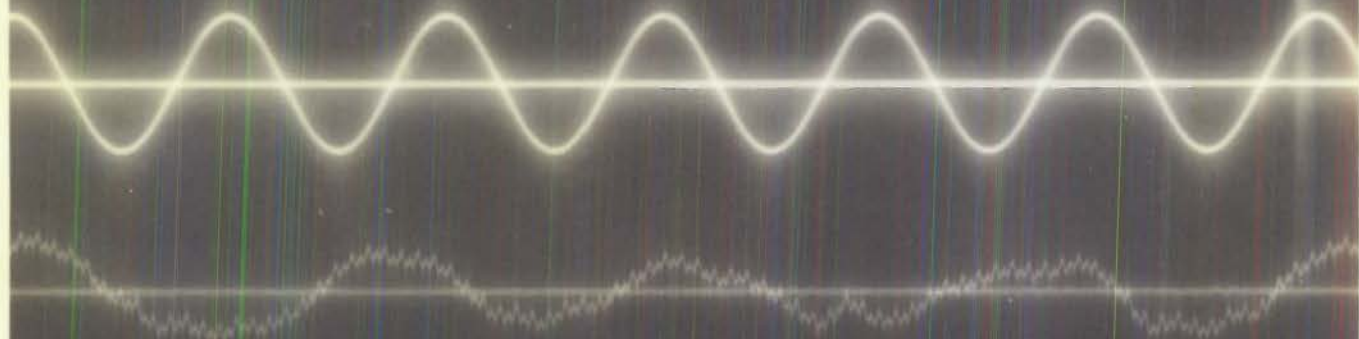
FILM 4B

PHONE POSITION RECTIFIER RIPPLE

$$\frac{0.2 \text{ CM.} \times \frac{1}{2} \times 2.5 \text{ VOLTS/CM.}}{490} \times 100 = 0.05\%$$

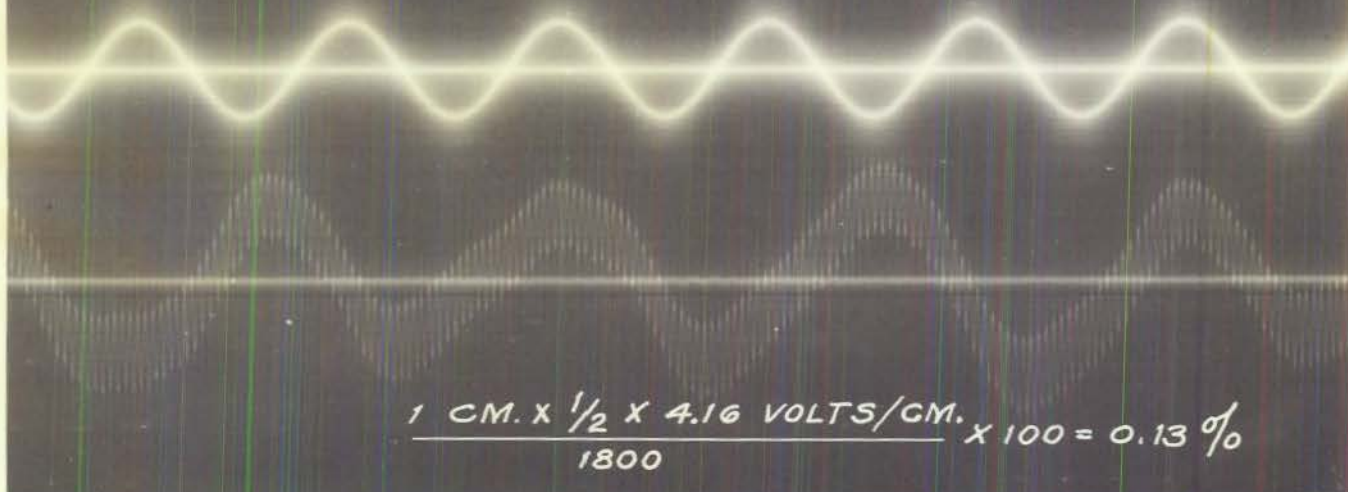
FILM 2A. PHONE POSITION RECTIFIER RIPPLE

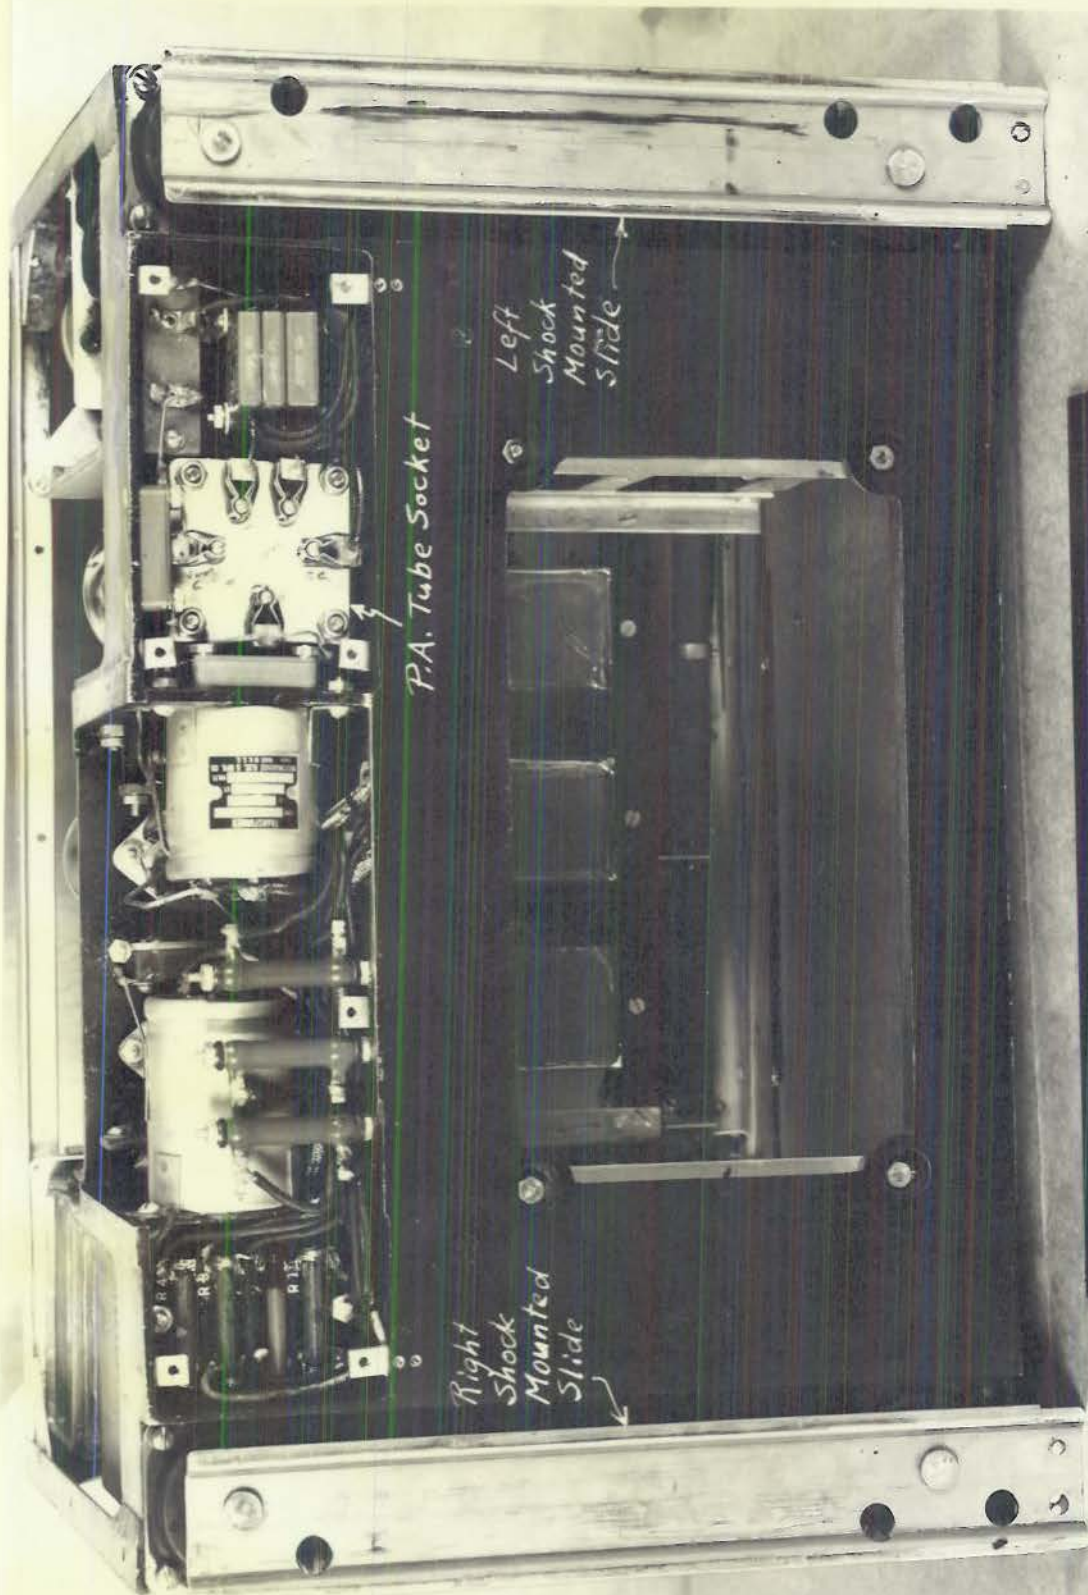
ENCLOSURE (L)

Preliminary Model GP-3 Equip- AN-34889 2-3-37 OFFICIAL NAVY PHOTOGRAPH  
ment; Left Side View into Transmitter-Rectifier Unit. NOT TO BE USED FOR PUBLICATION

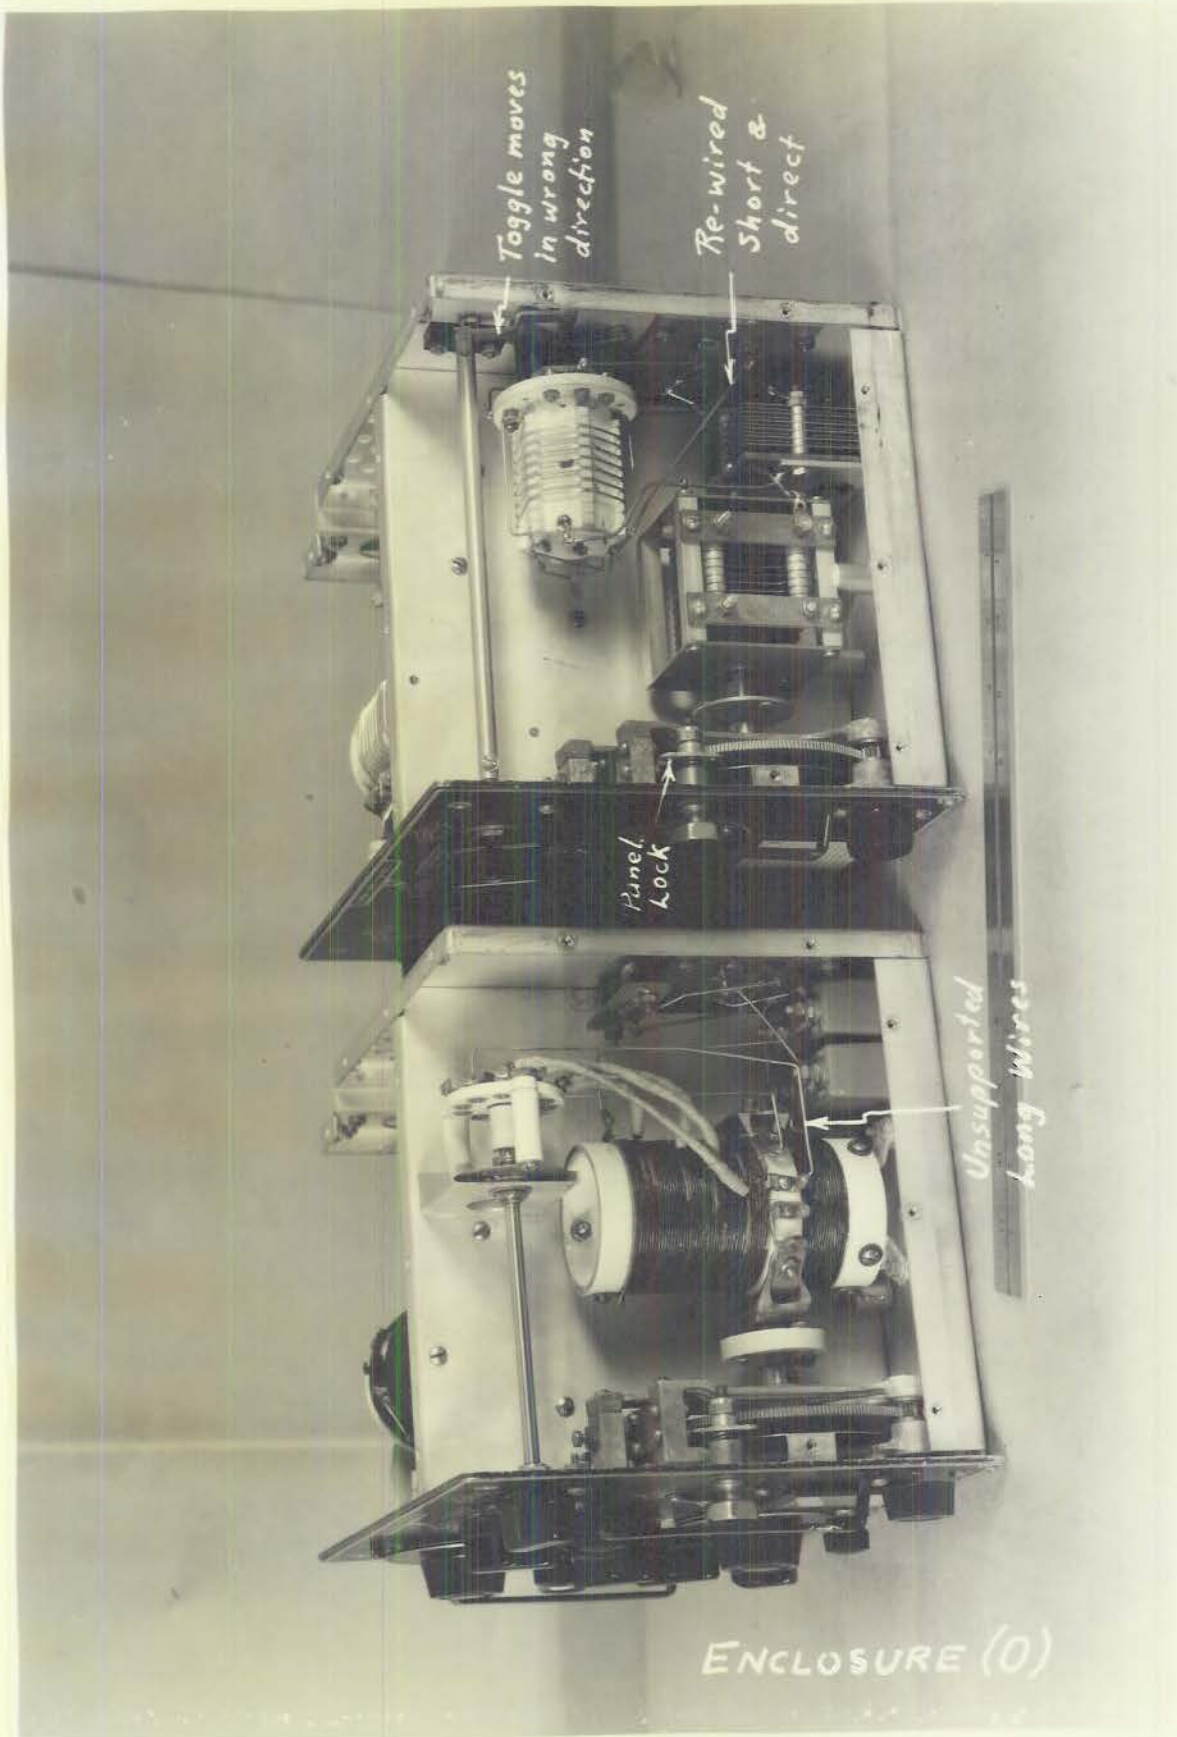
Preliminary Model GP-3 Equip- AN-34891 2-3-37 OFFICIAL NAVY PHOTOGRAPH  
ment; Tuning Units "A" and "F", with outer shields NOT TO BE USED FOR PUBLICATION  
removed.
