Acquisition Directorate

Research & Development Center

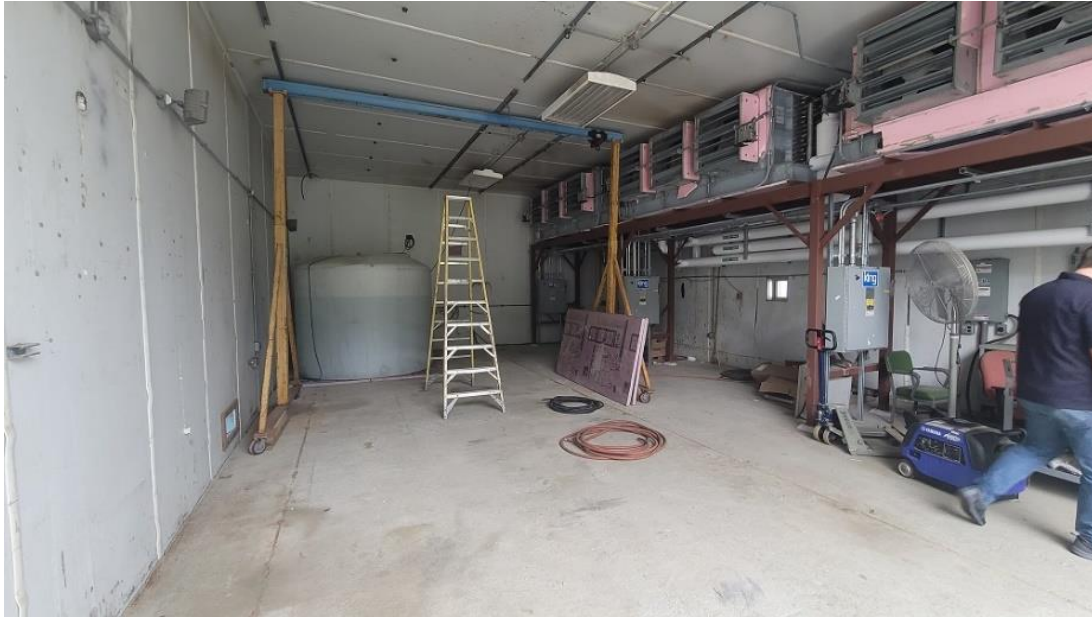
Figure 5. Interior view, CRREL Materiel Evaluation Facility.

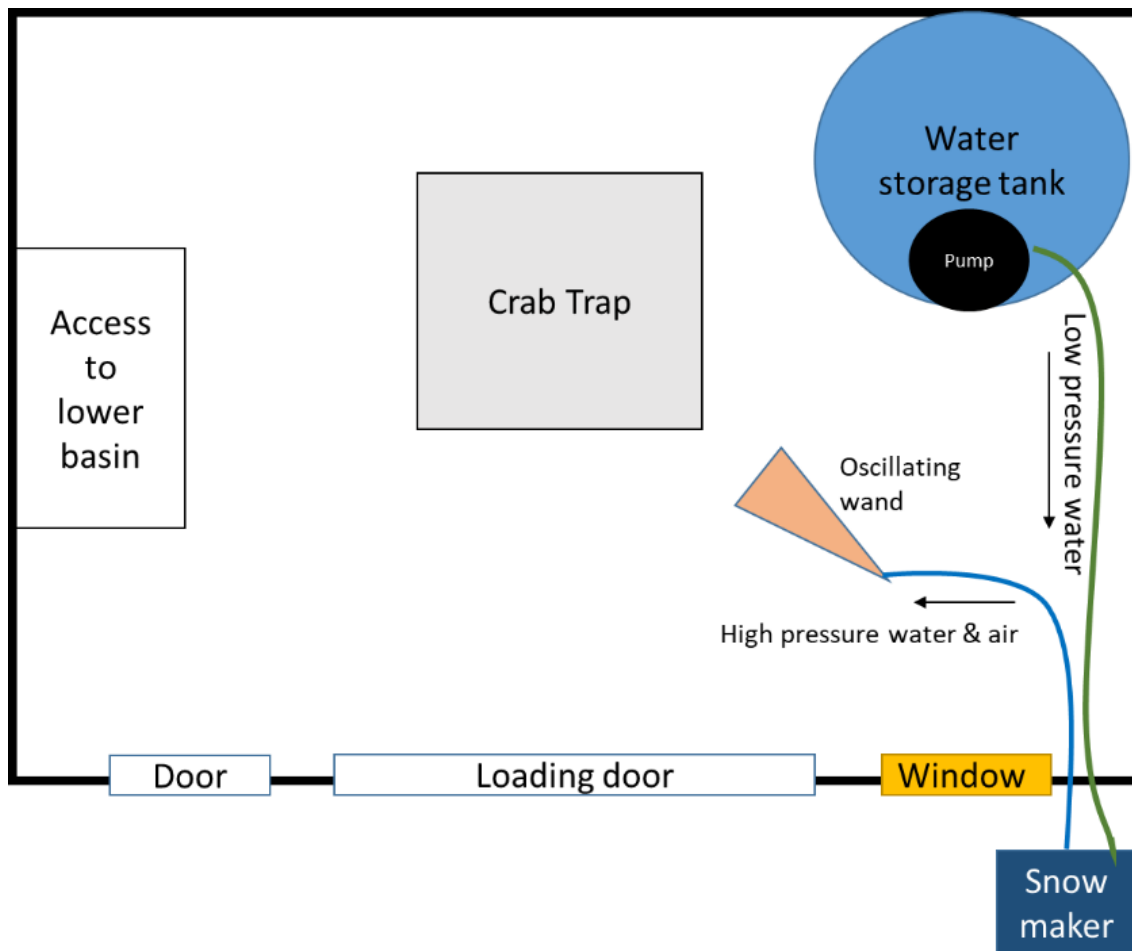
Figure 8. Schematic layout of the Cold-Pit for testing.

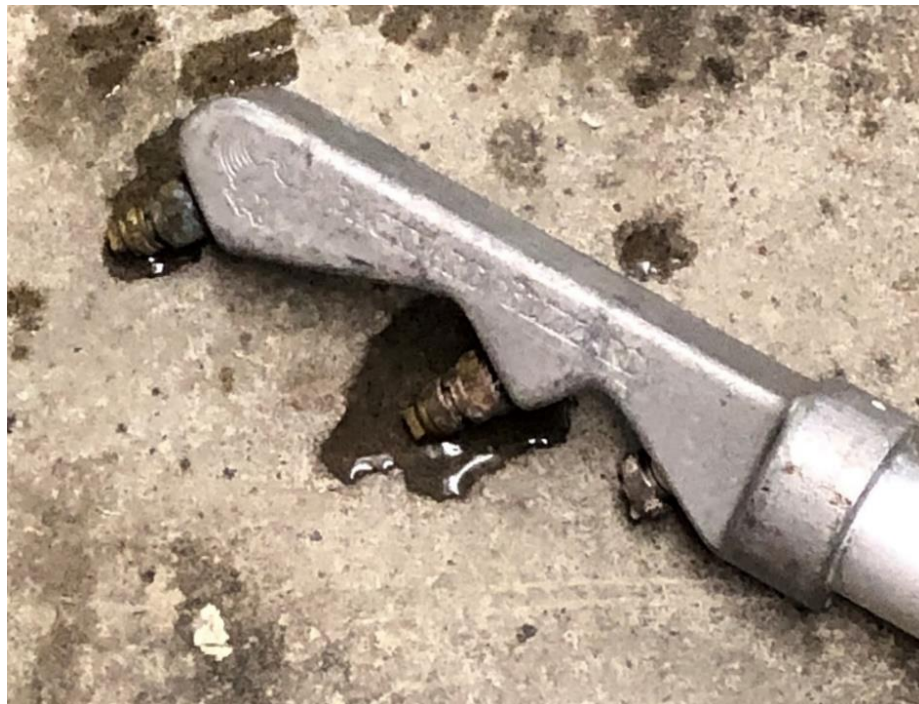
Figure 11. Snow-maker spray wand nozzle head thawing after 20 minutes of use.

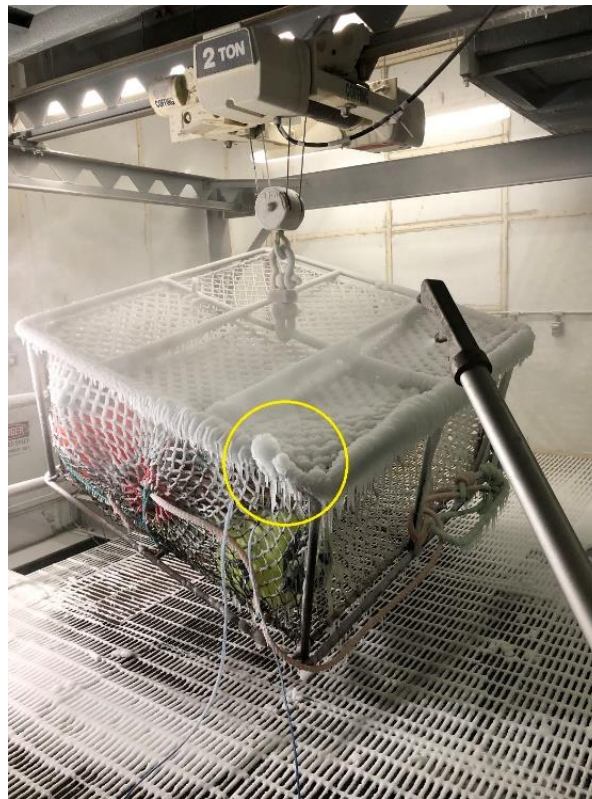
Figure 12. Crab pot in second trial run, highlighting obscured investigator's scale.

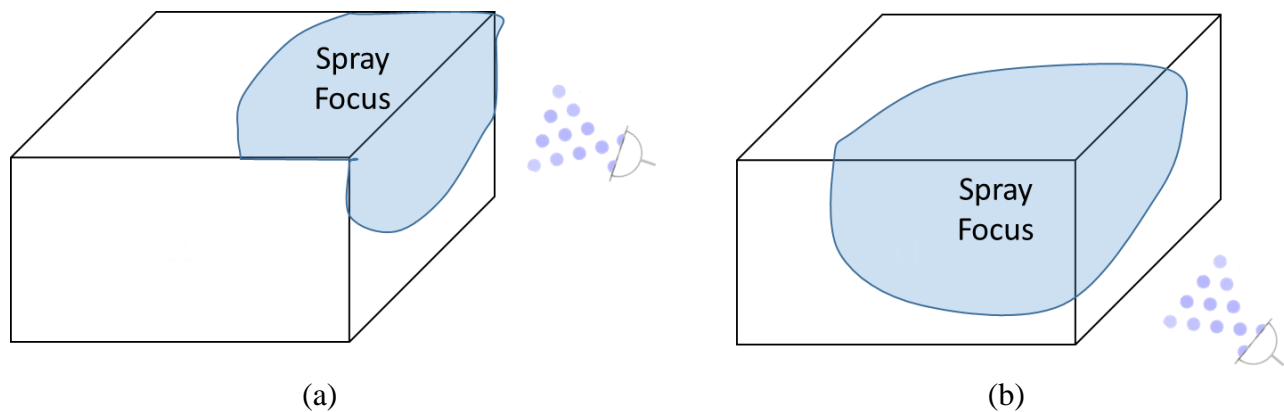
Figure 13. Focus areas for oscillating spray (a) perpendicular to side of pot and (b) centered on pot corner.

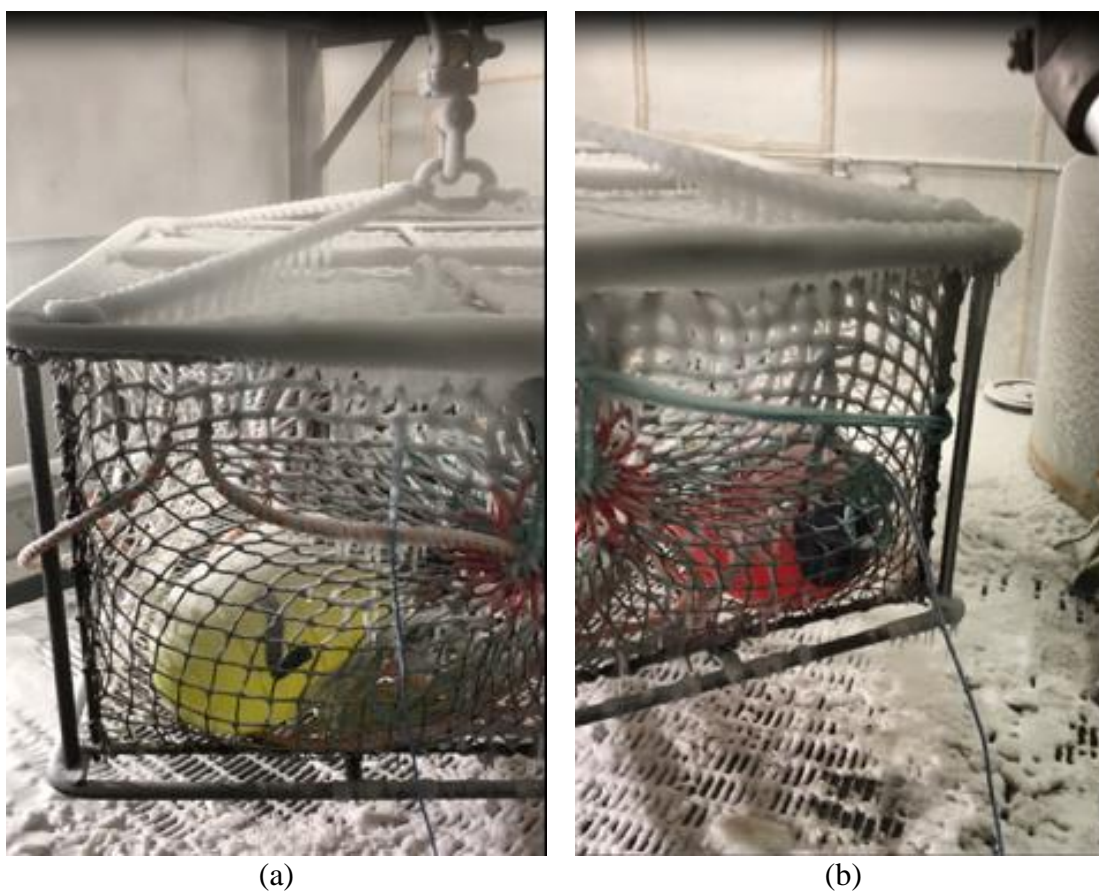
Figure 21. Test 1: (a) left half of pot side facing spray (b) right half of pot side facing spray.

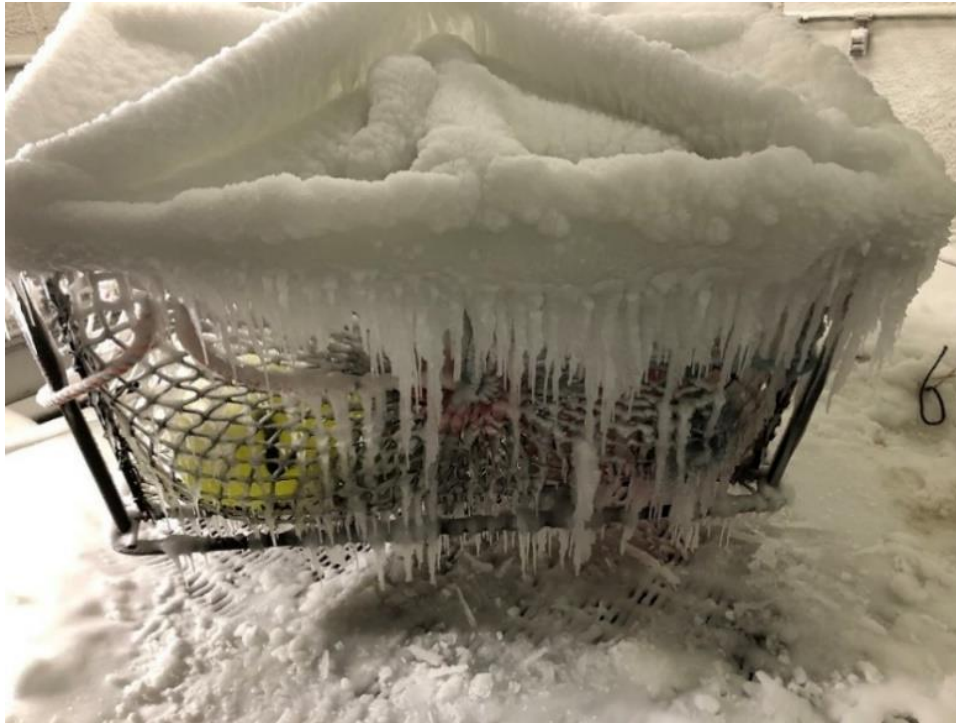
Figure 22. Test 1: Heavy accretion on top frame, mesh, and bridle.

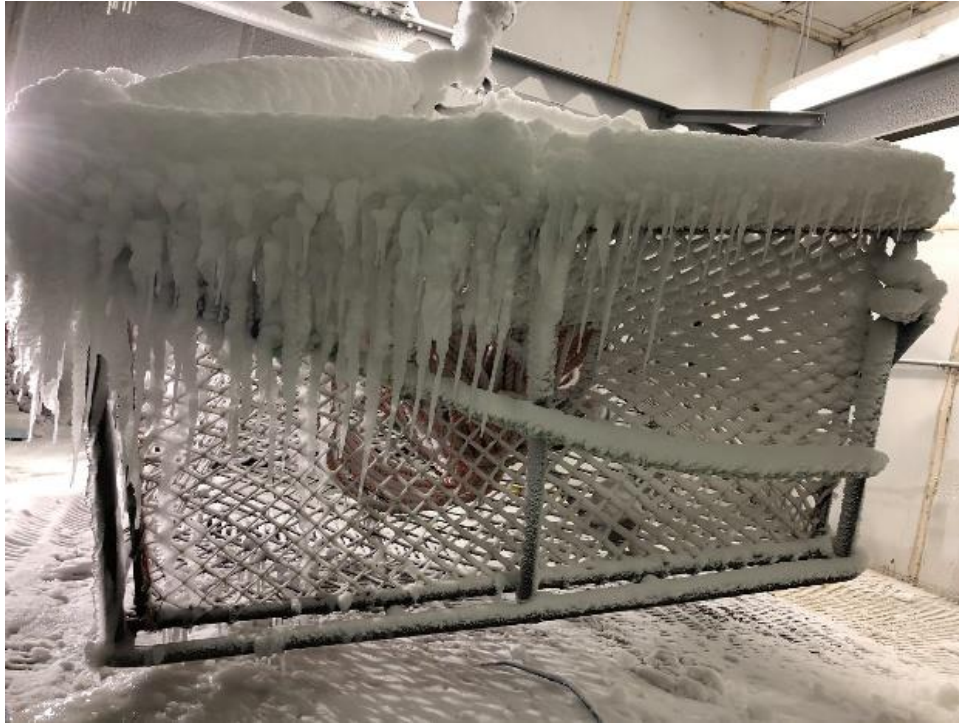
Figure 23. Test 2 ice accretion at end of spraying.

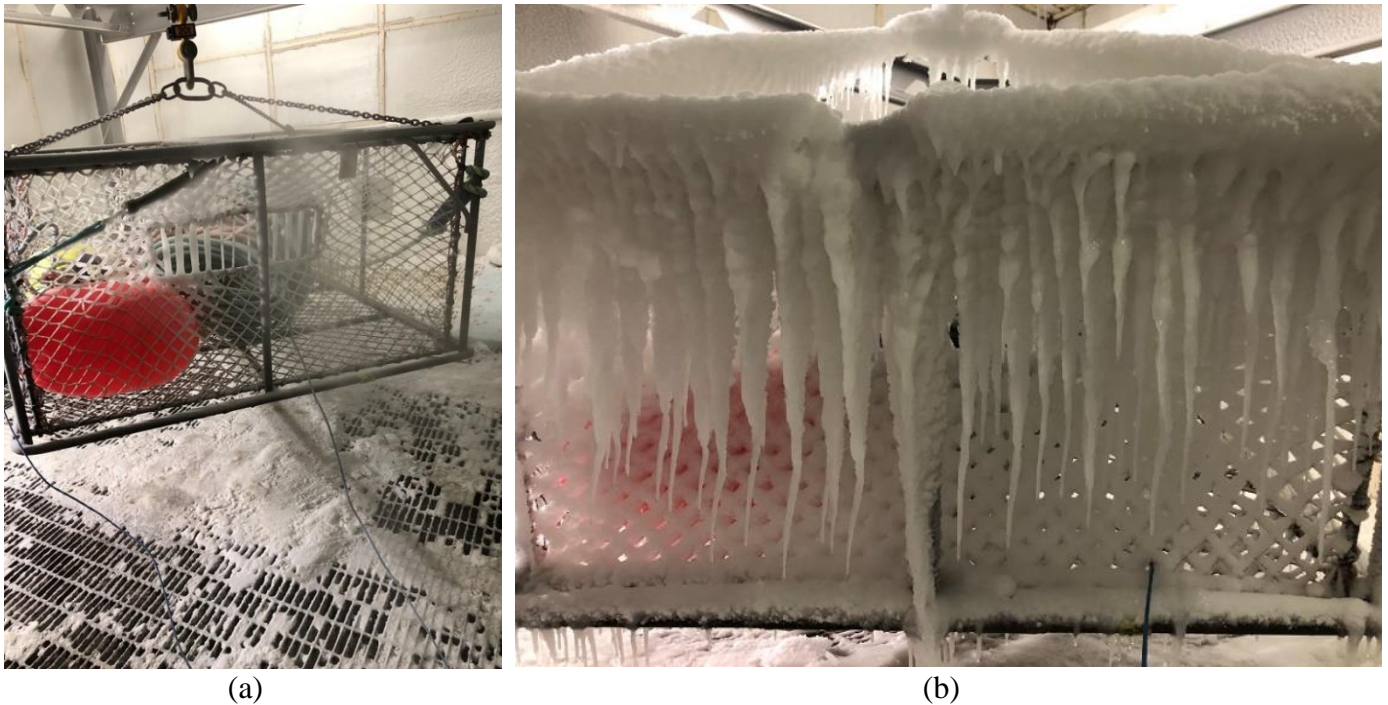
Figure 24. Test 3 (a) spray targeted more toward pot side rather than pot side, top edge, and (b) resulting heavy increase in icicles on side.

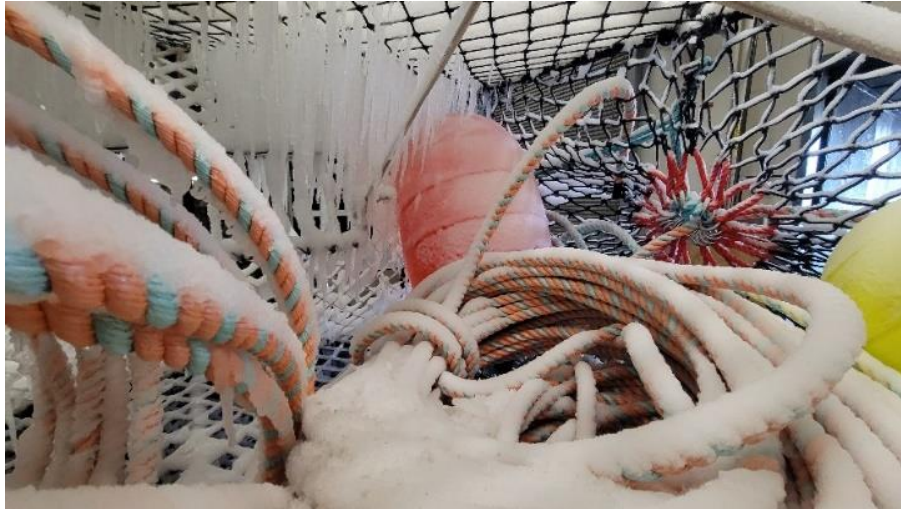
Figure 25. Test 4: Interior of top pot showing icicles and minimal accretion.

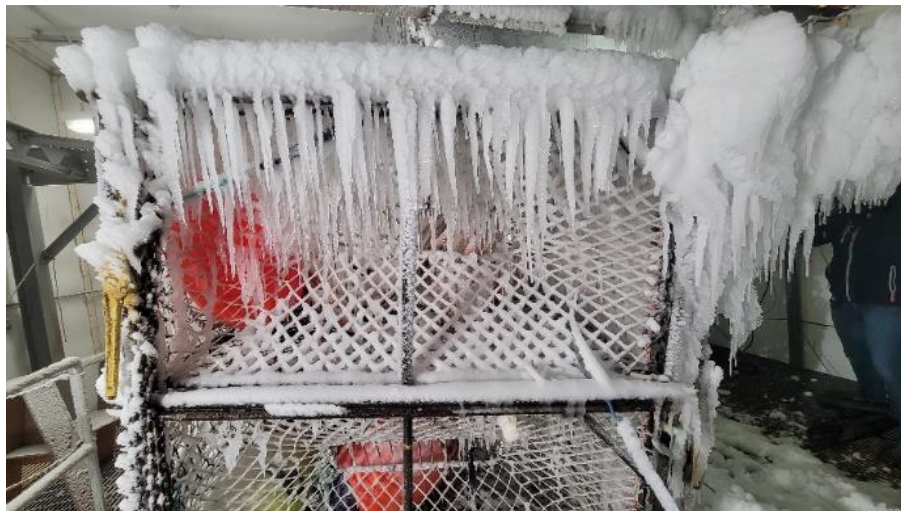
Figure 26. Test 4: Ice accumulation on top bar with large protrusion from the spray-facing corner.

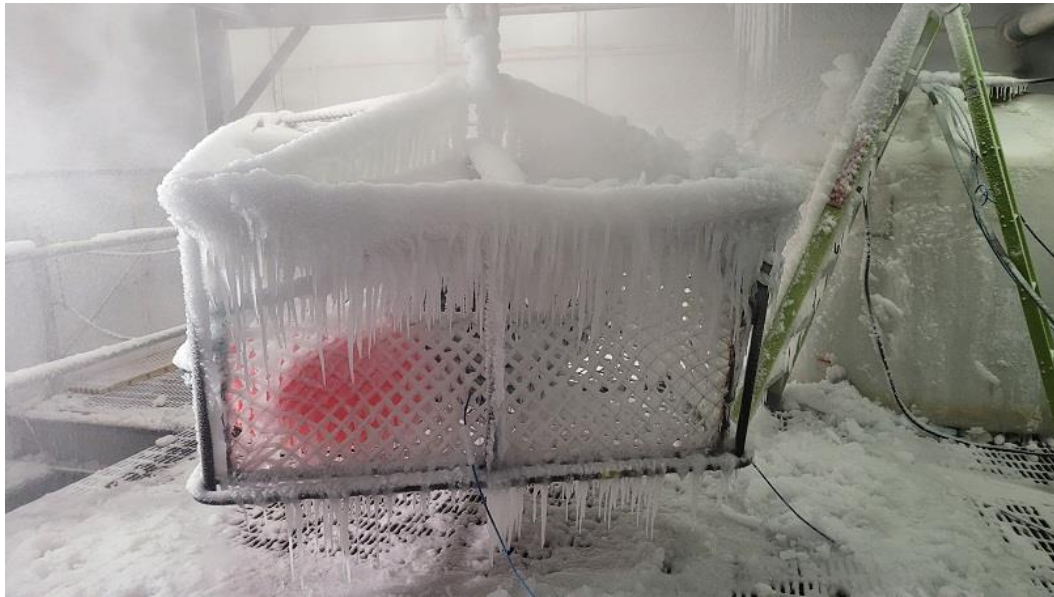
Figure 27. Test 5: Heavy ice accretion on top frame, mesh, and chain bridle, but very little inside.

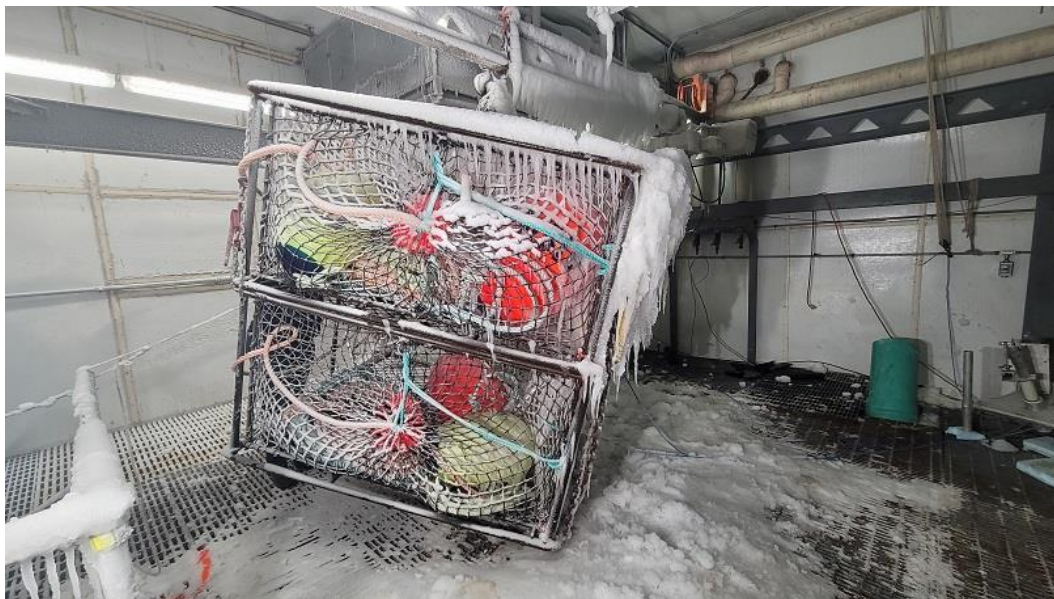
Figure 30. Test 6: Side of two-pot stack showing minimal accretion on mesh, both pots.

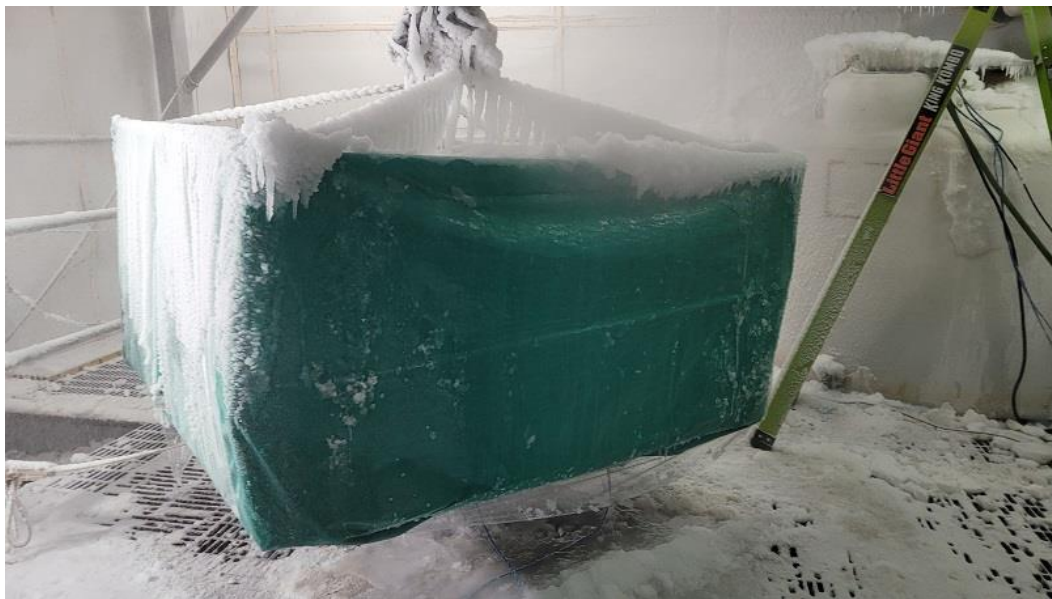
Figure 31. Test 7: Tarped crab pot, minimal to no ice accretion on side faces, but ice accretion on chain bridle and lip of tarp at top frame bar.

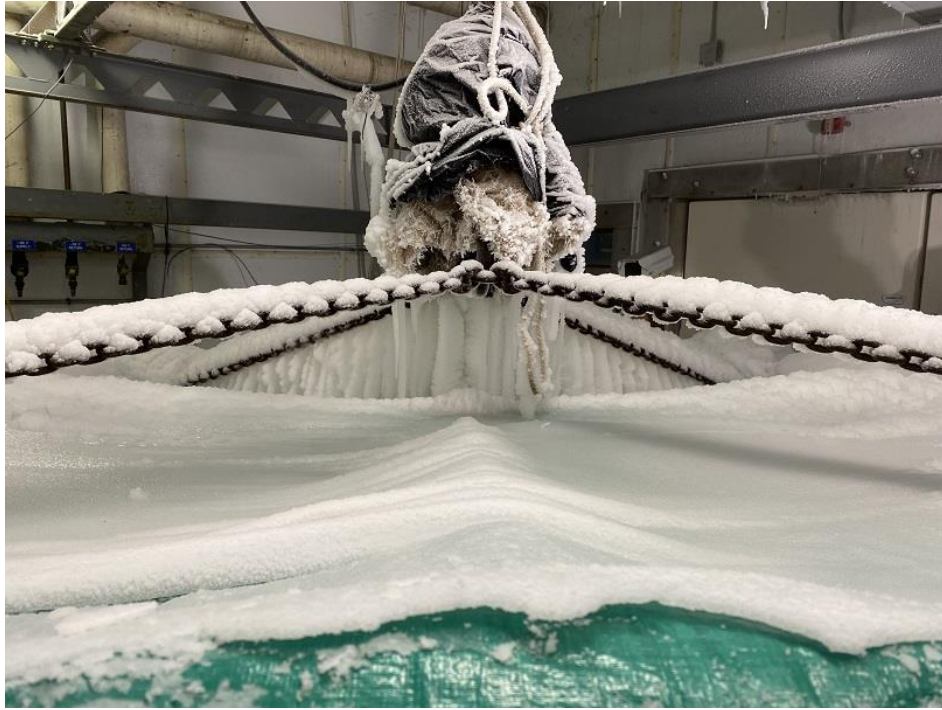
Figure 32. Test 7: View along top of tarped pot showing layer of ice on the tarp over frame and mesh areas.

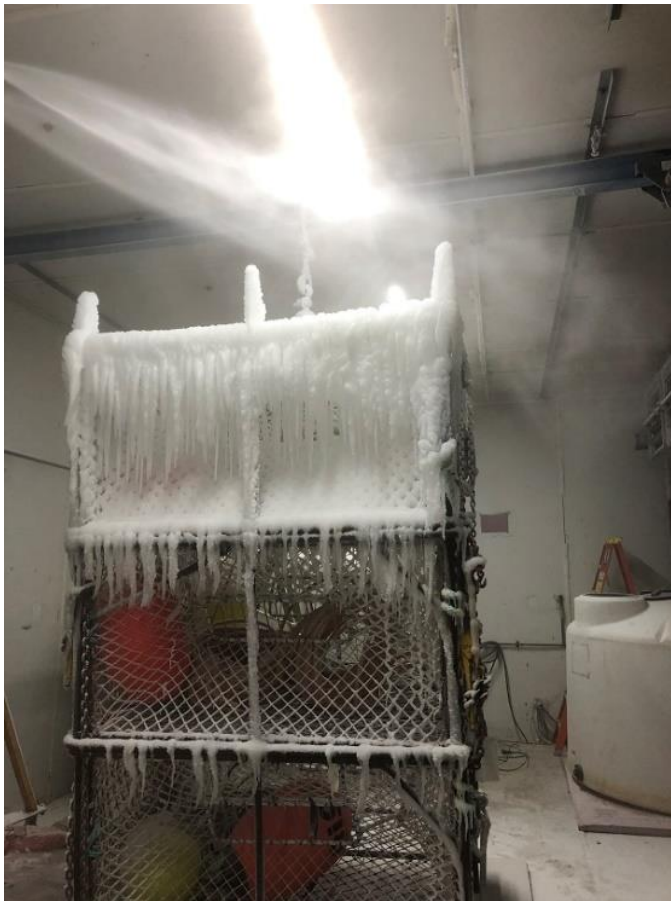
End conditions: Total spray time 2 hr 38 min, water temperature 29.8°F, air temperature -6.3°F, final weight 2,805 pounds (845 pounds of accretion).

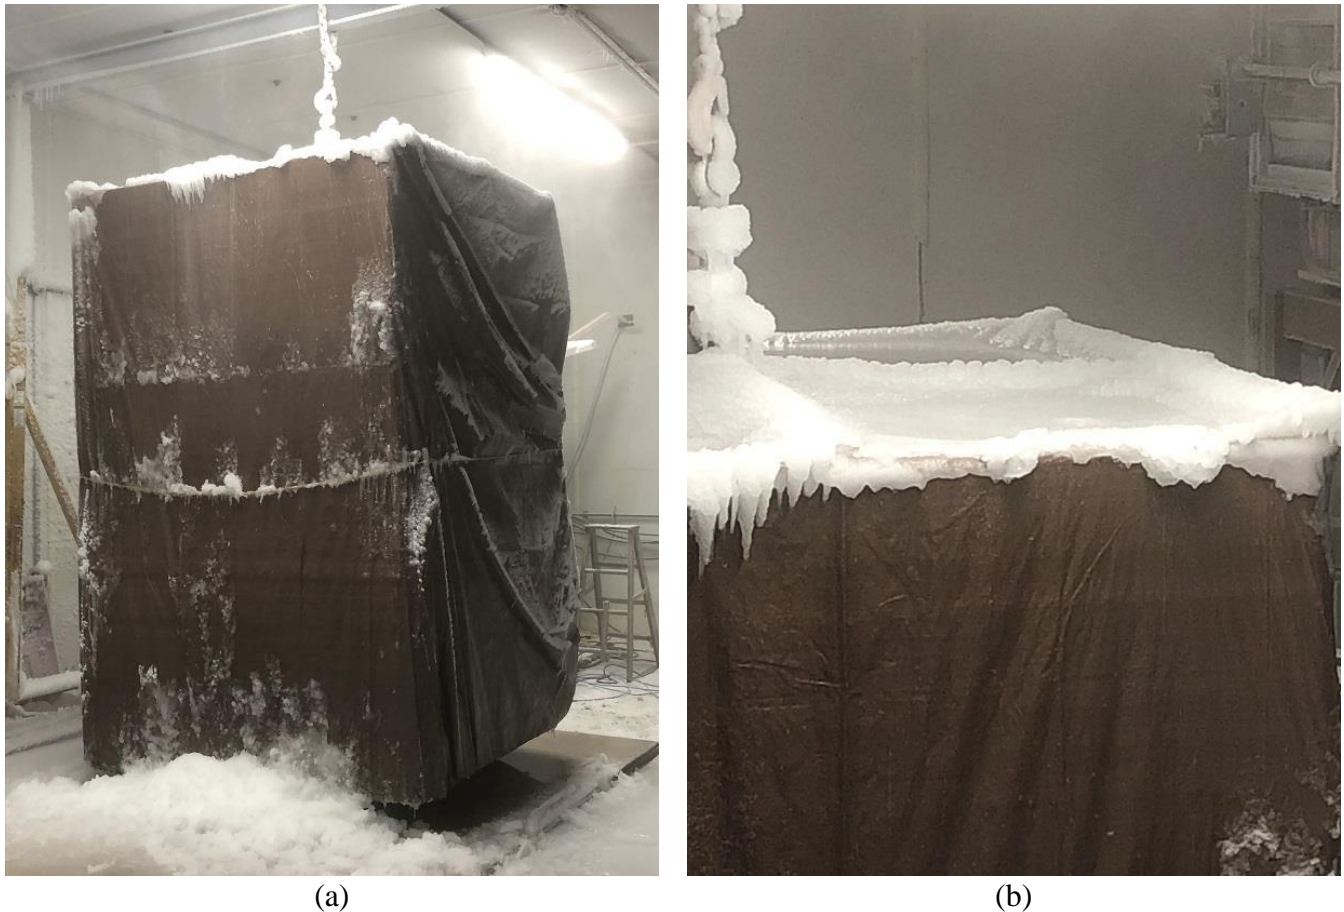
Figure 35. Test 9: (a) facing side of tarped stack with “clean” break in ice at top left and pile of ice and slush accumulation on pan, and (b) close-up view of pooled ice and slush atop the stack.

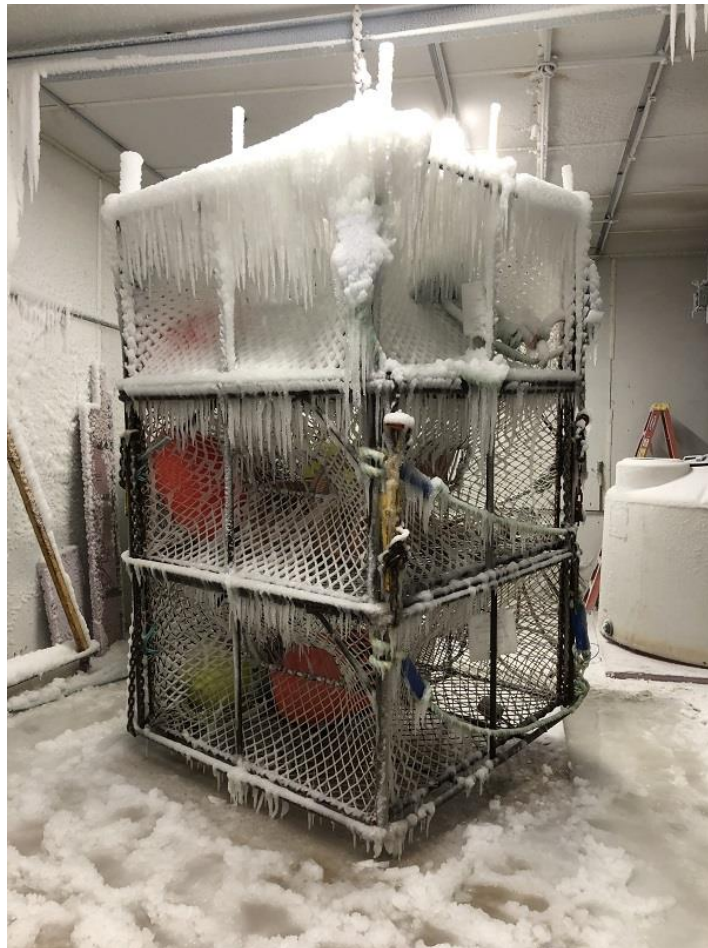
Figure 37. Test 10: Three-pot stack at the end of spraying.

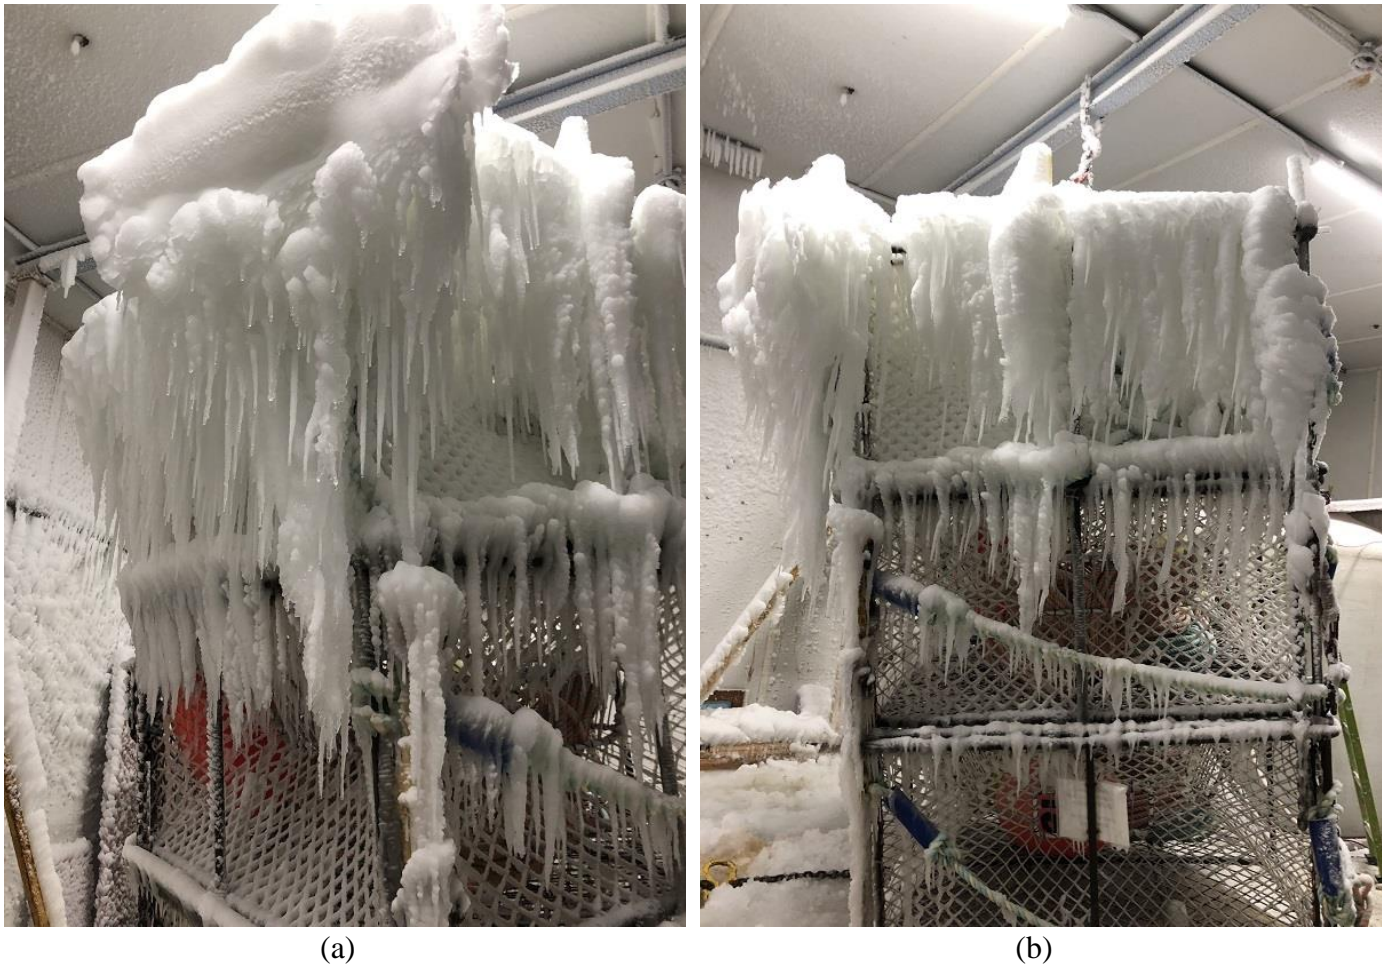
Figure 40. Test 11: At completion of spraying (a) left side facing sprayer and (b) right side facing sprayer.

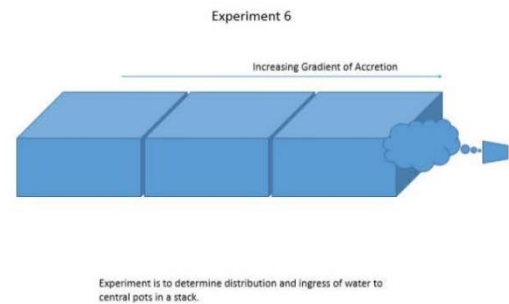
H. Record all tests with time-lapse video from a point near the water spray source and at 90 degrees to the source. Record continuous strain gauge measurements for tests one and two. Weigh the individual pots in tests three, four, five and six hourly (or time increments based on accretion rates determined in tests one and two). Include measurements of ice thickness using pre-positioned investigator's reference scale which is being documented with videos and photos. While the request is for hourly measurements, depending on the rate of ice accretion, the frequency of observations could change.

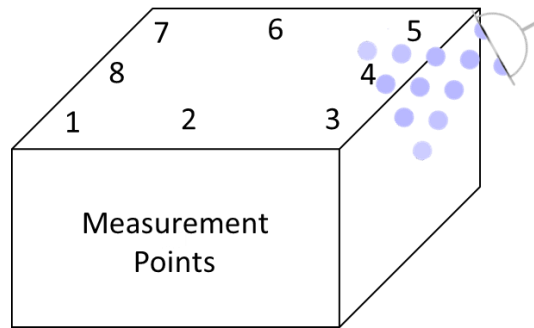
Figure C-1. Example key to ice thickness measurements.
