NRL Report No. R-1503  
BuEng.Prob. F3-12

Report of Test  
of  
Model LD-4 Frequency Measuring Equipment  
(Third Model)  
submitted by the  
Bendix Radio Corporation.

NAVAL RESEARCH LABORATORY  
ANACOSTIA STATION  
WASHINGTON, D.C.

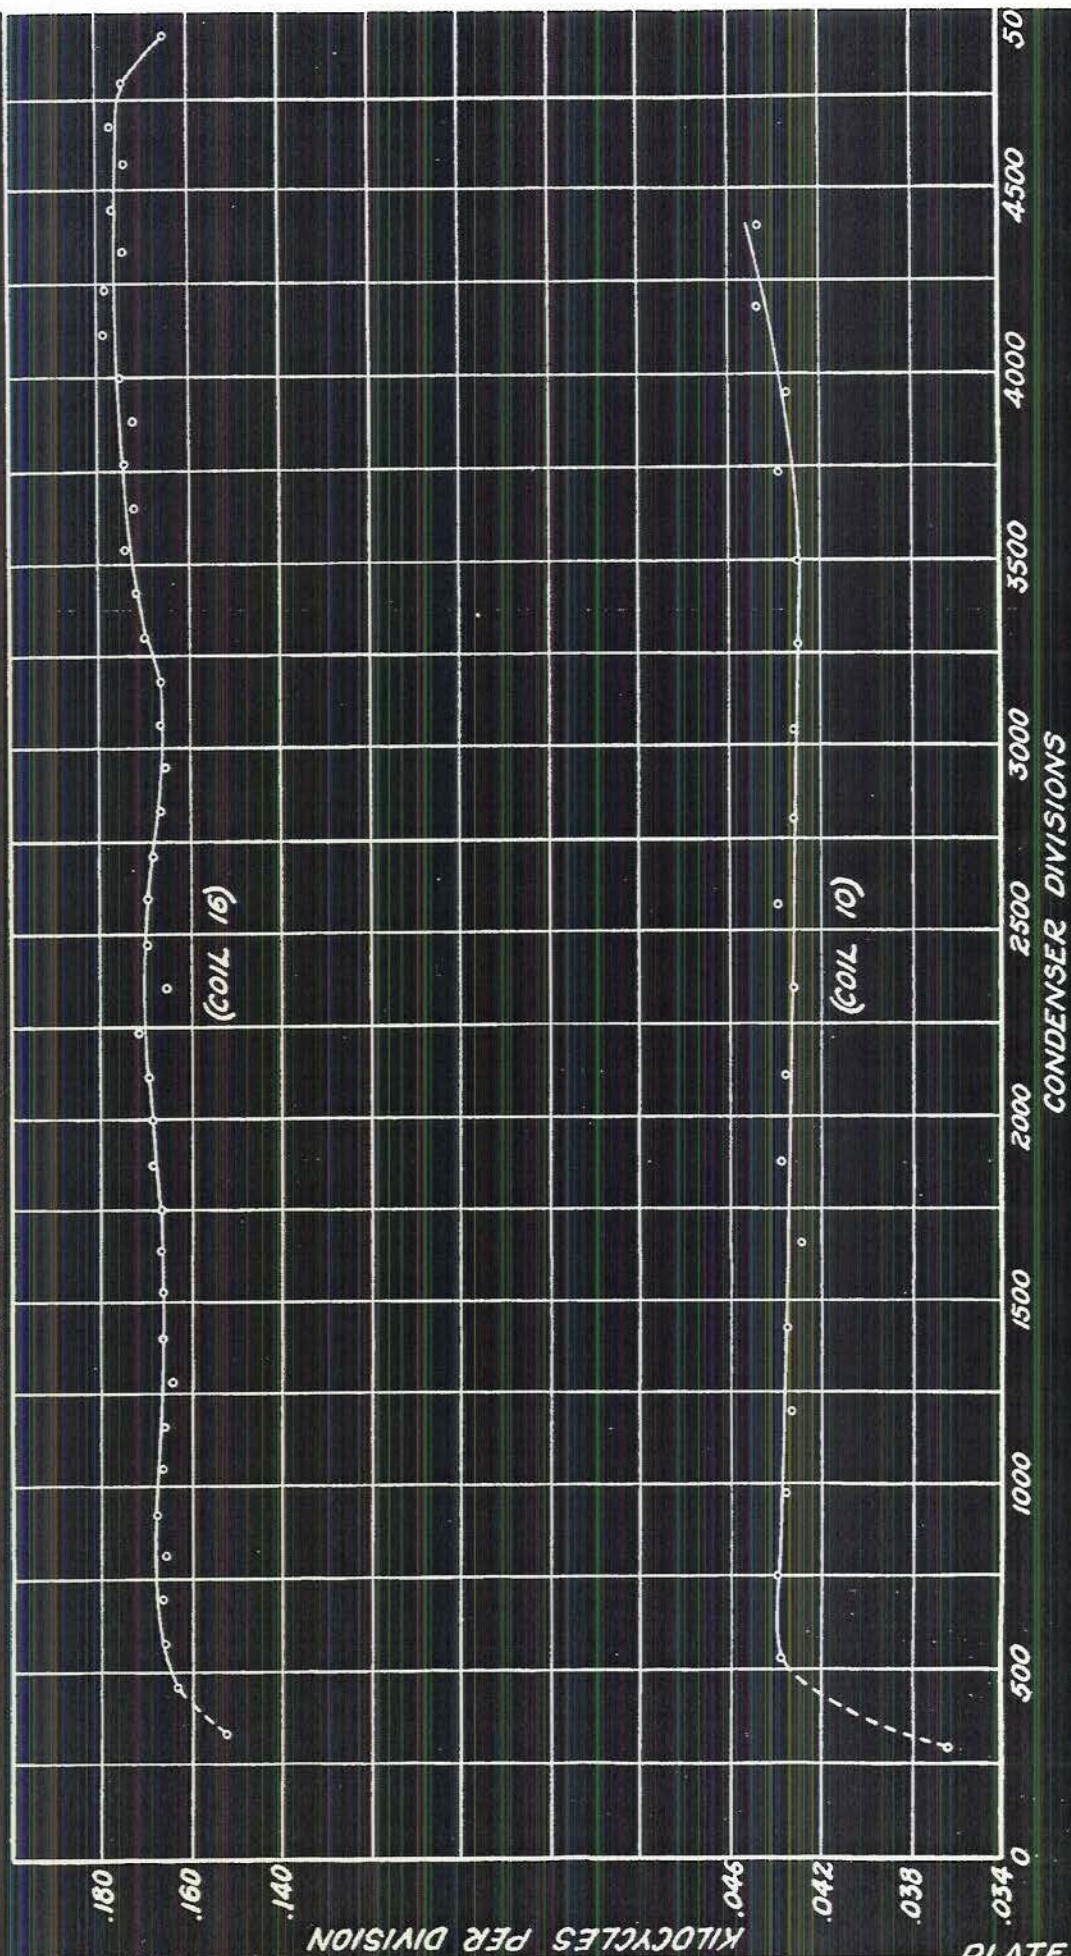
LD-4 HET. FREQ. METER (THIRD MODEL)  
 KC/DIV CURVE FOR COILS 10 AND 16  
 COIL 10 = 700 TO 885 KC.  
 COIL 16 = 2590 TO 3270 KC.

- 4-9. The calibration curve of the heterodyne frequency meter is essentially linear over the used portion of the frequency bands. The change in frequency per division change in setting along the condenser scale is quite uniform between 400 and 4800 divisions as shown by the kilocycles per division curves for coils 10 and 16 on Plate 1. The improvement from the previous model in this respect may be noted by comparing Plate 6 of reference (e) with Plate 1 herein. This improved condenser characteristic resulting from a redesign of the tuning condenser plates minimizes the error in interpolation along the condenser scale. See comment on paragraph 4-13 below.

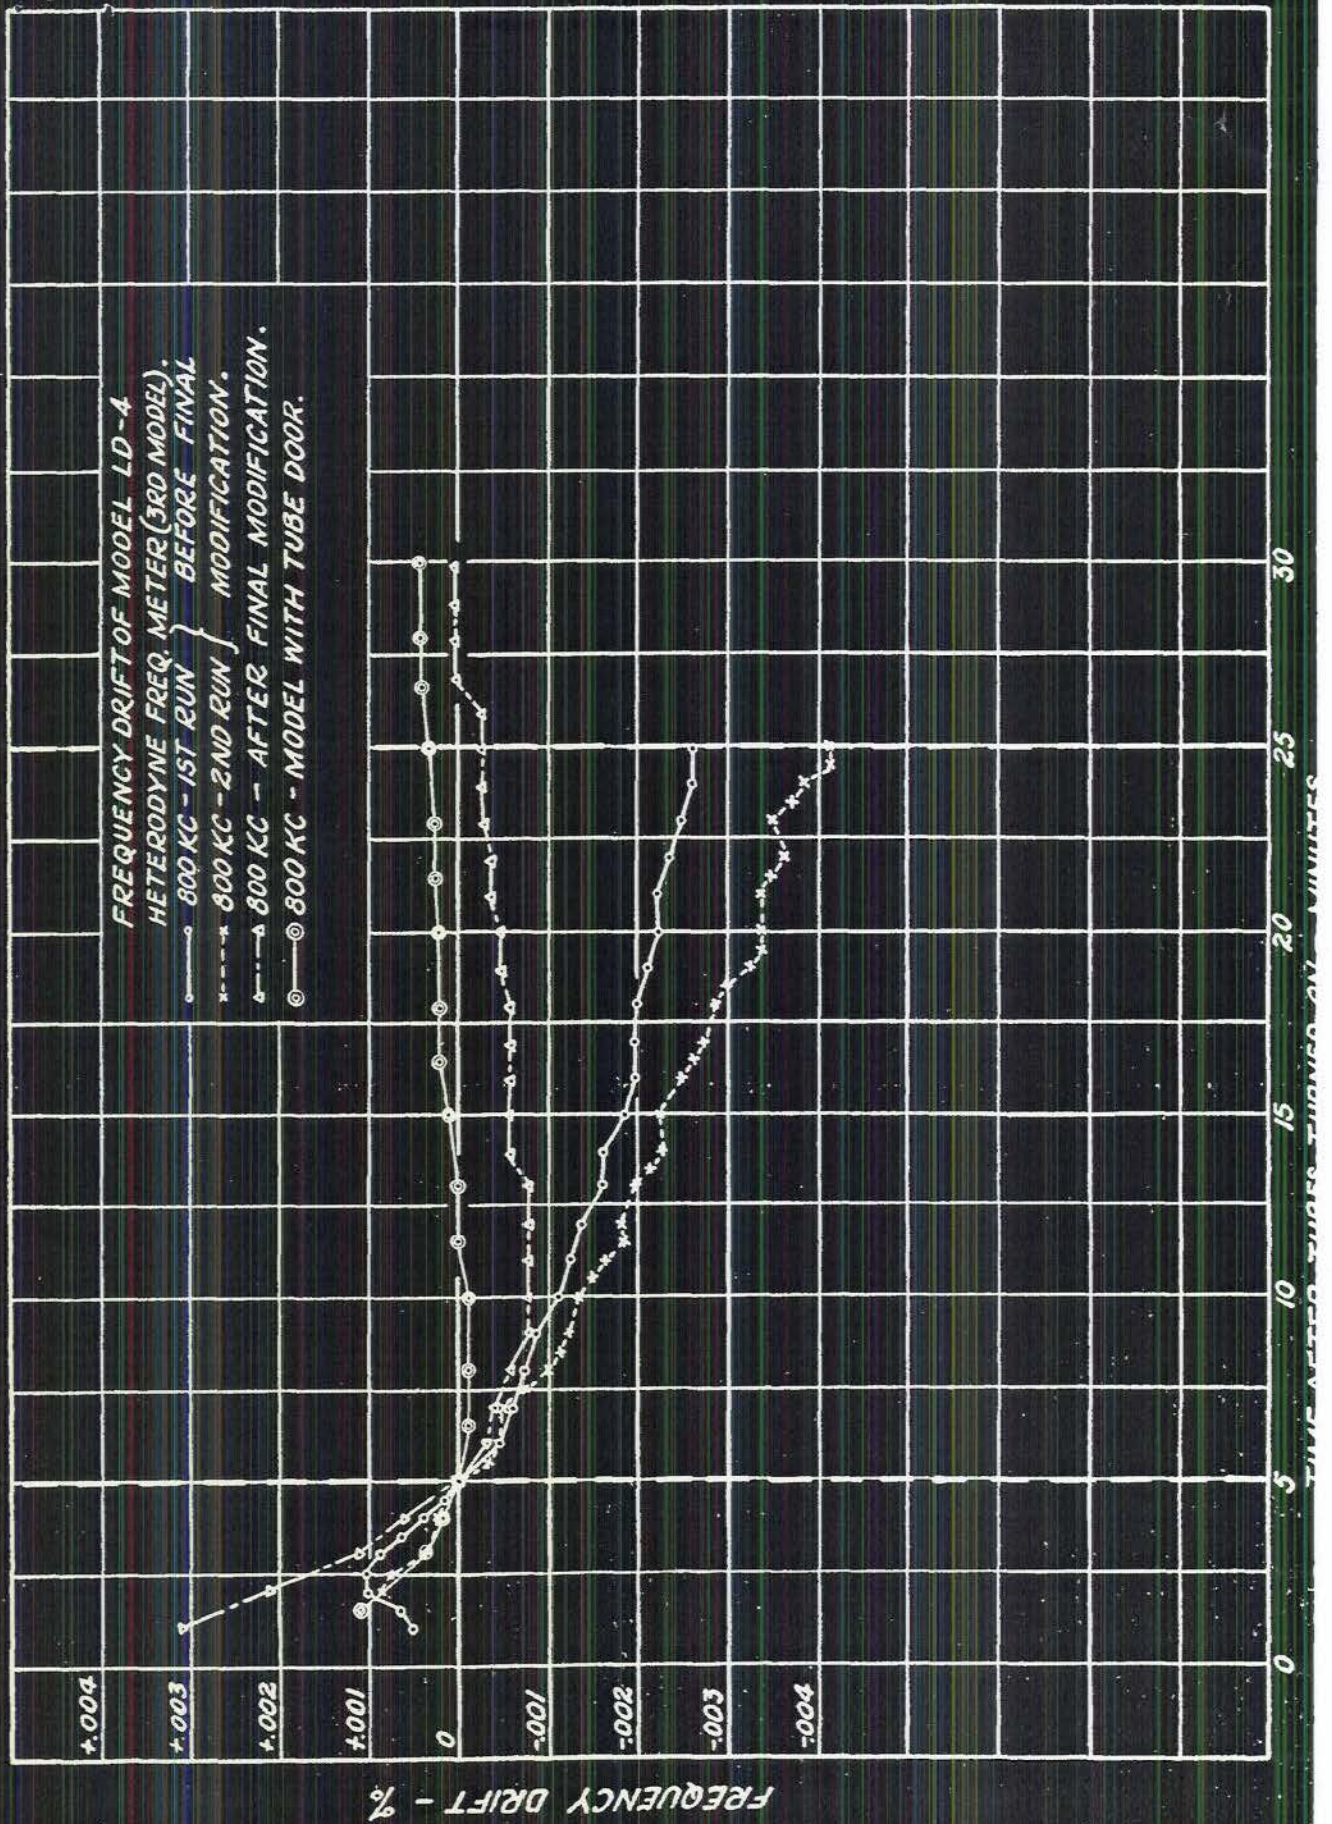
- 4-3. The heterodyne oscillator frequency drift during the warming up period of the vacuum tubes is indicated in Table 1 and Plates 2, 3 and 4. Drift runs were made at 120, 800 and 4500 kilocycles as specified and repeat runs were made at the two higher frequencies. In Table 1 the drift is given in per cent and the specified limit is included for comparison. It will be noted on the first run the frequency drift was in all cases less than the maximum allowed and that the average of the two runs is also below the limit except in the case of the last two periods on the 800 kilocycle test where it is slightly larger. These runs were all made with the heterodyne oscillator heater kept continuously heated by means of a special transformer provided as previously stated. From the curves of Plates 2 and 3 entitled "Before Final Modification", it will be observed that the rate of frequency drift is not appreciably greater during the first five minutes than thereafter.

The frequency drift of the heterodyne oscillator after final modification is given in Table 1 (column 4) and in Plates 2 and 3. These data were taken with the heterodyne oscillator tube heated previous to the beginning of the drift runs as provided in the wiring of the equipment; under this condition the frequency drift is very slight. (Paragraph 4-3.)

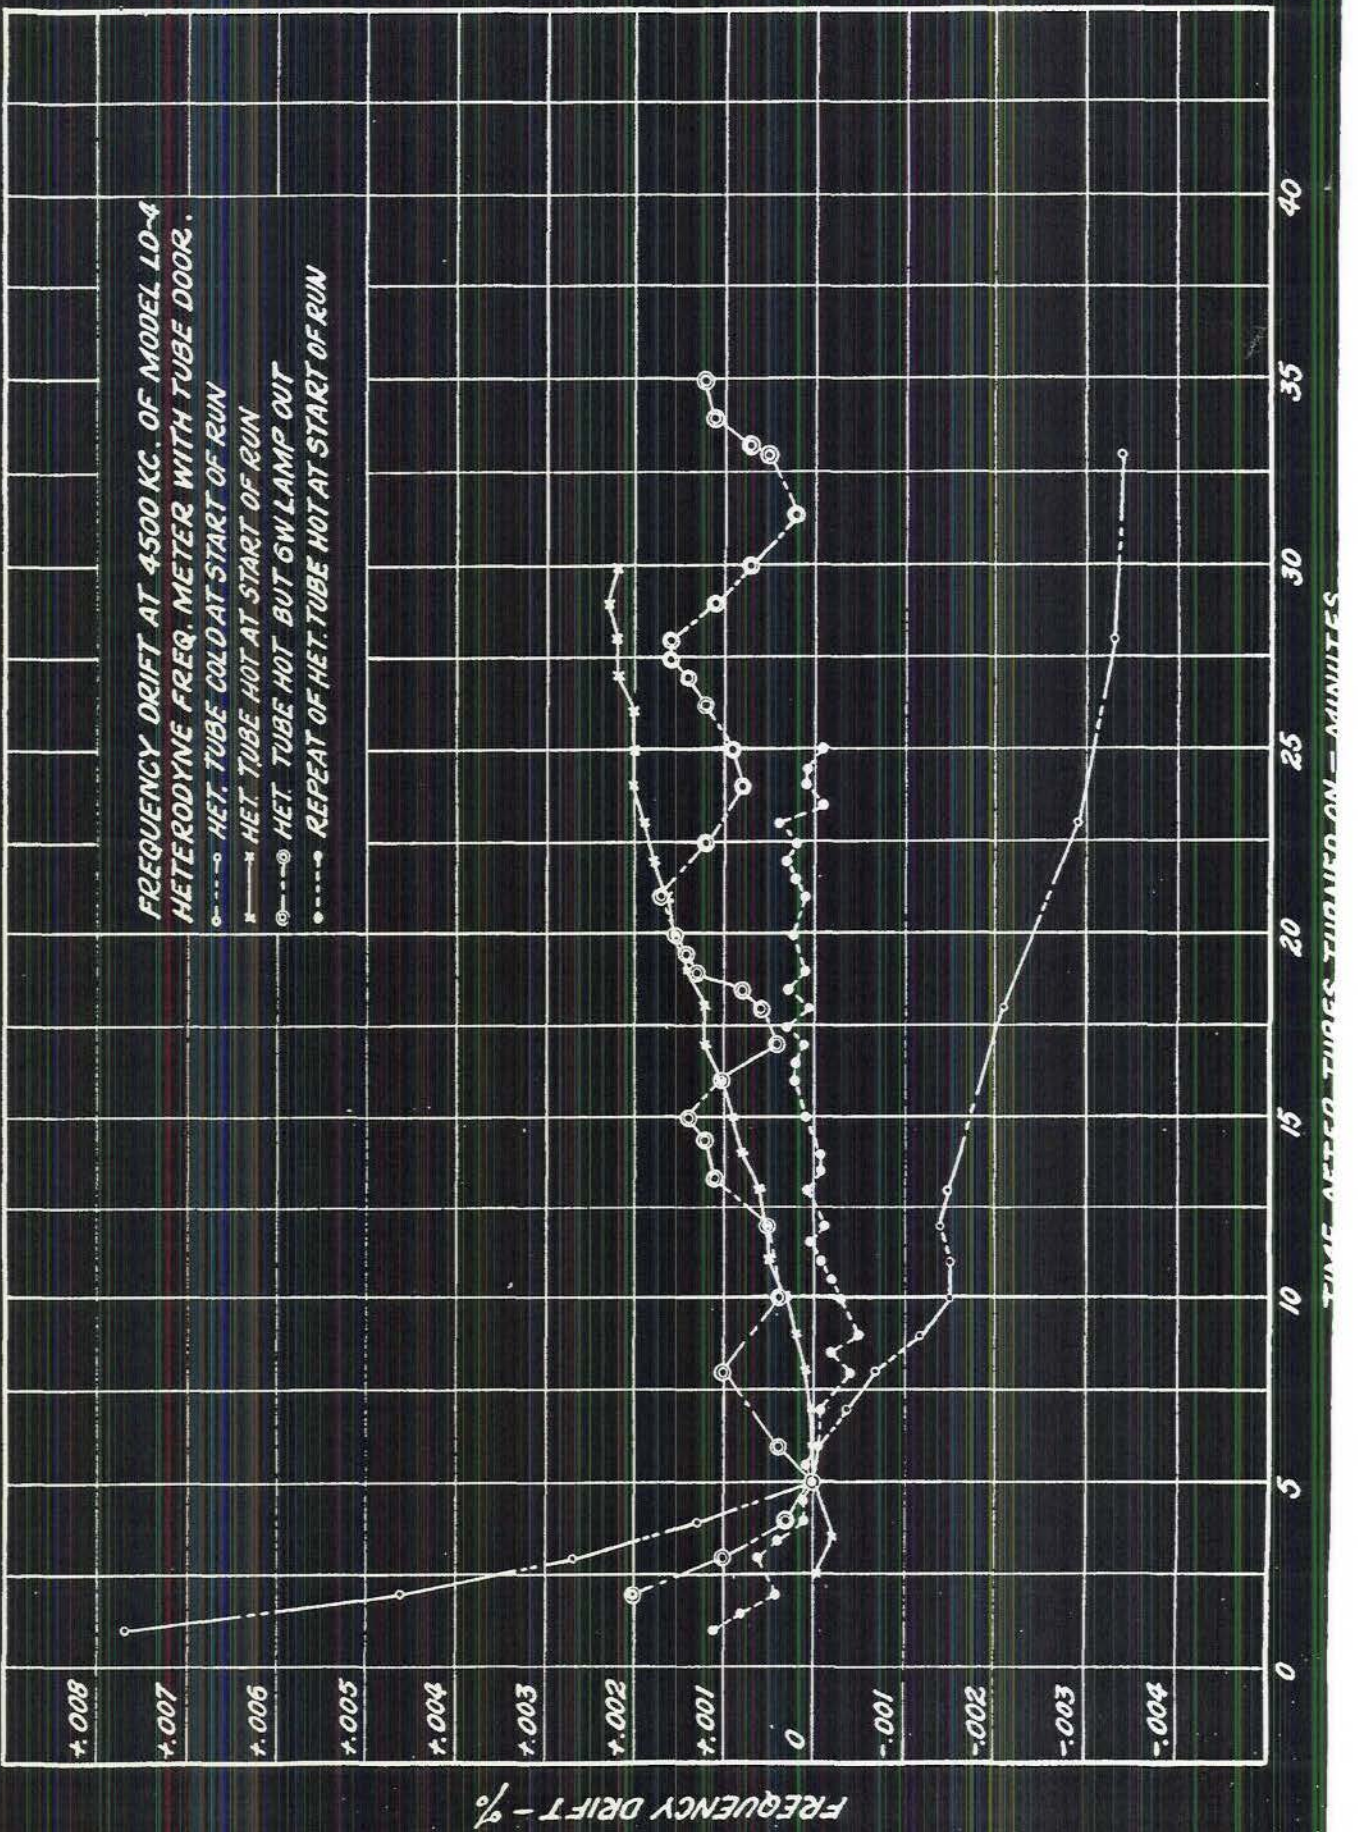
- (b) The frequency of the heterodyne oscillator executed a slight periodic variation corresponding to the heating cycle as shown in one of the curves on Plate 4. The magnitude of this frequency cycle was approximately  $\pm 0.0005\%$ . The failure of this 6 watt lamp in the heater circuit is indicated by the large change in the length of the heat cycle as mentioned just above and also by the absence of the visible illumination caused by the lamp which may be observed through the window provided for reading the tuning condenser dial. Therefore the use of this lamp as part of the heterodyne oscillator heater system is not considered objectionable. (Paragraphs 3-13 and 4-3.)

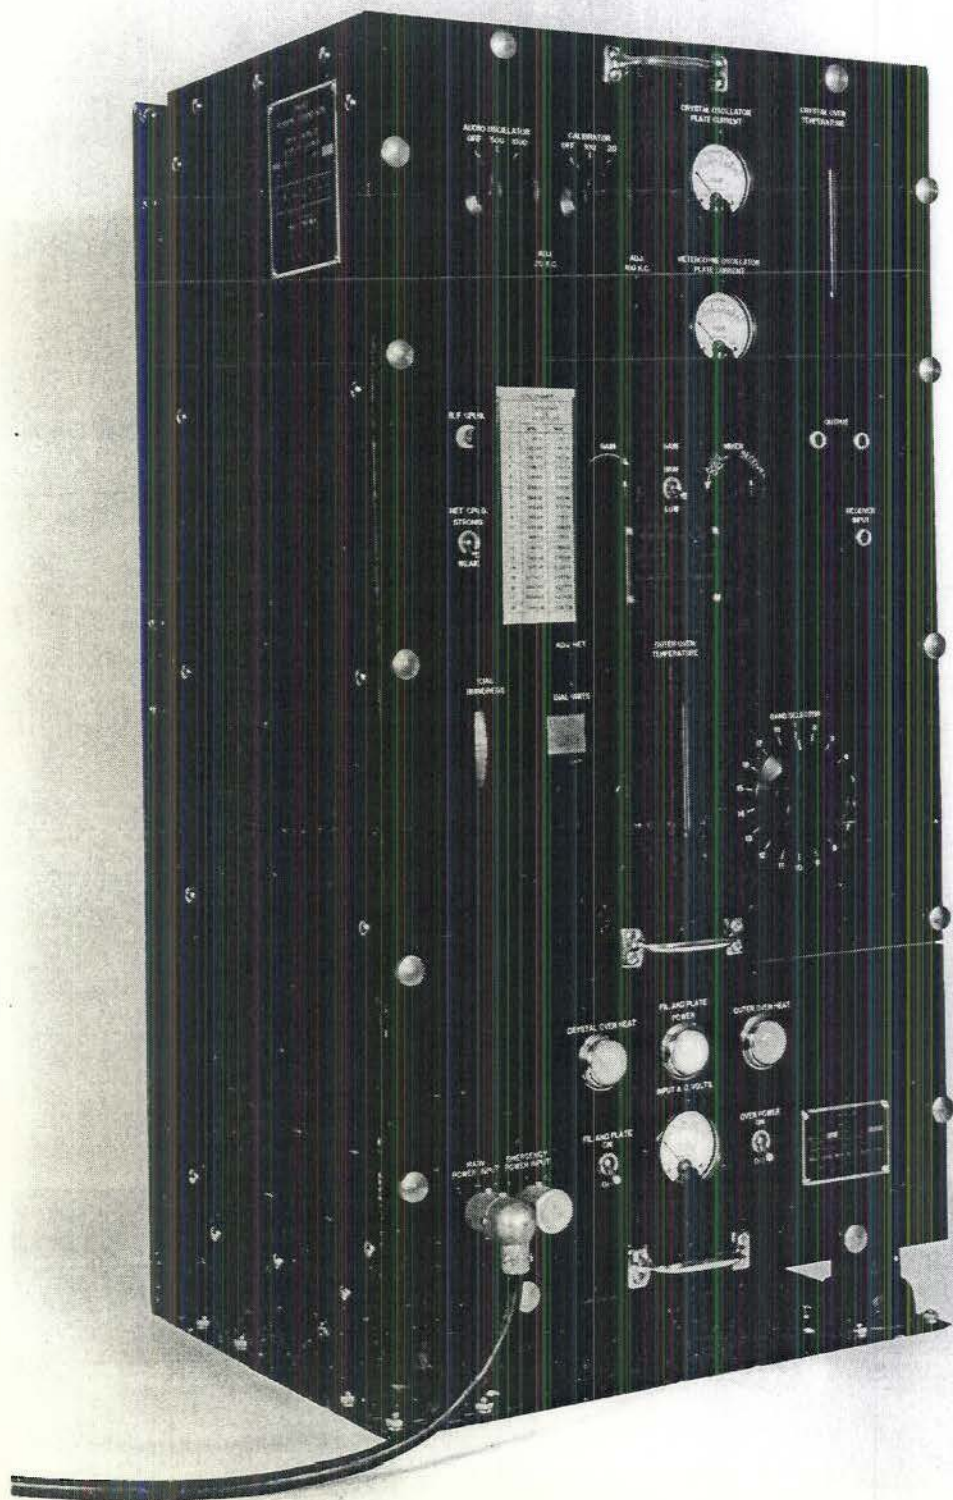
- (i) Name plates have been added as shown in Plate 5.
- (j) The rectifier tube is a Type 38183.
- (k) The window in the panel through which the hundreds of tuning condenser divisions are read has been extended so that two adjacent numbers are visible at all settings of the condenser dial.

1-3. The equipment is contained in one rugged metal cabinet which is mounted in a shock-proof frame. The cabinet contains two compartments, one housing the measuring unit and the other the power unit

as shown in Plate 5. The use of a single cabinet instead of two cabinets clamped together is considered quite satisfactory since the location of the controls is such that no advantage would be gained by mounting the power unit above the measuring unit which would be possible if two separate cabinets were provided.

- 2-22. Name plates are provided as required. See Plate 5.
- 2-23 and 2-24. No comment on these requirements for production equipments is submitted.
- 2-25. The equipment was operated continuously for a number of days without any damage or loss of accuracy, except for change in frequency of crystal #2 discussed in paragraphs 4-24 to 4-28 below.

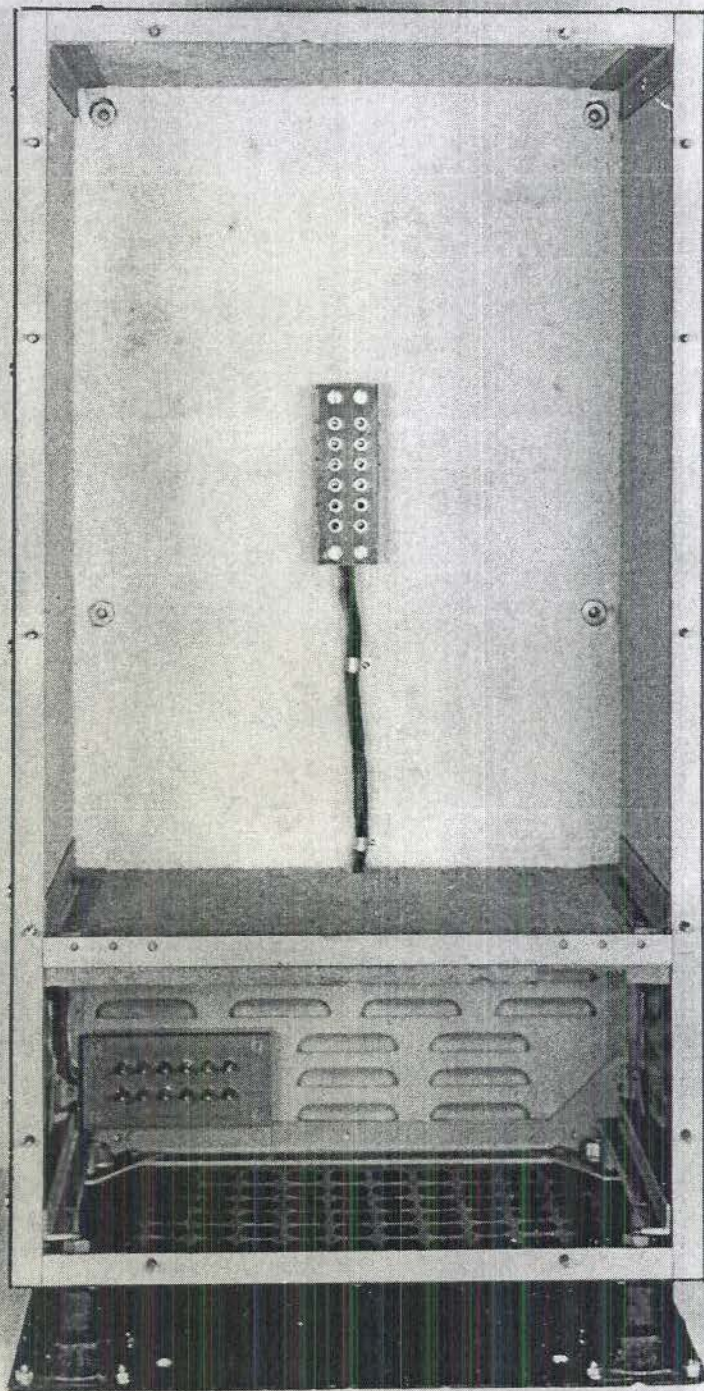
- 2-10. The power unit is suitably ventilated by means of holes in the bottom and three sides of the cabinet, as shown in Plates 5 and 8.
- 2-11. The equipment was operated for a short time at a temperature of approximately  $65^{\circ}$  without any compound flowing out of any container.
